Visual Site Inspection Report

Project Name	H-600 Pipeline Spread I	AFE	124300139	Spread	H-600 Pipeline Spread I
Contractor	Precision			Report #	37701
Inspector	Justin Burch			Date/Time	5/16/2022 11:23 AM
Permit #	TBD	Inspection Type	VA SWPP	Station Begin	15370+62
State	VA	Inspection Area	Full	Station End	15480+67
County	Pittsylvania	Ground	Wet	Temperature (°F)	80.00
Municipality	Chatham	Weather	Cloudy	Rain Gauge (in)	0.60
				Rain Accumulation Time (days)	6.00

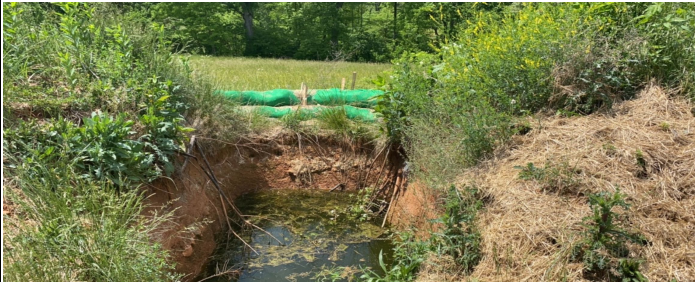
37°0'14" N 79°45'6" W 223°SW COURSE -1' GPS 05.16.2022 12:30:01 Accur +/-25.0 Ft ALT 931 Ft			37°0'9" N 79°45'0" W 159°SE COURSE -1' GPS 05.16.2022 12:32:53 594 Tobacco Rd, Glade Hill, VA 24092, United States Accur +/-104.7 Ft ALT 930 Ft		
GPS Location	1	GPS Location	2		
Field Station#	14552+00	Field Station#	14556+00		
Pic 1 Desc.	Sump pit and CFS end treatment in good condition.		Pic 2 Desc.	ROW stabilized and vegetated in temporary area.

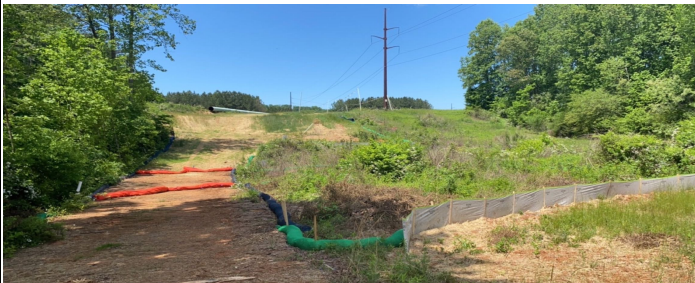
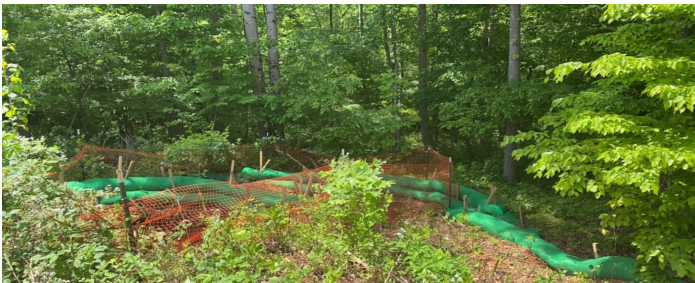
Pic 3 Desc.	Equipment bridge and surrounding ECDs in place and functional at stream crossing and resource buffer.		Pic 4 Desc.	CFS triple stacks in place and functional.

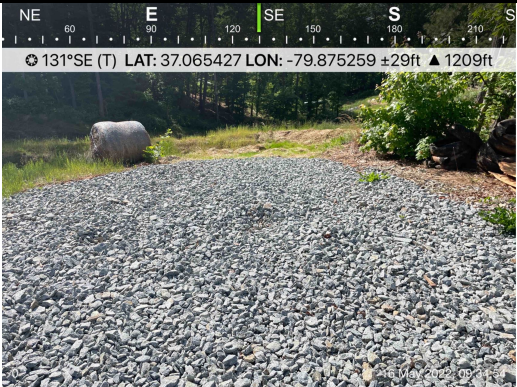
GPS Location	See photo		GPS Location	See photo	
Field Station#	14062+17		Field Station#	14066+77	
Pic 1 Desc.	RCEs are in good condition at all road crossings		Pic 2 Desc.	Equipment bridge ECDs are in good condition and functioning

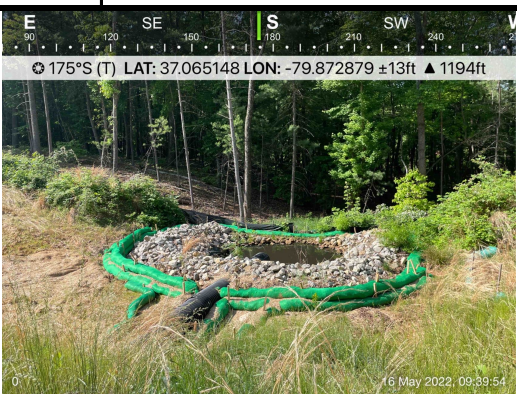
GPS Location	See photo		GPS Location	See photo	
Field Station#	14070+00		Field Station#	14081+53	
Pic 3 Desc.	CWDs are functioning as intended		Pic 4 Desc.	Safety fence needs to be repaired along MVP-FR-309.05

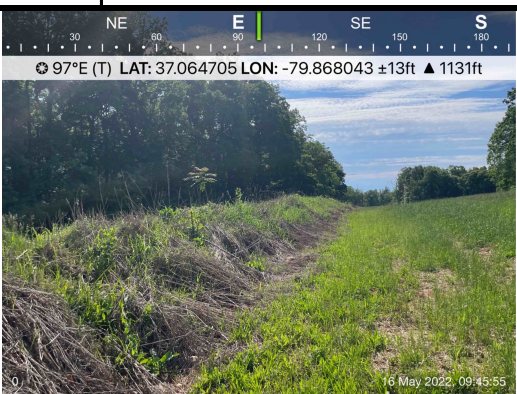
GPS Location	See photo		GPS Location	See photo	
Field Station#	14085+00		Field Station#	14093+00	
Pic 5 Desc.	Topsoil berms remain stabilized		Pic 6 Desc.	Mowers abandoned on ROW. LEI has been notified

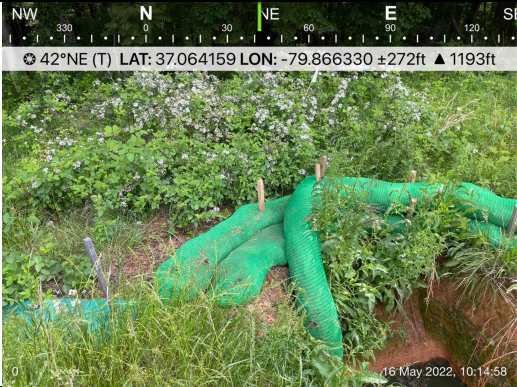
GPS Location	See photo		GPS Location	See photo	
Field Station#	14093+00		Field Station#	14093+00	
Pic 7 Desc.	CFS has been displaced by 3rd party and needs to be restaked		Pic 8 Desc.	CFS has been damaged by 3rd party and needs to be replaced with waddles.

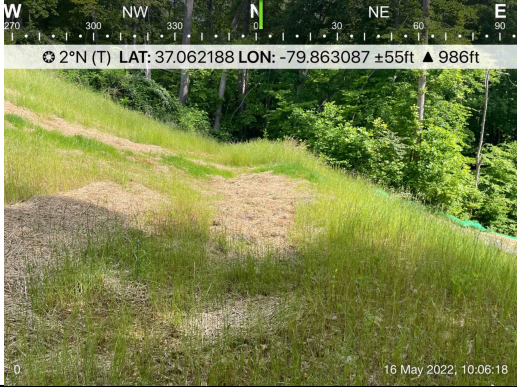
GPS Location	See photo		GPS Location	See photo	
Field Station#	14104+00		Field Station#	14105+32	
Pic 9 Desc.	Waterbars are functioning as intended		Pic 10 Desc.	Resource buffers remain well vegetated

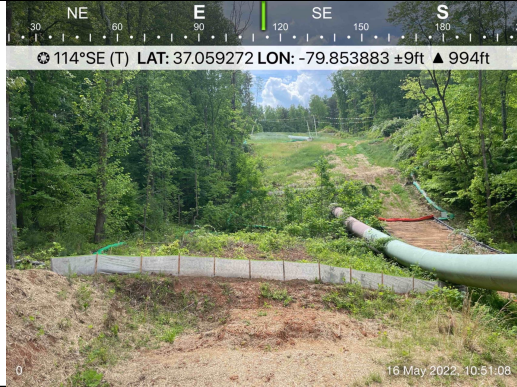
GPS Location	See photo		GPS Location	See photo	
Field Station#	14141+62		Field Station#	14156+00	
Pic 11 Desc.	P1 is in good condition at all stream and wetland buffers		Pic 12 Desc.	Slope drain is in good condition and functioning

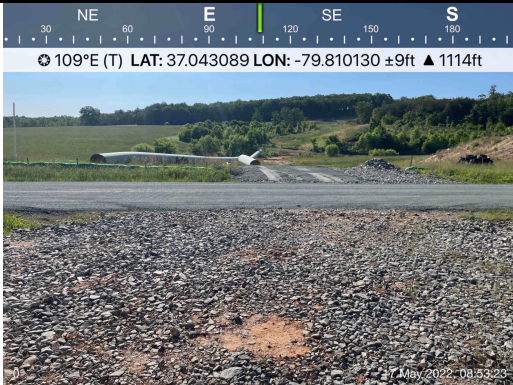
GPS Location	See photo		GPS Location	See photo	
Field Station#	14311+57		Field Station#	14307+00	
Pic 1 Desc.	RCEs are in good condition at all road crossings		Pic 2 Desc.	CWDs are functioning as intended

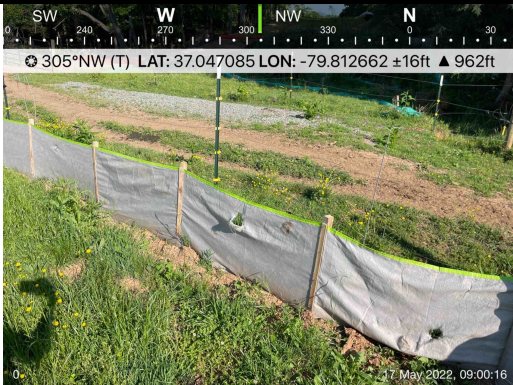
GPS Location	See photo		GPS Location	See photo	
Field Station#	14294+57		Field Station#	14293+00	
Pic 3 Desc.	P1 has been damaged by livestock and needs to be replaced		Pic 4 Desc.	SSF is in good condition

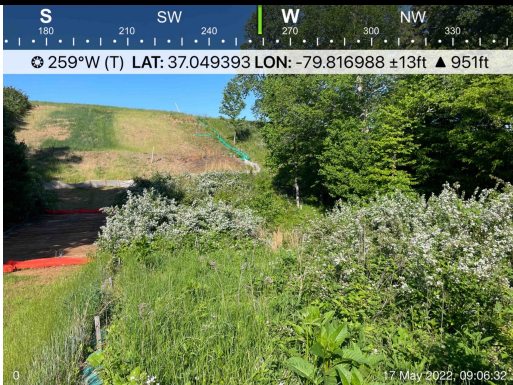
GPS Location	See photo		GPS Location	See photo	
Field Station#	14279+00		Field Station#	14273+00	
Pic 5 Desc.	Resource buffers remain well vegetated		Pic 6 Desc.	CFS is in good condition along drainage

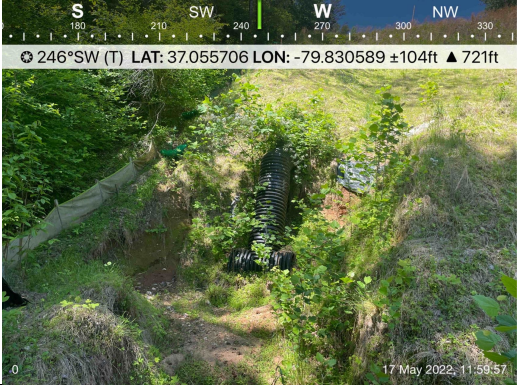
GPS Location	See photo		GPS Location	See photo	
Field Station#	14232+00		Field Station#	14223+41	
Pic 7 Desc.	Slope drain is in good condition		Pic 8 Desc.	MVP-FR-311 is in good condition with controls in place

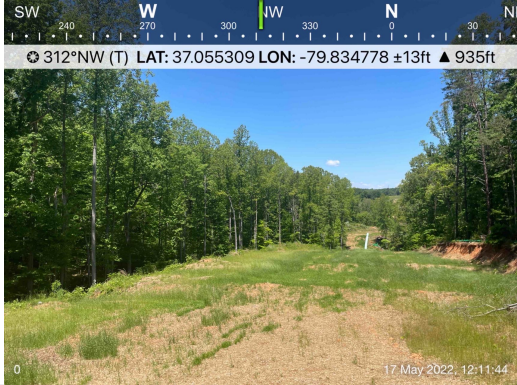
GPS Location	See photo		GPS Location	See photo	
Field Station#	14220+00		Field Station#	14189+00	
Pic 9 Desc.	Vegetation continues to fill in throughout this section		Pic 10 Desc.	Resource buffer is in good condition around avian nesting area.

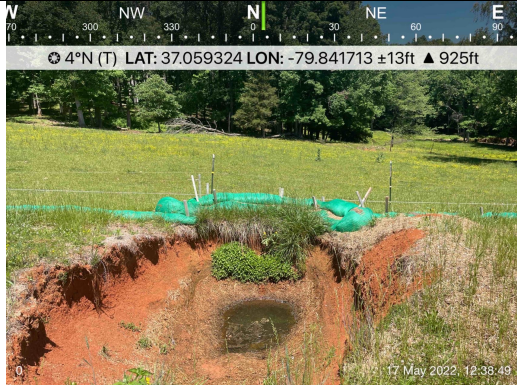
GPS Location	See photo		GPS Location	See photo	
Field Station#	14185+00		Field Station#	14176+09	
Pic 11 Desc.	Waterbars end treatments are in good condition		Pic 12 Desc.	Equipment bridge ECDs are in good condition

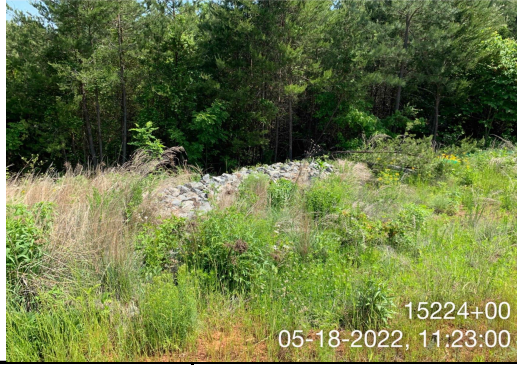
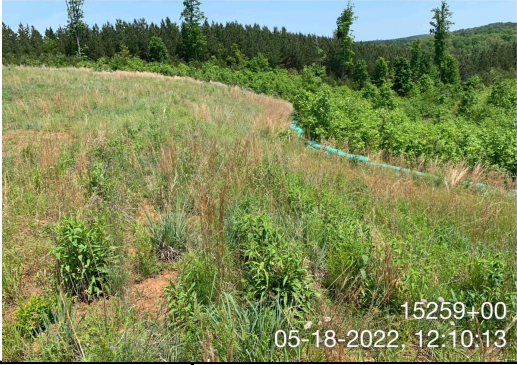
GPS Location	0	GPS Location	0		
Field Station#	15224+00	Field Station#	15259+00		
Pic 11 Desc.	Waterbar end treatment in acceptable condition	Pic 12 Desc.	Permanent vegetative stabilization and perimeter CFS in acceptable conditions

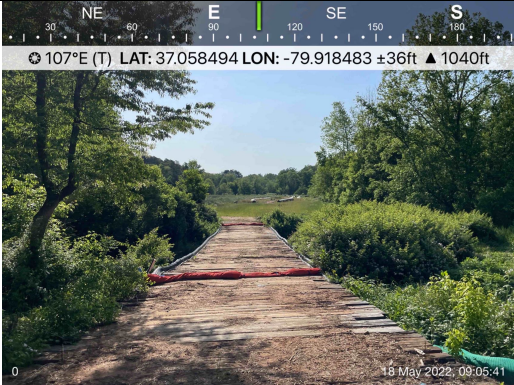
GPS Location	See photo	GPS Location	See photo		
Field Station#	13863+01	Field Station#	13863+01		
Pic 1 Desc.	Equipment bridge ECDs are in good condition and functioning	Pic 2 Desc.	Resource buffers remain well vegetated

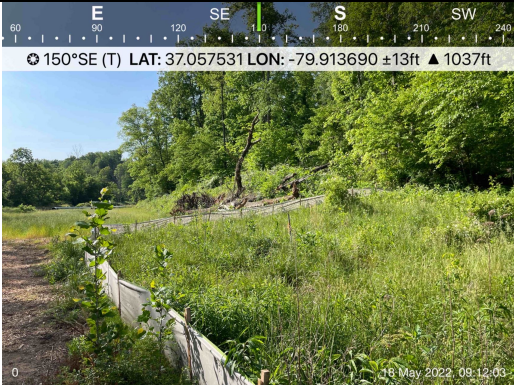
GPS Location	See photo	GPS Location	See photo		
Field Station#	13876+00	Field Station#	13889+00		
Pic 3 Desc.	P1 is in good condition at all stream and wetland buffers	Pic 4 Desc.	Slope drain is in good condition

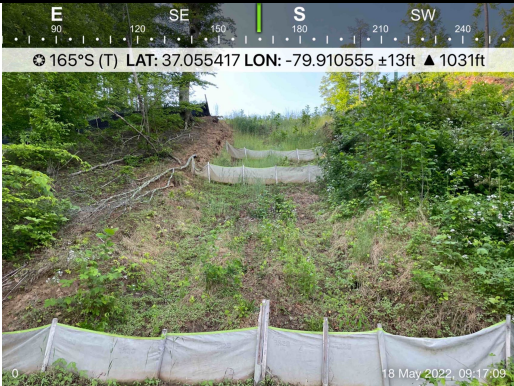
GPS Location	See photo	GPS Location	See photo		
Field Station#	13889+00	Field Station#	13892+45		
Pic 5 Desc.	Slope remains stabilized	Pic 6 Desc.	RCEs are in good condition at all road crossings

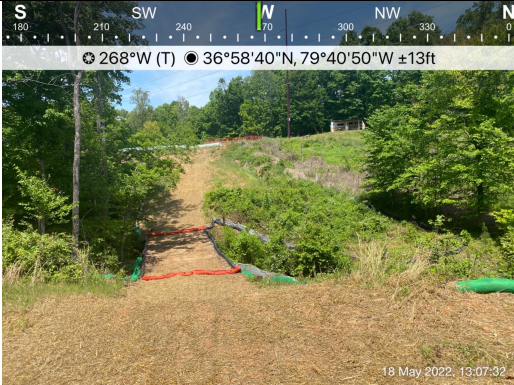
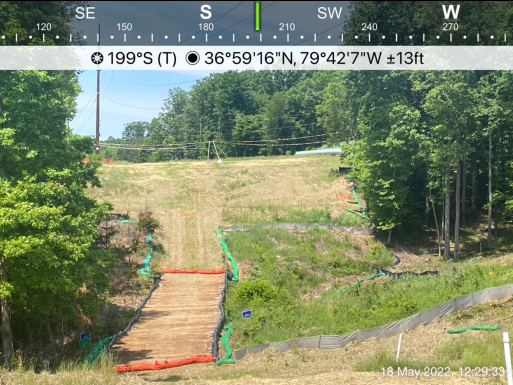
GPS Location	0	GPS Location	0		
Field Station#	14794+00	Field Station#	14716+00		
Pic 1 Desc.	Approximately 14794+00. Overview of stream crossing, equipment bridge and ECDs at stream S-H24.		Pic 2 Desc.	Approximately 14716+00. Overview of wetland crossing, equipment bridge and ECDs at wetland W-H11. Third party ground disturbance and ECDs uphill and on north side.

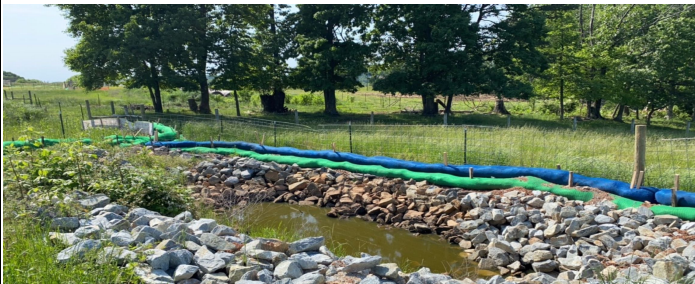
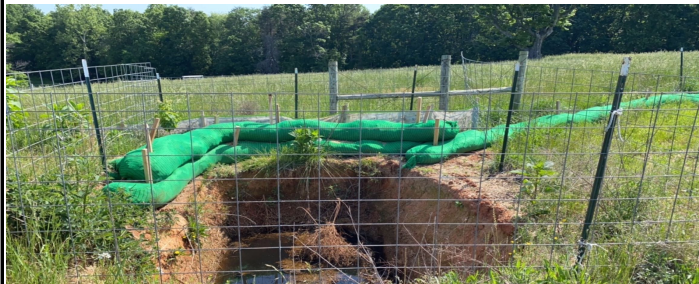
37°2'8" N 79°47'47" W 211°SW COURSE 214' GPS Glade Hill, VA 24092, United States 05.18.2022 10:22:21 Accur +/-16.5 Ft ALT 1098 Ft			37°2'9" N 79°47'43" W 168°S COURSE 95' GPS Glade Hill, VA 24092, United States 05.18.2022 10:20:33 Accur +/-24.6 Ft ALT 1104 Ft		
GPS Location	1	GPS Location	2		
Field Station#	14360+00	Field Station#	14365+00		
Pic 1 Desc.	Plunge pool in place and functional.	Pic 2 Desc.	Sump pit and CFS end treatment performing intended functions.

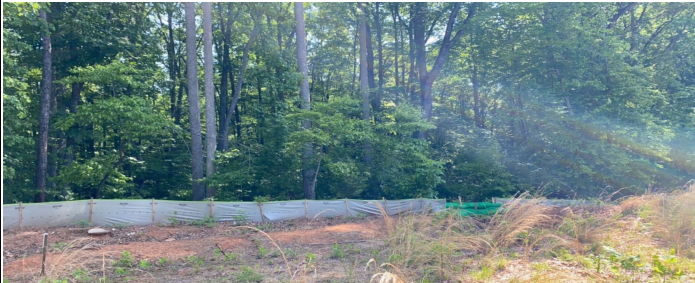
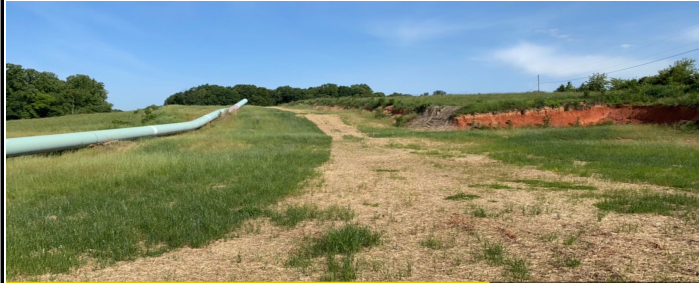
37°1'43" N 79°46'28" W 341°N COURSE 139' GPS Glade Hill, VA 24092, United States 05.18.2022 10:03:25 Accur +/-15.7 Ft ALT 1026 Ft			37°1'37" N 79°46'7" W 345°N COURSE 0' GPS 201-483 Old Carriage Rd, Glade Hill, VA 24092, United States 05.18.2022 09:55:07 Accur +/-79.7 Ft ALT 0 Ft		
GPS Location	5	GPS Location	6		
Field Station#	14437+00	Field Station#	14451+00		
Pic 5 Desc.	Perimeter P1 silt fence in good condition.	Pic 6 Desc.	ROW stabilized and vegetated in temporary area.

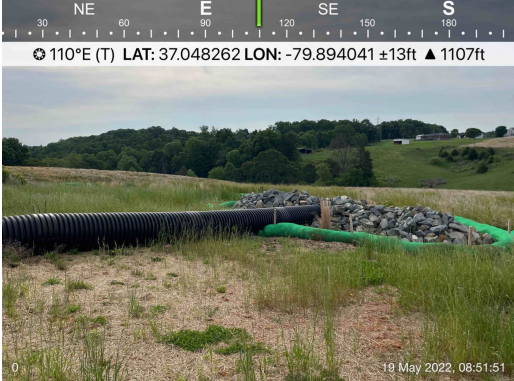
GPS Location	See photo		GPS Location	See photo	
Field Station#	13960+00		Field Station#	13970+00	
Pic 1 Desc.	CWDs are functioning as intended		Pic 2 Desc.	Vegetation continues to fill in throughout this section

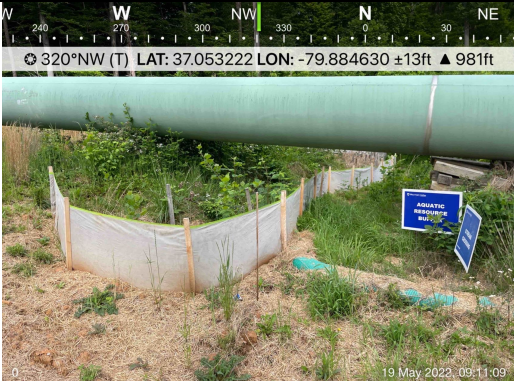
GPS Location	See photo		GPS Location	See photo	
Field Station#	13998+15		Field Station#	13998+15	
Pic 3 Desc.	P1 is in good condition at S-KL36 buffer.		Pic 4 Desc.	Equipment bridge ECDs are in good condition and functioning

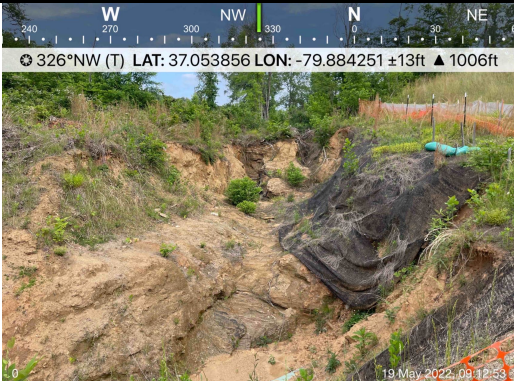
GPS Location	See photo		GPS Location	See photo	
Field Station#	14000+00		Field Station#	14009+11	
Pic 5 Desc.	No evidence of 3rd party pond discharging onto ROW.		Pic 6 Desc.	Slope remains stabilized

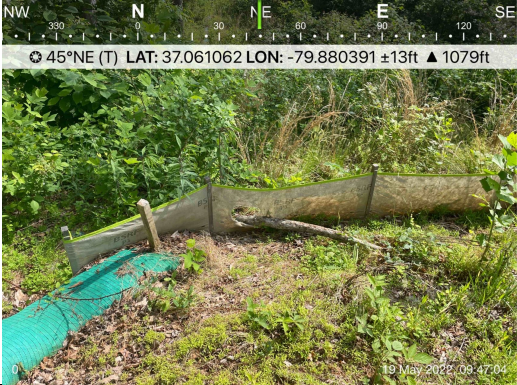
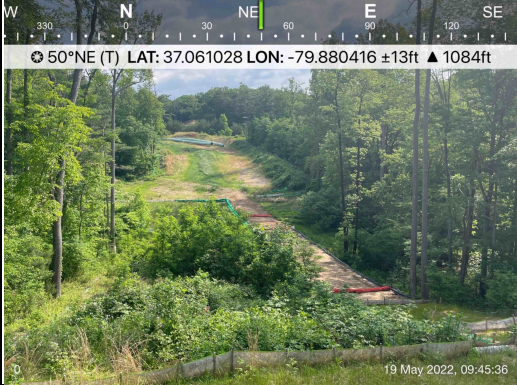
<p>50°NE (T) LAT: 37.061028 LON: -79.880416 ±13ft ▲ 1084ft</p> <p>19 May 2022, 09:45:36</p>			
GPS Location	See photo		GPS Location	See photo	
Field Station#	14035+00		Field Station#	14035+28	
Pic 13 Desc.	Buffer P1 has been damaged and needs to be replaced		Pic 14 Desc.	Resource buffers remain well vegetated

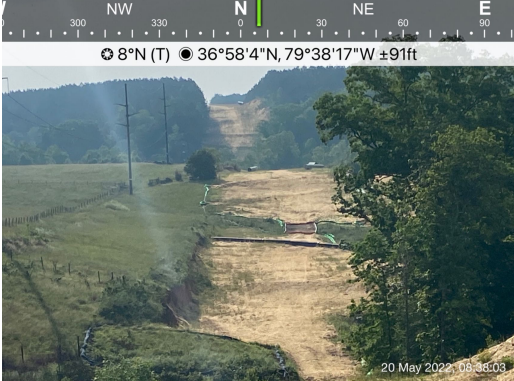
GPS Location	0	GPS Location	0		
Field Station#	14935+00	Field Station#	15062+00		
Pic 1 Desc.	Approximately 14935+00. Overview of ROW.		Pic 2 Desc.	Approximately 14062+00. Overview of ROW.

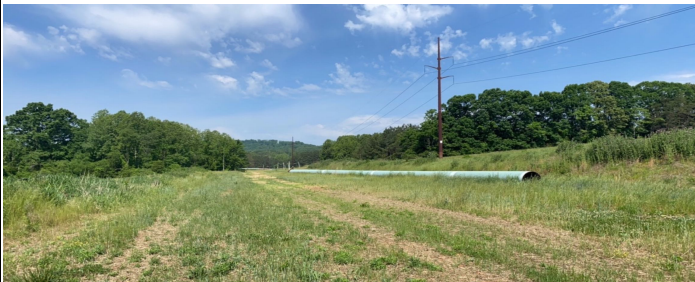
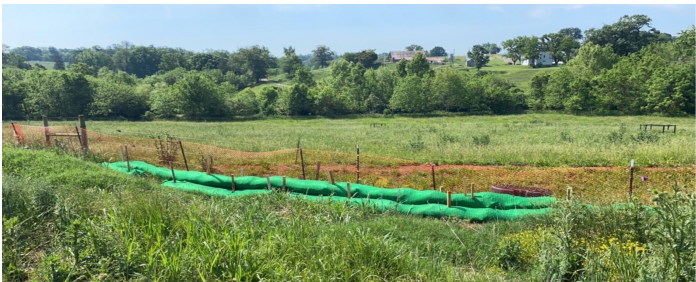
37°02' N 79°44'43" W 330°NW COURSE 268° GPS Glade Hill, VA 24092, United States 05.20.2022 10:38:25 Accur +/-22.4 Ft ALT 883 Ft			37°02' N 79°44'41" W 228°SW COURSE 294° GPS Glade Hill, VA 24092, United States 05.20.2022 10:38:10 Accur +/-122.2 Ft ALT 877 Ft		
GPS Location	1	GPS Location	2		
Field Station#	14571+00	Field Station#	14575+00		
Pic 1 Desc.	ROW stabilized and vegetated in temporary area.	Pic 2 Desc.	Perimeter CFS triple stack in good condition.

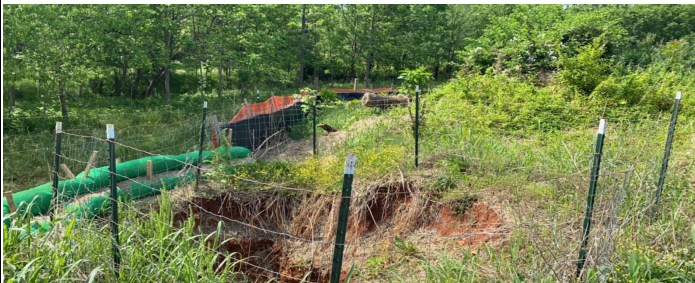
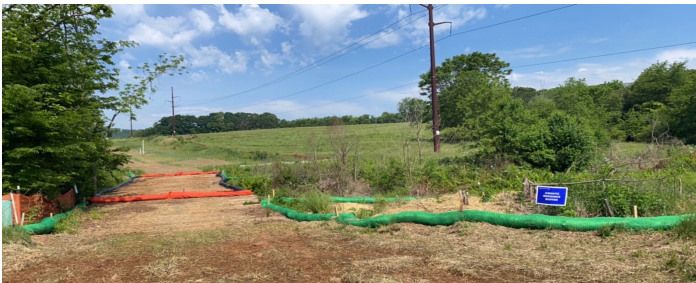
Pic 3 Desc.	Sump pit and CFS end treatment performing intended functions.	Pic 4 Desc.	Equipment bridge and surrounding ECDs in place and functional at stream crossing and resource buffer; signage visible and intact.

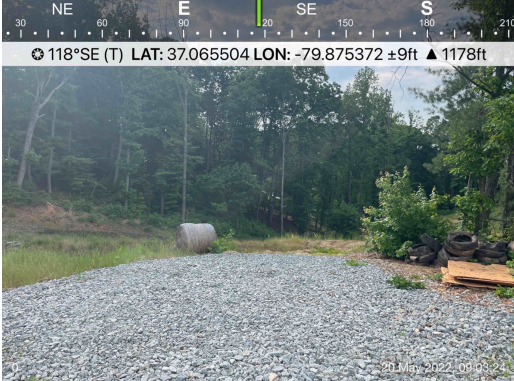
GPS Location	See photo		GPS Location	See photo	
Field Station#	14062+17		Field Station#	14066+77	
Pic 1 Desc.	RCEs are in good condition at all road crossings		Pic 2 Desc.	Equipment bridge ECDs are in good condition and functioning

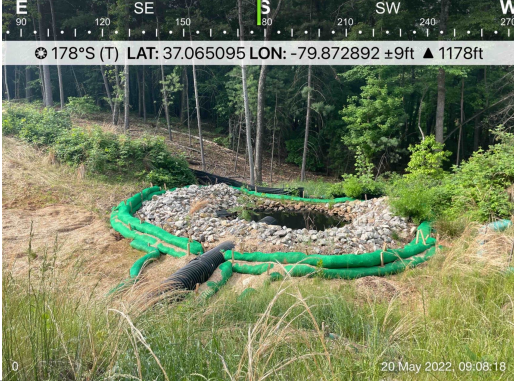
GPS Location	See photo		GPS Location	See photo	
Field Station#	14070+00		Field Station#	14081+53	
Pic 3 Desc.	CWDs are functioning as intended		Pic 4 Desc.	MVP-FR-309.05 is in good condition with controls in place

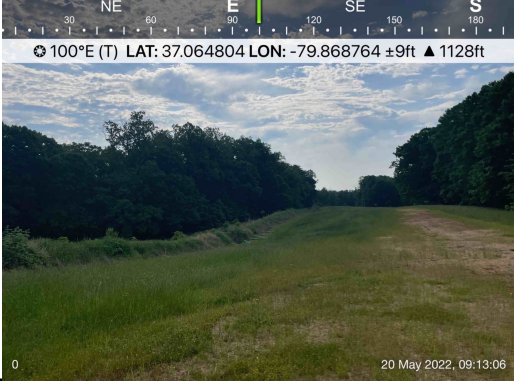
GPS Location	See photo		GPS Location	See photo	
Field Station#	14085+00		Field Station#	14090+00	
Pic 5 Desc.	Vegetation continues to fill in throughout this section		Pic 6 Desc.	Topsoil berms remain stabilized

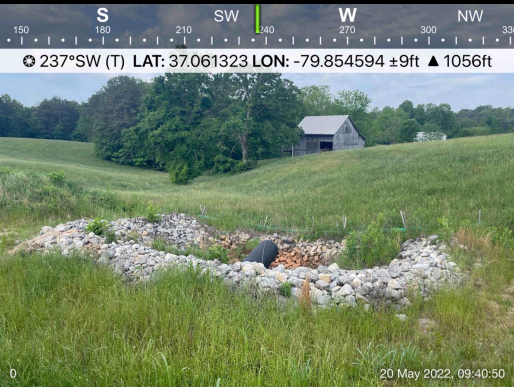
GPS Location	See photo		GPS Location	See photo	
Field Station#	14132+00		Field Station#	14141+00	
Pic 7 Desc.	CWD is functioning as intended		Pic 8 Desc.	P1 is in good condition at all stream and wetland buffers

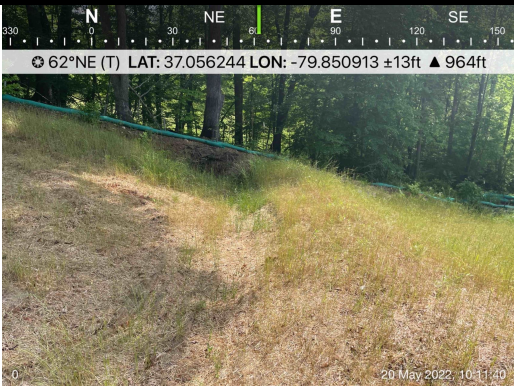
GPS Location	See photo		GPS Location	See photo	
Field Station#	14155+00		Field Station#	14156+00	
Pic 9 Desc.	Waterbars are in good condition		Pic 10 Desc.	Slope drain is in good condition and functioning

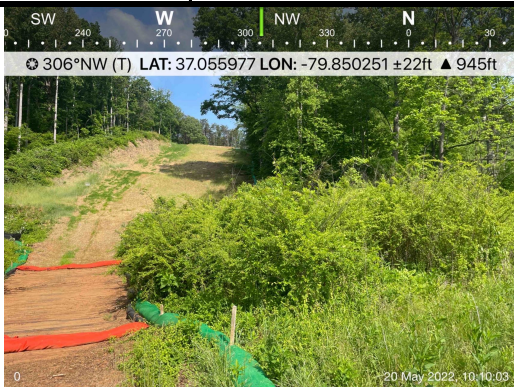
GPS Location	See photo		GPS Location	See photo	
Field Station#	14157+55		Field Station#	14163+00	
Pic 11 Desc.	Resource buffers remain well vegetated		Pic 12 Desc.	CFS is in good condition
