Visual Site Inspection Report

Project Name	H-600 Pipeline Spread I	AFE	124300139	Spread	H-600 Pipeline Spread I
Contractor	Precision			Report #	37935
Inspector	Glenn Mike Renfro			Date/Time	5/23/2022 12:15 PM
Permit #	TBD	Inspection Type	VA SWPP	Station Begin	0000+00
State	VA	Inspection Area	Full	Station End	0000+00
County	Franklin	Ground	Dry	Temperature (°F)	70.00
Municipality	N/A	Weather	Cloudy	Rain Gauge (in)	0.20
				Rain Accumulation Time (days)	6.00

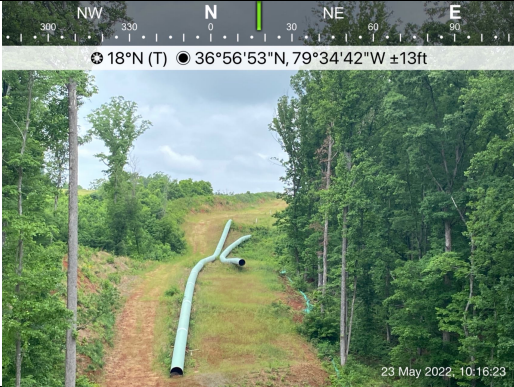
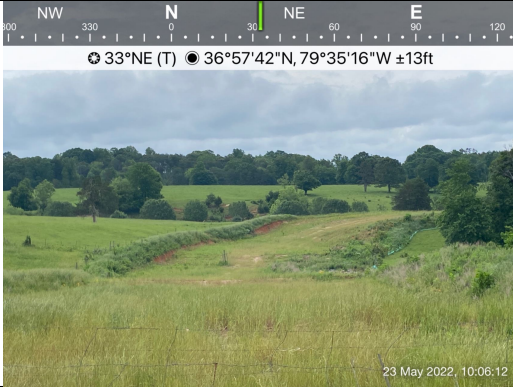
GPS Location	0	GPS Location	0		
Field Station#	15136+00	Field Station#	15086+00		
Pic 1 Desc.	Approximately 15136+00. Overview of ROW.		Pic 2 Desc.	Approximately 15086+00. Overview of ROW.

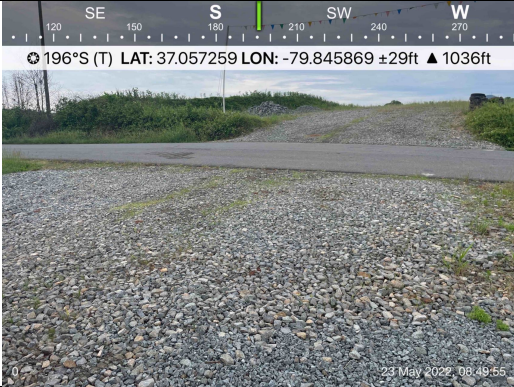
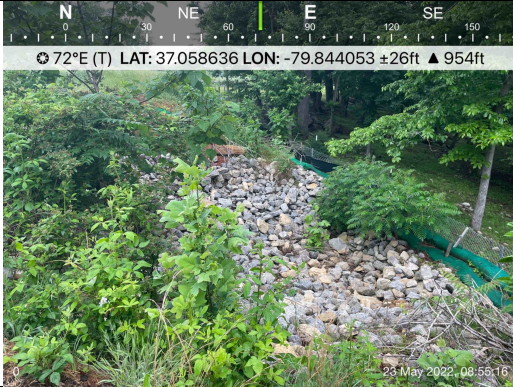
GPS Location	See photo		GPS Location	See photo	
Field Station#	14171+36		Field Station#	14180+00	
Pic 1 Desc.	RCEs are in good condition and functioning		Pic 2 Desc.	CWDs are functioning as intended

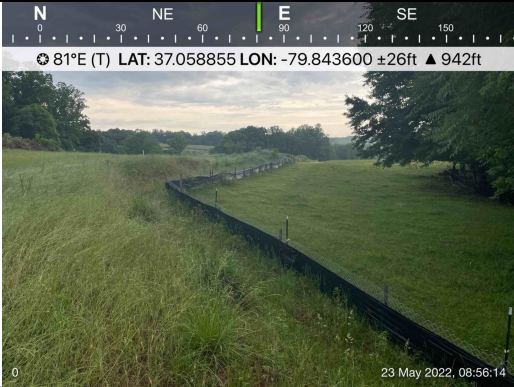
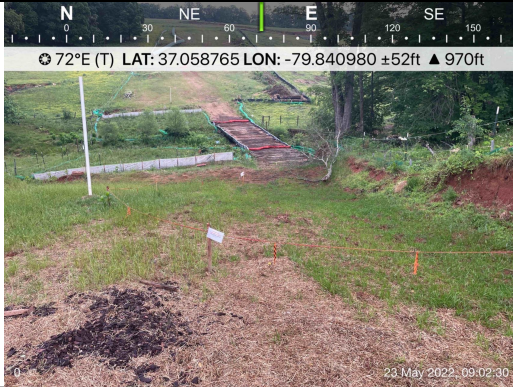
GPS Location	See photo		GPS Location	See photo	
Field Station#	14181+00		Field Station#	14189+00	
Pic 3 Desc.	SSF is in good condition throughout this section		Pic 4 Desc.	Avian nesting buffer remains in good condition

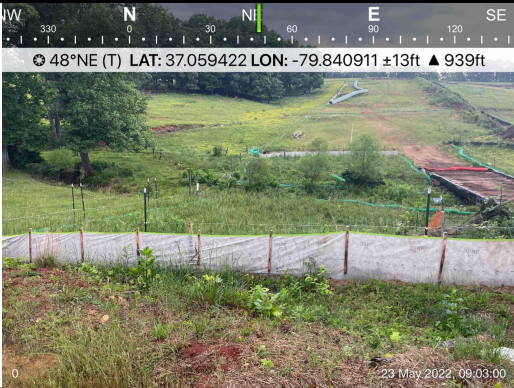
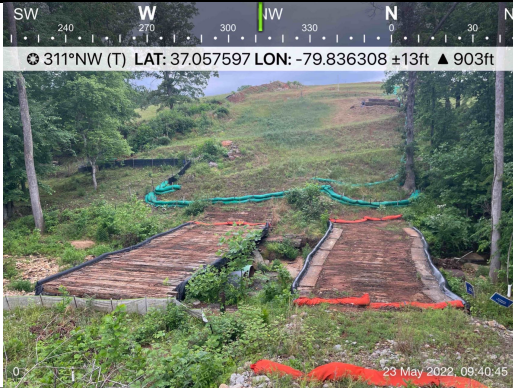
GPS Location	See photo		GPS Location	See photo	
Field Station#	14190+00		Field Station#	14209+02	
Pic 5 Desc.	P1 is in good condition at all stream and wetland buffers		Pic 6 Desc.	Equipment bridge ECDs are in good condition and functioning

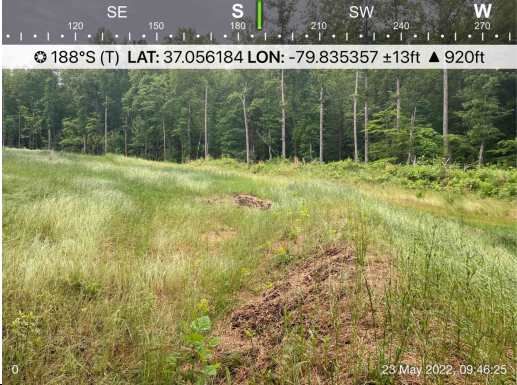
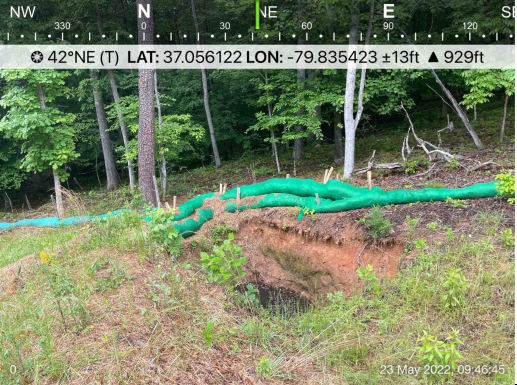
GPS Location	See photo	GPS Location	See photo		
Field Station#	14215+00	Field Station#	14215+00		
Pic 7 Desc.	Waterbars are functioning as intended	Pic 8 Desc.	End treatments are in good condition and functioning

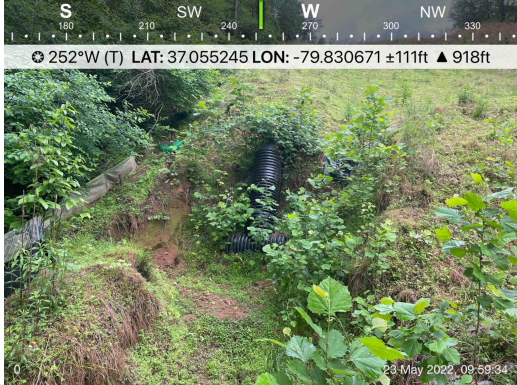
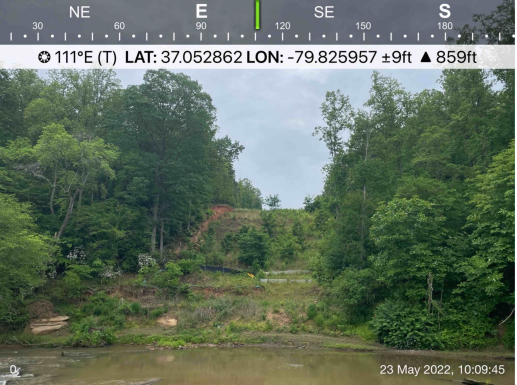
GPS Location	See photo	GPS Location	See photo		
Field Station#	14232+00	Field Station#	14250+00		
Pic 9 Desc.	Slope drain is in good condition	Pic 10 Desc.	Slope on the GAS of S-F11 remains stabilized with controls in place

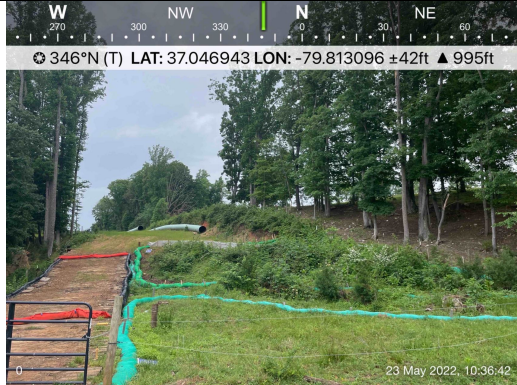
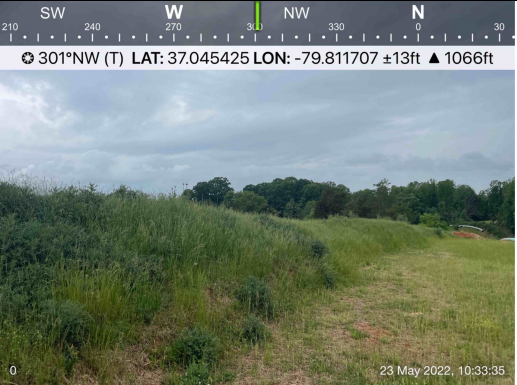
GPS Location	See photo	GPS Location	See photo		
Field Station#	14294+36	Field Station#	14297+00		
Pic 11 Desc.	Resource buffers remain well vegetated	Pic 12 Desc.	Topsoil berms remain stabilized

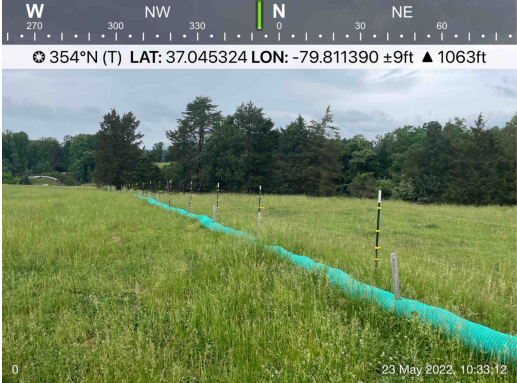
Insert image here			
GPS Location	See photo	GPS Location			
Field Station#	14300+00	Field Station#			
Pic 13 Desc.	CFS is in good condition throughout this section.	Pic 14 Desc.			
Insert image here		Insert image here			
GPS Location		GPS Location			
Field Station#		Field Station#			
Pic 15 Desc.		Pic 16 Desc.			
Insert image here		Insert image here			
GPS Location		GPS Location			
Field Station#		Field Station#			
Pic 17 Desc.		Pic 18 Desc.

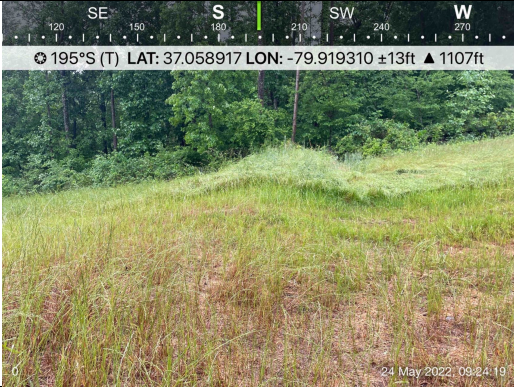
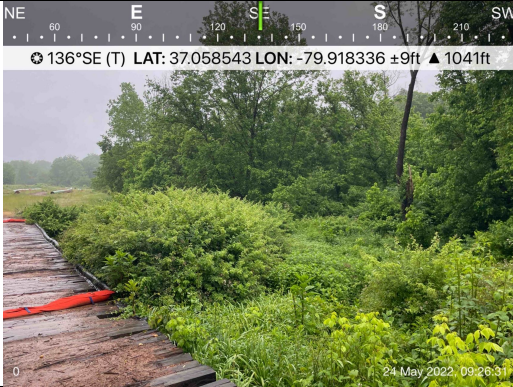
GPS Location	See photo	GPS Location	See photo		
Field Station#	13860+00	Field Station#	13862+60		
Pic 1 Desc.	Waterbars are in good condition	Pic 2 Desc.	Resource buffers remain well vegetated

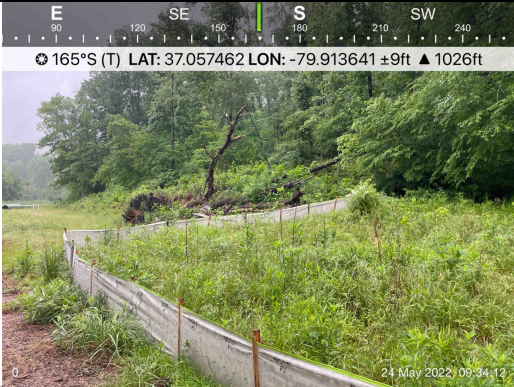
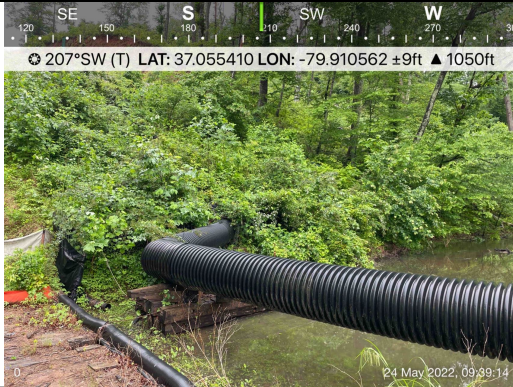
GPS Location	See photo	GPS Location	See photo		
Field Station#	13876+00	Field Station#	13889+00		
Pic 3 Desc.	P1 is in good condition at all stream and wetland buffers	Pic 4 Desc.	Slope drain is functioning as intended

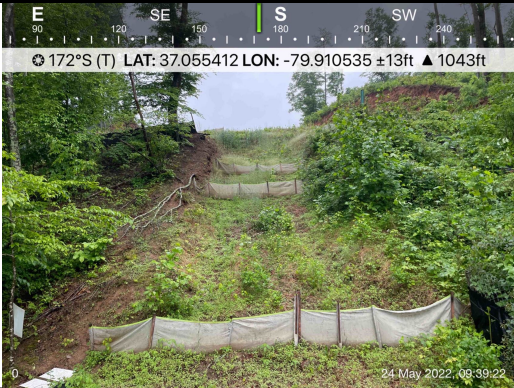
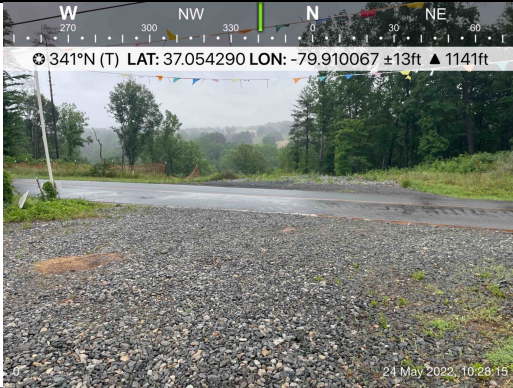
GPS Location	See photo	GPS Location	See photo		
Field Station#	13889+00	Field Station#	13892+45		
Pic 5 Desc.	Slope remains stabilized	Pic 6 Desc.	RCEs are in good condition at all road crossings

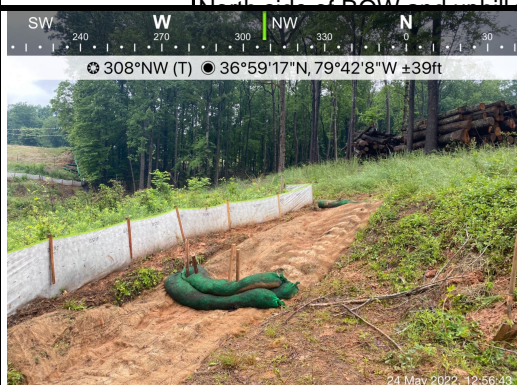
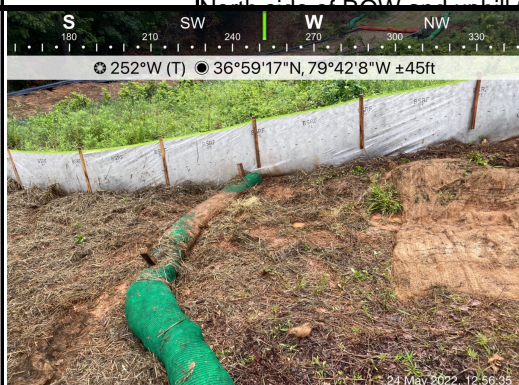
GPS Location	0		GPS Location	0	
Field Station#	14717+45		Field Station#	14717+50	
Pic 11 Desc.	Approximately 14717+45. Overview of repair completed by contractor of undermined P-1. Extra CFS and erosion control blanket was suggested to and installed by contractor at		Pic 12 Desc.	Approximately 14717+50. Overview of CFS after sediment has been removed.

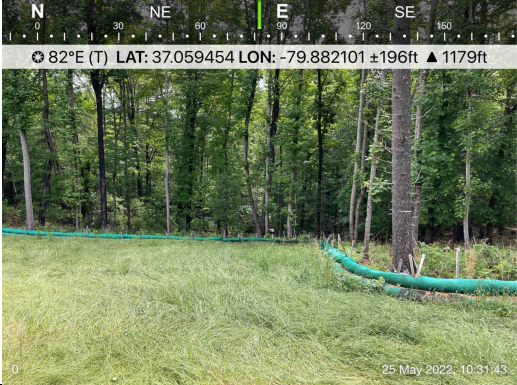
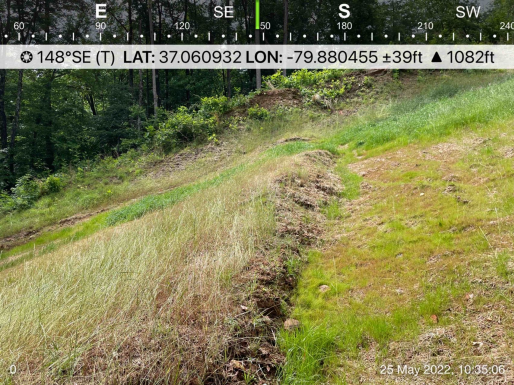
GPS Location	See photo		GPS Location	See photo	
Field Station#	14027+00		Field Station#	14033+00	
Pic 7 Desc.	CFS is in good condition throughout this section		Pic 8 Desc.	Waterbars are functioning as intended

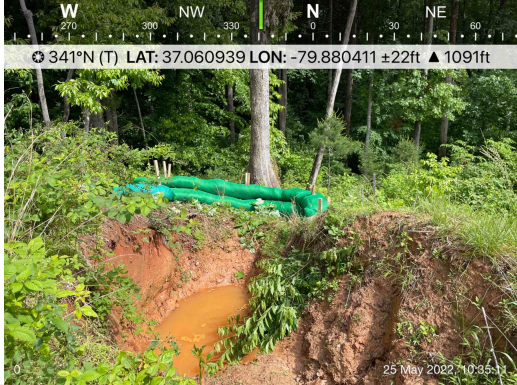
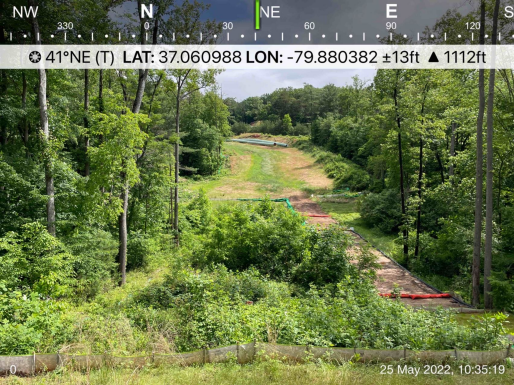
GPS Location	See photo		GPS Location	See photo	
Field Station#	14033+00		Field Station#	14035+00	
Pic 9 Desc.	End treatments are in good condition and functioning		Pic 10 Desc.	Resource buffers remain well vegetated.

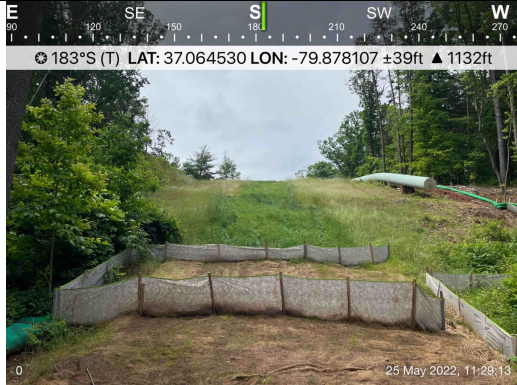
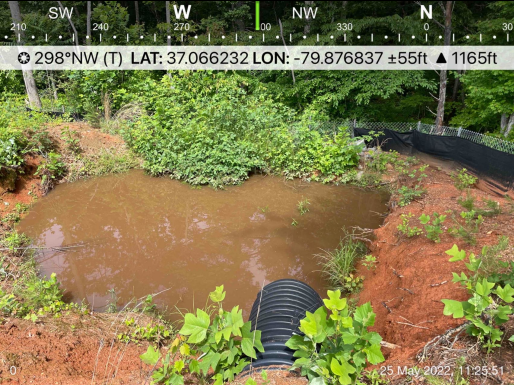
GPS Location	See photo		GPS Location	See photo	
Field Station#	14050+00		Field Station#	14057+00	
Pic 11 Desc.	Slope remains stabilized		Pic 12 Desc.	Slope drain is in good condition

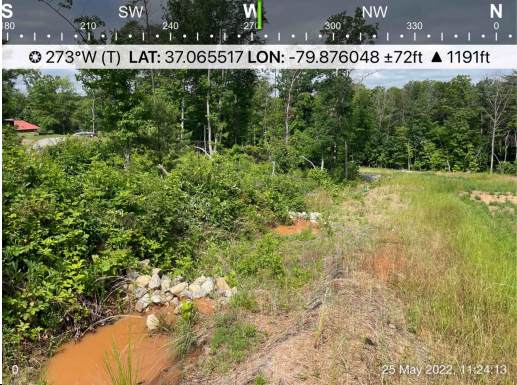
GPS Location	See photo	GPS Location			
Field Station#	14060+00	Field Station#			
Pic 13 Desc.	Check dams are in good condition and functioning.	Pic 14 Desc.			
Insert image here		Insert image here			
GPS Location		GPS Location			
Field Station#		Field Station#			
Pic 15 Desc.		Pic 16 Desc.			
Insert image here		Insert image here			
GPS Location		GPS Location			
Field Station#		Field Station#			
Pic 17 Desc.		Pic 18 Desc.

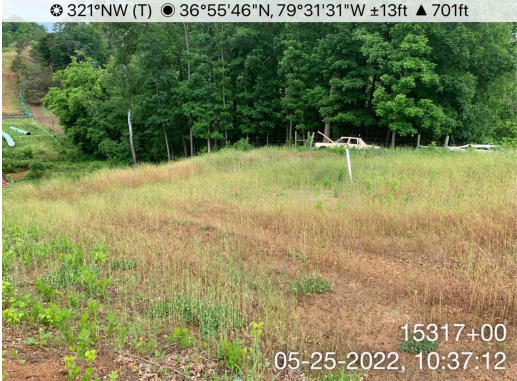
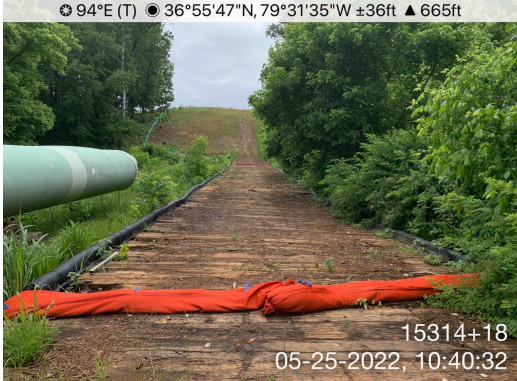
GPS Location	0	GPS Location	0		
Field Station#	15317+00	Field Station#	15314+18		
Pic 7 Desc.	Temporary vegetative stabilization in acceptable condition		Pic 8 Desc.	Equipment bridge in acceptable condition

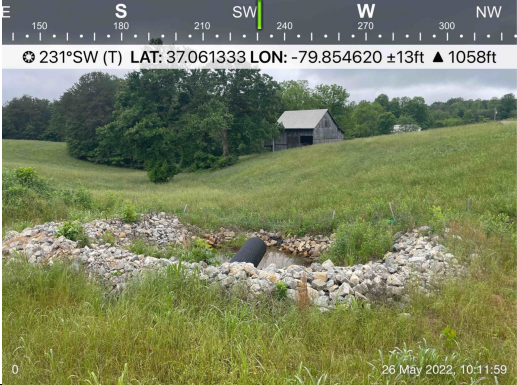
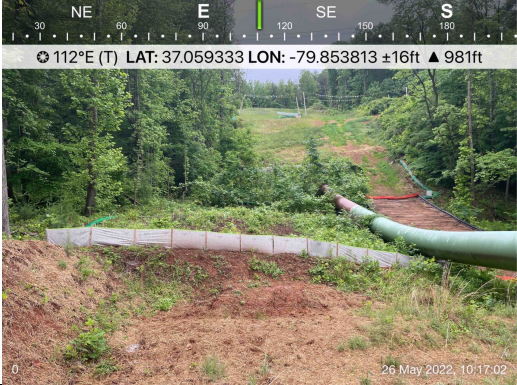
GPS Location	See photo		GPS Location	See photo	
Field Station#	14132+00		Field Station#	14141+62	
Pic 7 Desc.	CWDs are functioning as intended		Pic 8 Desc.	P1 is in good condition and functioning at all stream and wetland buffers

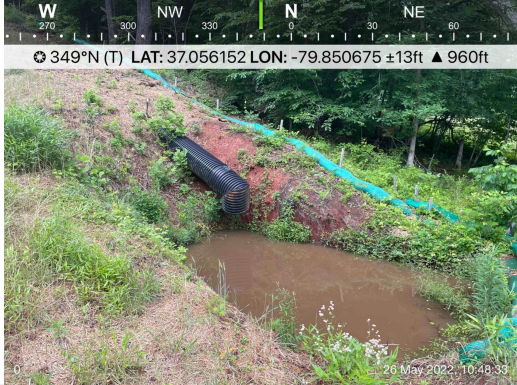
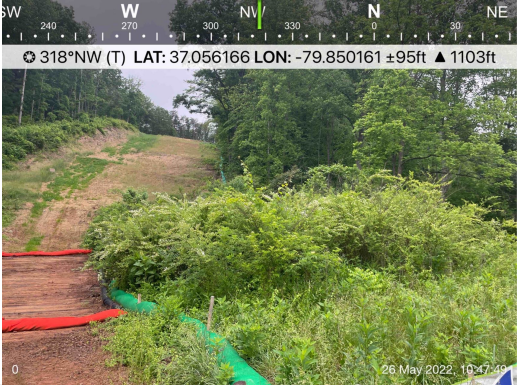
GPS Location	See photo		GPS Location	See photo	
Field Station#	14157+00		Field Station#	14158+00	
Pic 9 Desc.	Slope drain is functioning as intended		Pic 10 Desc.	Resource buffers remain well vegetated

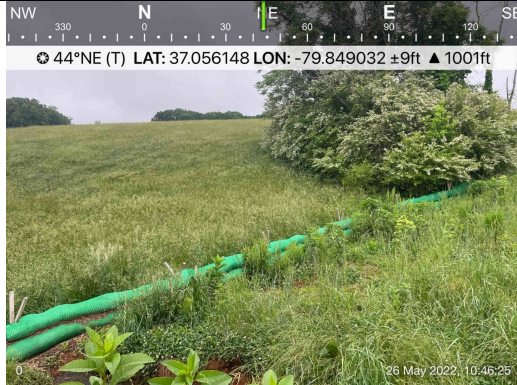
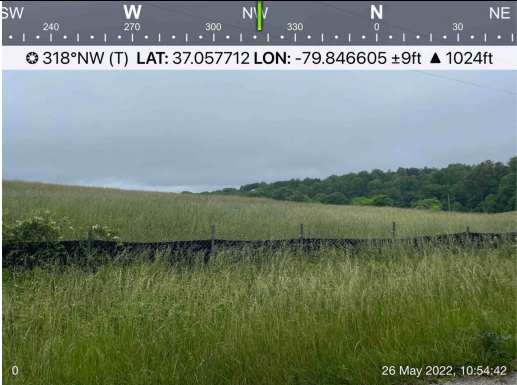
GPS Location	See photo		GPS Location	See photo	
Field Station#	14163+00		Field Station#	14170+00	
Pic 11 Desc.	CFS is in good condition throughout this section		Pic 12 Desc.	SSF is in good condition.

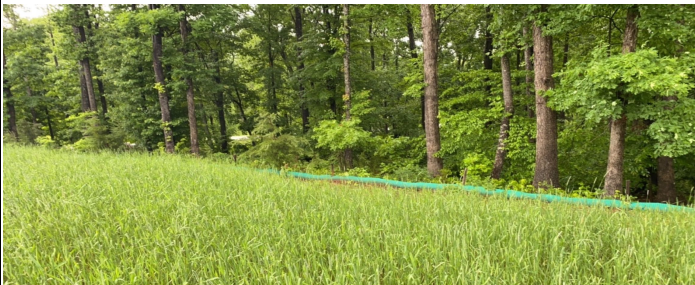
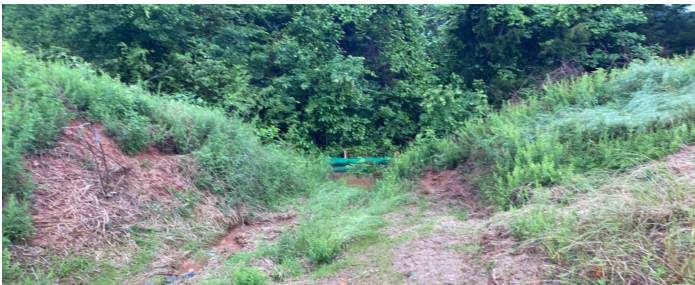
GPS Location	3	GPS Location	4		
Field Station#	14668+00	Field Station#	14687+00		
Pic 3 Desc.	Perimeter CFS in place and functional.		Pic 4 Desc.	Sump pit and CFS end treatment in good condition; minor erosion channel might be forming, will monitor as water flow subsides.

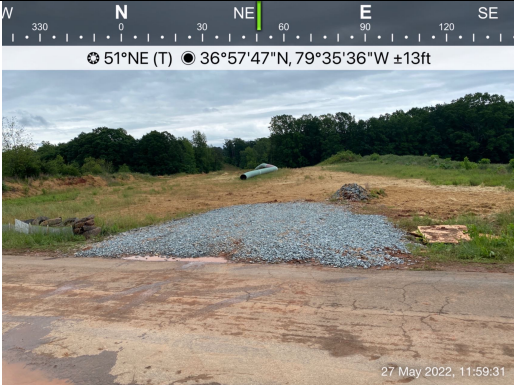
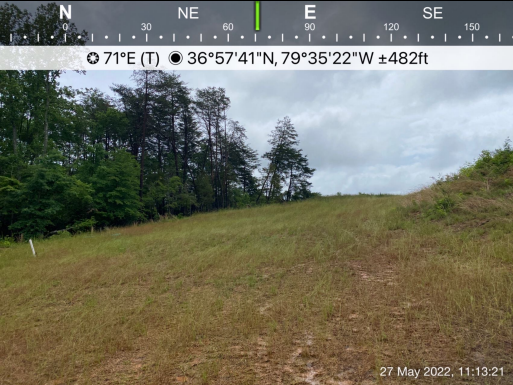
GPS Location	0	GPS Location	0		
Field Station#	15064+00	Field Station#	15074+00		
Pic 1 Desc.	Approximately 15064+00. Overview of road crossing and RCE.	Pic 2 Desc.	Approximately 15074+00. Overview of ROW.
