Visual Site Inspection Report

Project Name	H-600 Pipeline Spread I	AFE	124300139	Spread	H-600 Pipeline Spread I
Contractor	Precision			Report #	38203
Inspector	Frank Craycroft			Date/Time	5/30/2022 2:02 PM
Permit #	TBD	Inspection Type	VA SWPP	Station Begin	14694+77
State	VA	Inspection Area	Full	Station End	14802+19
County	Franklin	Ground	Wet	Temperature (°F)	85.00
Municipality	N/A	Weather	Sunny	Rain Gauge (in)	0.00
				Rain Accumulation Time (days)	1.00

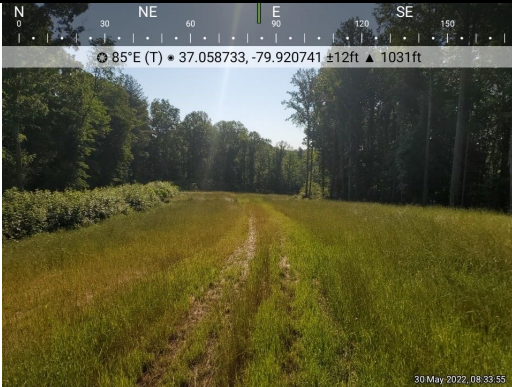
GPS Location	0	GPS Location	0		
Field Station#	13855+00	Field Station#	13862+00		
Pic 1 Desc.	Temporary vegetation	Pic 2 Desc.	CIS S-C17 ECDs

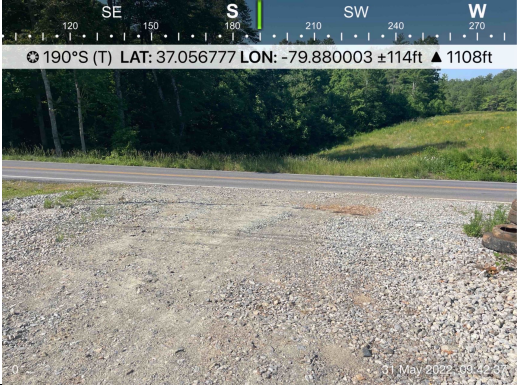
GPS Location	See photo		GPS Location	See photo	
Field Station#	14018+47		Field Station#	14027+00	
Pic 7 Desc.	RCEs are in good condition at all road crossings		Pic 8 Desc.	CFS is in good condition throughout this section

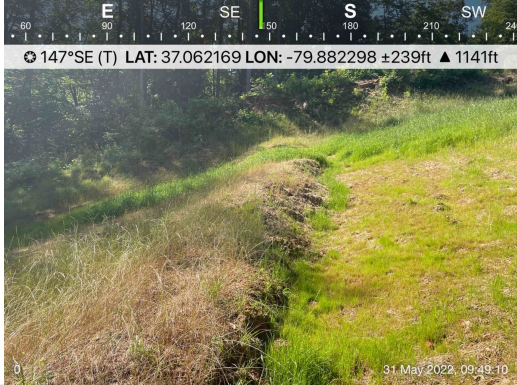
GPS Location	See photo		GPS Location	See photo	
Field Station#	14033+00		Field Station#	14033+00	
Pic 9 Desc.	Waterbars are in good condition		Pic 10 Desc.	End treatments are functioning as intended

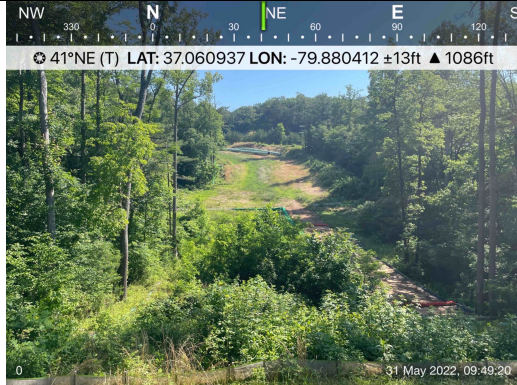
GPS Location	See photo		GPS Location	See photo	
Field Station#	14035+00		Field Station#	14050+00	
Pic 11 Desc.	Resource buffers remain well vegetated		Pic 12 Desc.	Slope remains stabilized

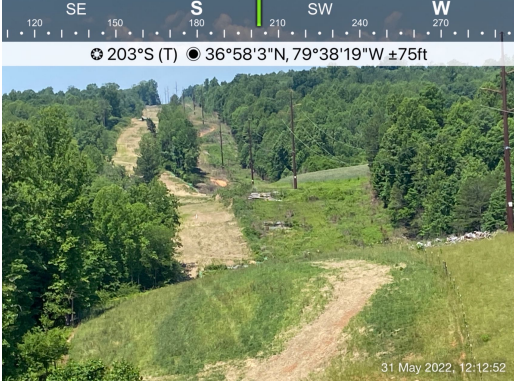
GPS Location	0	GPS Location	0		
Field Station#	14921+00	Field Station#	14870+00		
Pic 1 Desc.	Approximately 14921+00. Overview of ROW. Permanent vegetation.	Pic 2 Desc.	Approximately 14870+00. Overview of ROW.

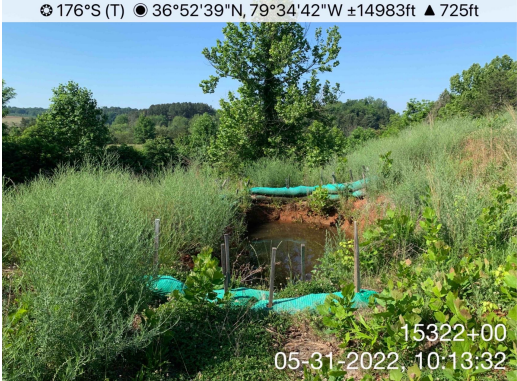
GPS Location	0	GPS Location	0		
Field Station#	15322+00	Field Station#	15315+00		
Pic 7 Desc.	Waterbar end treatment in acceptable condition	Pic 8 Desc.	CFS and P1 silt fence in acceptable conditions		
Insert image here		Insert image here			
GPS Location		GPS Location			
Field Station#		Field Station#			
Pic 9 Desc.		Pic 10 Desc.			
Insert image here		Insert image here			
GPS Location		GPS Location			
Field Station#		Field Station#			
Pic 11 Desc.		Pic 12 Desc.

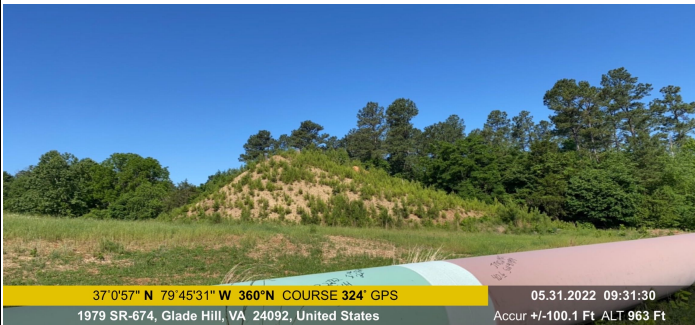
GPS Location	3	GPS Location	4		
Field Station#	14503+10	Field Station#	14498+00		
Pic 3 Desc.	Spoil pile stabilized and vegetated.		Pic 4 Desc.	Slope drain tile and sump pit in good condition.

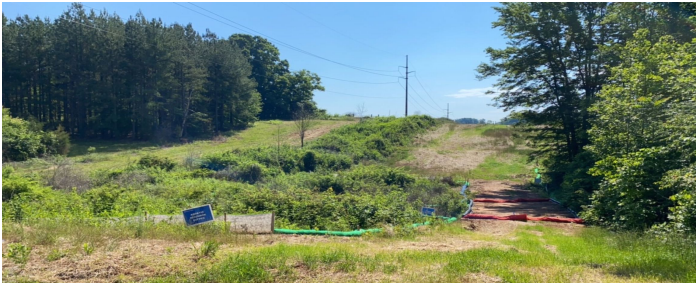
Field Station#	14568+10		Field Station#	14576+00	
Pic 3 Desc.	Equipment bridge and surrounding ECDs in place and functional at stream crossing and resource buffer; signage visible and intact.		Pic 4 Desc.	Water bar performing intended function.

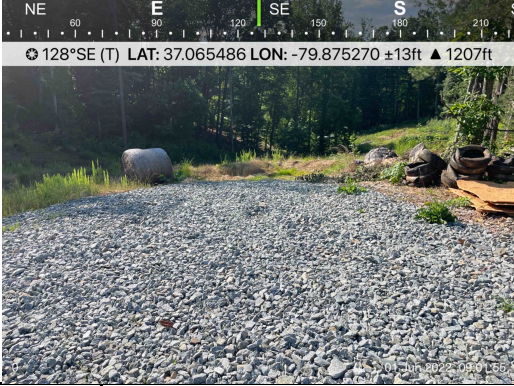
GPS Location	See photo		GPS Location	See photo	
Field Station#	14062+17		Field Station#	14066+77	
Pic 1 Desc.	RCEs are in good condition at all road crossings		Pic 2 Desc.	Equipment bridge ECDs are in place and functioning

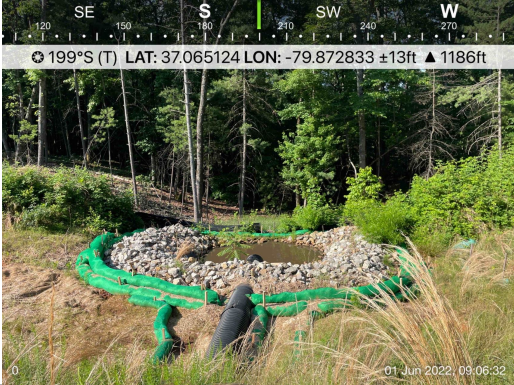
GPS Location	See photo		GPS Location	See photo	
Field Station#	14070+00		Field Station#	14081+46	
Pic 3 Desc.	CWDs are functioning as intended		Pic 4 Desc.	MVP-FR-309.05 is in good condition with controls in place.

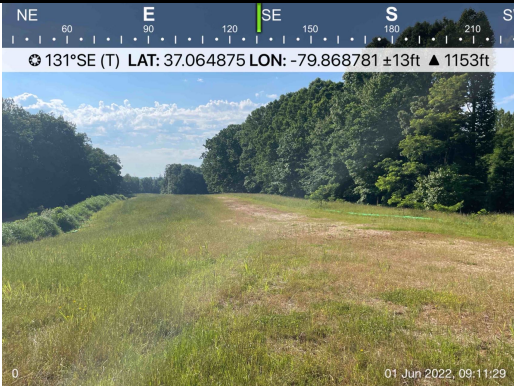
GPS Location	See photo		GPS Location	See photo	
Field Station#	14085+00		Field Station#	14090+00	
Pic 5 Desc.	Vegetation continues to fill in throughout this section		Pic 6 Desc.	Topsoil berms remain stabilized

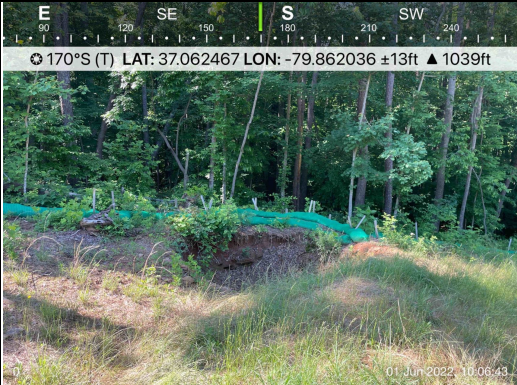
GPS Location	See photo		GPS Location	See photo	
Field Station#	14110+00		Field Station#	14110+00	
Pic 7 Desc.	End treatments are functioning as intended		Pic 8 Desc.	Waterbars remain in good condition

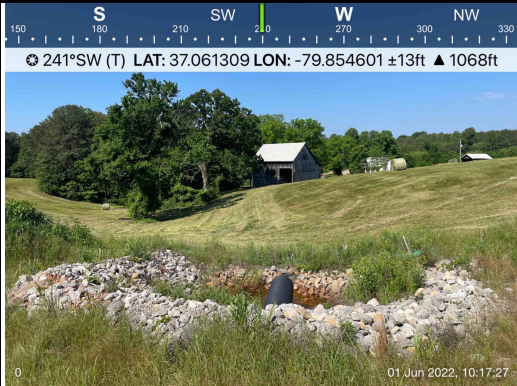
GPS Location	See photo		GPS Location	See photo	
Field Station#	14132+00		Field Station#	14141+50	
Pic 9 Desc.	CWDs are functioning as intended		Pic 10 Desc.	P1 is in good condition at all stream and wetland buffers

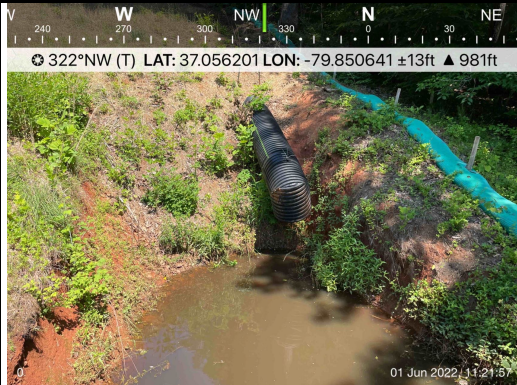
GPS Location	See photo		GPS Location	See photo	
Field Station#	14157+00		Field Station#	14158+00	
Pic 11 Desc.	Slope drain is in good condition and functioning		Pic 12 Desc.	Resource buffers remain well vegetated

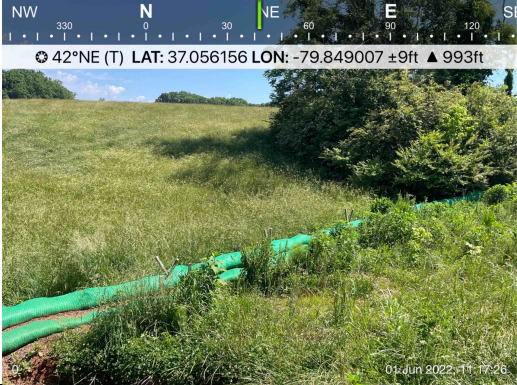
GPS Location	See photo	GPS Location			
Field Station#	14160+00	Field Station#			
Pic 13 Desc.	CFS is in good condition throughout this section.	Pic 14 Desc.			
Insert image here		Insert image here			
GPS Location		GPS Location			
Field Station#		Field Station#			
Pic 15 Desc.		Pic 16 Desc.			
Insert image here		Insert image here			
GPS Location		GPS Location			
Field Station#		Field Station#			
Pic 17 Desc.		Pic 18 Desc.

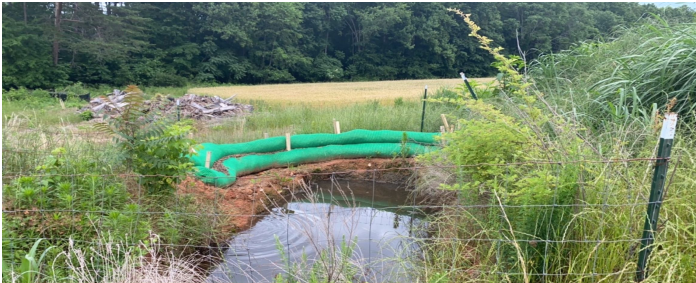
Pic 3 Desc.	Sump pit and CFS end treatment performing intended functions.		Pic 4 Desc.	ROW stabilized and vegetated in temporary area; water bars in place and functional.

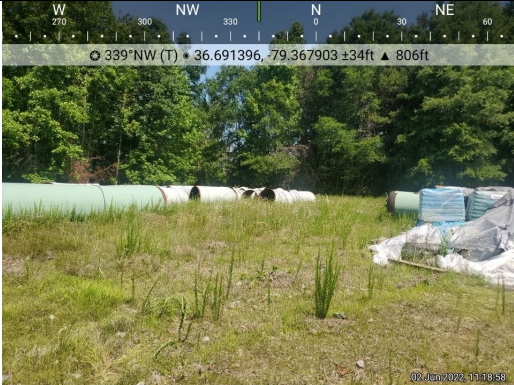
GPS Location	0	GPS Location	0		
Field Station#	0+00	Field Station#	0+00		
Pic 1 Desc.	LY-048 Temporary vegetation		Pic 2 Desc.	LY-048 West perimeter CFS

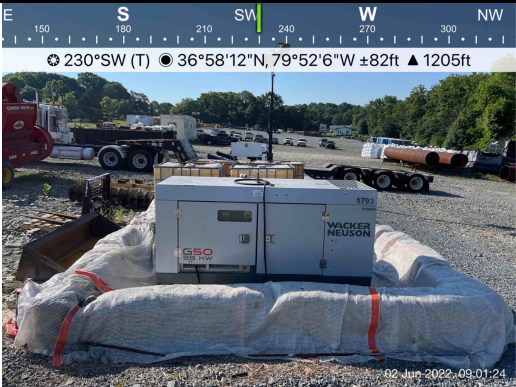
GPS Location	See picture	
		Field Station#	000+00	
Pic 1 Desc.	Secondary containment structure near tent at LY-045 in good condition.		Pic 2 Desc.	Perimeter ECD's on west side of LY-045 near employee parking area in acceptable condition.

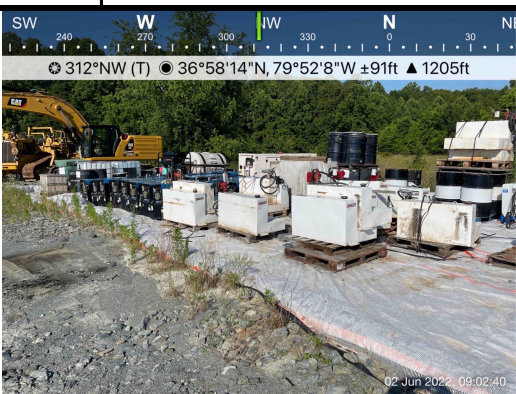
GPS Location	See picture	
		Field Station#	0000+00	
Pic 3 Desc.	Secondary containment structure on north end of LY-045 in good condition.		Pic 4 Desc.	Perimeter ECD's on northwest corner of LY-046 good condition.

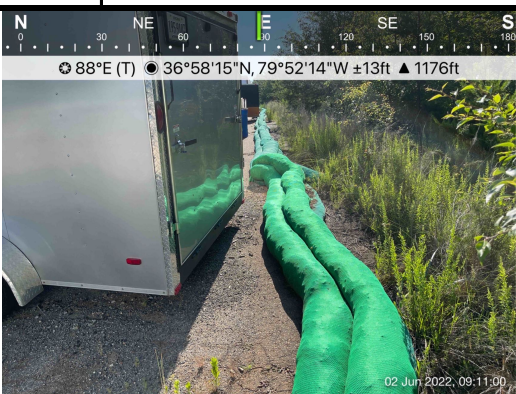
GPS Location	See picture	
		Field Station#	0000+00	
Pic 5 Desc.	Perimeter ECD's on south end of LY-046 in good condition.		Pic 6 Desc.	Secondary containment structure for fuel cell at LY-046 in good condition.

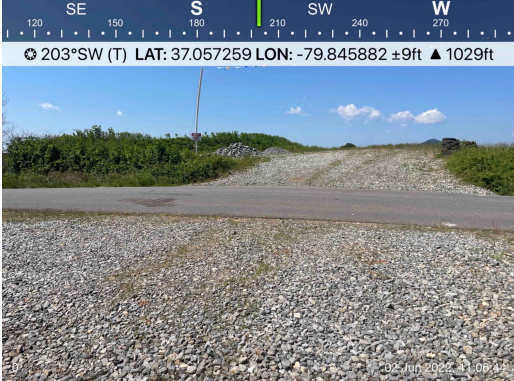
GPS Location	See photo	GPS Location	See photo		
Field Station#	14171+36	Field Station#	14180+00		
Pic 1 Desc.	RCEs are in good condition at all road crossings	Pic 2 Desc.	CWDs are functioning as intended

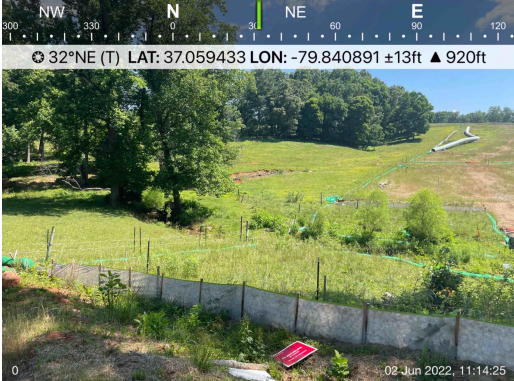
GPS Location	See photo	GPS Location	See photo		
Field Station#	14190+14	Field Station#	14208+69		
Pic 3 Desc.	P1 is in good condition at all stream and wetland buffers	Pic 4 Desc.	Equipment bridge ECDs are in good condition

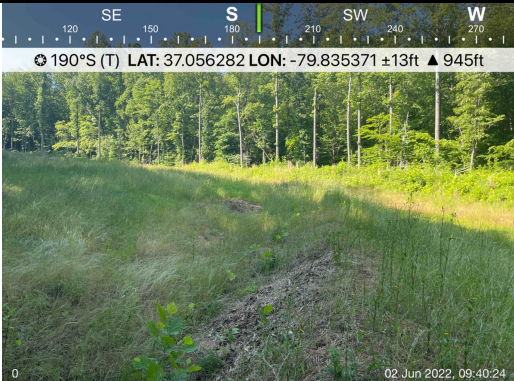
GPS Location	See photo	GPS Location	See photo		
Field Station#	14215+00	Field Station#	14215+00		
Pic 5 Desc.	Waterbars are in good condition	Pic 6 Desc.	End treatments are functioning as intended

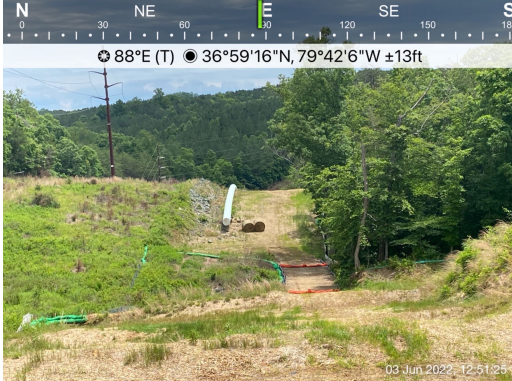
GPS Location		0		GPS Location		0	
Field Station#		14723+00		Field Station#		14716+92	
Pic 1 Desc.		Approximately 14723+00. Overview of ROW.		Pic 2 Desc.		Approximately 14716+92. Overview of stream crossing, equipment bridge and ECDs at stream S-H30. Ground disturbance along north side of stream S-H30 and uphill from wetland W-L144 by third

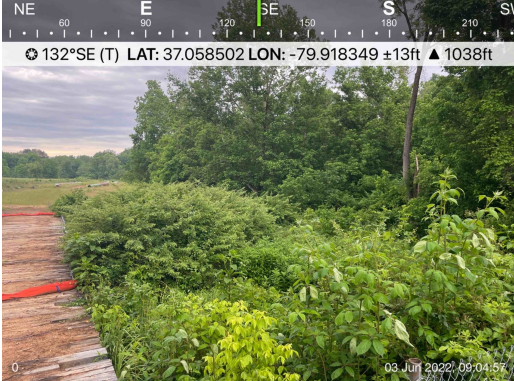
GPS Location	See photo		GPS Location	See photo	
Field Station#	13862+60		Field Station#	13875+16	
Pic 1 Desc.	Resource buffers remain well vegetated		Pic 2 Desc.	Equipment bridge ECDs are in good condition and functioning

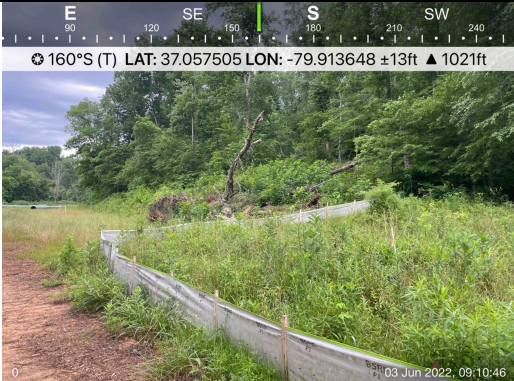
GPS Location	See photo		GPS Location	See photo	
Field Station#	13876+00		Field Station#	13889+00	
Pic 3 Desc.	P1 is in good condition at all stream and wetland buffers		Pic 4 Desc.	Slope drain is in good condition and functioning

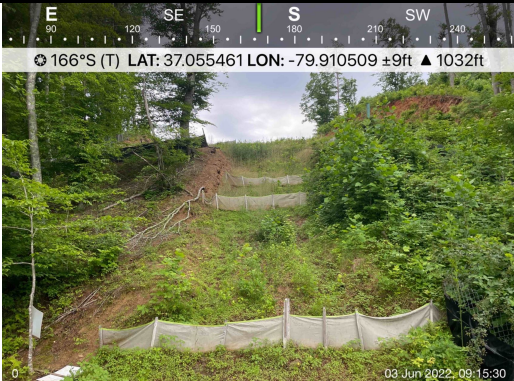
GPS Location	See photo		GPS Location	See photo	
Field Station#	13889+00		Field Station#	13892+45	
Pic 5 Desc.	Slope remains stabilized		Pic 6 Desc.	RCEs are in good condition and functioning at all road crossings.

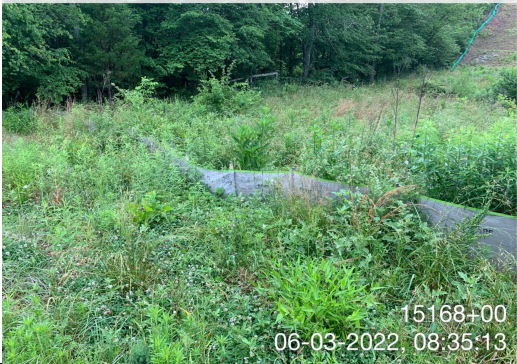
<p>15168+00 06-03-2022, 08:35:13</p>

<p>15168+00 06-03-2022, 08:35:39</p>			
GPS Location	0	GPS Location	0		
Field Station#	15168+00	Field Station#	15168+00		
Pic 7 Desc.	P1 silt fence is deteriorated from 15168+00 to 15169+50		Pic 8 Desc.	CFS is deteriorated from 15168+00 to 15169+50

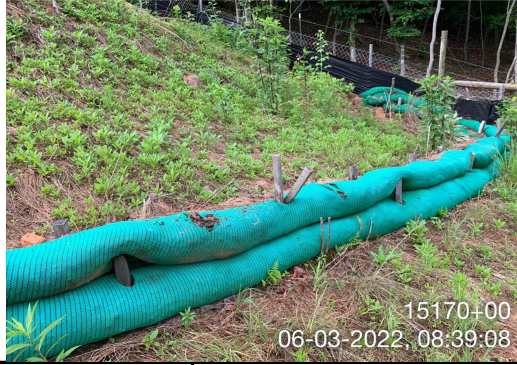
<p>15170+00 06-03-2022, 08:39:08</p>

<p>15172+00 06-03-2022, 08:41:08</p>			
GPS Location	0	GPS Location	0		
Field Station#	15170+00	Field Station#	15172+00		
Pic 11 Desc.	CFS is deteriorated		Pic 12 Desc.	P1 silt fence is deteriorated
