Visual Site Inspection Report

Project Name	H-600 Pipeline Spread I	AFE	124300139	Spread	H-600 Pipeline Spread I
Contractor	Precision	Report #	38444		
Inspector	Ben Farmer	Date/Time	6/6/2022 12:58 PM		
Permit #	TBD	Inspection Type	VA SWPP	Station Begin	13958+31
State	VA	Inspection Area	Partial	Station End	14062+17
County	Franklin	Ground	Dry	Temperature (°F)	65.00
Municipality	N/A	Weather	Sunny	Rain Gauge (in)	0.00
				Rain Accumulation Time (days)	0.00

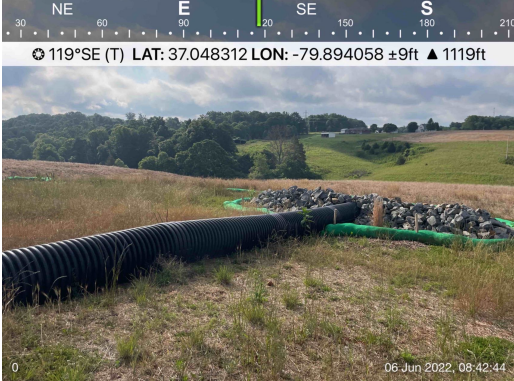
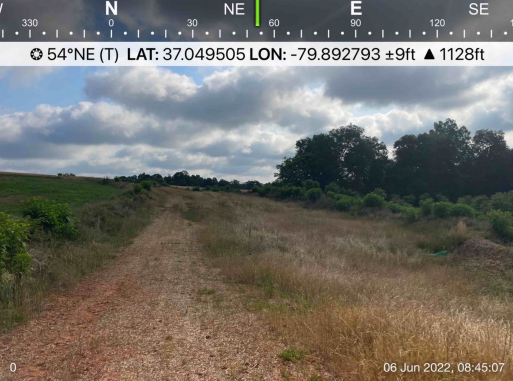
GPS Location	See photo		GPS Location	See photo	
Field Station#	13960+00		Field Station#	13970+00	
Pic 1 Desc.	CWDs are functioning as intended		Pic 2 Desc.	Vegetation continues to fill in throughout this section

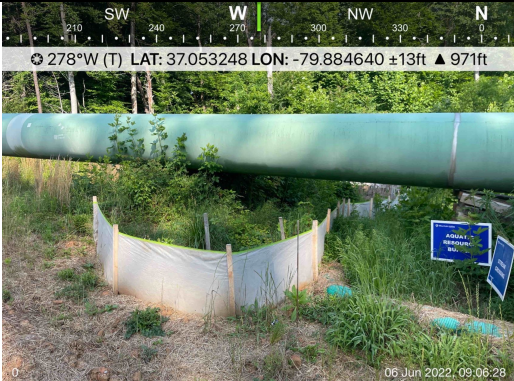
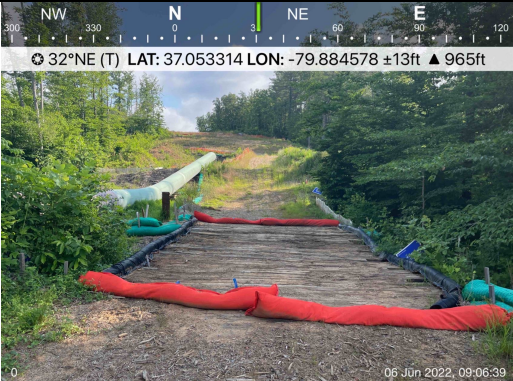
GPS Location	See photo		GPS Location	See photo	
Field Station#	13998+00		Field Station#	13998+15	
Pic 3 Desc.	P1 is in good condition at all stream and wetland buffers		Pic 4 Desc.	Equipment bridge ECDs are in good condition and functioning

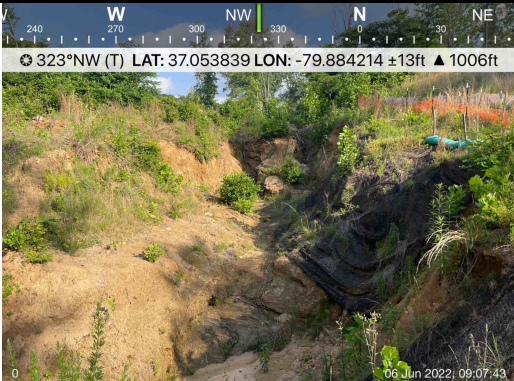
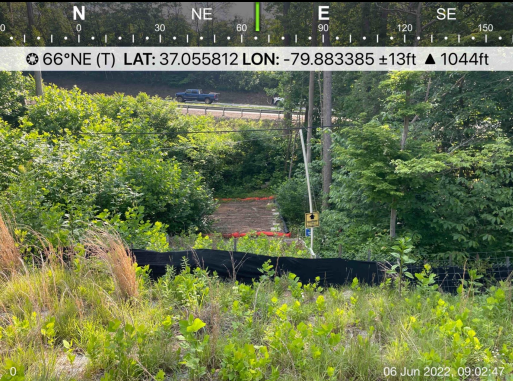
GPS Location	See photo		GPS Location	See photo	
Field Station#	14000+00		Field Station#	14009+00	
Pic 5 Desc.	No evidence of 3rd party pond discharging onto ROW		Pic 6 Desc.	SSF is in good condition

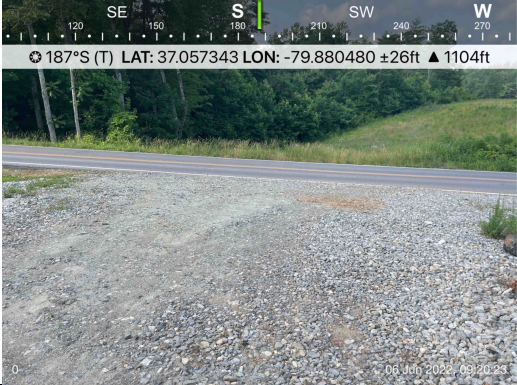
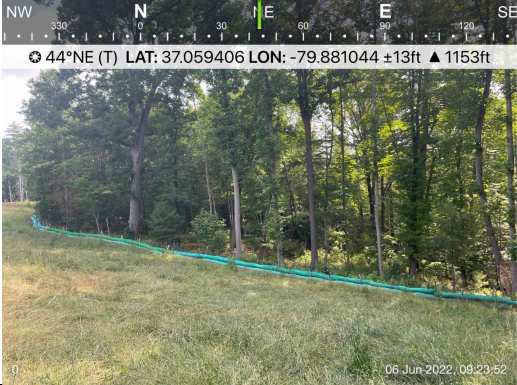
GPS Location	See photo		GPS Location	See photo	
Field Station#	14018+47		Field Station#	14027+00	
Pic 7 Desc.	RCEs are in good condition at all road crossings		Pic 8 Desc.	CFS is in good condition throughout this section

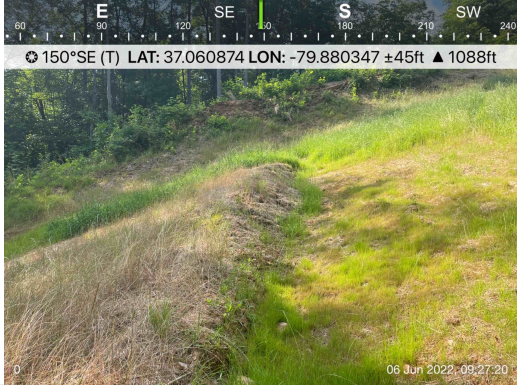
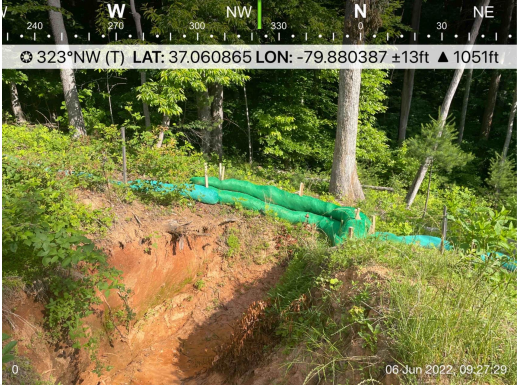
GPS Location	See photo		GPS Location	See photo	
Field Station#	14033+00		Field Station#	14033+00	
Pic 9 Desc.	Waterbars are functioning as intended		Pic 10 Desc.	End treatments are in good condition

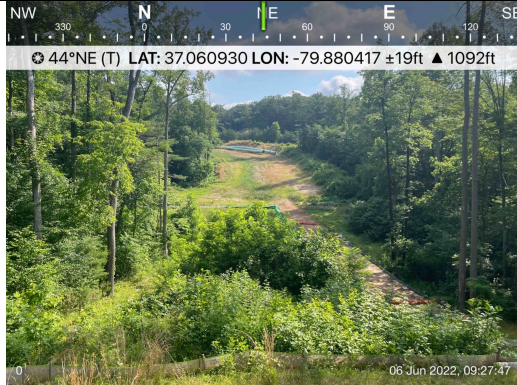
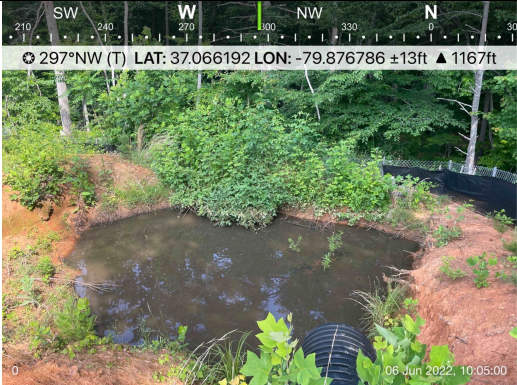
GPS Location	See photo		GPS Location	See photo	
Field Station#	14035+00		Field Station#	14057+00	
Pic 11 Desc.	Resource buffers remain well vegetated		Pic 12 Desc.	Slope drain is functioning as intended

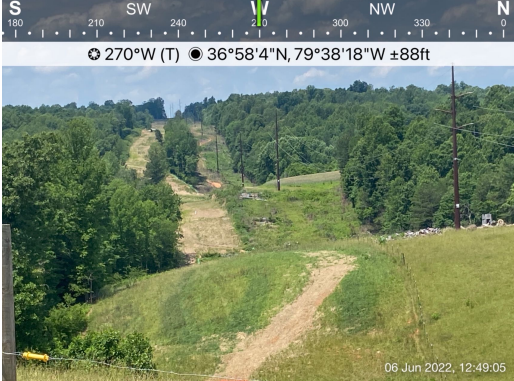
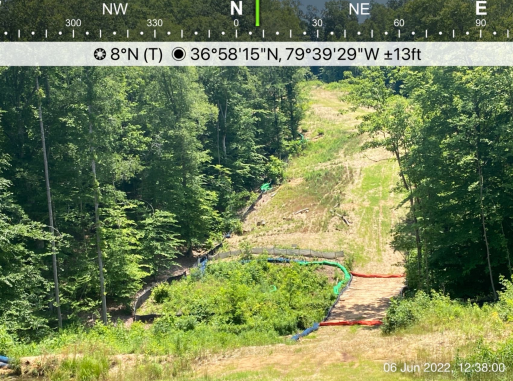
GPS Location	0	GPS Location	0		
Field Station#	14923+00	Field Station#	14870+43		
Pic 1 Desc.	Approximately 14923+00. Overview of ROW. Permanent vegetation.	Pic 2 Desc.	Approximately 14870+43. Overview of stream crossing, equipment bridge and ECDs at stream S-SS8.

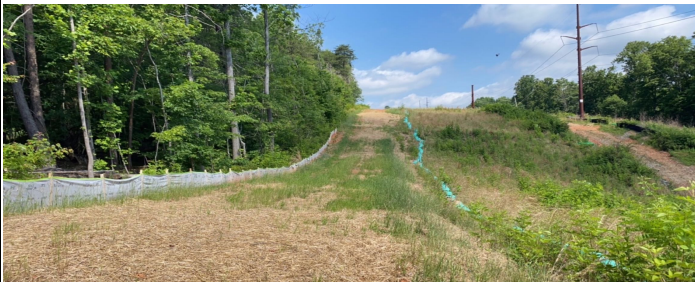
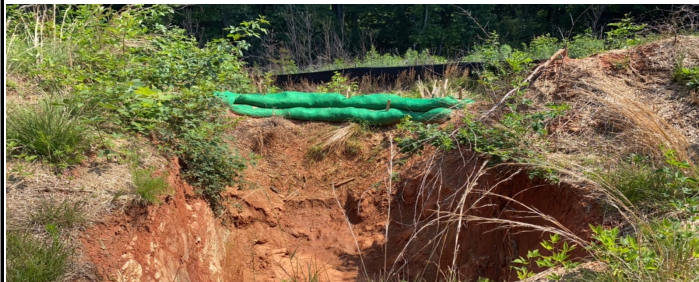
06.06.2022 10:53:31 Accur +/-641.2 Ft ALT 1061 Ft			06.06.2022 10:51:19 Accur +/-32.8 Ft ALT 1056 Ft		
GPS Location	1	GPS Location	2		
Field Station#	14467+00	Field Station#	14492+00		
Pic 1 Desc.	Perimeter controls in place and functional; ROW stabilized and vegetated in temporary area.		Pic 2 Desc.	Sump pit and CFS end treatment performing intended functions.

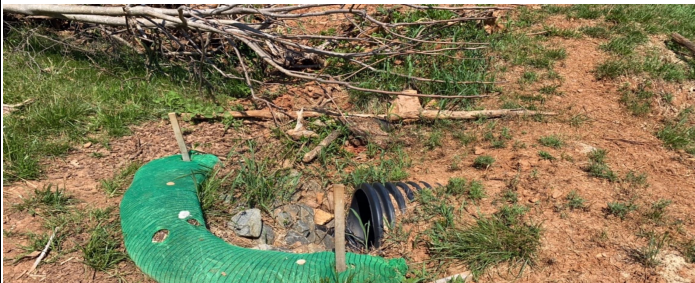
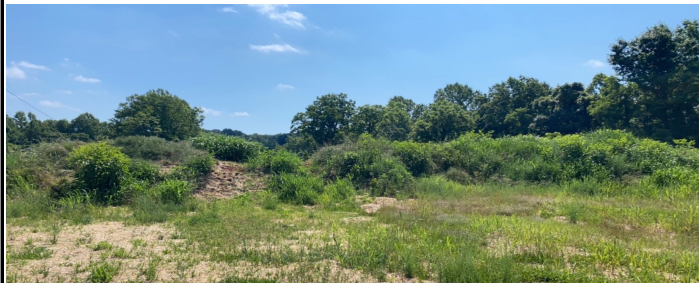
06.06.2022 11:13:44 Accur +/-15.4 Ft ALT 1028 Ft			06.06.2022 11:06:14 Accur +/-36.4 Ft ALT 1062 Ft		
GPS Location	3	GPS Location	4		
Field Station#	14521+00	Field Station#	14525+25		
Pic 3 Desc.	Slope drain inlet in good condition.		Pic 4 Desc.	Temporary diversion berm stabilized and vegetated.

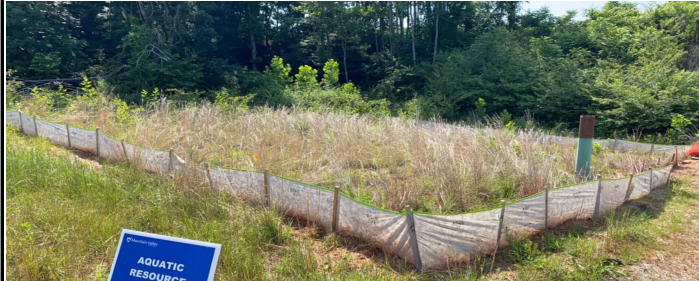
06.06.2022 10:27:57 Accur +/-41.1 Ft ALT 1028 Ft			06.06.2022 10:21:34 Accur +/-33.9 Ft ALT 951 Ft		
GPS Location	5	GPS Location	6		
Field Station#	14531+58	Field Station#	14545+83		
Pic 5 Desc.	Equipment bridge and surrounding ECDs in place and functional at stream crossing and resource buffer.		Pic 6 Desc.	P1 silt fence in place and functional at resource buffer; signage visible and intact.

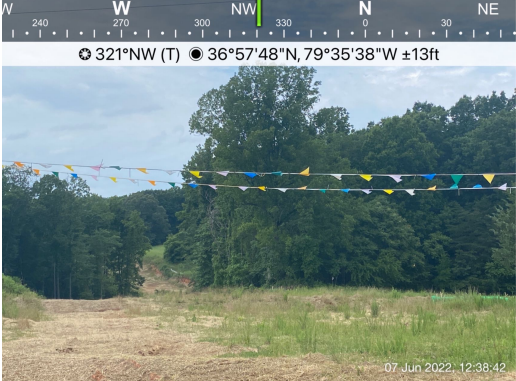
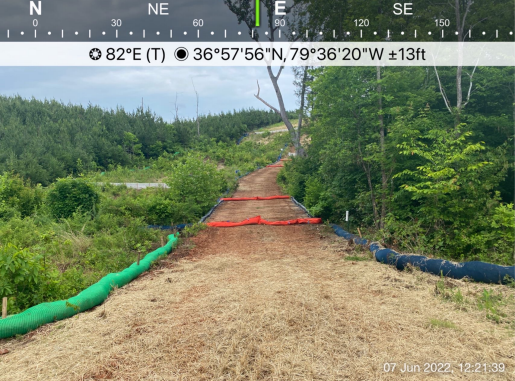
GPS Location	0	GPS Location	0		
Field Station#	15061+00	Field Station#	15026+00		
Pic 1 Desc.	Approximately 15061+00. Overview of ROW.	Pic 2 Desc.	Approximately 15026+00. Overview of stream crossing, equipment bridge and ECDs at stream S-D3.

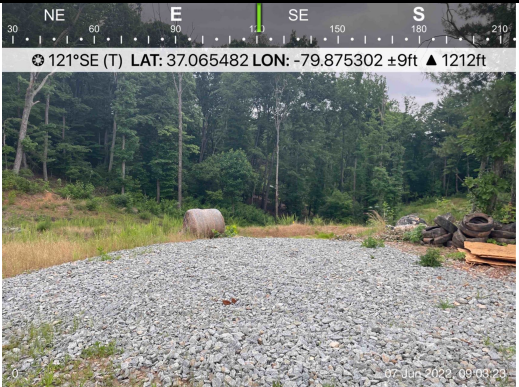
GPS Location		See photo			
Field Station#		14062+17			
Pic 1 Desc.		RCEs are in good condition at all road crossings.

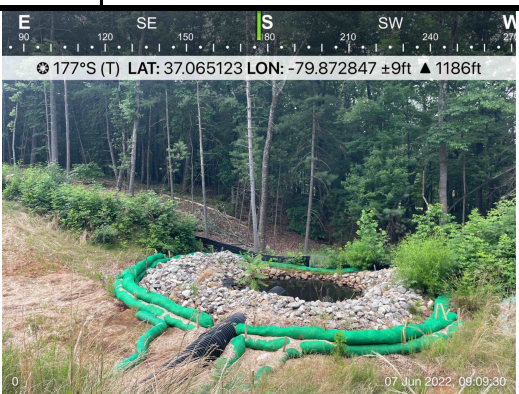
GPS Location		See photo			
Field Station#		14070+00			
Pic 3 Desc.		CWDs are functioning as intended

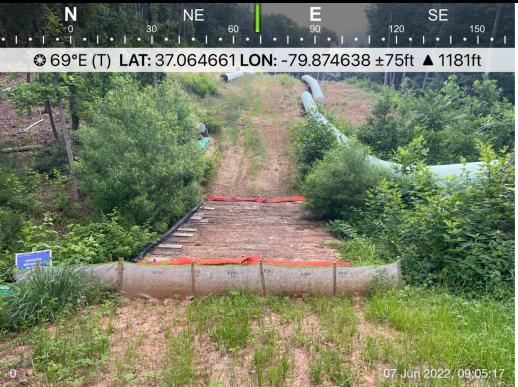
GPS Location		See photo			
Field Station#		14066+77			
Pic 2 Desc.		Equipment bridge ECDs are in good condition and functioning

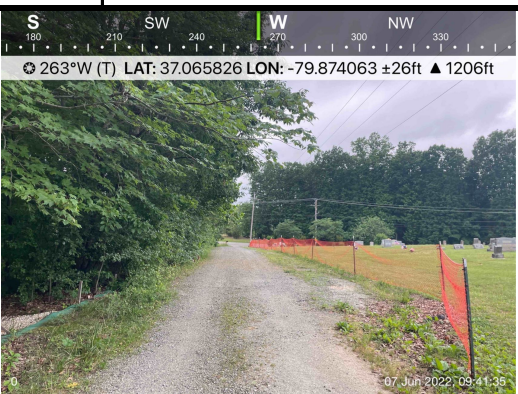
GPS Location		See photo			
Field Station#		14081+53			
Pic 4 Desc.		MVP-FR-309.05 is in good condition with controls in place.

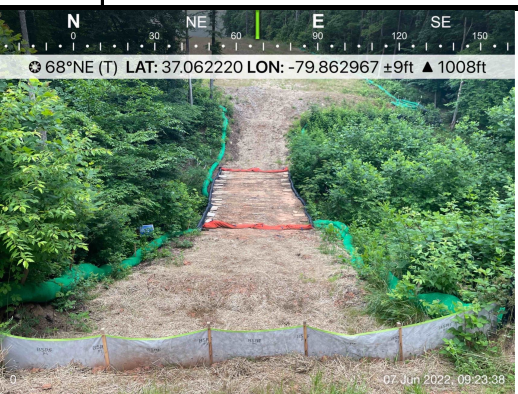
GPS Location		See photo			
Field Station#		14105+32			
Pic 6 Desc.		Equipment bridge ECDs are functioning as intended

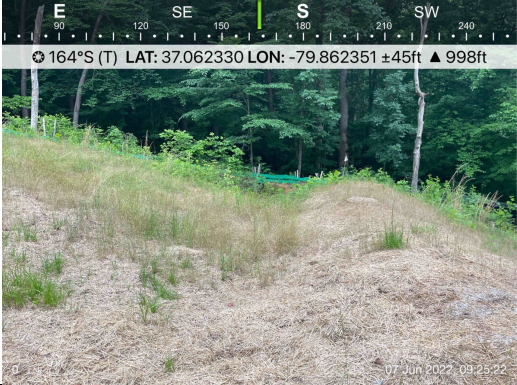
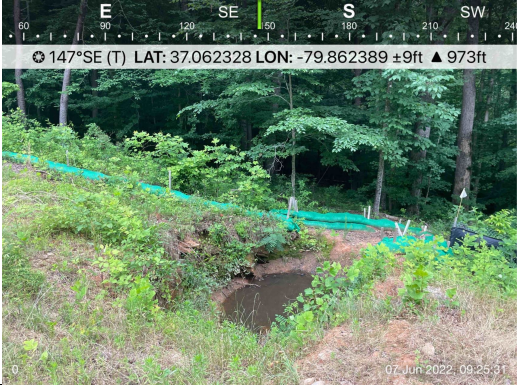
GPS Location	See photo		GPS Location	See photo	
Field Station#	14107+00		Field Station#	14107+00	
Pic 7 Desc.	Waterbars are in good condition		Pic 8 Desc.	End treatments are functioning as intended

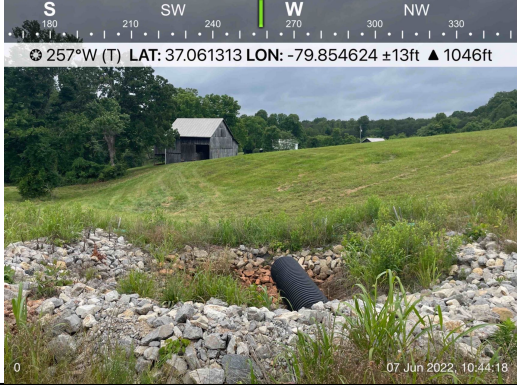
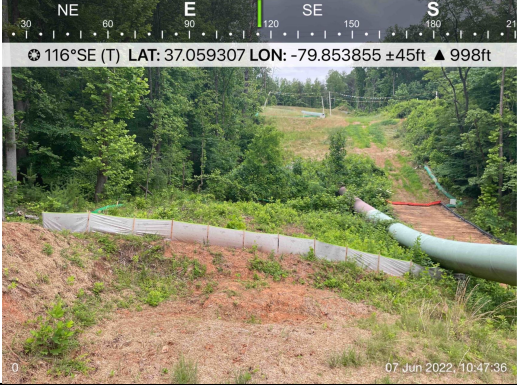
GPS Location	See photo		GPS Location	See photo	
Field Station#	14132+00		Field Station#	14141+50	
Pic 9 Desc.	CWDs are functioning as intended		Pic 10 Desc.	P1 is in good condition at all stream and wetland buffers

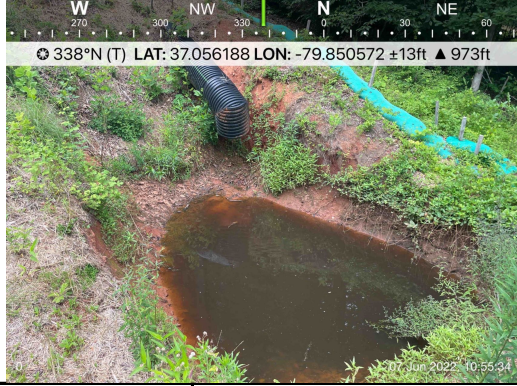
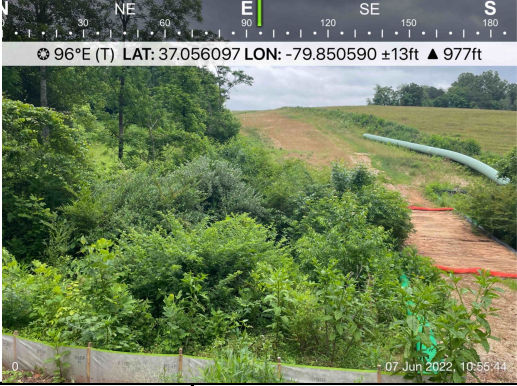
GPS Location	See photo		GPS Location	See photo	
Field Station#	14156+00		Field Station#	14157+55	
Pic 11 Desc.	Slope drain is in good condition		Pic 12 Desc.	Resource buffers remain well vegetated.

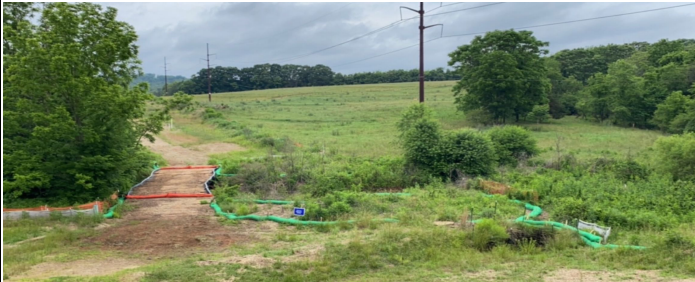
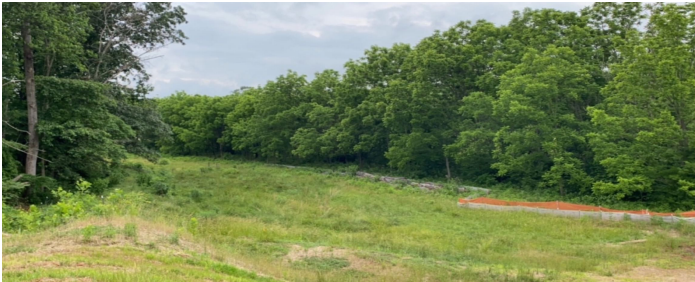
37°01' N 79°44'32" W 293°W COURSE -1' GPS 753 Simmons Creek Rd, Union Hall, VA 24176, United States 06.07.2022 10:29:15 Accur +/-31.8 Ft ALT 867 Ft			37°01' N 79°44'32" W 319°NW COURSE -1' GPS 753 Simmons Creek Rd, Union Hall, VA 24176, United States 06.07.2022 10:29:19 Accur +/-22.0 Ft ALT 866 Ft		
GPS Location	1		GPS Location	2	
Field Station#	14582+85		Field Station#	14584+23	
Pic 1 Desc.	Equipment bridge and surrounding ECDs in place and functional at stream crossing and resource buffer; signage visible and intact.		Pic 2 Desc.	Perimeter controls in good condition in extra workspace.

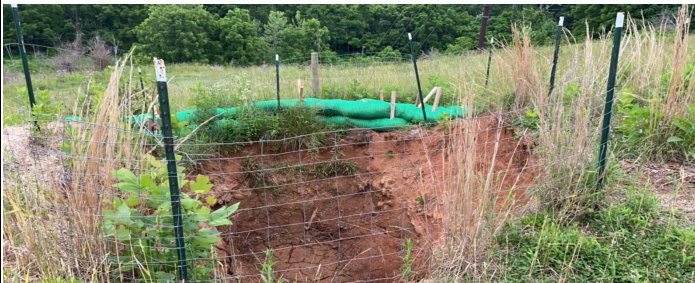
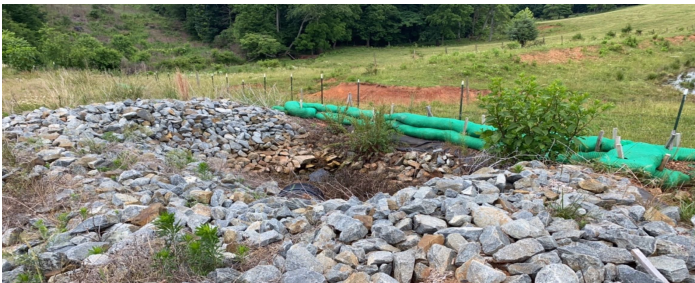
GPS Location	3		GPS Location	4	
Field Station#	14594+00		Field Station#	14605+00	
Pic 3 Desc.	Sump pit and CFS end treatment performing intended functions.		Pic 4 Desc.	Plunge pool performing intended function.

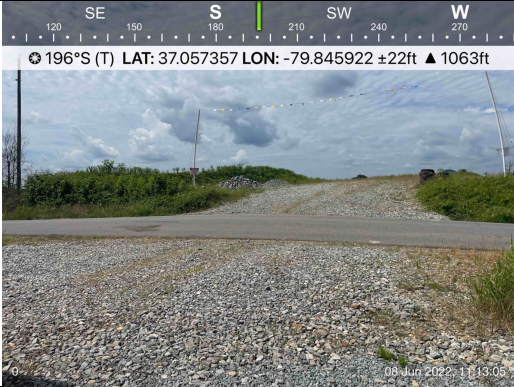
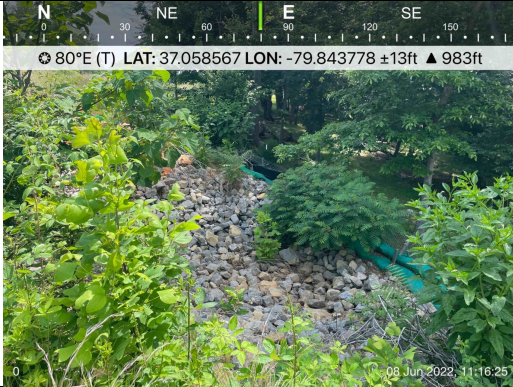
GPS Location	See photo	GPS Location	See photo		
Field Station#	14171+36	Field Station#	14180+00		
Pic 1 Desc.	RCEs are in good condition at all road crossings	Pic 2 Desc.	CWDs are functioning as intended

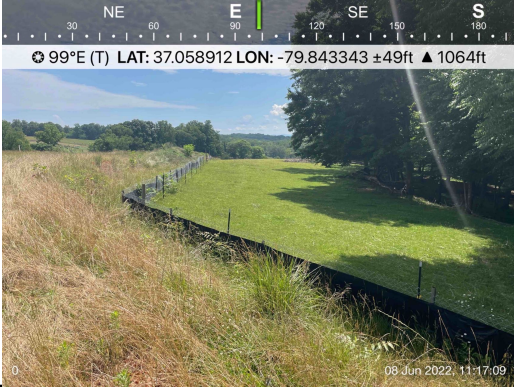
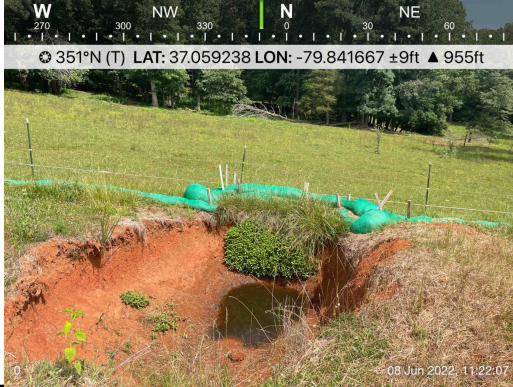
GPS Location	See photo	GPS Location	See photo		
Field Station#	14182+00	Field Station#	14185+00		
Pic 3 Desc.	SSF is in good condition throughout this section	Pic 4 Desc.	End treatments are functioning as intended

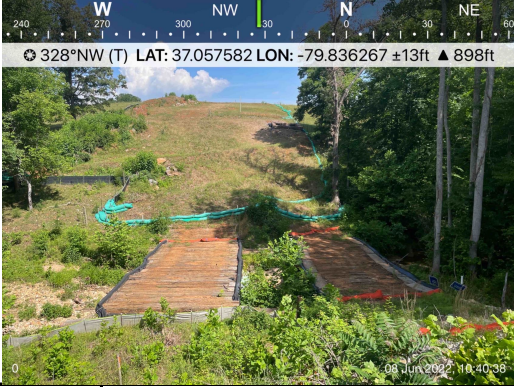
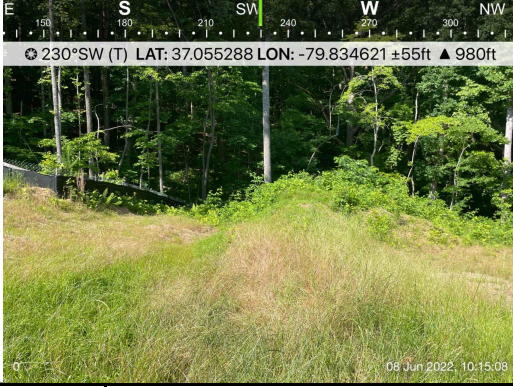
GPS Location	See photo	GPS Location	See photo		
Field Station#	14209+00	Field Station#	14220+00		
Pic 5 Desc.	Equipment bridge ECDs are in good condition and functioning	Pic 6 Desc.	Waterbars remain in good condition

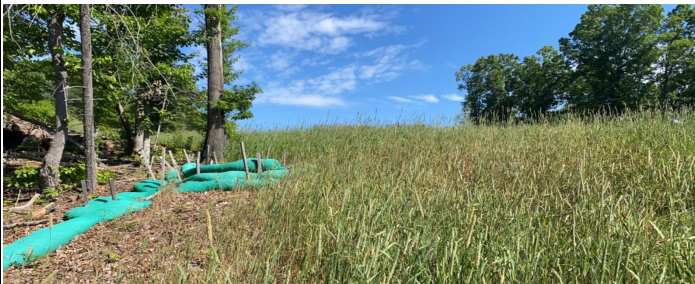
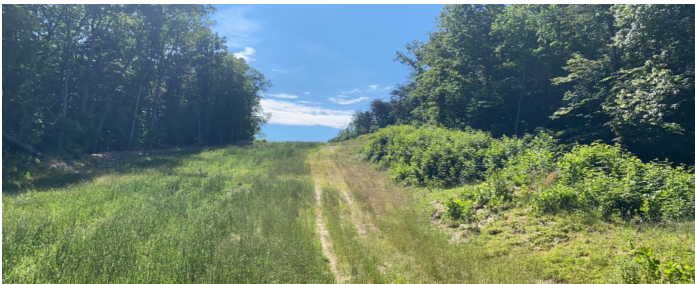
36°59'23" N 79°43'24" W 350°N COURSE 173° GPS 06.08.2022 10:19:10 Accur +/-48.0 Ft ALT 975 Ft			36°59'21" N 79°43'18" W 160°S COURSE 107° GPS 06.08.2022 10:22:50 9400-9598 Old Franklin Tpke, Union Hall, VA 24176, United States Accur +/-366.1 Ft ALT 927 Ft		
GPS Location	1		GPS Location	2	
Field Station#	14653+00		Field Station#	14660+00	
Pic 1 Desc.	Perimeter CFS in good condition in final cleanup area.		Pic 2 Desc.	ROW stabilized and vegetated in temporary area.

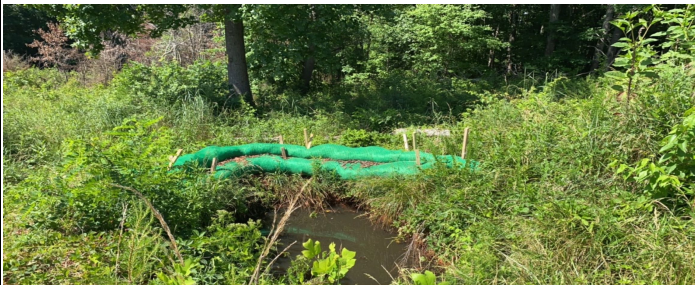
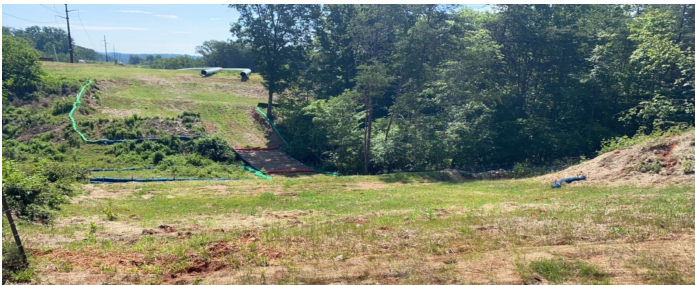
36°59'21" N 79°43'17" W 206°SW COURSE 107° GPS 06.08.2022 10:26:38 Union Hall, VA 24176, United States Accur +/-3509.4 Ft ALT 927 Ft			36°59'17" N 79°43'4" W 153°SE COURSE 103° GPS 06.08.2022 10:29:33 Union Hall, VA 24176, United States Accur +/-21.9 Ft ALT 976 Ft		
GPS Location	3		GPS Location	4	
Field Station#	14667+00		Field Station#	14673+10	
Pic 3 Desc.	Sump pit and CFS end treatment performing intended functions.		Pic 4 Desc.	Equipment bridge and surrounding ECDs in place and functional at stream crossing and resource buffer.

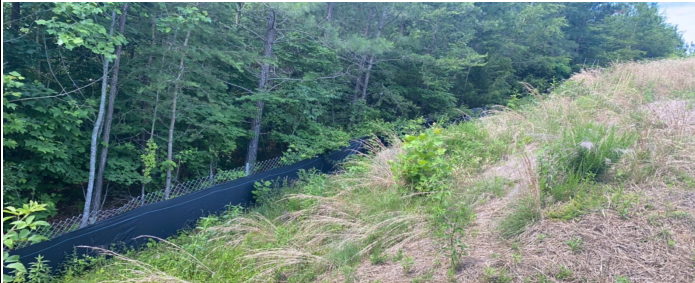
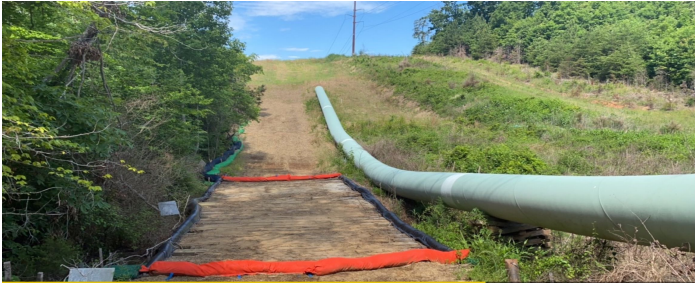
36°59'16" N 79°42'42" W 297°NW COURSE 288° GPS 06.08.2022 10:55:20 Sorry no results found Accur +/-1069.9 Ft ALT 911 Ft			36°59'16" N 79°42'40" W 343°N COURSE 247° GPS 06.08.2022 10:52:42 1559-2499 Jacks Creek Rd, Union Hall, VA 24176, United States Accur +/-1098.0 Ft ALT 939 Ft		
GPS Location	5		GPS Location	6	
Field Station#	14686+00		Field Station#	14689+36	
Pic 5 Desc.	Perimeter SSF in place and functional.		Pic 6 Desc.	Equipment bridge and surrounding ECDs in place and functional at stream crossing and resource buffer.

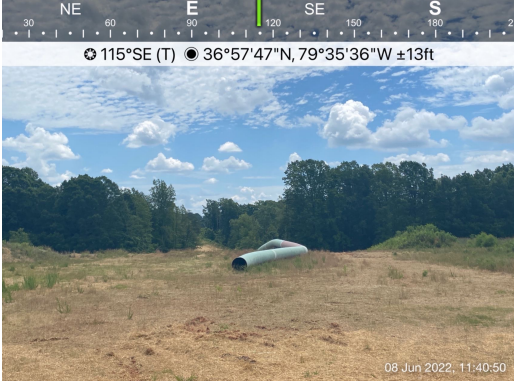
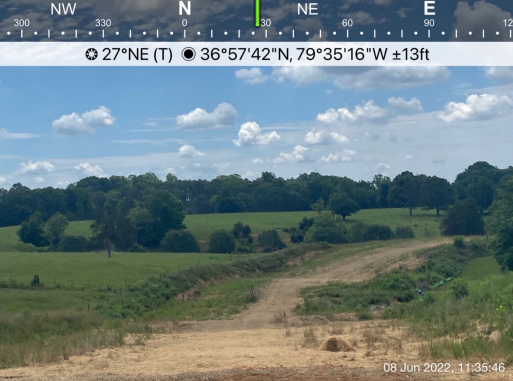
GPS Location	0	GPS Location	0		
Field Station#	15066+00	Field Station#	15085+00		
Pic 1 Desc.	Approximately 15066+00. Overview of ROW.	Pic 2 Desc.	Approximately 15085+00. Overview of ROW.

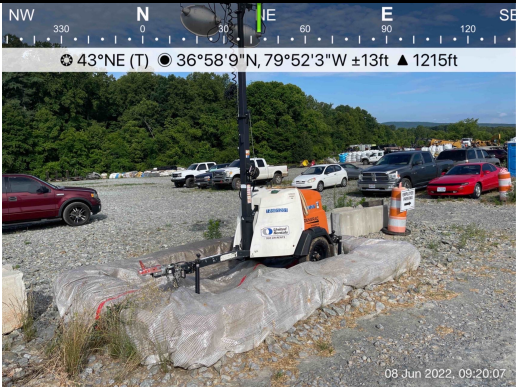
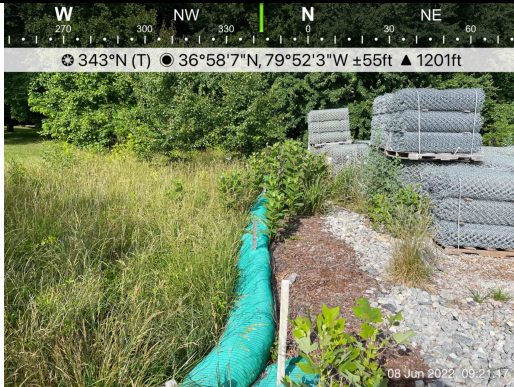
GPS Location	See picture		GPS Location	See picture	
Field Station#	0000+00		Field Station#	0000+00	
Pic 1 Desc.	Secondary containment structure for light plant near employee parking area at LY-045 in good condition.		Pic 2 Desc.	Perimeter ECD's on south end of LY-045 in good condition.

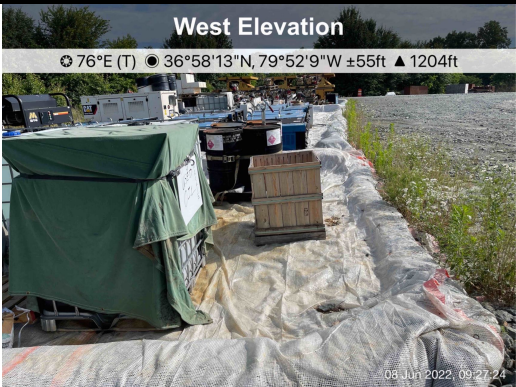
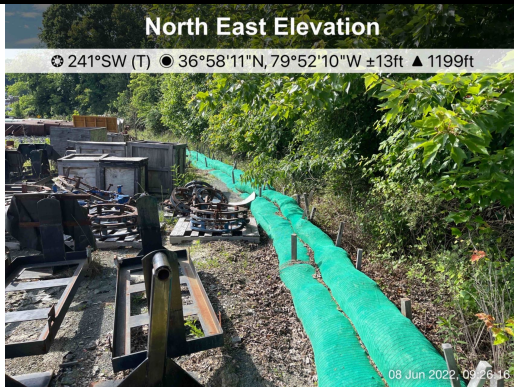
GPS Location	See picture		GPS Location	See picture	
Field Station#	0000+00		Field Station#	0000+00	
Pic 3 Desc.	Secondary containment structure on north end of LY-045 in good condition.		Pic 4 Desc.	Perimeter ECD's on northwest corner of LY-045 in acceptable condition.

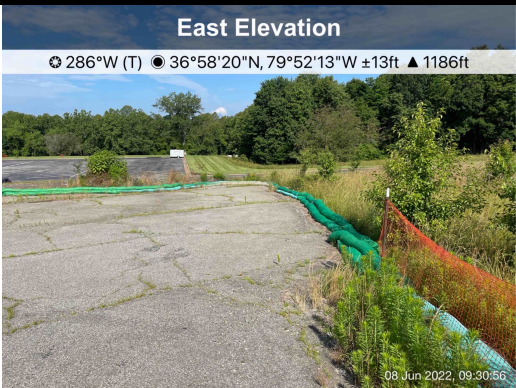
GPS Location	See picture		GPS Location	See picture	
Field Station#	0000+00		Field Station#	0000+00	
Pic 5 Desc.	Perimeter ECD's on northwest corner of LY-046 in good condition.		Pic 6 Desc.	Inlet protection near storage building and perimeter ECD's on west side of LY-046 in good condition.

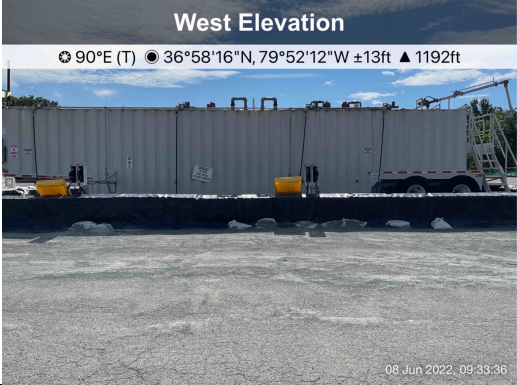
GPS Location	See picture	GPS Location			
Field Station#	0000+00	Field Station#			
Pic 7 Desc.	Secondary containment structure for fuel cell at LY-046 in good condition.	Pic 8 Desc.			
Insert image here		Insert image here			
GPS Location		GPS Location			
Field Station#		Field Station#			
Pic 9 Desc.		Pic 10 Desc.			
Insert image here		Insert image here			
GPS Location		GPS Location			
Field Station#		Field Station#			
Pic 11 Desc.		Pic 12 Desc.

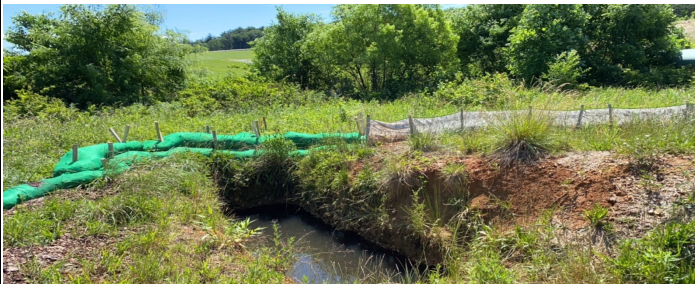
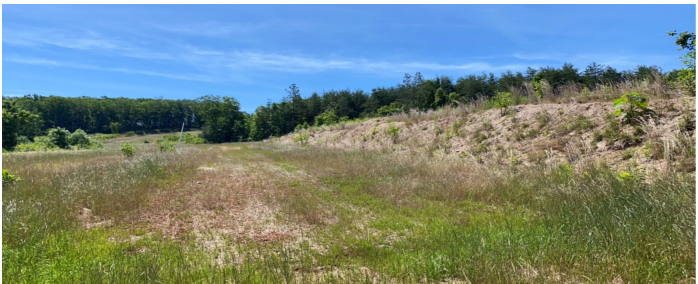
37°2'34" N 79°48'33" W 185°S COURSE 29° GPS 530 Farm View Rd, Glade Hill, VA 24092, United States 06.09.2022 10:51:36 Accur +/-23.9 Ft ALT 1056 Ft			37°2'33" N 79°48'32" W 170°S COURSE 125° GPS 530 Farm View Rd, Glade Hill, VA 24092, United States 06.09.2022 10:54:06 Accur +/-908.9 Ft ALT 1057 Ft		
GPS Location	1	GPS Location	2		
Field Station#	14314+00	Field Station#	14321+00		
Pic 1 Desc.	Perimeter controls in place and functional.		Pic 2 Desc.	ROW stabilized and vegetated in temporary area.

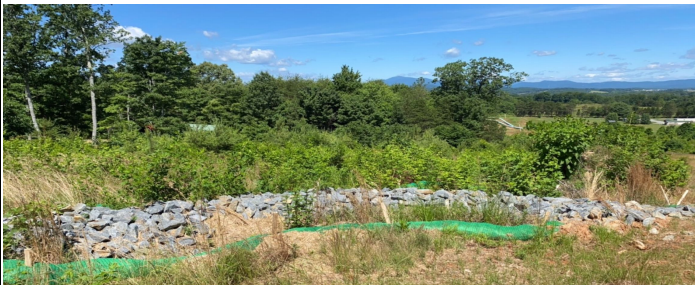
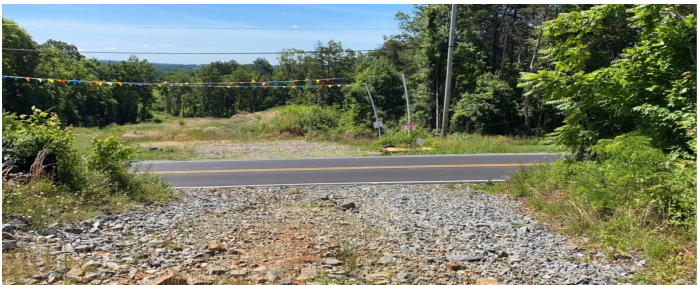
Field Station#	14326+00	Field Station#	14333+27		
Pic 3 Desc.	Water bar end treatment performing intended function.		Pic 4 Desc.	RCE at Golden View Rd in good condition.

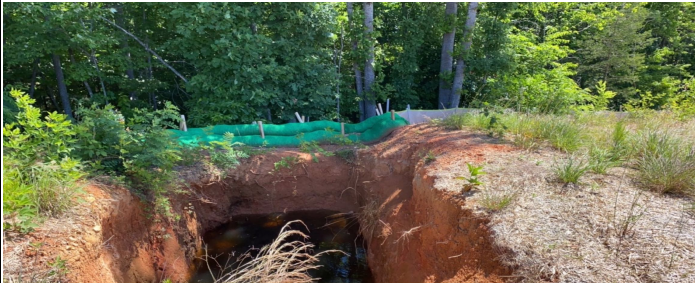
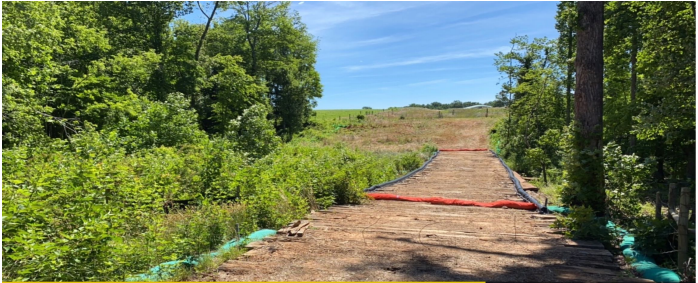
37°2'12" N 79°48'3" W 132°SE COURSE 72° GPS Glade Hill, VA 24092, United States 06.09.2022 11:11:50 Accur +/-60.4 Ft ALT 1127 Ft			37°2'10" N 79°47'59" W 112°E COURSE 67° GPS Glade Hill, VA 24092, United States 06.09.2022 11:13:25 Accur +/-15.4 Ft ALT 1097 Ft		
GPS Location	5	GPS Location	6		
Field Station#	14348+00	Field Station#	14353+53		
Pic 5 Desc.	Sump pit and CFS end treatment performing intended functions.		Pic 6 Desc.	Equipment bridge and surrounding ECDs in place and functional at stream crossing and resource buffer.

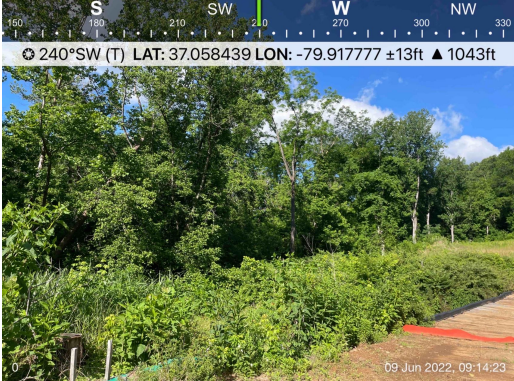
GPS Location	See photo	GPS Location	See photo		
Field Station#	13862+60	Field Station#	13875+73		
Pic 1 Desc.	Resource buffers remain well vegetated	Pic 2 Desc.	Equipment bridge ECDs are in good condition and functioning

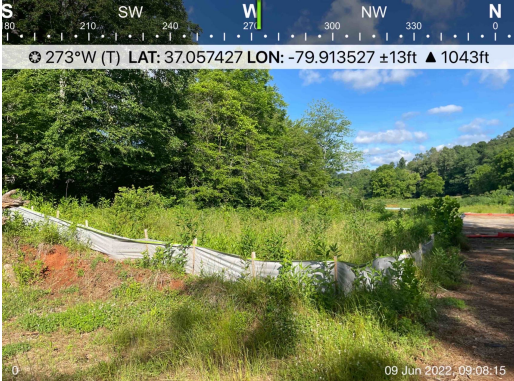
GPS Location	See photo	GPS Location	See photo		
Field Station#	13876+00	Field Station#	13889+00		
Pic 3 Desc.	P1 is in good condition at all stream and wetland buffers	Pic 4 Desc.	Slope drain is functioning as intended

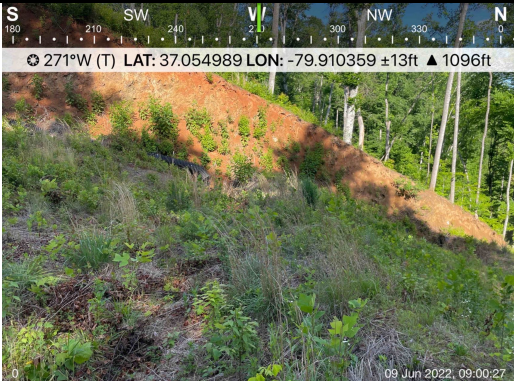
GPS Location	See photo	GPS Location	See photo		
Field Station#	13890+00	Field Station#	13892+45		
Pic 5 Desc.	Waterbars are in good condition	Pic 6 Desc.	RCEs are in good condition at all road crossings.

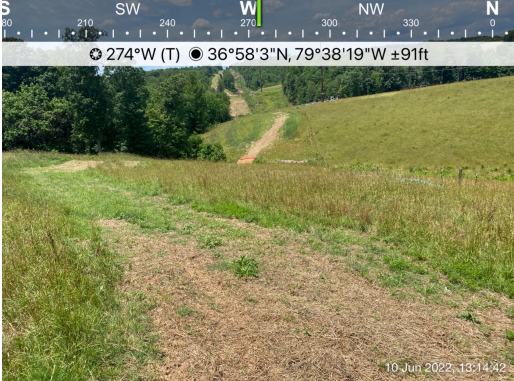
GPS Location	0	GPS Location	0		
Field Station#	14926+00	Field Station#	14870+43		
Pic 1 Desc.	Approximately 14926+00. Overview of ROW. Permanent vegetation.	Pic 2 Desc.	Approximately 14870+43. Overview of stream crossing, equipment bridge and ECDs at stream S-SS8.

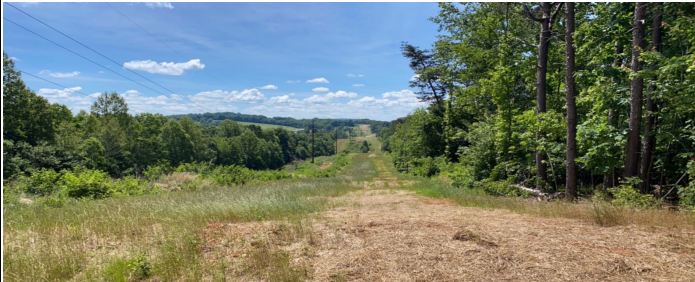
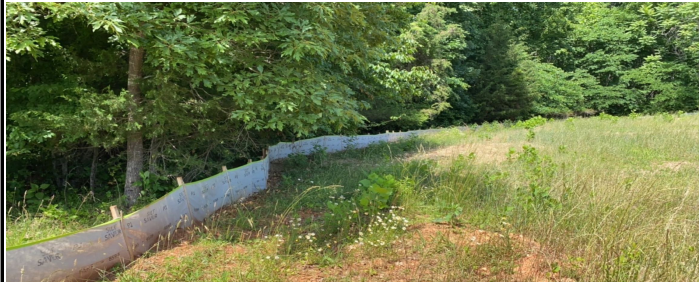
06.10.2022 11:27:23 Accur +/-64.6 Ft ALT 1048 Ft			06.10.2022 11:34:38 Accur +/-64.2 Ft ALT 933 Ft		
GPS Location	1	GPS Location	2		
Field Station#	14464+00	Field Station#	14477+00		
Pic 1 Desc.	ROW stabilized and vegetated in temporary area.		Pic 2 Desc.	Perimeter P1 silt fence in good condition.
