Visual Site Inspection Report

Project Name	H-600 Pipeline Spread G	AFE	124300137	Spread	H-600 Pipeline Spread G
Contractor	Precision			Report #	38959
Inspector	Jared Saunders			Date/Time	6/20/2022 7:10 PM
Permit #	TBD	Inspection Type	VA SWPP	Station Begin	11788+52
State	VA	Inspection Area	Partial	Station End	11899+89
County	Montgomery	Ground	Dry	Temperature (°F)	78.00
Municipality	N/A	Weather	Sunny	Rain Gauge (in)	0.00
				Rain Accumulation Time (days)	1.00

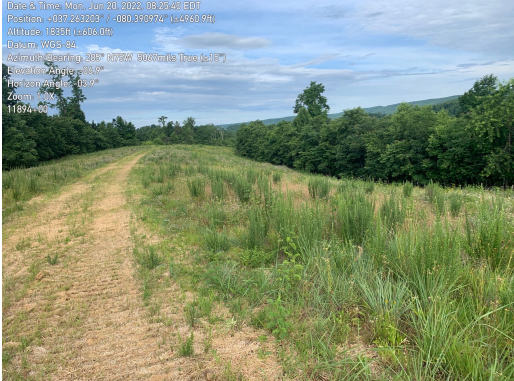
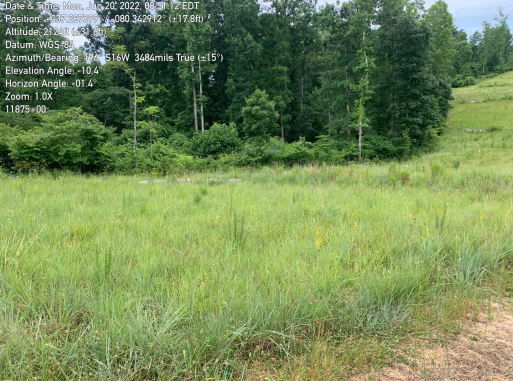
GPS Location	See photo for GPS location.		GPS Location	See photo for GPS location.	
Field Station#	11894+00		Field Station#	11875+00	
Pic 1 Desc.	ROW permanently restored.		Pic 2 Desc.	ROW permanently restored. Waterbar with level spreader in place.

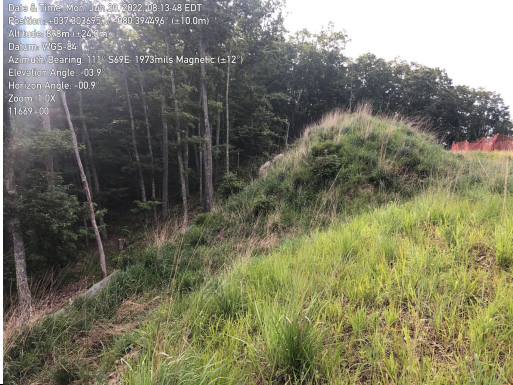
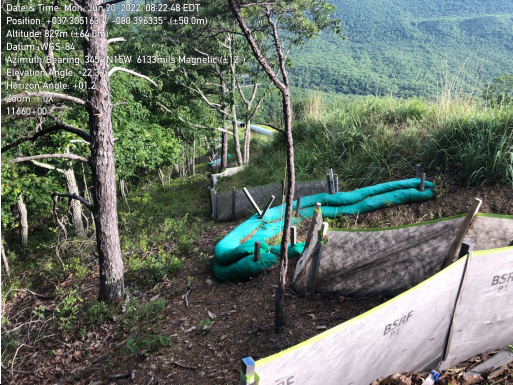
GPS Location				On photo				GPS Location				On photo			
Field Station#				11669+00				Field Station#				11660+00			
Pic 1 Desc.				ROW stable with ECDs in place.				Pic 2 Desc.				ECDs were checked for function and maintenance needs.

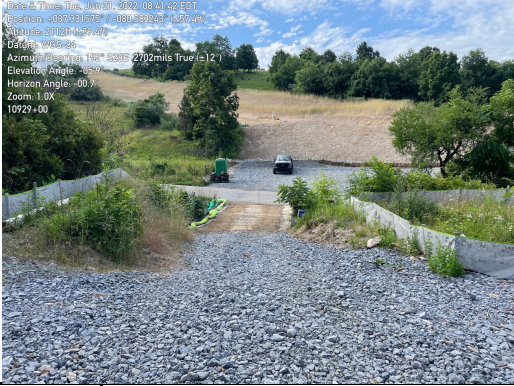
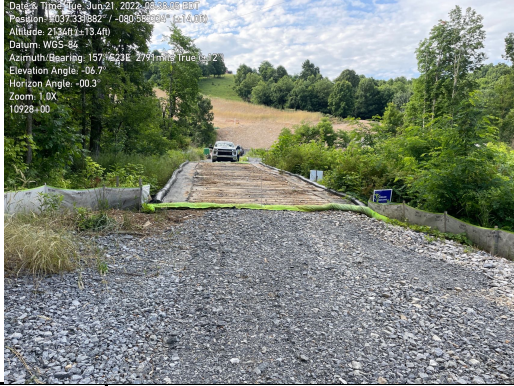
GPS Location	See photo	GPS Location	See photo		
Field Station#	10929+00	Field Station#	10928+00		
Pic 1 Desc.	Resource buffers in place	Pic 2 Desc.	Equipment bridge functional

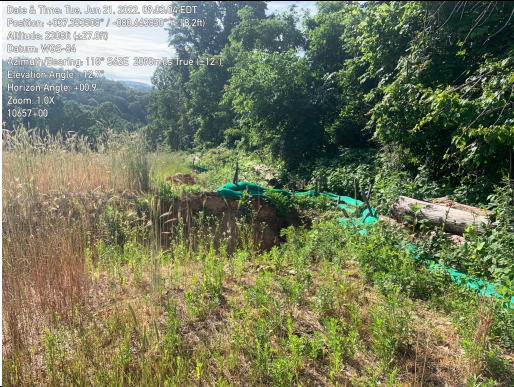
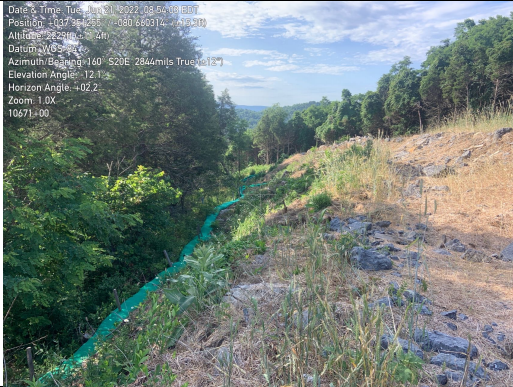
GPS Location	See photo		GPS Location	See photo	
Field Station#	10657+00		Field Station#	10671+00	
Pic 1 Desc.	Section of Row showing conditions and controls		Pic 2 Desc.	Section of Row showing conditions and controls

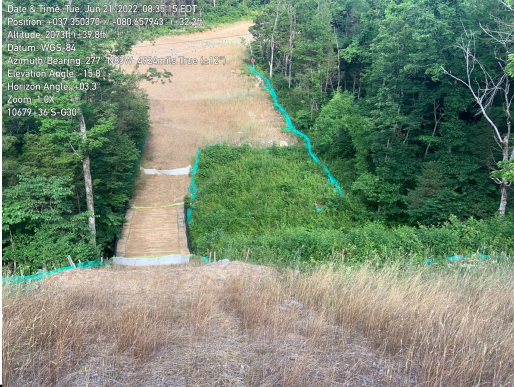
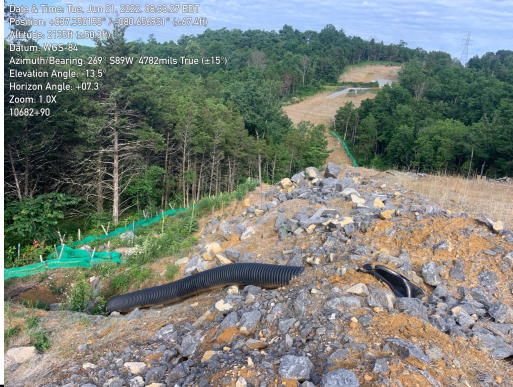
GPS Location	See photo		GPS Location	See photo	
Field Station#	10679+79		Field Station#	10682+90	
Pic 3 Desc.	Overview of S-G30		Pic 4 Desc.	Section of Row showing conditions and controls

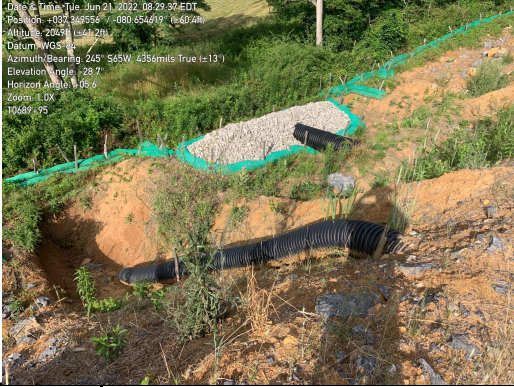
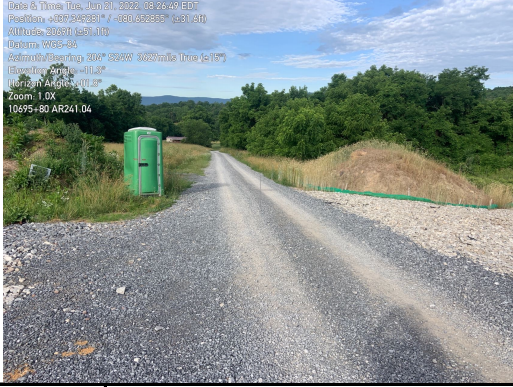
GPS Location	See photo		GPS Location	See photo	
Field Station#	10689+95		Field Station#	10695+80	
Pic 5 Desc.	Perimeter controls are in places		Pic 6 Desc.	AR241.04 is maintained in acceptable condition

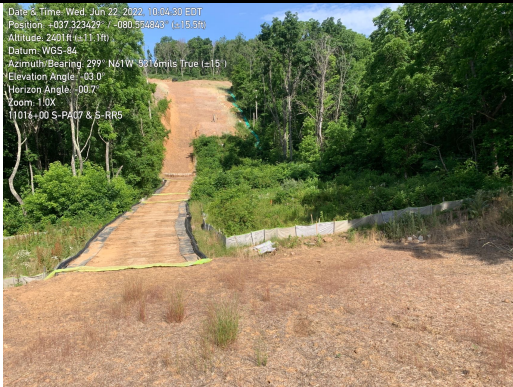
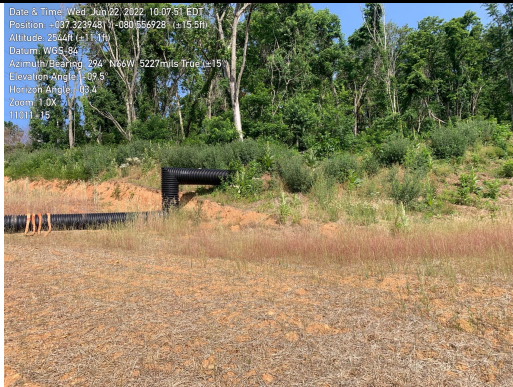
GPS Location				See photo for GPS location.				GPS Location				See photo for GPS location.			
Field Station#				11016+00				Field Station#				11011+15			
Pic 1 Desc.				Sensitive resource buffer in place at streams S-PA07 and S-RR5.				Pic 2 Desc.				Clean water diversion pipe and clean water diversion berm in place.

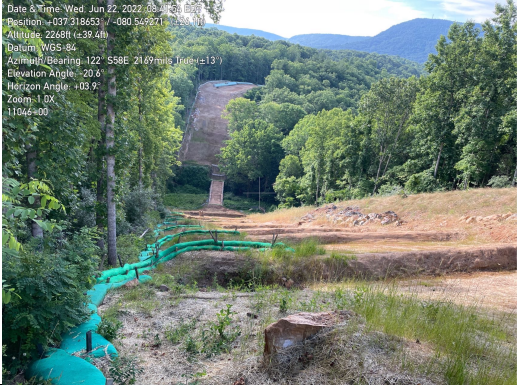
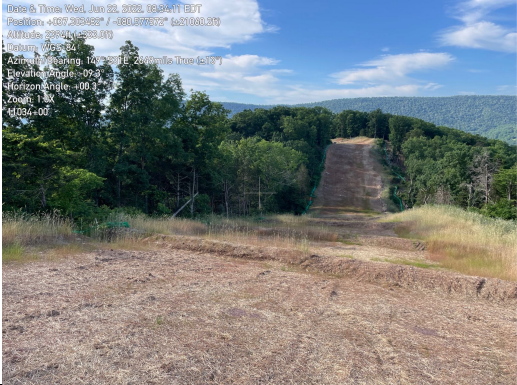
GPS Location	See photo	GPS Location	See photo		
Field Station#	11046+00	Field Station#	11034+00		
Pic 7 Desc.	Water bars and ET in place	Pic 8 Desc.	Picture showing condition of row

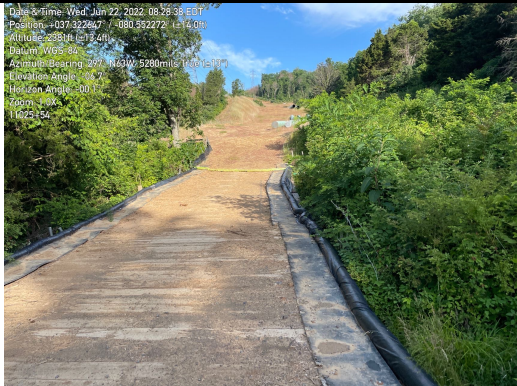
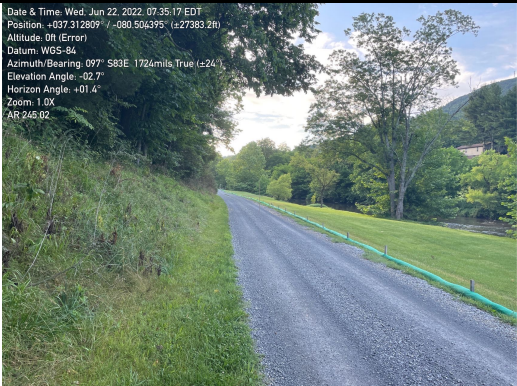
GPS Location	See photo	GPS Location	See photo		
Field Station#	11025+54	Field Station#	11023+80		
Pic 9 Desc.	Wattles in place	Pic 10 Desc.	Access road in good condition		
Insert image here		Insert image here			
GPS Location		GPS Location			
Field Station#		Field Station#			
Pic 11 Desc.		Pic 12 Desc.

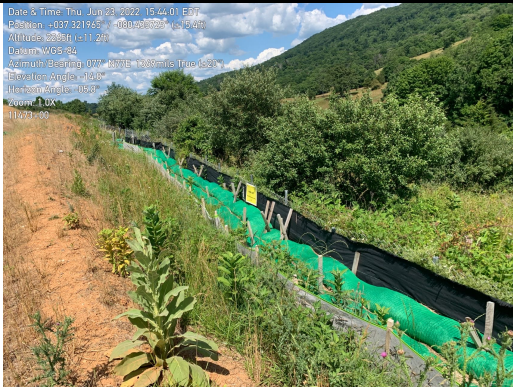
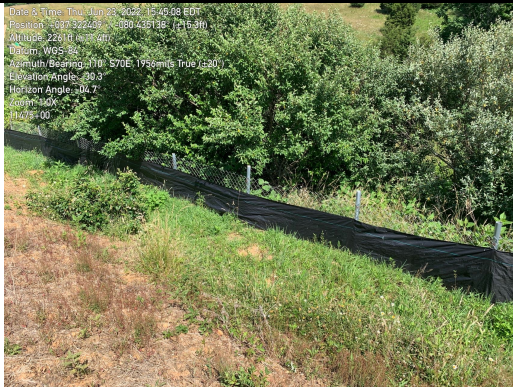
GPS Location		See photo for GPS location.						GPS Location		See photo for GPS location.	
Field Station#		11473+00						Field Station#		11475+00	
Pic 1 Desc.		Triple barrier ECDs in place at off ROW karst feature.						Pic 2 Desc.		Super silt fence in place along LOD.

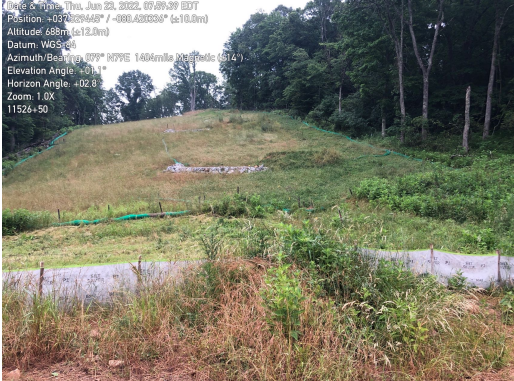
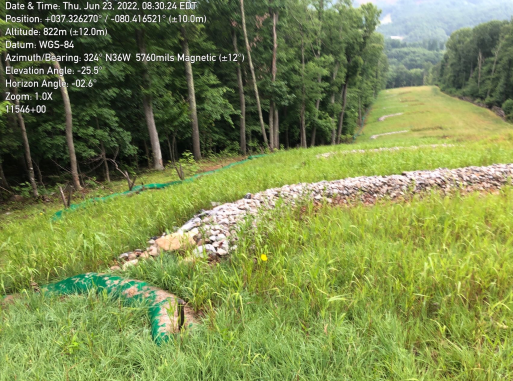
GPS Location	On photo	GPS Location	On photo		
Field Station#	11526+50	Field Station#	11546+00		
Pic 1 Desc.	ECDs are in place. ROW is stable.	Pic 2 Desc.	Permanent ECDs are in place. ROW is stable.

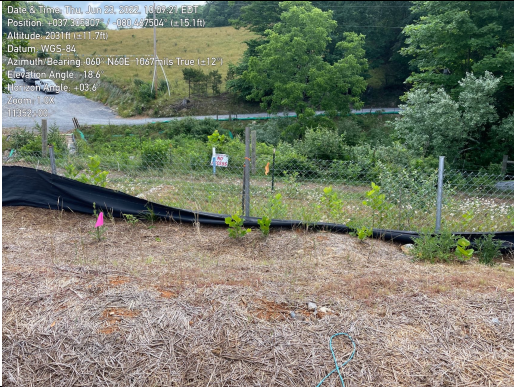
GPS Location	See photo	GPS Location	See photo		
Field Station#	11352+00	Field Station#	11350+00		
Pic 1 Desc.	SSF fabric needs replaced	Pic 2 Desc.	Throat of water bar needs repaired and stabilized

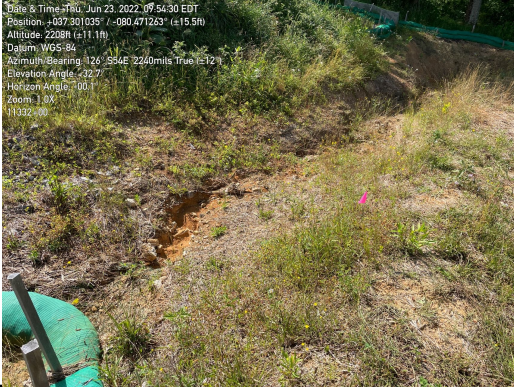
GPS Location	See photo	GPS Location	See photo		
Field Station#	11332+00	Field Station#	11327+85		
Pic 3 Desc.	Throat of water bar needs repaired and stabilized	Pic 4 Desc.	Equipment bridge functional

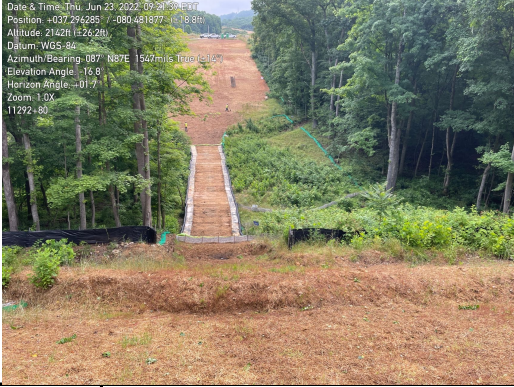
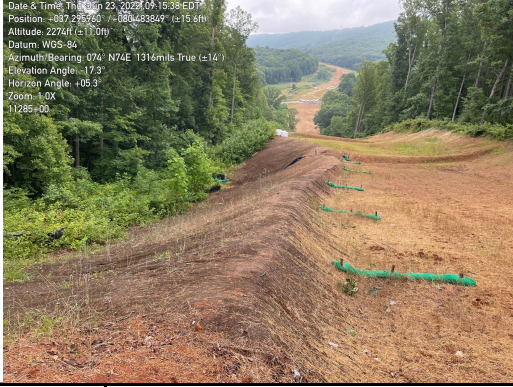
GPS Location	See photo	GPS Location	See photo		
Field Station#	11292+80	Field Station#	11285+00		
Pic 5 Desc.	Resource buffers in place	Pic 6 Desc.	Picture showing condition of row

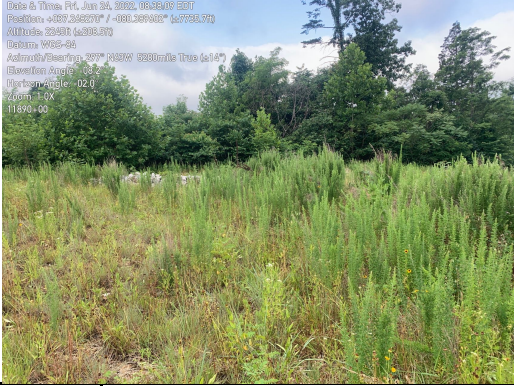
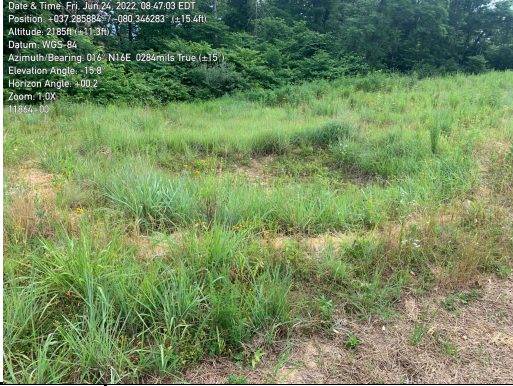
GPS Location	See photo for GPS location.		GPS Location	See photo for GPS location.	
Field Station#	11890+00		Field Station#	11864+00	
Pic 1 Desc.	ROW permanently restored. Waterbar with levee; spreader in place.		Pic 2 Desc.	Sensitive resource P-KL2.

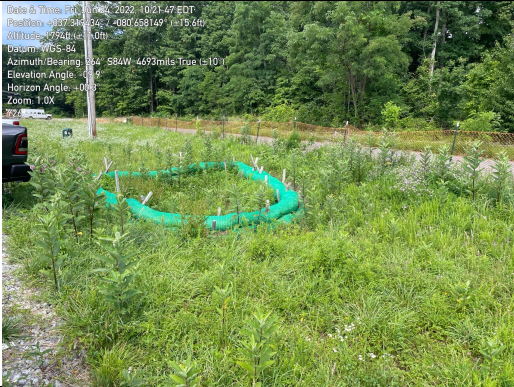
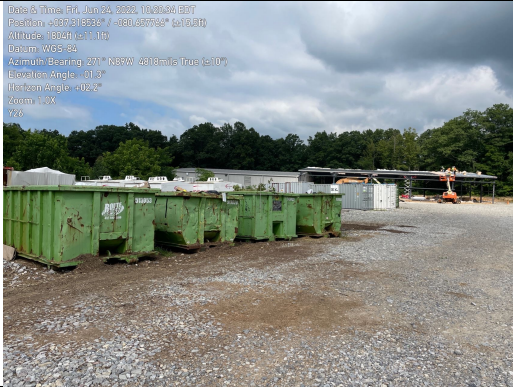
GPS Location	See photo	GPS Location	See photo		
Field Station#	12005+00	Field Station#	12005+00		
Pic 1 Desc.	CFS in place y26	Pic 2 Desc.	Housekeeping trash clearly marked y26

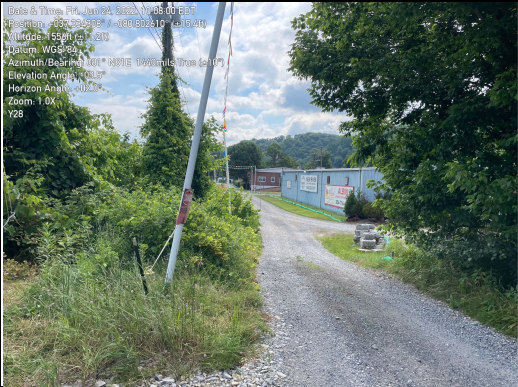
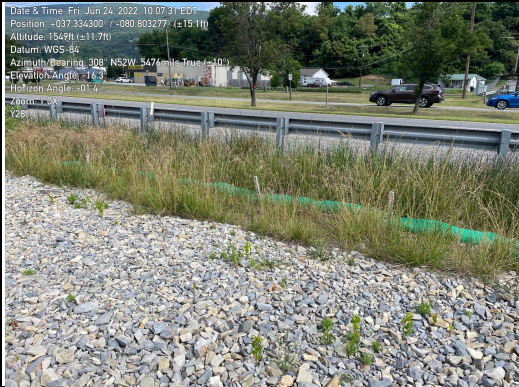
GPS Location	See photo		GPS Location	See photo	
Field Station#	12005+00		Field Station#	12005+00	
Pic 7 Desc.	Permanent stabilization in place y28 CFS in place		Pic 8 Desc.	CFS perimeter controls functional y28

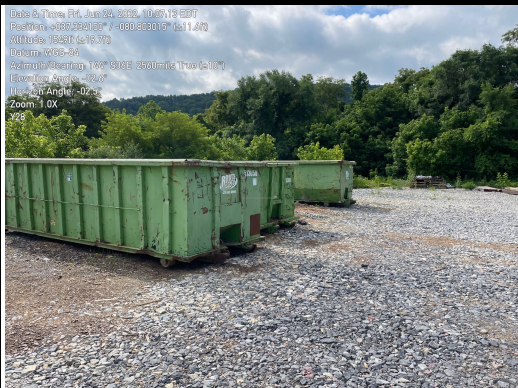
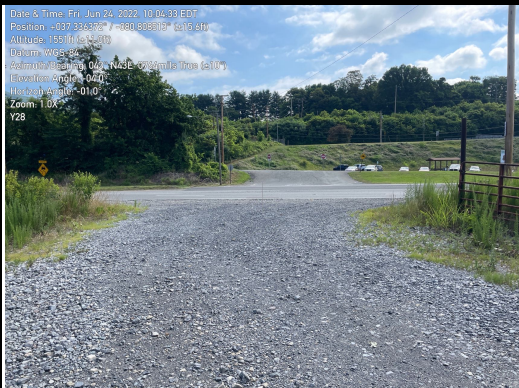
GPS Location	See photo		GPS Location	See photo	
Field Station#	12005+00		Field Station#	12005+00	
Pic 9 Desc.	Housekeeping trash in good y28		Pic 10 Desc.	RCE functional y28

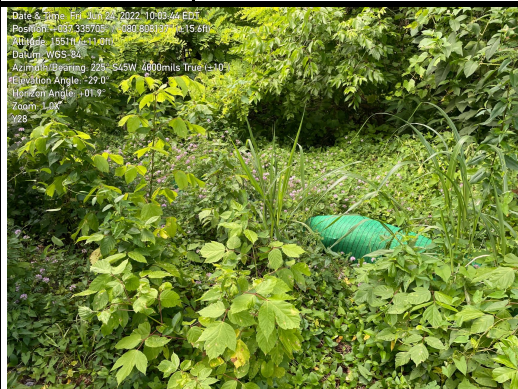
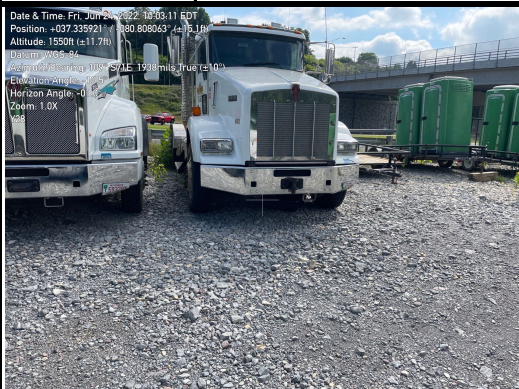
GPS Location	See photo		GPS Location	See photo	
Field Station#	12005+00		Field Station#	12005+00	
Pic 11 Desc.	CFS perimeter controls functional y28		Pic 12 Desc.	Drip pan in place y28
