# Visual Site Inspection Report

<b>Project Name</b>	H-600 Pipeline Spread G	<b>AFE</b>	124300137	<b>Spread</b>	H-600 Pipeline Spread G
<b>Contractor</b>	Precision			<b>Report #</b>	39183
<b>Inspector</b>	Joe Sweeden			<b>Date/Time</b>	6/27/2022 6:29 AM
<b>Permit #</b>	TBD	<b>Inspection Type</b>	VA SWPP	<b>Station Begin</b>	10798+92
<b>State</b>	VA	<b>Inspection Area</b>	Partial	<b>Station End</b>	10859+46
<b>County</b>	Giles	<b>Ground</b>	Damp	<b>Temperature (°F)</b>	72.00
<b>Municipality</b>	N/A	<b>Weather</b>	Light Rain	<b>Rain Gauge (in)</b>	0.05
				<b>Rain Accumulation Time (days)</b>	1.00

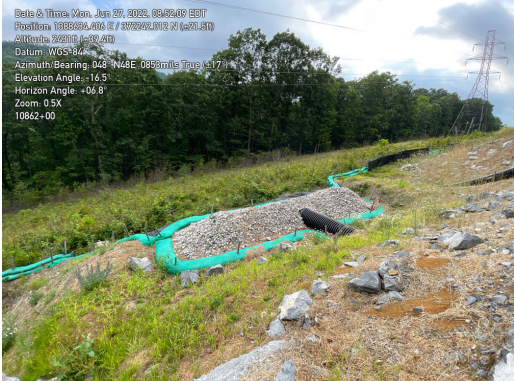
<b>GPS Location</b>	1	<b>GPS Location</b>	2		
<b>Field Station#</b>	10862+00	<b>Field Station#</b>	10867+75		
<b>Pic 1 Desc.</b>	CWDP outlet protection functional.	<b>Pic 2 Desc.</b>	Section of RoW showing conditions and controls.

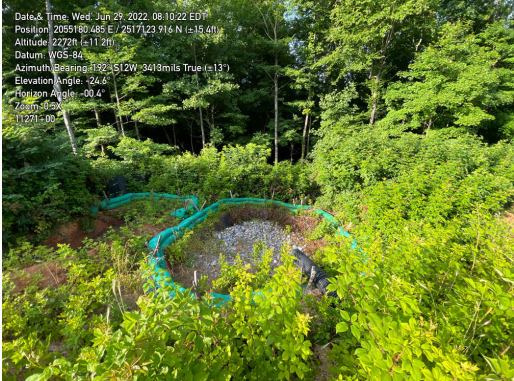
<b>GPS Location</b>	3	<b>GPS Location</b>	4		
<b>Field Station#</b>	11271+00	<b>Field Station#</b>	11286+00		
<b>Pic 3 Desc.</b>	Plunge pool functional.	<b>Pic 4 Desc.</b>	Perimeter controls functional.

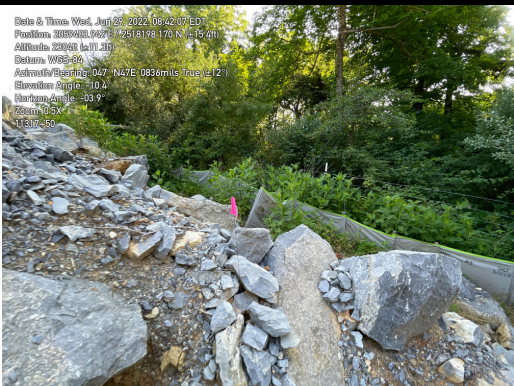
<b>GPS Location</b>	9		<b>GPS Location</b>	10	
<b>Field Station#</b>	11317+50		<b>Field Station#</b>	11327+85	
<b>Pic 9 Desc.</b>	Repair P-1.		<b>Pic 10 Desc.</b>	S-NN12.

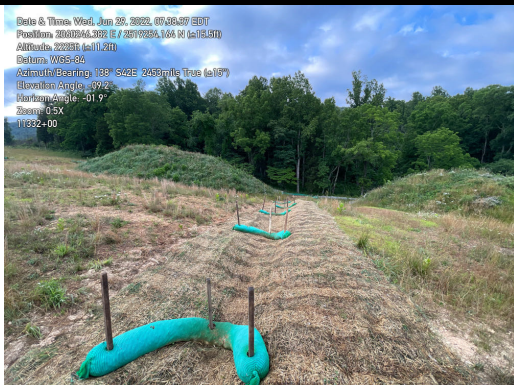
<b>GPS Location</b>	11		<b>GPS Location</b>	12	
<b>Field Station#</b>	11332+00		<b>Field Station#</b>	11343+00	
<b>Pic 11 Desc.</b>	Repaired punch list item from 6/23/2022.		<b>Pic 12 Desc.</b>	Section of RoW showing conditions and controls.

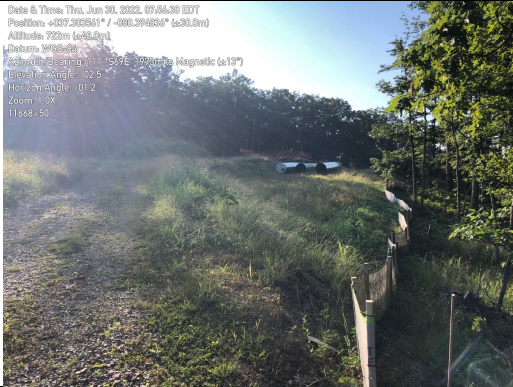
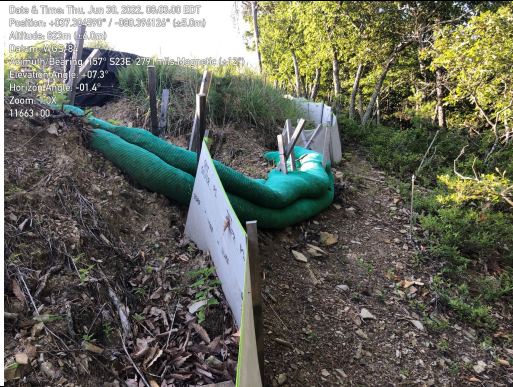
GPS Location		On photo		GPS Location	
Field Station#		11668+50		Field Station#	
Pic 1 Desc.		ROW stable top of Brush Mountain.		Pic 2 Desc.	
				ECDs in place. ROW stable.

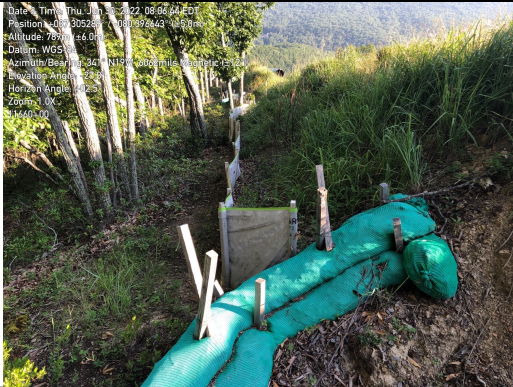
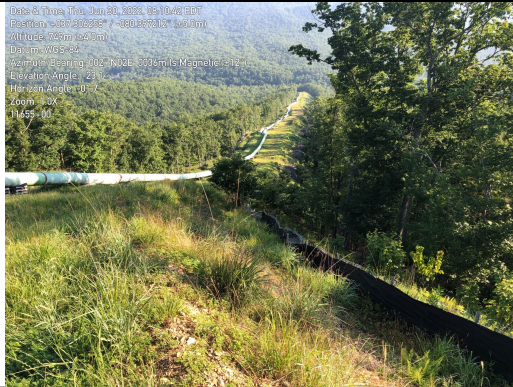
GPS Location		On photo		GPS Location	
Field Station#		11660+00		Field Station#	
Pic 3 Desc.		ECDs effective. No sediment accumulation.		Pic 4 Desc.	
				ROW stable. Perimeter ECDs are in acceptable condition.

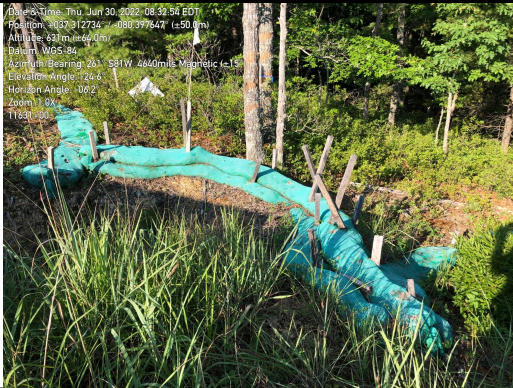
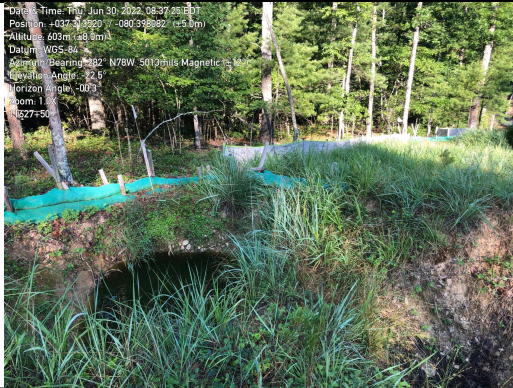
GPS Location		On photo		GPS Location	
Field Station#		11631+00		Field Station#	
Pic 5 Desc.		ROW stable. ECDs in place.		Pic 6 Desc.	
				ECDs in acceptable condition. ROW well vegetated.

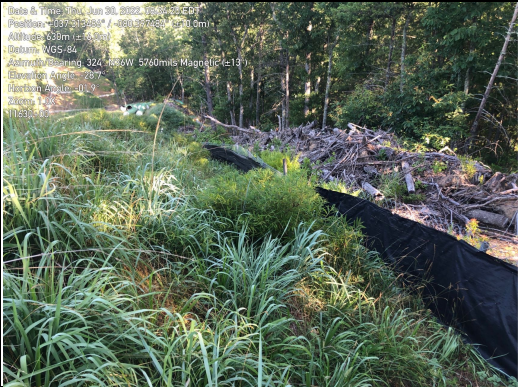
GPS Location	On photo		GPS Location	On photo	
Field Station#	11630+00		Field Station#	11626+04	
Pic 7 Desc.	ECDs in place. ROW stable.		Pic 8 Desc.	The S-HH18 crossing remains stable.

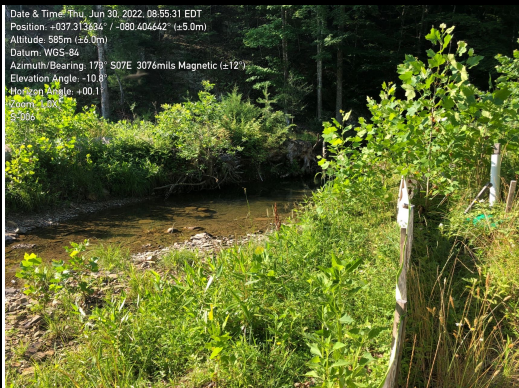
GPS Location	On photo		GPS Location	On photo	
Field Station#	11614+20		Field Station#	11607+81	
Pic 9 Desc.	The S-RR14 crossing is stable.		Pic 10 Desc.	The S-006 crossing is stable.

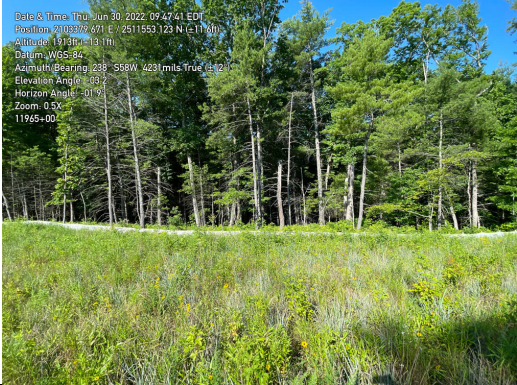
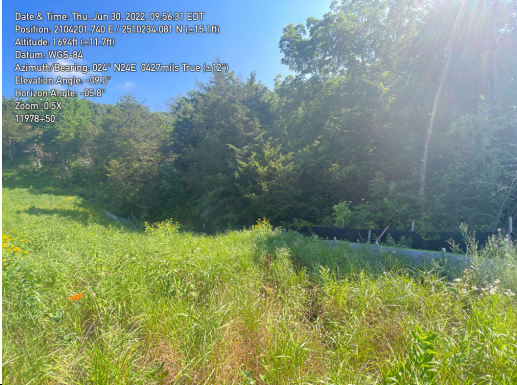
<b>GPS Location</b>	7	<b>GPS Location</b>	8		
<b>Field Station#</b>	11965+00	<b>Field Station#</b>	11978+50		
<b>Pic 7 Desc.</b>	Perimeter controls functional.	<b>Pic 8 Desc.</b>	Karst feature protection functional.

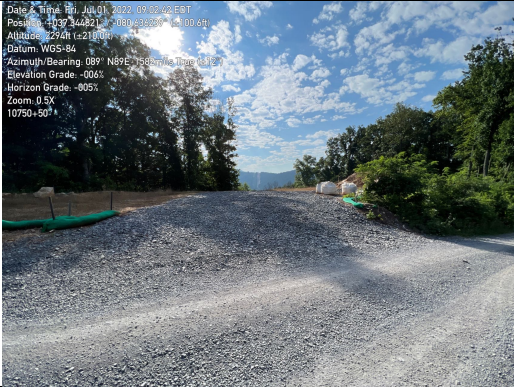
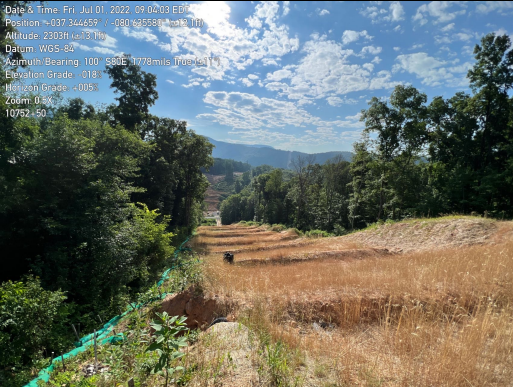
<b>GPS Location</b>	See photo	<b>GPS Location</b>	See photo		
<b>Field Station#</b>	10750+50	<b>Field Station#</b>	10752+50		
<b>Pic 1 Desc.</b>	RCE in place	<b>Pic 2 Desc.</b>	Waterbars in place
