Visual Site Inspection Report

Project Name	H-602 Pipeline Spread I	AFE	124300139	Spread	H-602 Pipeline Spread I	
Contractor	Precision			Report #	38944	
Inspector	John White			Date/Time	6/20/2022 12:50 PM	
Permit #	TBD	Inspection Type	VA SWPP	Station Begin	00+00	
State	VA	Inspection Area	Full	Station End	19+25	
County	Pittsylvania	Ground	Dry	Temperature (°F)	74.00	
Municipality	Chatham	Weather	Cloudy	Rain Gauge (in)	0.80	
				Rain Accumulation Time (days)	6.00

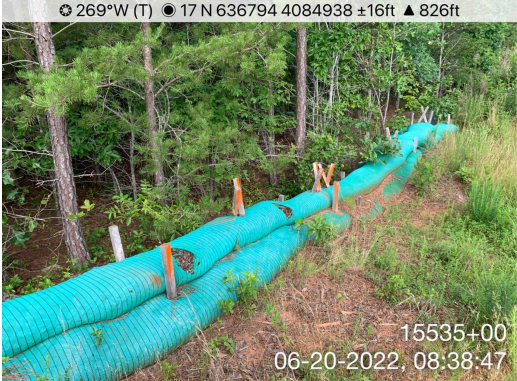
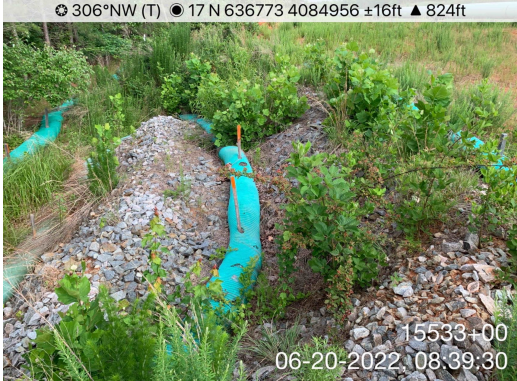
GPS Location	0	GPS Location	0		
Field Station#	15535+00	Field Station#	15533+00		
Pic 7 Desc.	Perimeter CFS is deteriorated from 15534+00 to 15535+00		Pic 8 Desc.	CFS at clean water diversion outlet is deteriorated

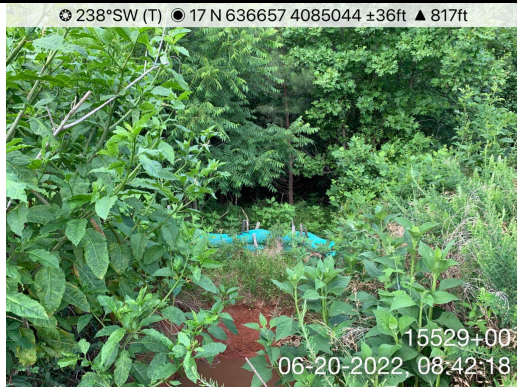
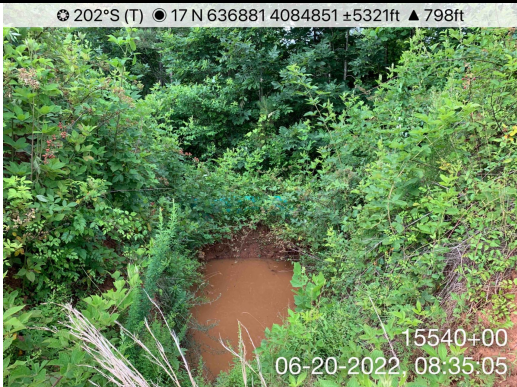
GPS Location	0	GPS Location	0		
Field Station#	15532+75	Field Station#	15530+00		
Pic 9 Desc.	CFS end treatment is deteriorated		Pic 10 Desc.	CFS end treatment is deteriorated

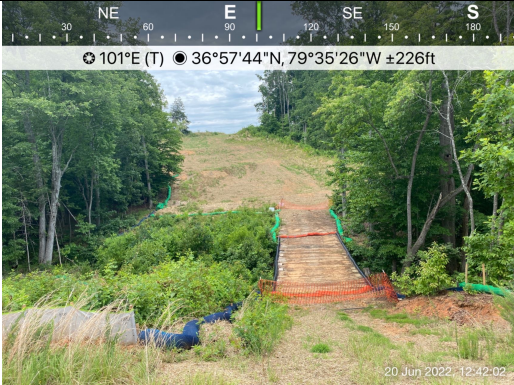
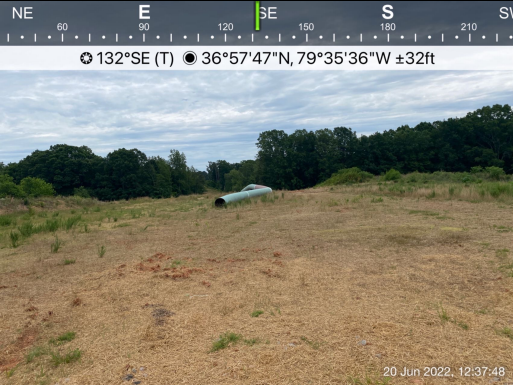
GPS Location	0	GPS Location	0		
Field Station#	15072+86	Field Station#	15065+00		
Pic 1 Desc.	Approximately 15072+86. Overview of stream crossing, equipment bridge and ECDs at stream S-G11.		Pic 2 Desc.	Approximately 15065+00. Overview of ROW.

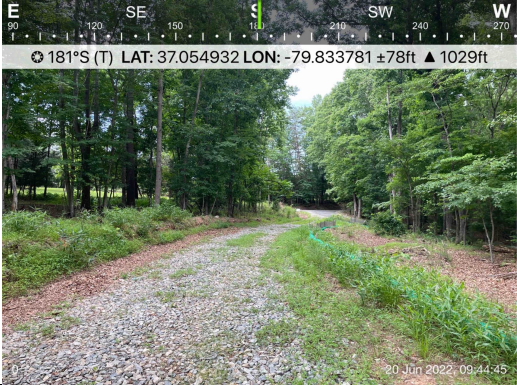
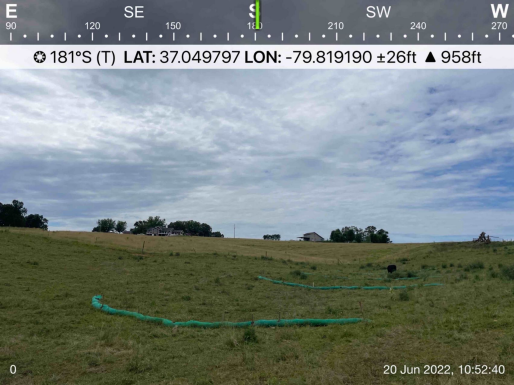
GPS Location	See photo		GPS Location	See photo	
Field Station#	14223+41		Field Station#	14273+00	
Pic 7 Desc.	MVP-FR-311 is in good condition with controls in place		Pic 8 Desc.	CFS is in good condition throughout this section

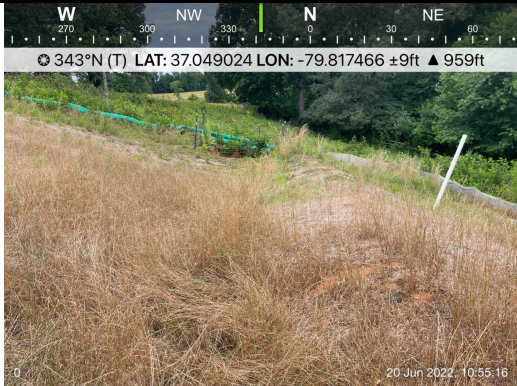
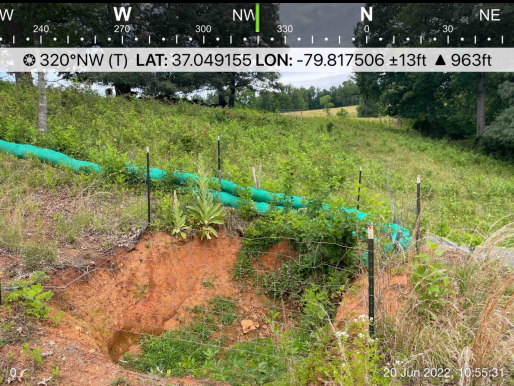
GPS Location	See photo		GPS Location	See photo	
Field Station#	14277+00		Field Station#	14277+00	
Pic 9 Desc.	Waterbars are in good condition		Pic 10 Desc.	End treatments are functioning as intended

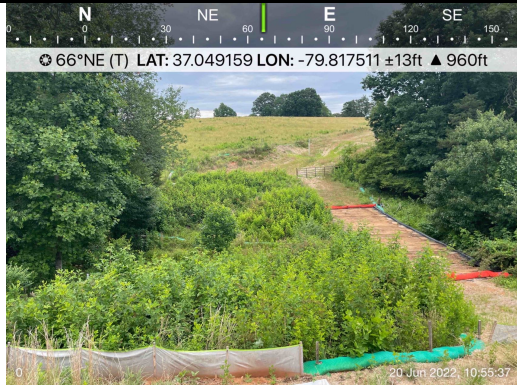
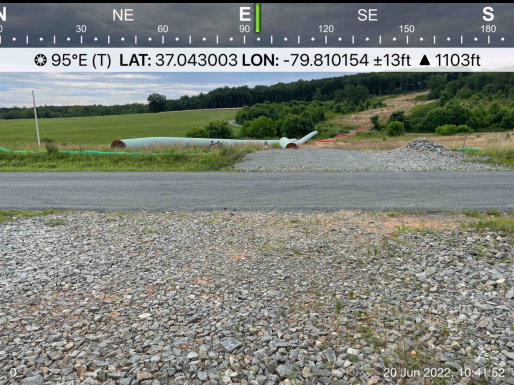
GPS Location	See photo		GPS Location	See photo	
Field Station#	14279+00		Field Station#	14311+57	
Pic 11 Desc.	Resource buffers remain well vegetated		Pic 12 Desc.	RCEs are in good condition at all road crossings.

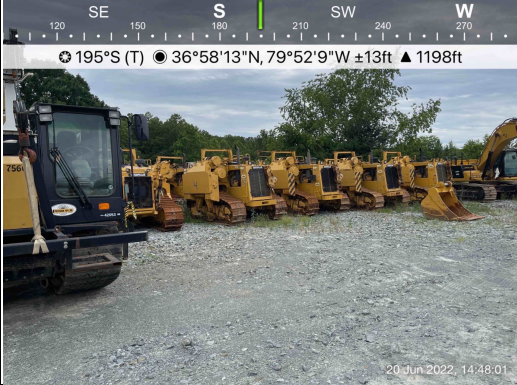
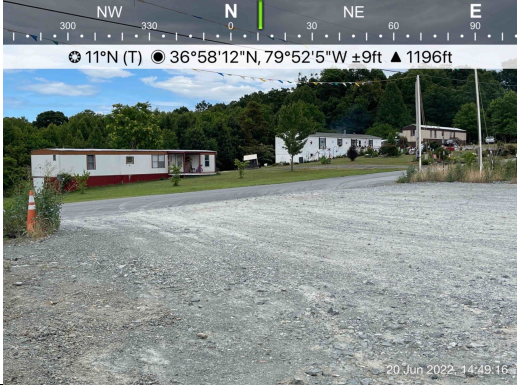
GPS Location	See picture		GPS Location	See picture	
Field Station#	0000+00		Field Station#	0000+00	
Pic 7 Desc.	Equipment inspected and no leaks observed during inspection at LY-045.		Pic 8 Desc.	RCE at LY-045 in good condition.	
Insert image here			Insert image here		
GPS Location			GPS Location		
Field Station#			Field Station#		
Pic 9 Desc.			Pic 10 Desc.		
Insert image here			Insert image here		
GPS Location			GPS Location		
Field Station#			Field Station#		
Pic 11 Desc.			Pic 12 Desc.

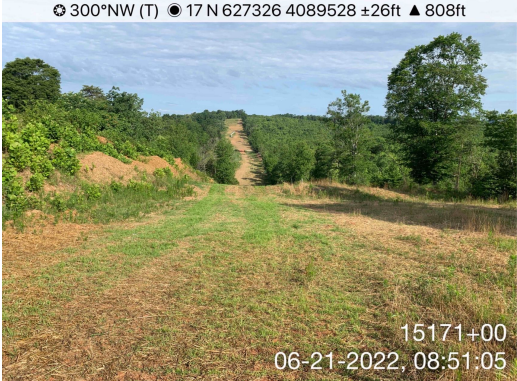
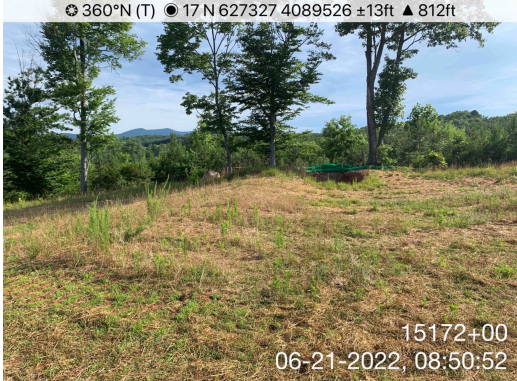
GPS Location	0	GPS Location	0		
Field Station#	15171+00	Field Station#	15172+00		
Pic 7 Desc.	Temporary vegetative stabilization in acceptable condition; recently planted grass is coming up		Pic 8 Desc.	Waterbar in acceptable condition

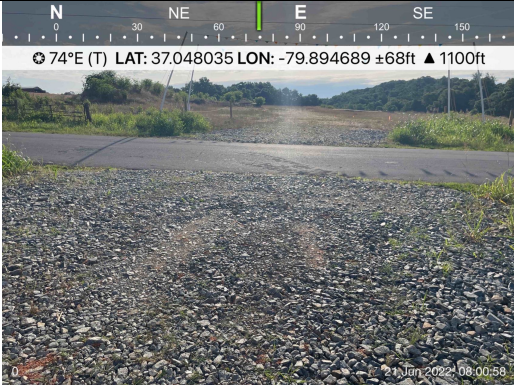
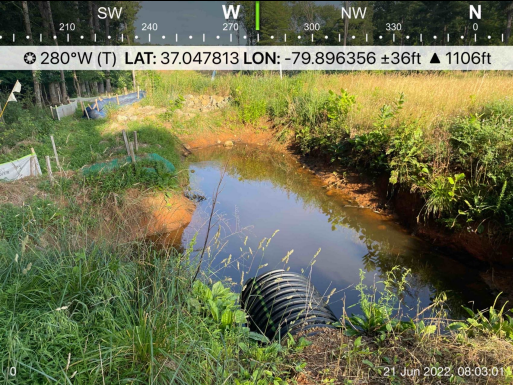
GPS Location	See photo		GPS Location	See photo	
Field Station#	13958+31		Field Station#	13955+00	
Pic 1 Desc.	RCEs are in good condition at all road crossings		Pic 2 Desc.	Slope drain outlet is in good condition

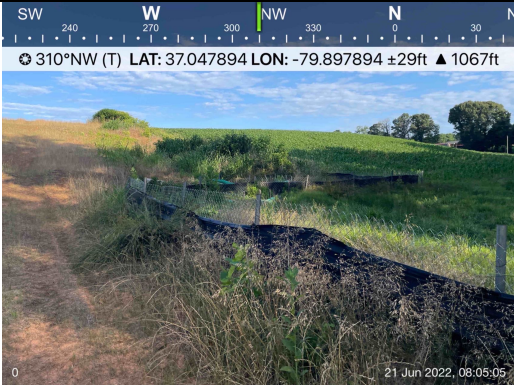
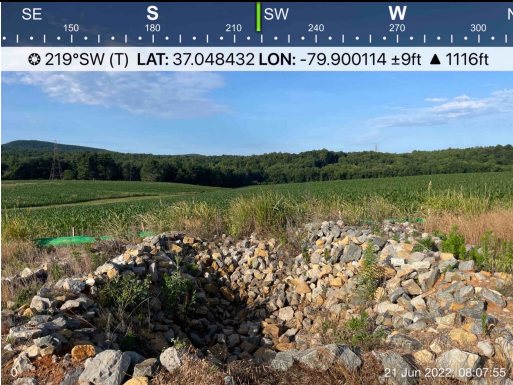
GPS Location	See photo		GPS Location	See photo	
Field Station#	13948+00		Field Station#	13942+00	
Pic 3 Desc.	SSF is in good condition		Pic 4 Desc.	CWDs are functioning as intended

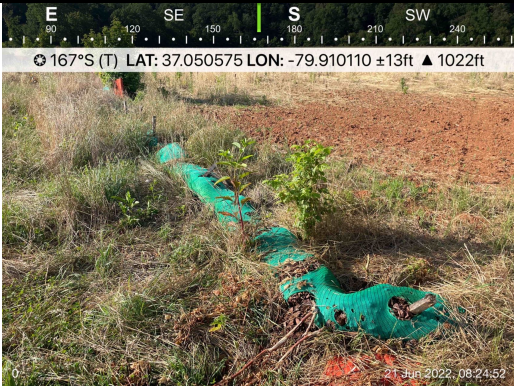
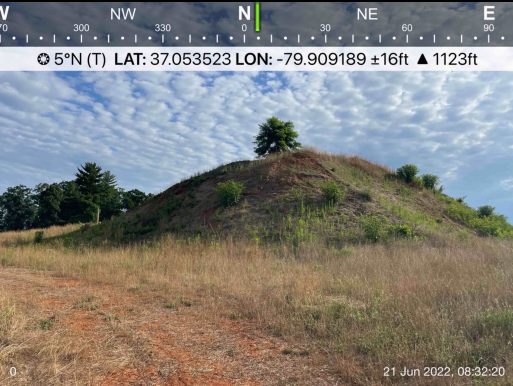
GPS Location	See photo		GPS Location	See photo	
Field Station#	13909+00		Field Station#	13897+00	
Pic 5 Desc.	CFS has been damaged by 3rd party and needs to be replaced		Pic 6 Desc.	Topsoil pile remains stabilized

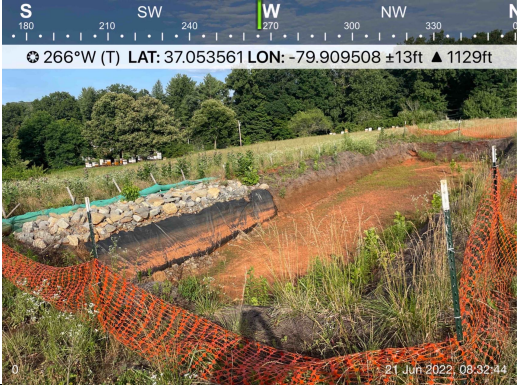
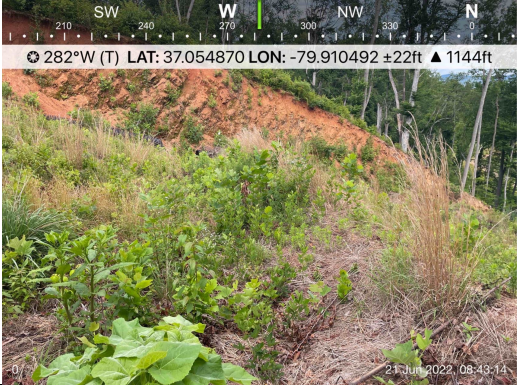
GPS Location	See photo		GPS Location	See photo	
Field Station#	13897+00		Field Station#	13891+00	
Pic 7 Desc.	Sediment trap is functioning as intended		Pic 8 Desc.	Waterbars are in good condition

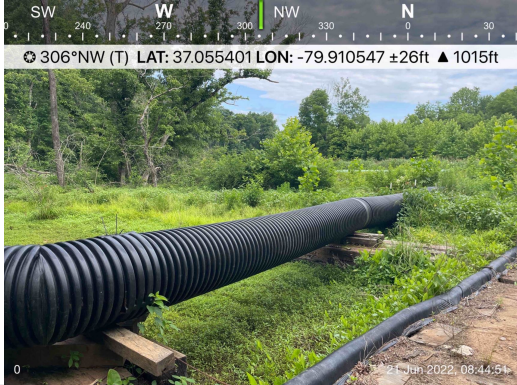
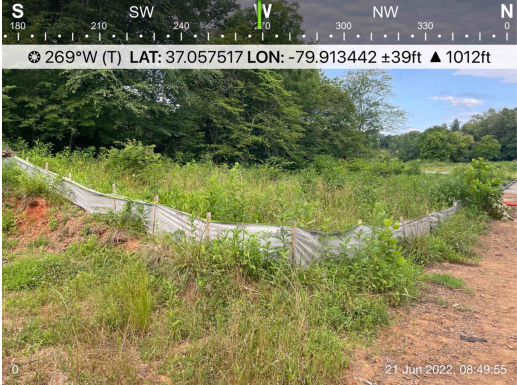
GPS Location	See photo		GPS Location	See photo	
Field Station#	13889+00		Field Station#	13876+00	
Pic 9 Desc.	Slope drain is in good condition and functioning		Pic 10 Desc.	P1 is in good condition at all stream and wetland buffers

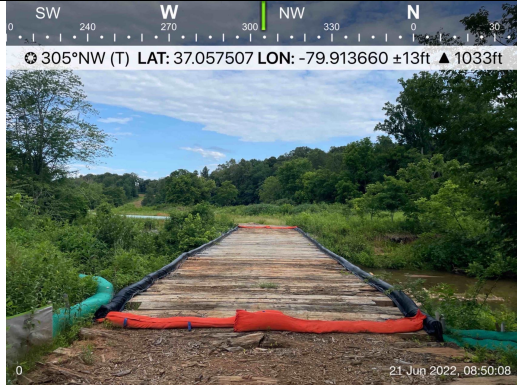
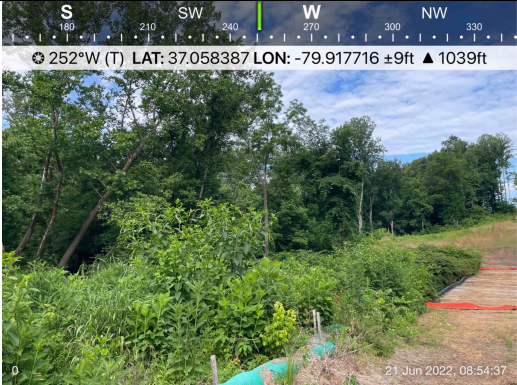
GPS Location	See photo		GPS Location	See photo	
Field Station#	13875+73		Field Station#	13863+01	
Pic 11 Desc.	Equipment bridge ECDs are in good condition		Pic 12 Desc.	Resource buffers remain well vegetated

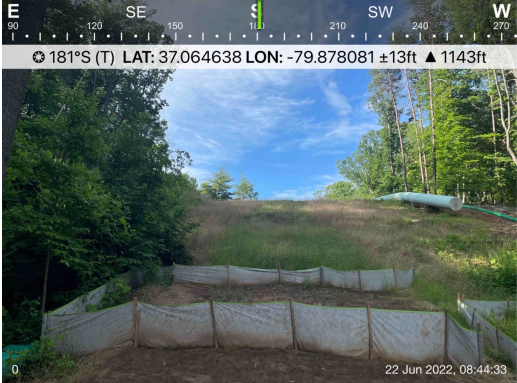
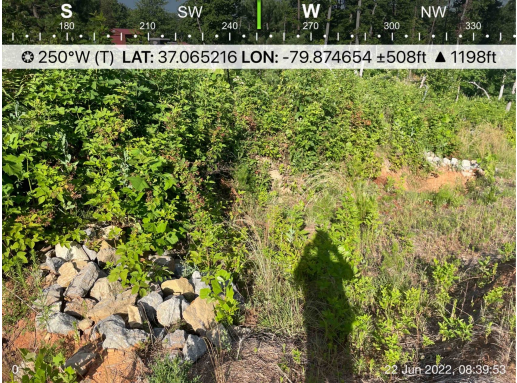
GPS Location	See photo	GPS Location	See photo		
Field Station#	14050+00	Field Station#	14060+00		
Pic 13 Desc.	Slope remains stabilized with controls in place	Pic 14 Desc.	Rock check dams are in good condition		
Insert image here		Insert image here			
GPS Location		GPS Location			
Field Station#		Field Station#			
Pic 15 Desc.		Pic 16 Desc.			
Insert image here		Insert image here			
GPS Location		GPS Location			
Field Station#		Field Station#			
Pic 17 Desc.		Pic 18 Desc.

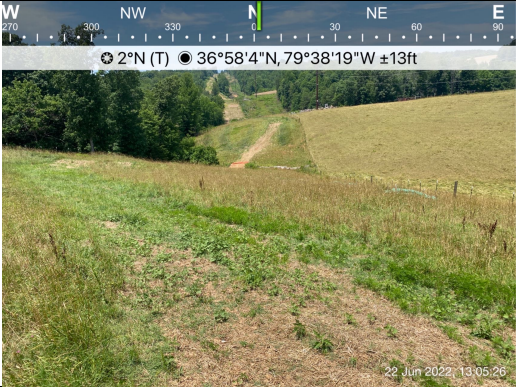
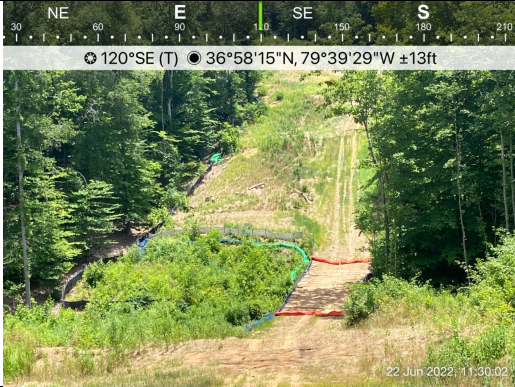
GPS Location	0	GPS Location	0		
Field Station#	14925+00	Field Station#	14870+43		
Pic 1 Desc.	Approximately 14925+00. Overview of ROW. Permanent vegetation.	Pic 2 Desc.	Approximately 14870+43. Overview of stream crossing, equipment bridge and ECDs at stream S-SS8.

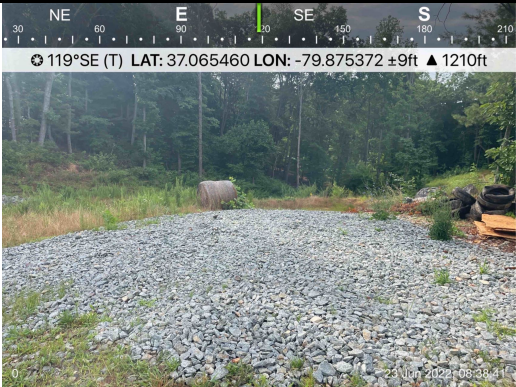
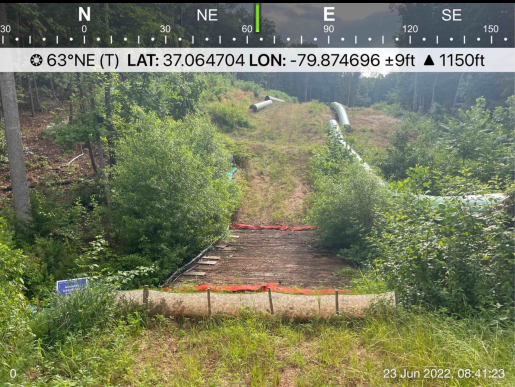
GPS Location	See photo		GPS Location	See photo	
Field Station#	14062+17		Field Station#	14066+77	
Pic 1 Desc.	RCEs are in good condition at all road crossings.		Pic 2 Desc.	Equipment bridge ECDs are in good condition and functioning

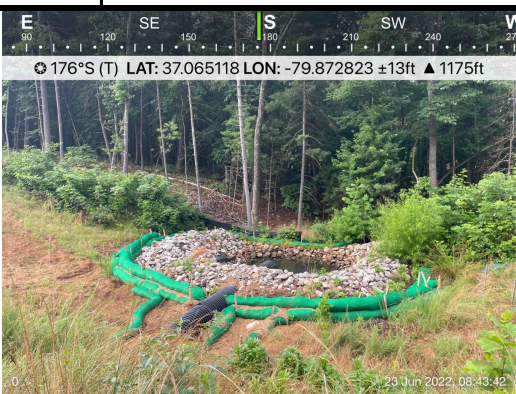
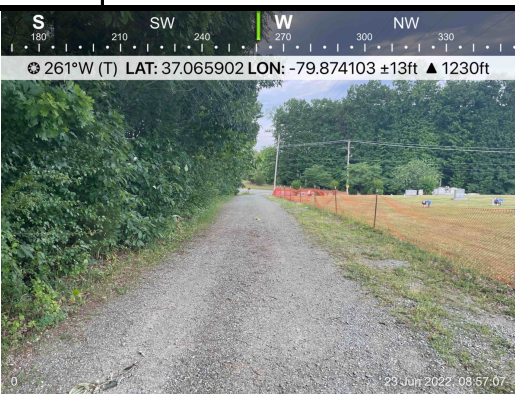
GPS Location	See photo		GPS Location	See photo	
Field Station#	14070+00		Field Station#	14081+53	
Pic 3 Desc.	CWDs are functioning as intended		Pic 4 Desc.	MVP-FR-309.05 is in good condition with controls in place

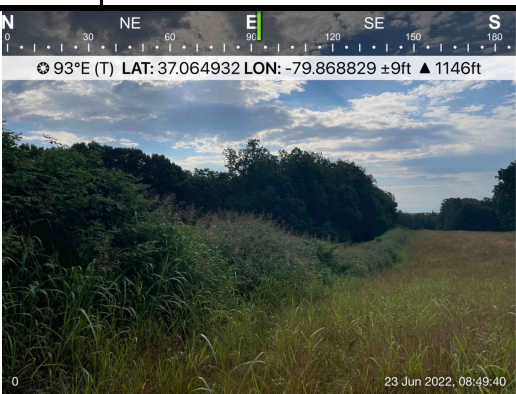
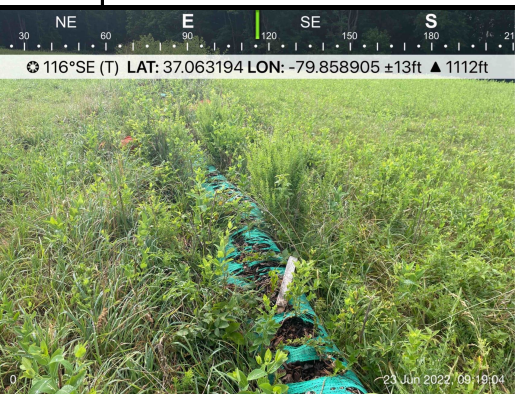
GPS Location	See photo		GPS Location	See photo	
Field Station#	14090+00		Field Station#	14118+00	
Pic 5 Desc.	Topsoil berms remain stabilized		Pic 6 Desc.	CFS has been damaged by 3rd party and needs to be replaced

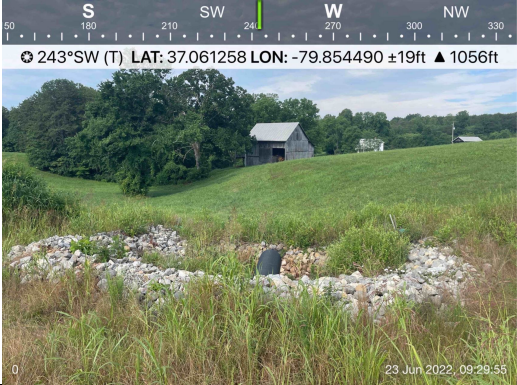
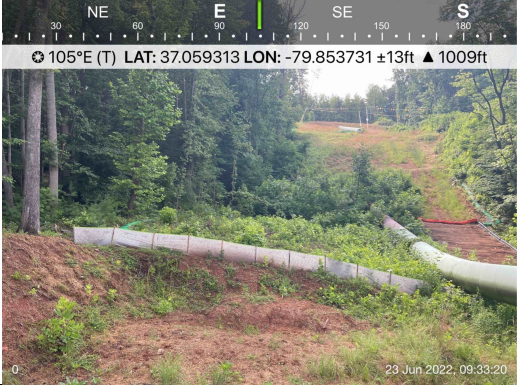
GPS Location	See photo		GPS Location	See photo	
Field Station#	14132+00		Field Station#	14141+62	
Pic 7 Desc.	CWD is functioning as intended		Pic 8 Desc.	P1 is in good condition at all stream and wetland buffers

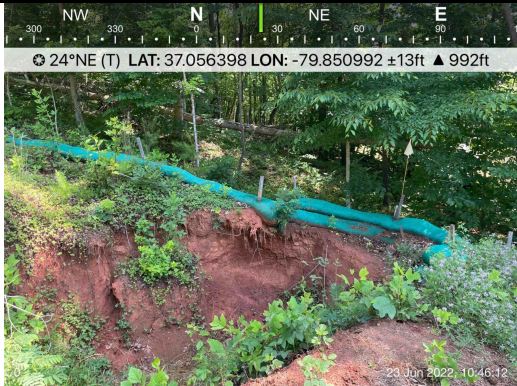
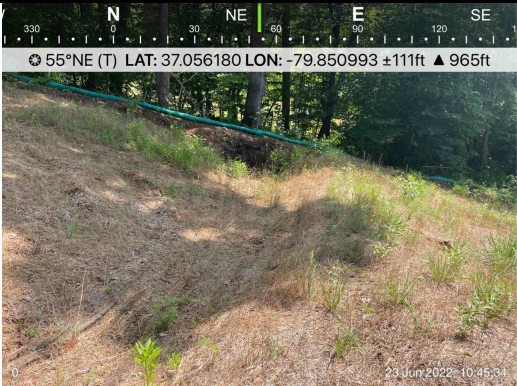
GPS Location	See photo		GPS Location	See photo	
Field Station#	14155+00		Field Station#	14155+00	
Pic 9 Desc.	End treatments are functioning as intended		Pic 10 Desc.	Waterbars are in good condition

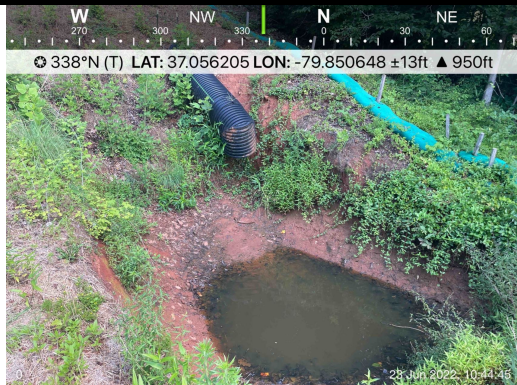
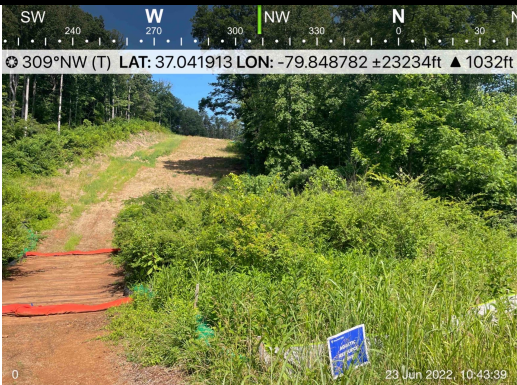
GPS Location	See photo		GPS Location	See photo	
Field Station#	14156+00		Field Station#	14157+55	
Pic 11 Desc.	Slope drain is functioning as intended		Pic 12 Desc.	Resource buffers remain well vegetated

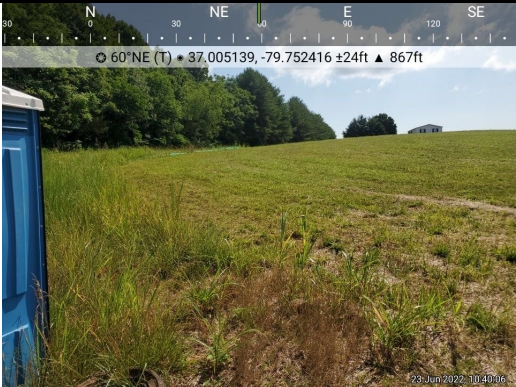
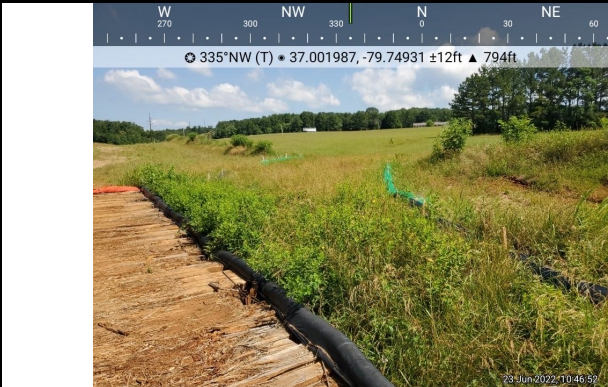
GPS Location	0		GPS Location	0	
Field Station#	14547+50		Field Station#	14565+00	
Pic 1 Desc.	GAS Tobacco Rd ATWS Vegetation		Pic 2 Desc.	Dry swale perimeter ECDs

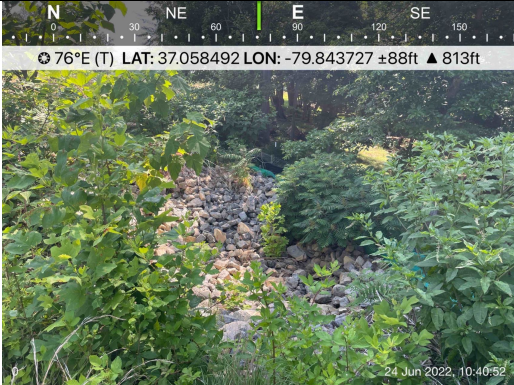
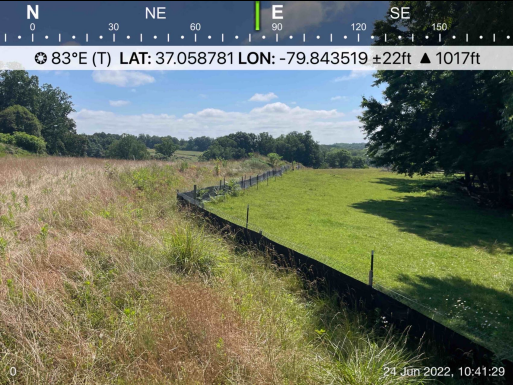
GPS Location	See photo		GPS Location	See photo	
Field Station#	14180+00		Field Station#	14182+00	
Pic 1 Desc.	CWDs are functioning as intended		Pic 2 Desc.	SSF is in good condition

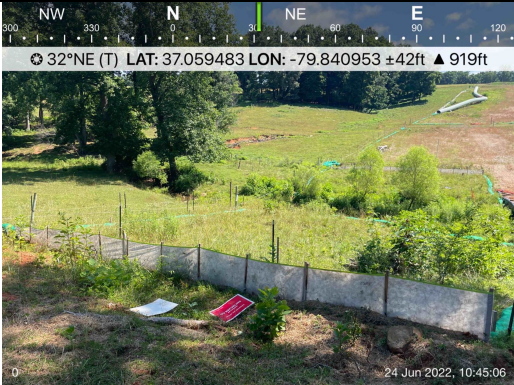
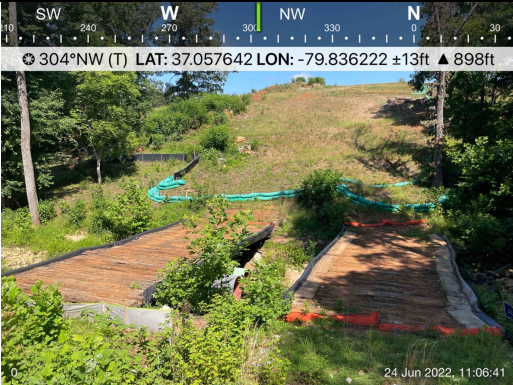
GPS Location	See photo		GPS Location	See photo	
Field Station#	14190+00		Field Station#	14209+00	
Pic 3 Desc.	P1 is in good condition at all stream and wetland buffers		Pic 4 Desc.	Equipment bridge ECDs are in good condition and functioning

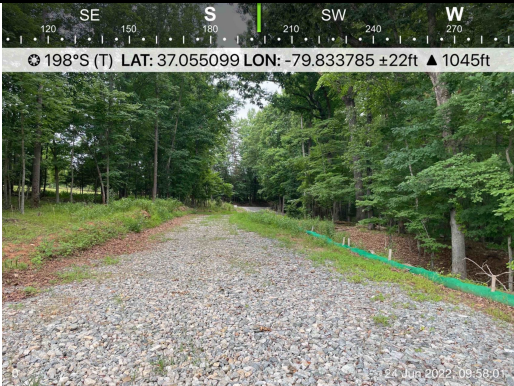
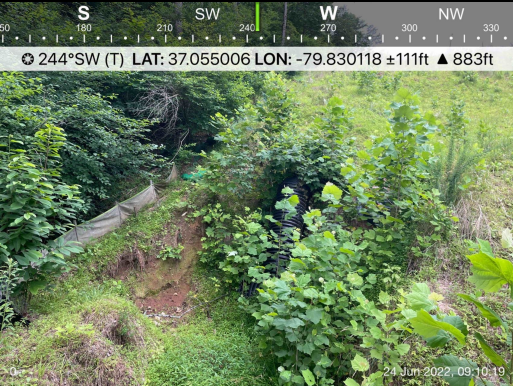
GPS Location	See photo		GPS Location	See photo	
Field Station#	14223+41		Field Station#	14232+00	
Pic 5 Desc.	MVP-FR-311 is in good condition with controls in place		Pic 6 Desc.	Slope drain is functioning as intended

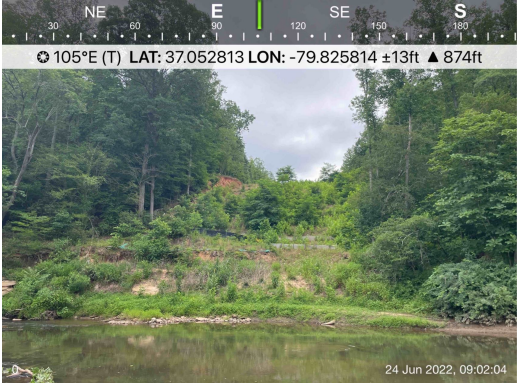
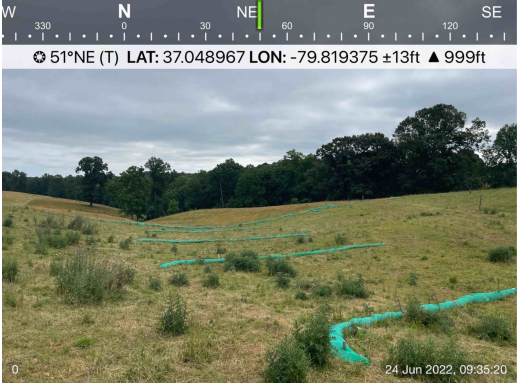
GPS Location	See photo		GPS Location	See photo	
Field Station#	14251+00		Field Station#	14273+00	
Pic 7 Desc.	Slope remains stabilized		Pic 8 Desc.	CFS is in good condition throughout this section

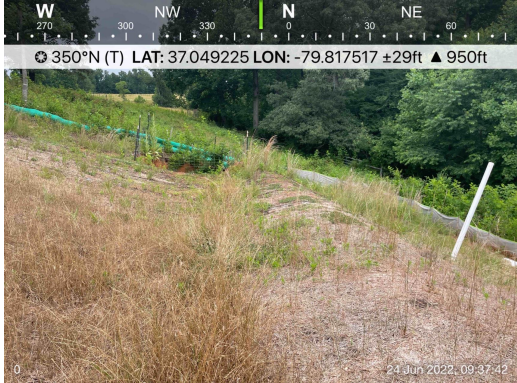
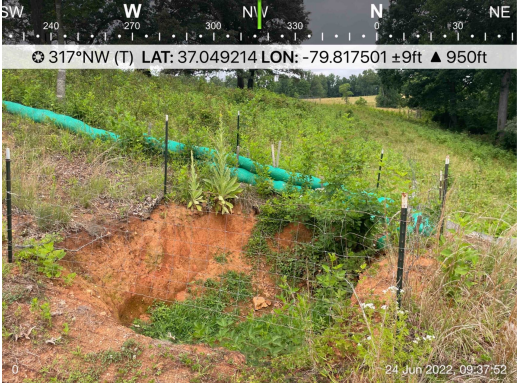
GPS Location	See photo		GPS Location	See photo	
Field Station#	14278+00		Field Station#	14278+00	
Pic 9 Desc.	Waterbars are in good condition		Pic 10 Desc.	End treatments are functioning as intended

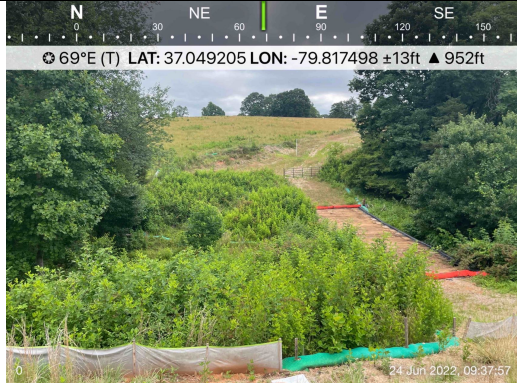
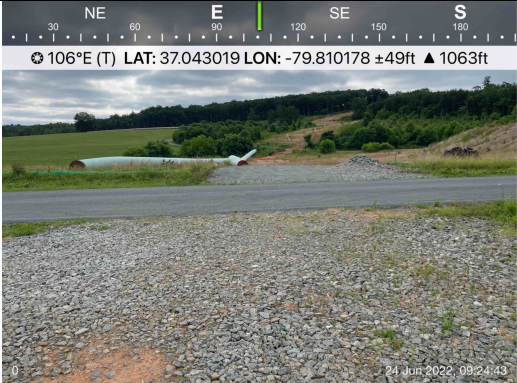
GPS Location	See photo		GPS Location	See photo	
Field Station#	14279+00		Field Station#	14311+57	
Pic 11 Desc.	Resource buffers remain well vegetated		Pic 12 Desc.	RCEs are in good condition at all road crossings.

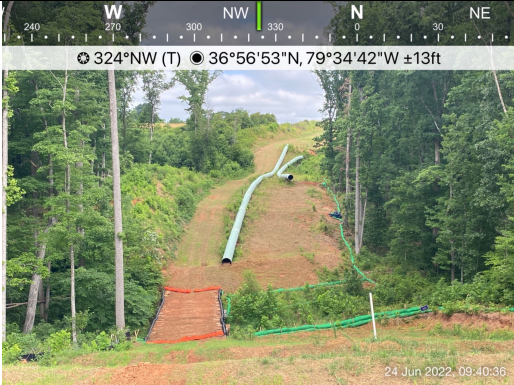
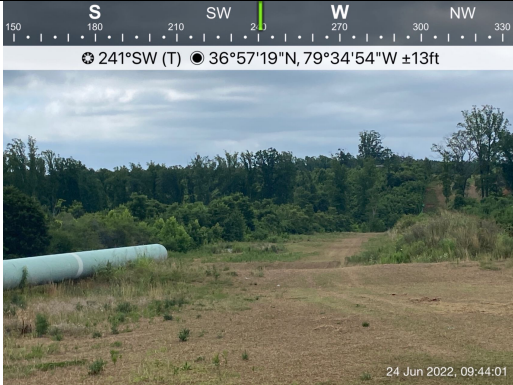
GPS Location	0	GPS Location	0		
Field Station#	15139+00	Field Station#	15120+00		
Pic 1 Desc.	Approximately 15139+00. Overview of ROW.	Pic 2 Desc.	Approximately 15120+00. Overview of ROW.

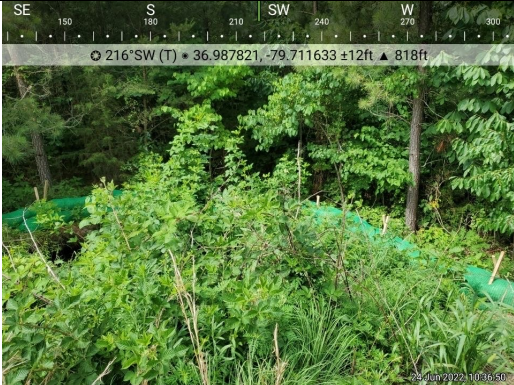
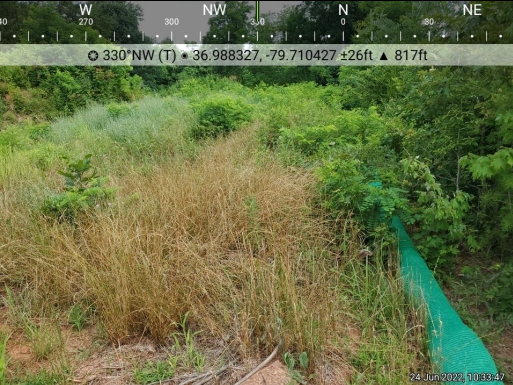
GPS Location	0	GPS Location	0		
Field Station#	14690+50	Field Station#	14694+50		
Pic 1 Desc.	Perimeter CFS	Pic 2 Desc.	CIS Jacks Creek Rd Vegetation

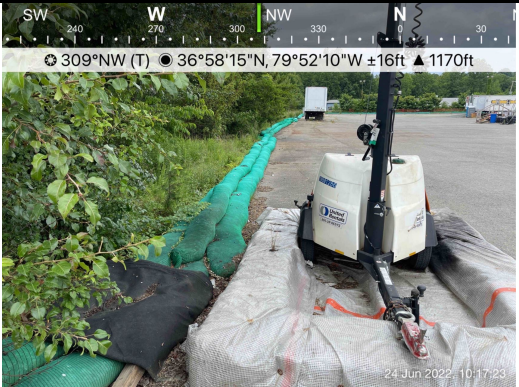
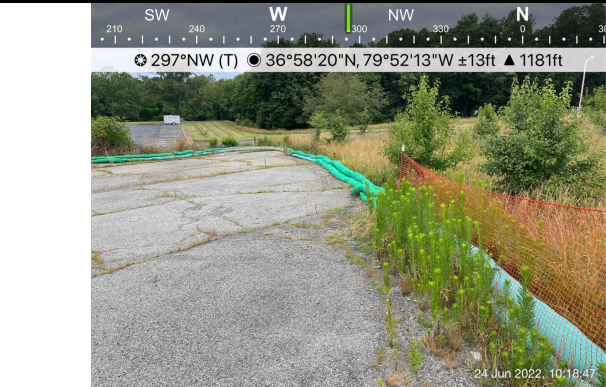
<p>SW W NW N 297°NW (T) 36°58'20"N, 79°52'13"W ±13ft ▲1181ft 24 Jun 2022, 10:18:47</p>	
GPS Location	See picture		GPS Location	See picture	
Field Station#	0000+00		Field Station#	0000+00	
Pic 1 Desc.	Perimeter ECD's and secondary containment structure for light plant on south end of LY-046 in good condition.		Pic 2 Desc.	Perimeter ECD's on on northwest corner of LY-046 in good condition.

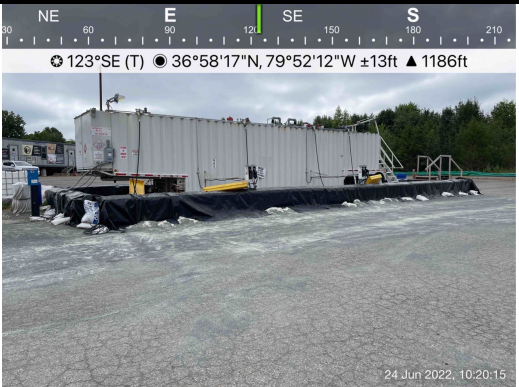
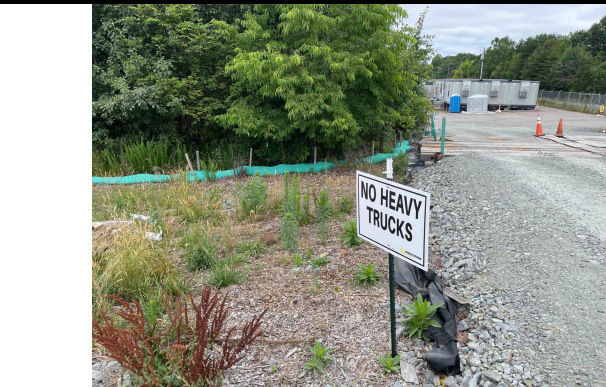
GPS Location	See picture		GPS Location	See picture	
Field Station#	0000+00		Field Station#	0000+00	
Pic 3 Desc.	Secondary containment structure for fuel cell at LY-046 in good condition.		Pic 4 Desc.	Perimeter ECD's on north end of LY-045 near bridge mats in good condition.

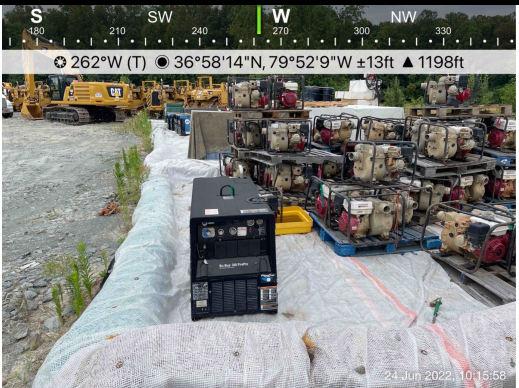
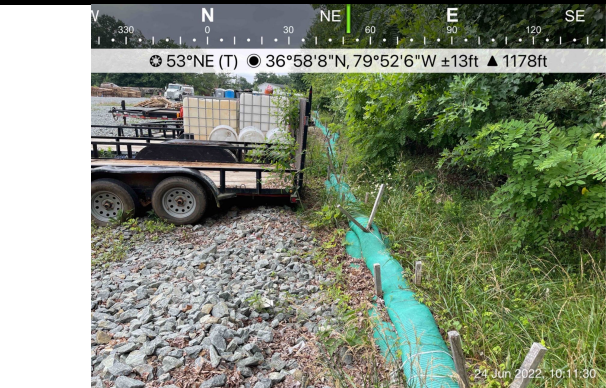
<p>N NE E SE 53°NE (T) 36°58'8"N, 79°52'6"W ±13ft ▲1178ft 24 Jun 2022, 10:11:30</p>	
GPS Location	See picture		GPS Location	See picture	
Field Station#	0000+00		Field Station#	0000+00	
Pic 5 Desc.	Secondary containment structure on north end of LY-045 in good condition.		Pic 6 Desc.	Perimeter ECD's on west side of LY-045 near employee parking area in good condition.
