Visual Site Inspection Report

| Project Name | H-600 Pipeline Spread I | AFE | 124300139 | Spread | H-600 Pipeline Spread I |
| Permit # | TBD | Inspection Type | VA SWPP | Station Begin | 15584+23 |

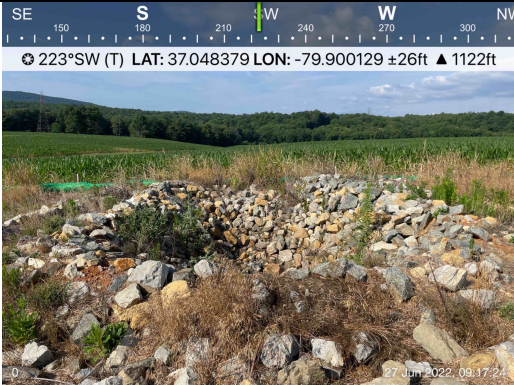
| Field Station# | 13941+00 | | Field Station# | 13935+00 | |

| Pic 1 Desc. | Slope drain outlet is in good condition and functioning | | Pic 2 Desc. | SSF is in good condition | |

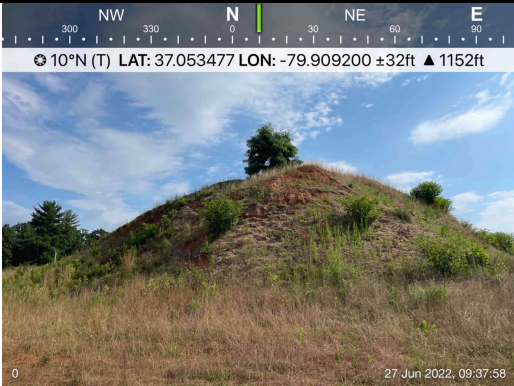
| Field Station# | 13897+00 | | Field Station# | 13897+00 | |

| Pic 3 Desc. | CWDs are functioning as intended | | Pic 4 Desc. | CFS has been damaged by wildlife and needs to be repaired | |

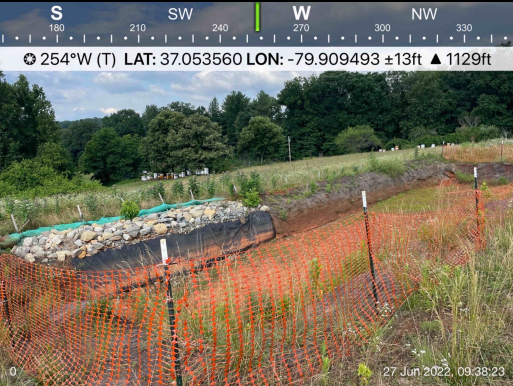
| Compost Filter Sock | Communication | CFS has been damaged by wildlife | | | |

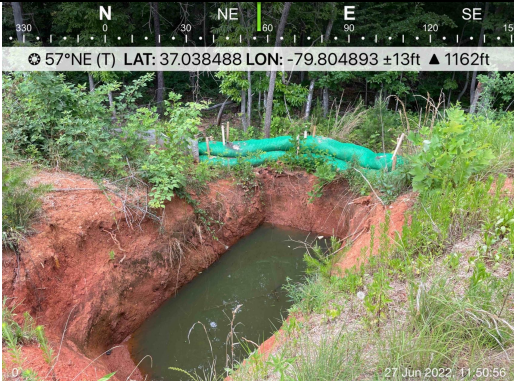
| Field Station# | 14335+00 | | Field Station# | 14338+56 | |

| Pic 1 Desc. | Perimeter P1 is in good condition | | Pic 2 Desc. | Waterbars are in good condition | |

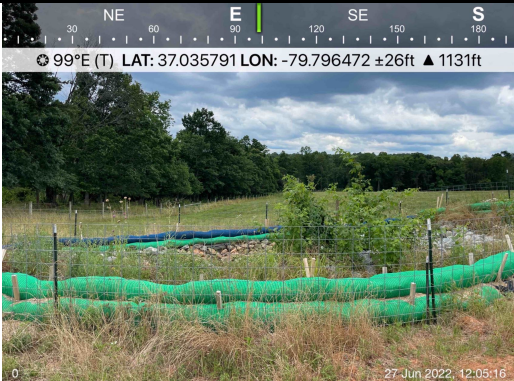
| Field Station# | 14364+00 | | Field Station# | 14366+00 | |

| Pic 3 Desc. | End treatments are functioning as intended | | Pic 4 Desc. | P1 is in good condition condition at all stream and wetland buffers | |

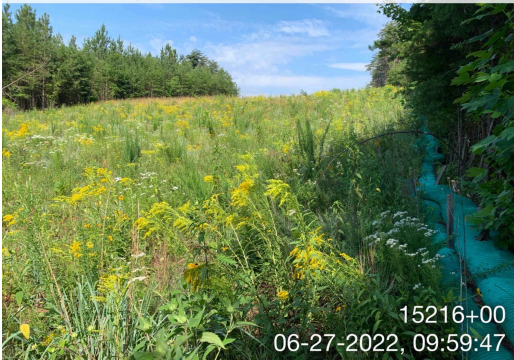
| Field Station# | 15216+00 | | Field Station# | 15159+00 | |

| Pic 1 Desc. | Waterbar and permanent vegetative stabilization in acceptable conditions | | Pic 2 Desc. | Waterbar end treatment in acceptable condition | |

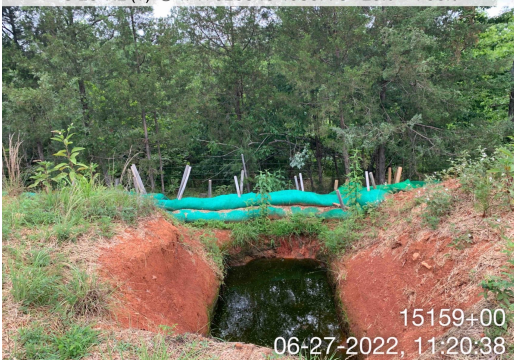
| Field Station# | 15159+00 | | Field Station# | 15167+00 | |

| Pic 3 Desc. | Permanent vegetative stabilization and perimeter CFS in acceptable conditions | | Pic 4 Desc. | Waterbar in acceptable condition | |

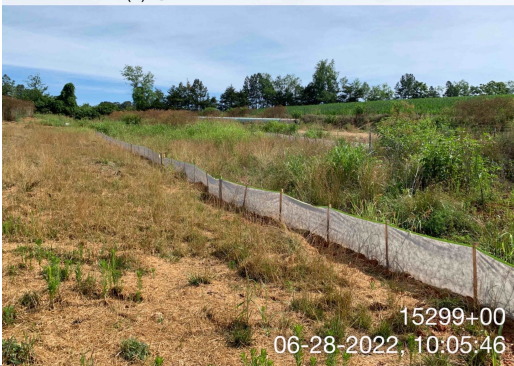
| Field Station# | 15299+00 | Field Station# | 15299+00 | | |

| Pic 1 Desc. | Waterbar in acceptable condition | Pic 2 Desc. | Waterbar end treatment in acceptable condition | | |

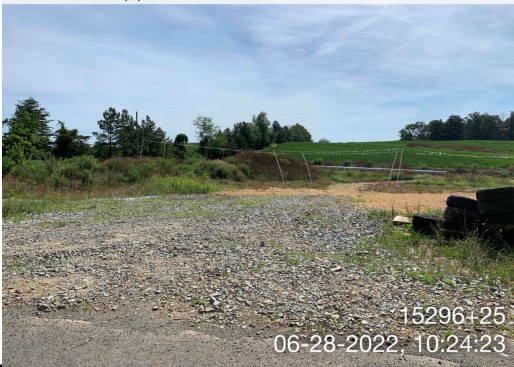
| Field Station# | 15296+25 | Field Station# | 15321+00 | | |

| Pic 3 Desc. | P1 silt fence in acceptable condition | Pic 4 Desc. | Clean water diversion pipe and plunge pool in acceptable conditions | | |

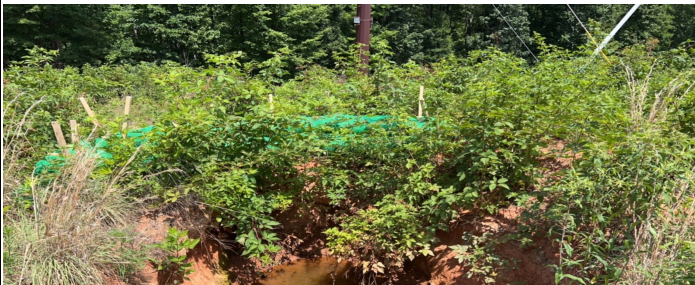
| Pic 1 Desc. | CFS along ROW in good condition. | Pic 2 Desc. | Perimeter SSF in place and functional. | | |

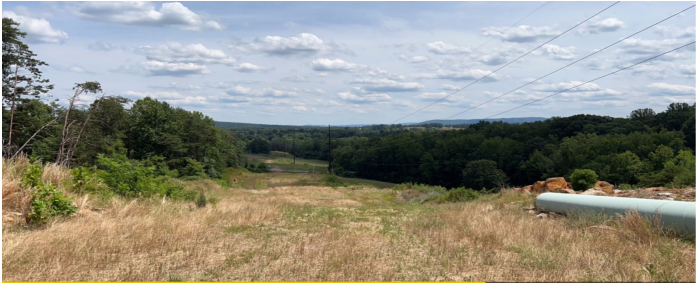
| Pic 3 Desc. | Sump pit and CFS end treatment in good condition. | Pic 4 Desc. | Equipment bridge and surrounding ECDs in place and functional at stream crossing and resource buffer. | | |

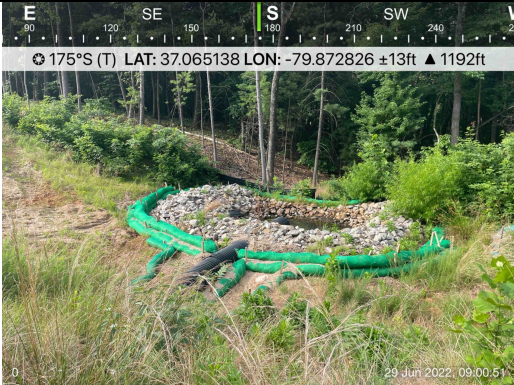
| Field Station# | 14070+00 | | Field Station# | 14081+46 | |

| Pic 1 Desc. | RCEs are in good condition at all road crossings | | Pic 2 Desc. | Equipment bridge ECDs are in good condition | |

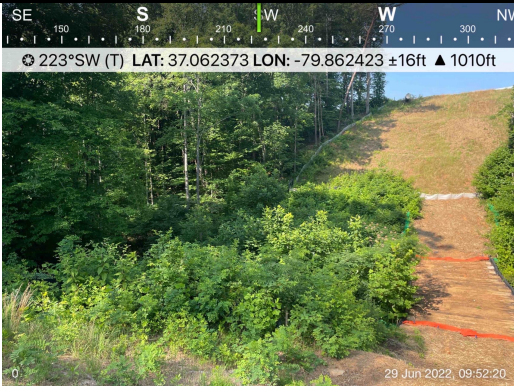
| Field Station# | 14105+32 | | Field Station# | 14110+00 | |

| Pic 3 Desc. | CWDs are functioning as intended | | Pic 4 Desc. | MVP-FR-309.05 remains in good condition with controls in place | |

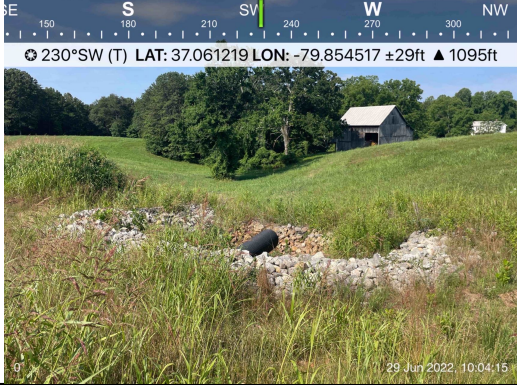
| Field Station# | 14132+00 | | Field Station# | 14141+62 | |

| Pic 7 Desc. | End treatments are in good condition | | Pic 8 Desc. | CFS is in good condition throughout this section | |

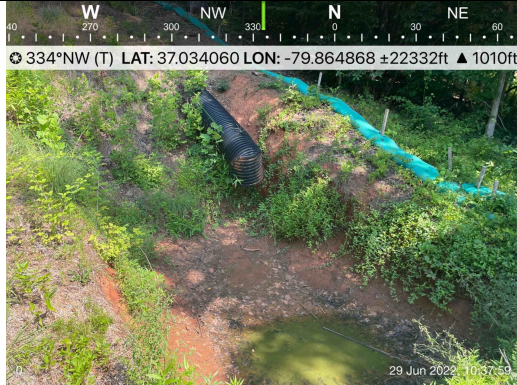
| Field Station# | 14156+00 | | Field Station# | 14171+00 | |

| Pic 9 Desc. | CWDs are functioning as intended | | Pic 10 Desc. | P1 is in good condition at all stream and wetland buffers | |

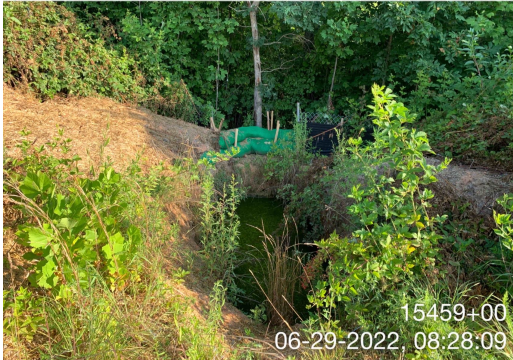
| Field Station# | | 15459+00 | | Field Station# | | 15446+00 | |

| Pic 1 Desc. | | Perimeter CFS in acceptable condition | | Pic 2 Desc. | | Waterbar in acceptable condition | |

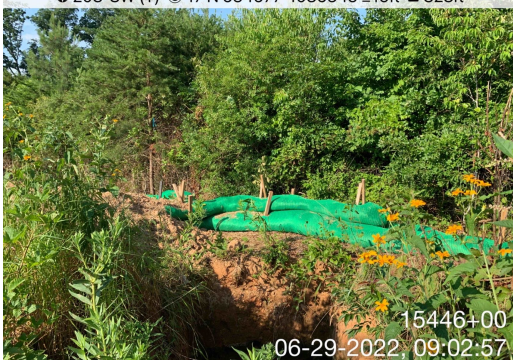
| Field Station# | | 15446+00 | | Field Station# | | 15427+00 | |

| Pic 3 Desc. | | Waterbar end treatment in acceptable condition | | Pic 4 Desc. | | Waterbar in acceptable condition | |

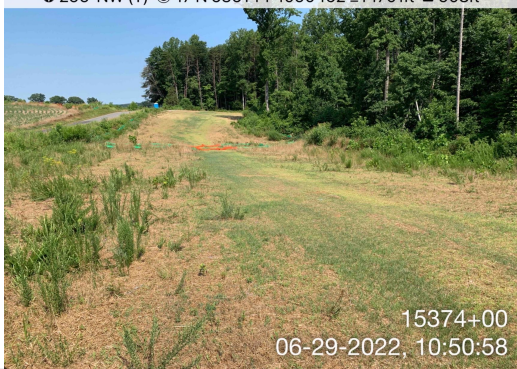
| Field Station# | 15374+00 | Field Station# | 15475+00 | | |

| Pic 7 Desc. | Temporary vegetative stabilization in acceptable condition | | Pic 8 Desc. | Super silt fence in acceptable condition | |

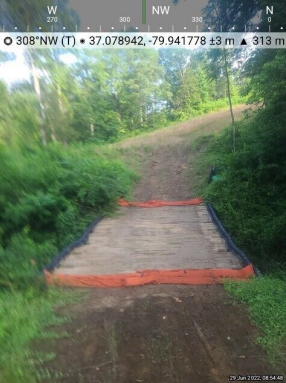
| Field Station# | 13728+40 | Field Station# | 13679+00 | | |

| Pic 1 Desc. | Monitored equipment bridge and protection. ECDs in place and functioning at the time of inspection. | | Pic 2 Desc. | Stream observation photo facing upstream during routine inspection. No issues were observed at the time of inspection. | |

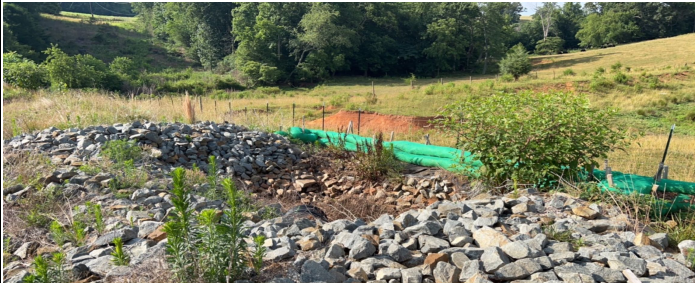
| Pic 3 Desc. | Water bar in good condition. | | Pic 4 Desc. | Temporary diversion berm stabilized and vegetated. | |

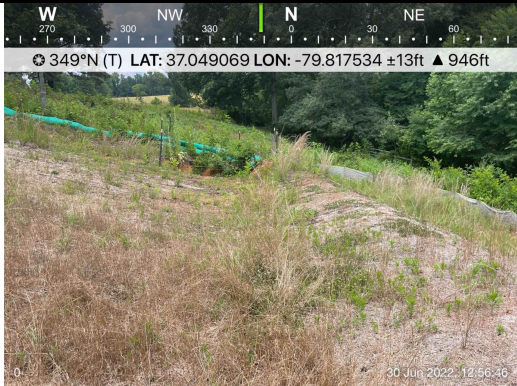
| Field Station# | 14277+00 | | Field Station# | 14277+00 | |

| Pic 7 Desc. | P1 is in good condition at all stream and wetland buffers | | Pic 8 Desc. | CFS is in good condition throughout this section | |

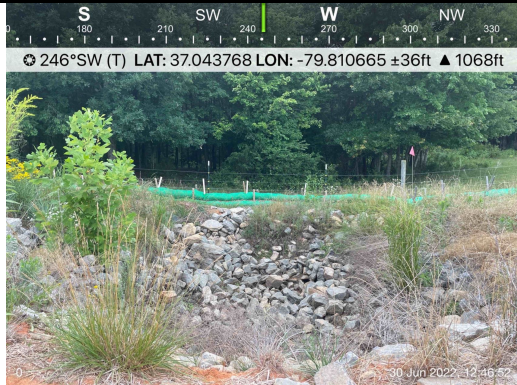
| Field Station# | 14308+00 | | Field Station# | 14311+57 | |

| Pic 9 Desc. | Waterbars are in good condition | | Pic 10 Desc. | End treatments are functioning as intended | |

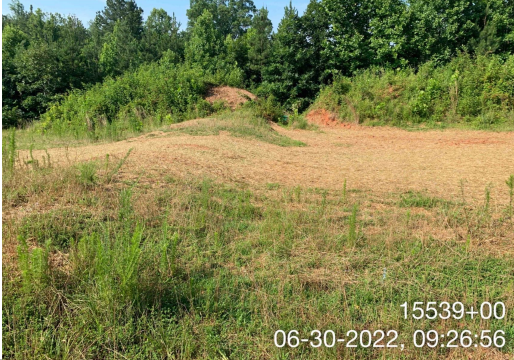
| Field Station# | 15539+00 | Field Station# | 15539+00 | | |

| Pic 1 Desc. | Permanent vegetative stabilization in acceptable condition | Pic 2 Desc. | Clean water diversion pipe in acceptable condition | | |

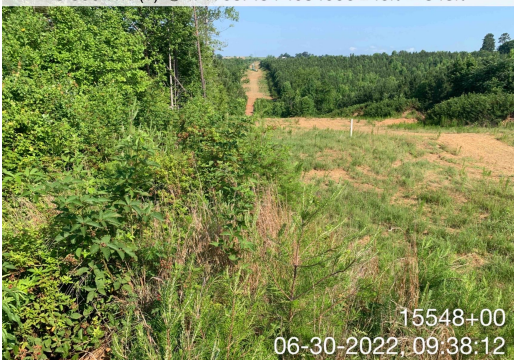
| Field Station# | 15548+00 | Field Station# | 15556+00 | | |

| Pic 3 Desc. | Waterbar in acceptable condition | Pic 4 Desc. | Waterbar end treatment in acceptable condition | | |

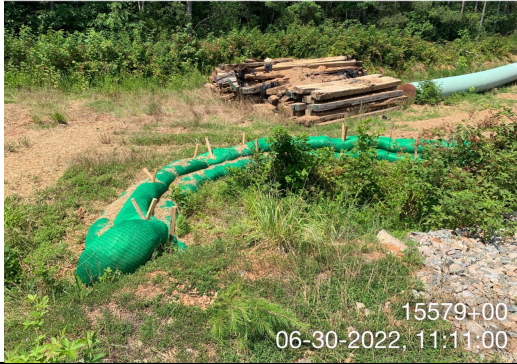
| Field Station# | 15579+00 | Field Station# | 15505+00 | | |

| Pic 7 Desc. | Waterbar in acceptable condition | | Pic 8 Desc. | Waterbar end treatment in acceptable condition | |

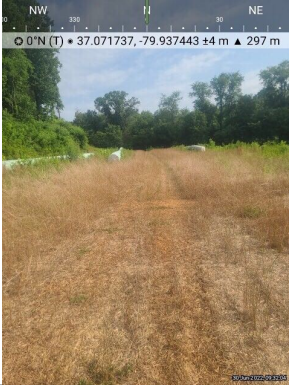
| Field Station# | 13766+10 | Field Station# | 13826+50 | | |

| Pic 1 Desc. | Observed perimeter ECDs during inspection. All in place and functioning at the time of inspection. | | Pic 2 Desc. | Monitored ECDs throughout row inspection today. No environmental issues observed at the time of inspection. | |

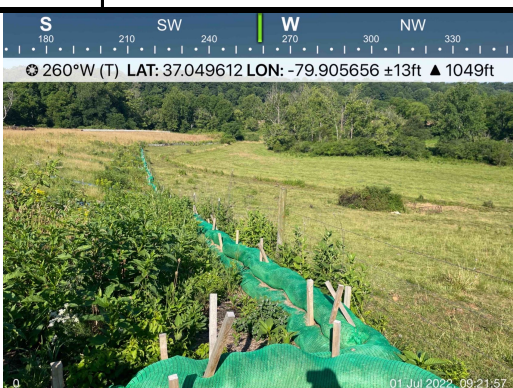
| | Pic 1 Desc. | Slope drain outlet remains in good condition | | Pic 2 Desc. | CWDs are functioning as intended |

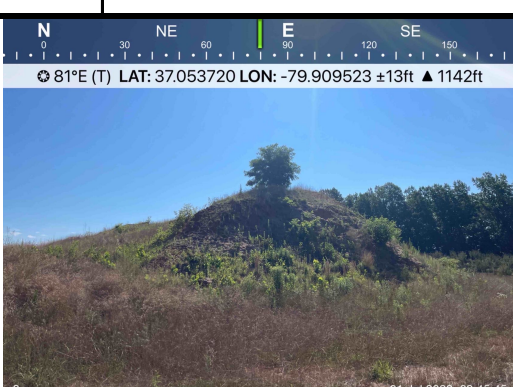
| | Pic 3 Desc. | CFS is in good condition throughout this section | | Pic 4 Desc. | SSF is in good condition |

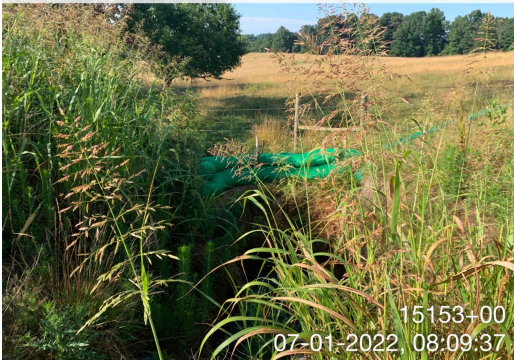
| 15153+00 07-01-2022, 08:09:37 | | | 15155+00 07-01-2022, 08:29:04 | | |

| Pic 1 Desc. | Permanent vegetative stabilization in acceptable condition | | Pic 2 Desc. | Waterbar in acceptable condition | |

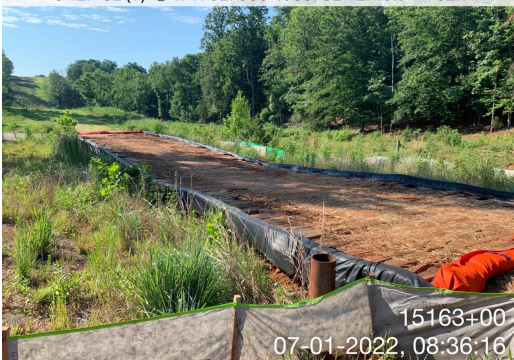
| 15163+00 07-01-2022, 08:36:16 | | | 15168+00 07-01-2022, 08:48:17 | | |

| Pic 3 Desc. | Waterbar end treatment in acceptable condition | | Pic 4 Desc. | Temporary vegetative stabilization in acceptable condition | |

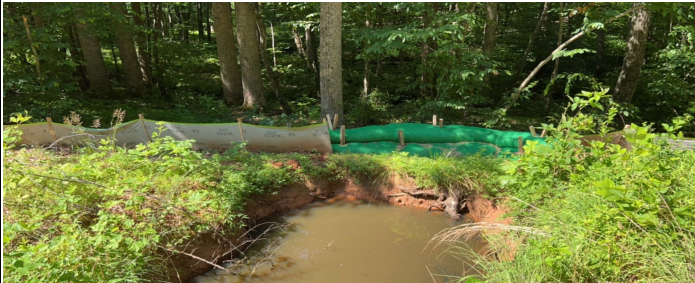
| Pic 3 Desc. | Sump pit and CFS end treatment in good condition; erosion control blanket in throat of water bar performing intended function. | | Pic 4 Desc. | Equipment bridge and surrounding ECDs in place and functional at stream crossing and resource buffer. | |
