Visual Site Inspection Report

Project Name	H-600 Pipeline Spread G	AFE	124300137	Spread	H-600 Pipeline Spread G
Contractor	Precision			Report #	40219
Inspector	Patrick Shields			Date/Time	7/25/2022 10:14 AM
Permit #	TBD	Inspection Type	VA SWPP	Station Begin	10749+92
State	VA	Inspection Area	Full	Station End	10798+92
County	Giles	Ground	Dry	Temperature (°F)	82.00
Municipality	N/A	Weather	Cloudy	Rain Gauge (in)	0.00
				Rain Accumulation Time (days)	1.00

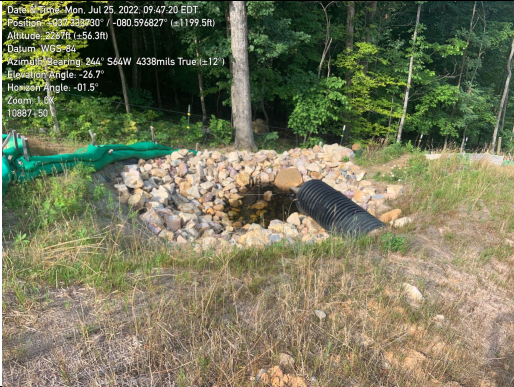
GPS Location	See photo	GPS Location	See photo		
Field Station#	10887+50	Field Station#	10889+00		
Pic 1 Desc.	Plunge pool in place	Pic 2 Desc.	Section of Row showing conditions and controls

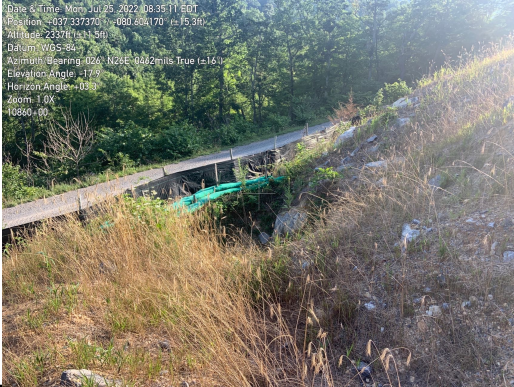
GPS Location	See photo	GPS Location	See photo		
Field Station#	10860+00	Field Station#	10893+75		
Pic 3 Desc.	Perimeter controls are in place and in acceptable condition	Pic 4 Desc.	Section of Row showing conditions and controls

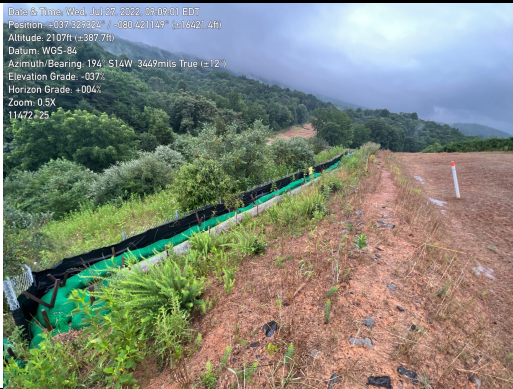
GPS Location	See photo	GPS Location	See photo		
Field Station#	11507+65	Field Station#	11472+25		
Pic 1 Desc.	Multiple holes and broken stakes in P1 silt fence perimeter control	Pic 2 Desc.	Triple protection ECDs in place at karst feature		
<p>Date & Time Wed Jul 27, 2022, 05:15:44 EDT Position: +037.922742° / -80.494007° (±3.00') Altitude: 2275ft (±3.00') Datum: WGS-84 Azimuth/Bearing: 222° S42W 394mils True (±12°) Elevation Grade: -04% Horizon Grade: +010% Zoom: 0.5X 11476+75</p>

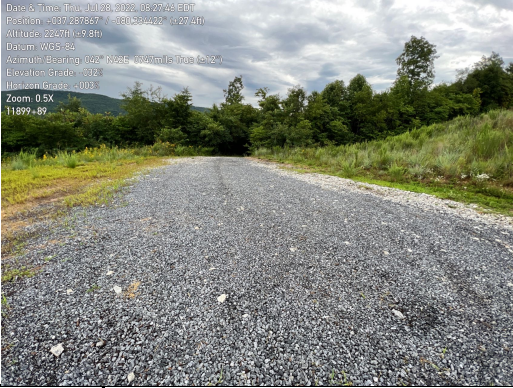
GPS Location	See photo	GPS Location	See photo		
Field Station#	11788+52	Field Station#	11899+89		
Pic 1 Desc.	MT Tabor rain gauge measured 0.3" of rainfall	Pic 2 Desc.	RCE in place

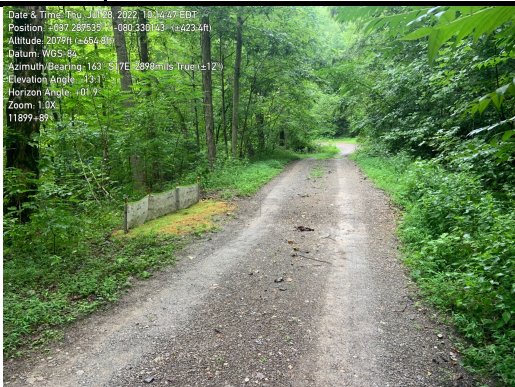
GPS Location		See photo		GPS Location	
Field Station#		11934+45		Field Station#	
Pic 5 Desc.		Section of Row with abundant vegetation		Pic 6 Desc.	
				AR266.03 broad based dips and P1 are in acceptable condition

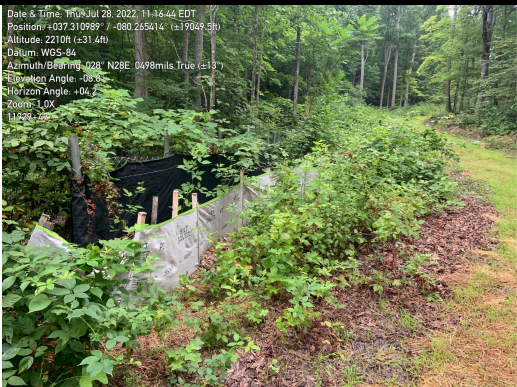
GPS Location		See photo		GPS Location	
Field Station#		11993+00		Field Station#	
Pic 11 Desc.		Section of Row with abundant vegetation		Pic 12 Desc.	
				ECD's are in acceptable condition

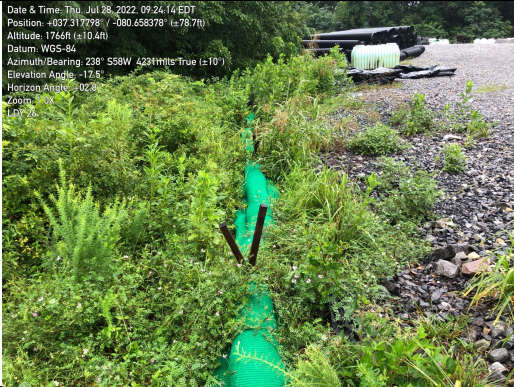
GPS Location	See photo for GPS location.		GPS Location	See photo for GPS location.	
Field Station#	12005+00		Field Station#	12005+00	
Pic 1 Desc.	Triple stack CFS in place along LOD.		Pic 2 Desc.	Rock line channel in place.

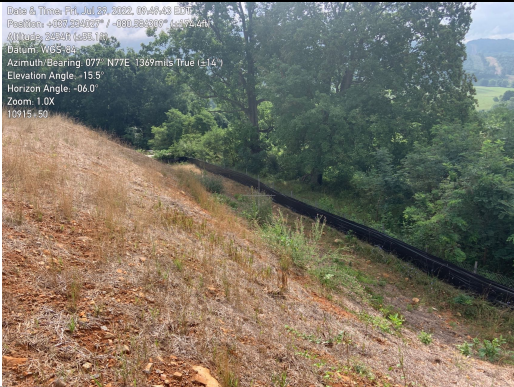
GPS Location	See photo	GPS Location	See photo		
Field Station#	10915+50	Field Station#	10905+00		
Pic 3 Desc.	SSF is in acceptable condition	Pic 4 Desc.	P1 silt fence is in acceptable condition

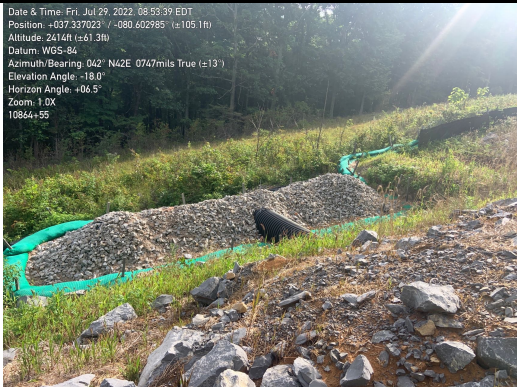
GPS Location	See photo	GPS Location	See photo		
Field Station#	10877+50	Field Station#	10864+55		
Pic 11 Desc.	Section of Row showing conditions and controls	Pic 12 Desc.	Level spreader in place
