Visual Site Inspection Report

| Project Name | H-600 Pipeline Spread G | AFE | 124300137 | Spread | H-600 Pipeline Spread G |
| Permit # | TBD | Inspection Type | VA SWPP | Station Begin | 10929+80 |

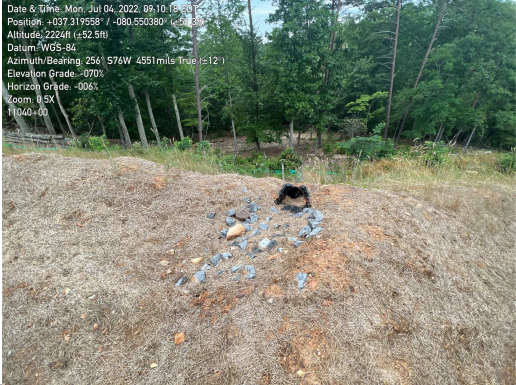
| Field Station# | 11040+00 | Field Station# | 11040+00 | | |

| Pic 1 Desc. | Damaged silt fence | Pic 2 Desc. | Approach to the S-IJ18 stream resource and well vegetated buffer zones. | | |

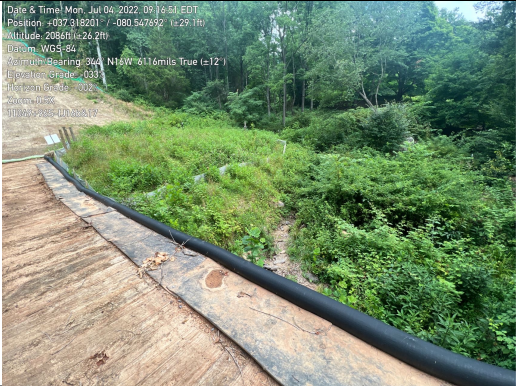
| Field Station# | 11049+96 | Field Station# | 11057+22 | | |

| Pic 3 Desc. | Stone inlet protection condition. | Pic 4 Desc. | Slope drain pipe to functional sump pit and water bar end treatment. | | |

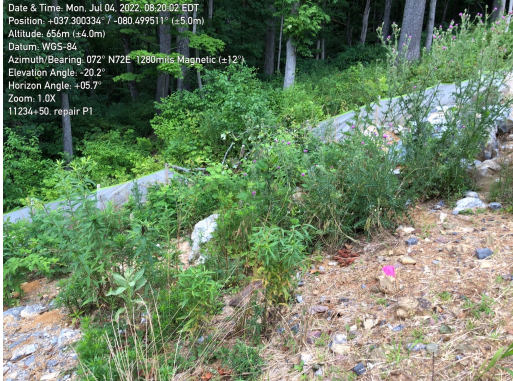
| Field Station# | 11234+50 | | Field Station# | 11184+85 | |

| Pic 1 Desc. | Communication; repair P1 silt fence damaged by weather impact. | | Pic 2 Desc. | ROW is stable. ECDs in place. Access road GI-249.02 in good condition. | |

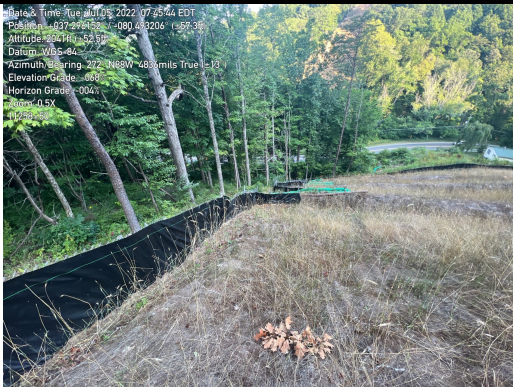
| AFE | | 124300137 | | Date/Time | | 7/5/2022 12:36 PM | | Report # | | | | | | | |
|---|--|---|--|--|--|---|--|--|--|--|--|--|--|--|--|
| Field Station# | | 11258+50 | | | | Field Station# | | 11258+50 | | | | | | | |

| <p>Completed a SWPP inspection from station # 11254+99 to 11353+67 (MP 213.6-215.04) Rte 42 to Old Furnace Rd. "Station numbers are approximate."</p> <p>Deficiencies Observed: Sediment packed P1 silt fence and Damaged filter lined fabric in presumed Karst sump pit, both at or near location 11347+00. This has been communicated to the LEI and the Precision environmental coordinator. This has been documented to the punch list for repairs.</p> <p>Observances: The ROW has been temporarily stabilized and remains at a stable repose overall.</p> <p>There is slightly visible temporary grasses throughout the areas of inspection. The water bars and compost sock remain in a functional condition in these areas as well as all other areas of inspection. Steep slopes have erosion control fabric (CC4) installed. There is limited visible growth where the CC4 ECB have been installed. There is visible vegetation that has began to re-emerge through out the travel lane area. Slope drains are functioning as intended without issues. Stone inlet protections are also functional at this time. There are three stream resources in the areas of inspection. Conditions are as follows:</p> <p>S-MM18 - near 11292+80 - Equipment bridge functional, vegetated buffer zones remain undisturbed. ECD's protecting resource functioning with no maintenance required.</p> <p>S-NN12 - near 11327+80 - Equipment bridge functional, vegetated buffer zones remain undisturbed. ECD's protecting resource functioning with no maintenance required.</p> <p>S-NN11 - near 11352+97 - Equipment bridge functional, vegetated buffer zones remain undisturbed. ECD's protecting resource functioning with no maintenance required.</p> | | | | | |

| AFE | | 124300137 | | Date/Time | | 7/5/2022 12:36 PM | | Report # | | | | | | | |
|---|--|---|--|--|--|---|--|--|--|--|--|--|--|--|--|
| Pic 1 Desc. | | View of damaged filter fabric lining to the presumed sump pit. Also in view is the silt matted P1 silt fence. | | | | Pic 2 Desc. | | Steep slope temporary vegetation and functional water bar conditions. | | | | | | | |

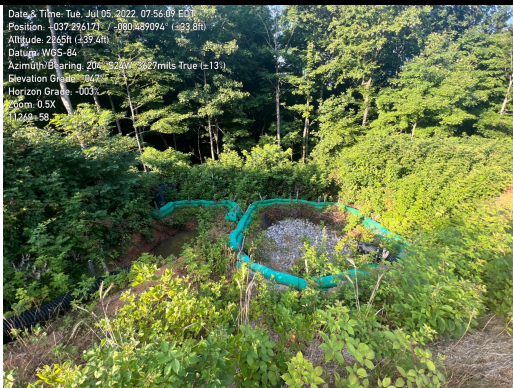
| AFE | | 124300137 | | Date/Time | | 7/5/2022 12:36 PM | | Report # | | | | | | | |
|---|--|---|--|--|--|---|--|--|--|--|--|--|--|--|--|
| Field Station# | | 11269+58 | | | | Field Station# | | 11269+58 | | | | | | | |

| AFE | | 124300137 | | Date/Time | | 7/5/2022 12:36 PM | | Report # | | | | | | | |
|---|--|---|--|--|--|---|--|--|--|--|--|--|--|--|--|
| Pic 3 Desc. | | Perimeter super silt fence conditions | | | | Pic 4 Desc. | | Steep slope temporary stabilization. | | | | | | | |

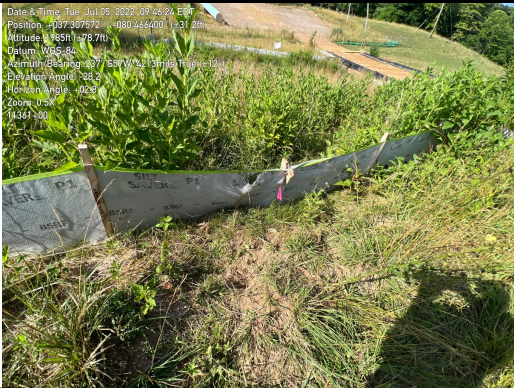
| Field Station# | 11361+00 | Field Station# | 11354+00 | | |

| Pic 3 Desc. | Restoration | Pic 4 Desc. | Damaged P1 | | |

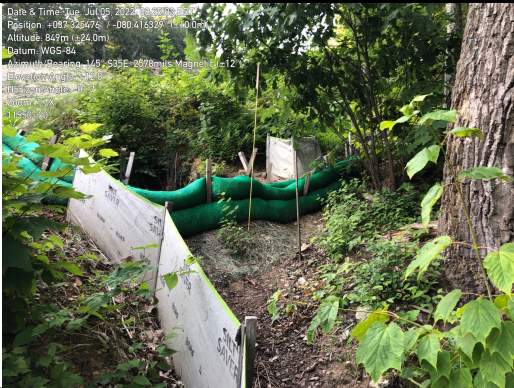
| Field Station# | 11550+00 | Field Station# | 11557+00 | | |

| Pic 3 Desc. | Restored section of ROW stable. ECDs remain in place. | Pic 4 Desc. | Perimeter ECDs in place. ROW surface stable. | | |

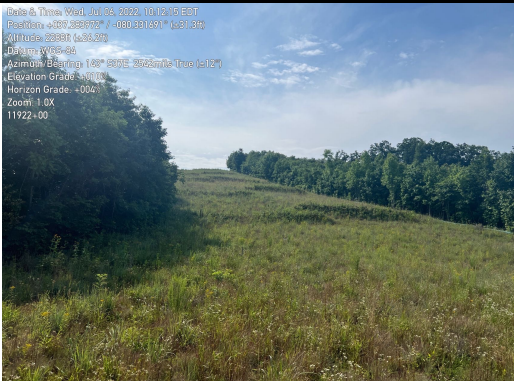
| Field Station# | 11922+00 | Field Station# | 11927+00 | | |

| Pic 3 Desc. | Permanent vegetative row status. No Issues. | Pic 4 Desc. | Level spreader and well vegetated row conditions. | | |

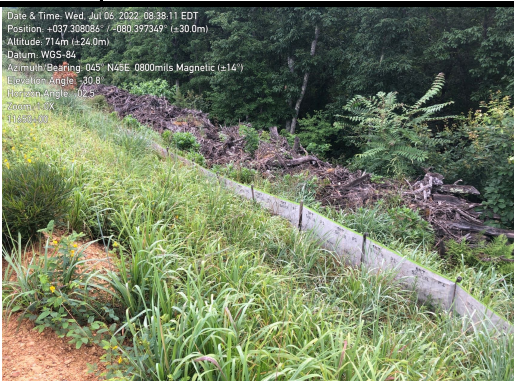
| Pic 3 Desc. | Slope breakers, sumps and end treatments are effective. | Pic 4 Desc. | Communication; repair downed P1 silt fence. | | |

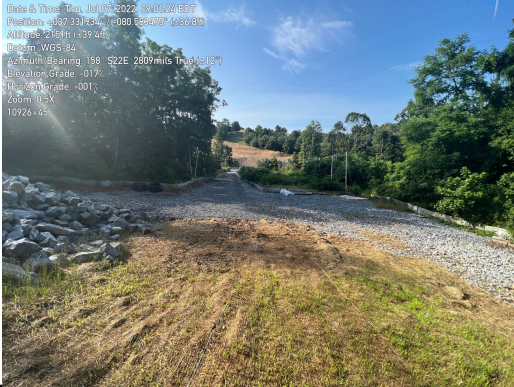
| Pic 1 Desc. | S-Y2 equipment bridge condition. | Pic 2 Desc. | S-Y3 Stream resource area. ECDs found functional as intended. | | |
