Visual Site Inspection Report

Project Name	H-600 Pipeline Spread H	AFE	124300138	Spread	H-600 Pipeline Spread H
Contractor	Precision			Report #	40227
Inspector	Bryan Cole			Date/Time	7/25/2022 1:14 PM
Permit #	TBD	Inspection Type	VA SWPP	Station Begin	13141+65
State	VA	Inspection Area	Partial	Station End	13316+21
County	Franklin	Ground	Dry	Temperature (°F)	92.00
Municipality	N/A	Weather	Sunny	Rain Gauge (in)	0.00
				Rain Accumulation Time (days)	0.00

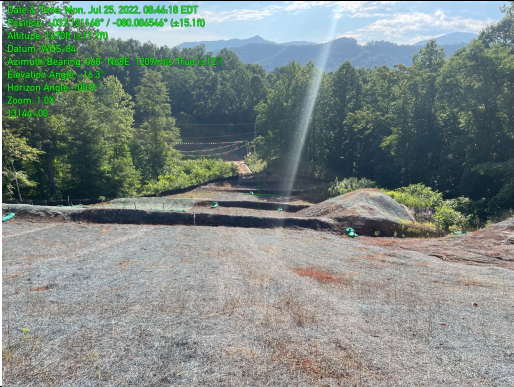
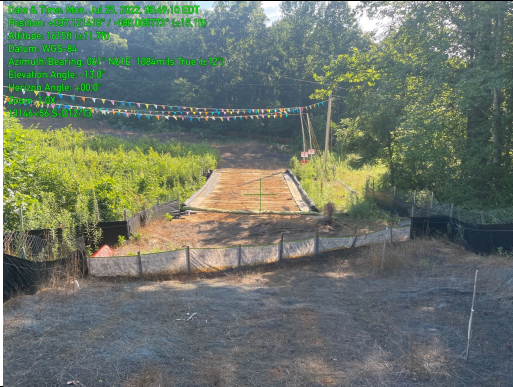
GPS Location	0	GPS Location	0		
Field Station#	13144+00	Field Station#	13146+56		
Pic 1 Desc.	ROW and ECDs In good condition and stable		Pic 2 Desc.	MVP-S-D12/13 and corresponding buffer zone in good condition

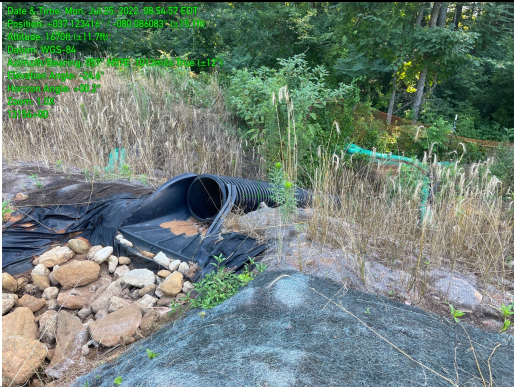
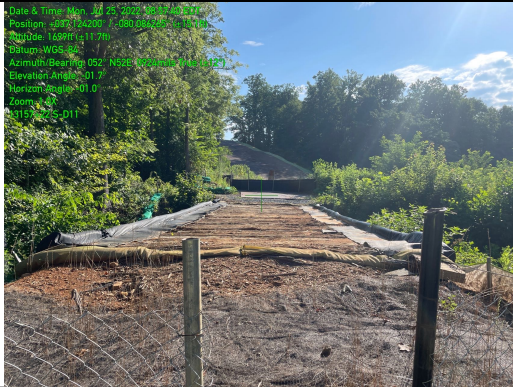
GPS Location	0	GPS Location	0		
Field Station#	13154+00	Field Station#	13157+22		
Pic 3 Desc.	Slope drain pipe in good condition		Pic 4 Desc.	MVP-S-D11 and corresponding buffer zone in good condition

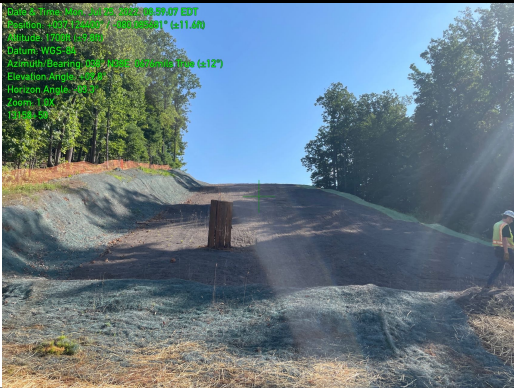
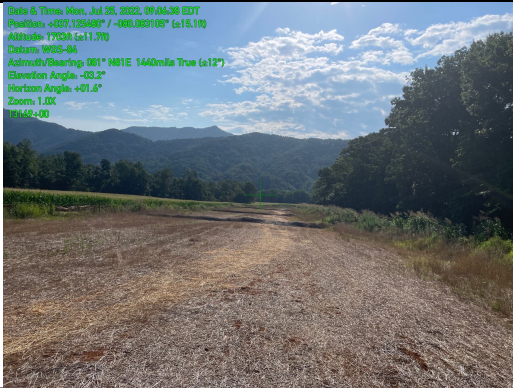
GPS Location	0	GPS Location	0		
Field Station#	13158+50	Field Station#	13169+00		
Pic 5 Desc.	ROW and ECDs In good condition		Pic 6 Desc.	ROW and ECDs In good condition

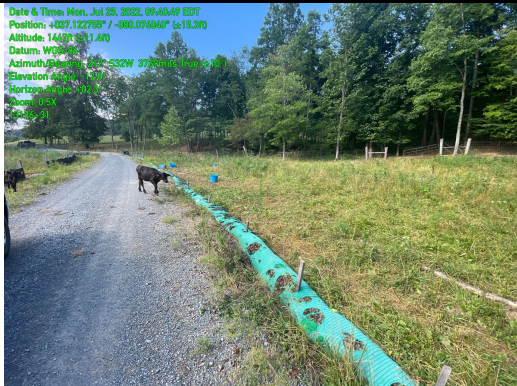
GPS Location	0	GPS Location	0		
Field Station#	13196+31	Field Station#	13196+31		
Pic 9 Desc.	3rd party damage to sock along access road, received approval to remove sock. 72 hour maintenance item		Pic 10 Desc.	3rd party damage to fence fabric along access road. 72 hour maintenance item	
<p>Date & Time: Mon, Jul 25, 2022, 12:30:11 EDT Position: +037.122880° / -080.076040° (s15.10) Altitude: 1408ft (s11.70) Datum: WGS-84 Azimuth/Bearing: 185° S04W 3307mils True (s12°) Elevation Angle: -09.9° Horizon Angle: +02.2° Zoom: 0.5X 13196+31</p>

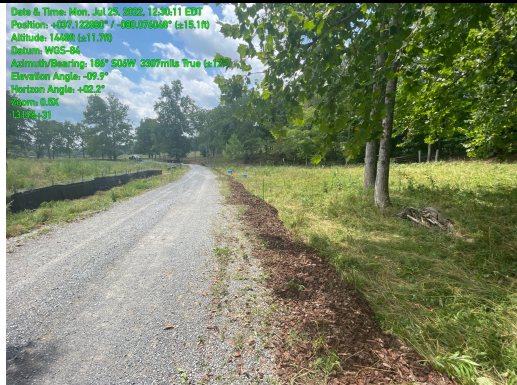
<p>ert image here</p>			
GPS Location	0	GPS Location	0		
Field Station#	13196+31	Field Station#	13196+31		
Pic 11 Desc.	Sock removed along access road and mulch spread from 3rd party cattle damage.		Pic 12 Desc.	Fence fabric repaired along access road from 3rd party cattle damage

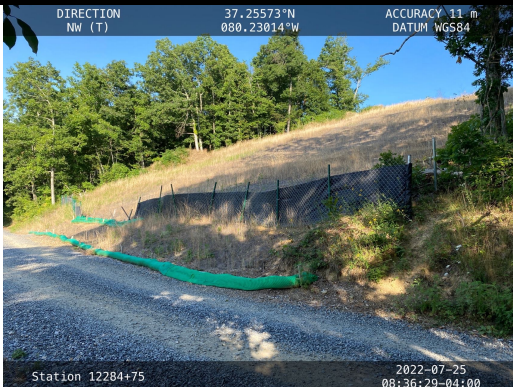
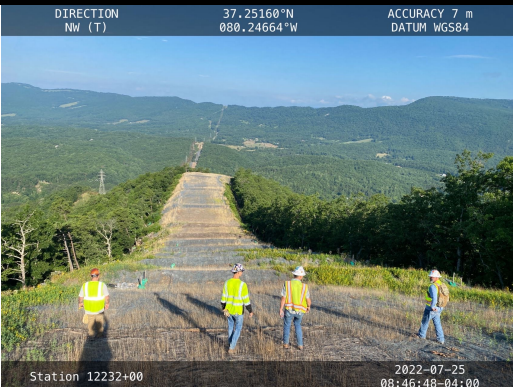
GPS Location	Please see photo for details.		GPS Location	Please see photo for details.	
Field Station#	12284+75		Field Station#	12232+00	
Pic 1 Desc.	Photo shows the stabilized ROW conditions with water bars and that all ECDs are installed and are functioning as designed.		Pic 2 Desc.	Photo shows current stabilized ROW conditions with environmental crew walking the SWPPP inspection area along with E.I.

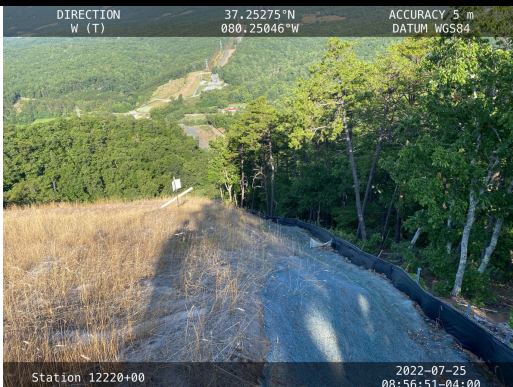
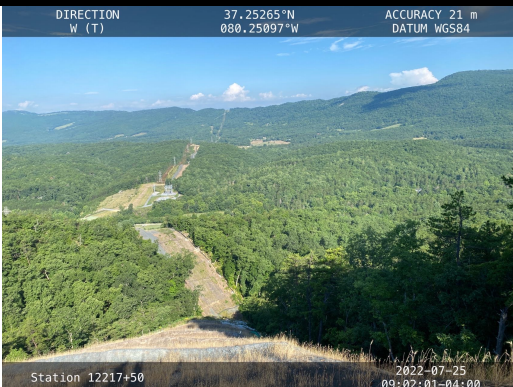
GPS Location	Please see photo for details.		GPS Location	Please see photo for details.	
Field Station#	12220+00		Field Station#	12217+50	
Pic 3 Desc.	Photo shows the stabilized ROW conditions with water bars and that all ECDs are installed and are functioning as designed.		Pic 4 Desc.	Photo shows the stabilized ROW conditions with water bars and that all ECDs are installed and are functioning as designed.

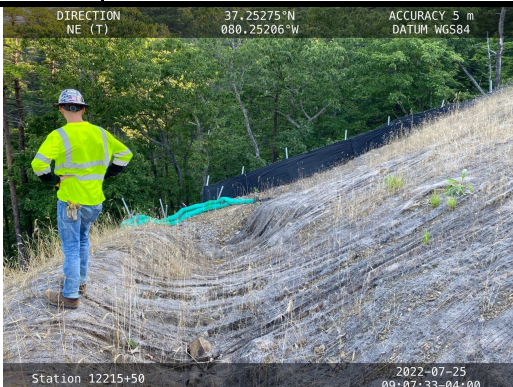
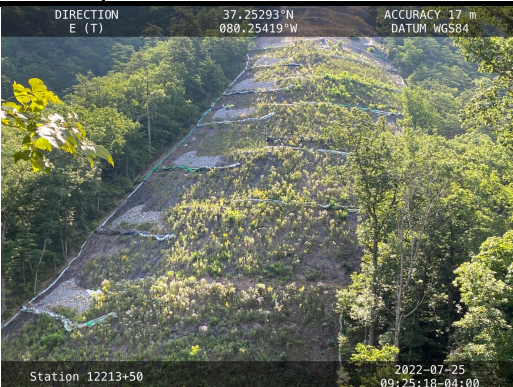
GPS Location	Please see photo for details.		GPS Location	Please see photo for details.	
Field Station#	12215+50		Field Station#	12213+50	
Pic 5 Desc.	Photo shows waterbar, sump and CFS waterbar end treatment.		Pic 6 Desc.	Photo shows stabilized ROW conditions in permanent restoration area. Permanent waterbars with level spreaders installed.

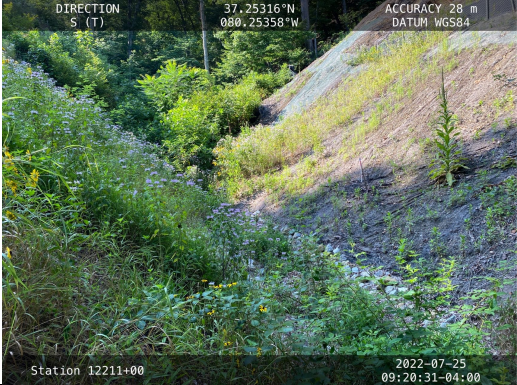
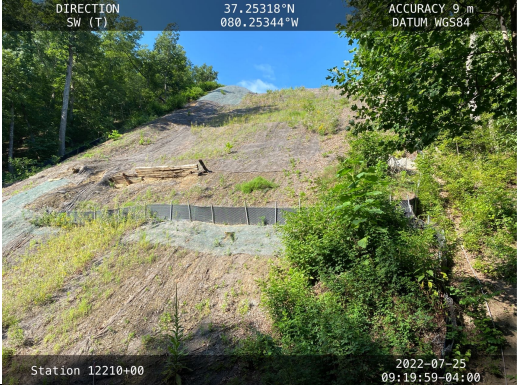
GPS Location	Please see photo for details.		GPS Location	Please see photo for details.	
Field Station#	12211+00		Field Station#	12210+00	
Pic 7 Desc.	Photo shows low lying drainage area that runs across the ROW. (Not a resource).		Pic 8 Desc.	Photo shows the stabilized ROW conditions with water bars and that all ECDs are installed and are functioning as designed.

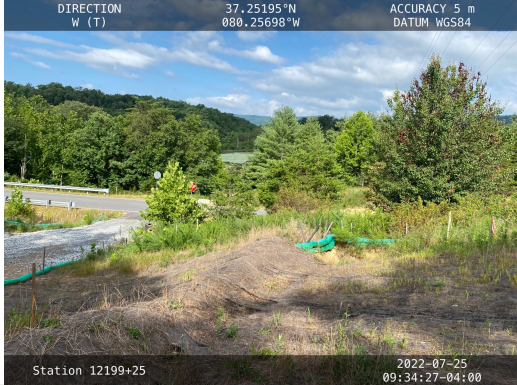
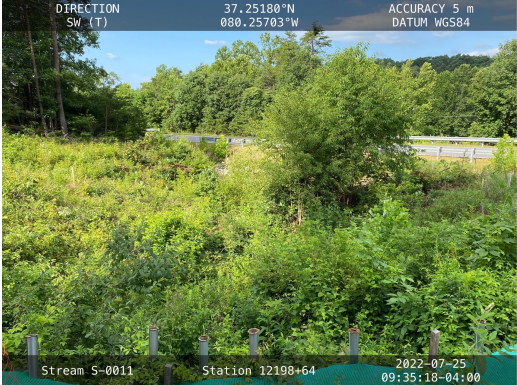
GPS Location	Please see photo for details.		GPS Location	Please see photo for details.	
Field Station#	12199+25		Field Station#	12198+64	
Pic 9 Desc.	Photo shows waterbar, sump and CFS waterbar end treatment.		Pic 10 Desc.	Photo shows overview of Stream S-0011 and its buffer zone from the going away side.

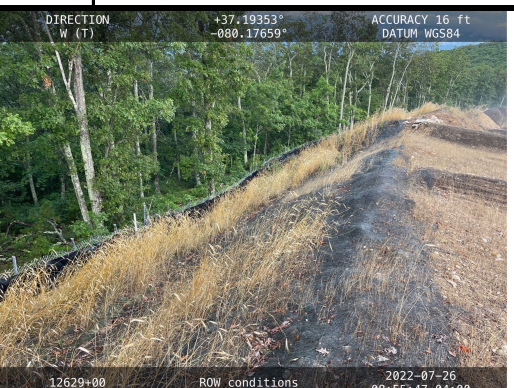
<p>DIRECTION W (T) +37.19353° -080.17659° ACCURACY 16 ft DATUM WGS84</p> <p>12629+00 ROW conditions 2022-07-26 08:55:47-04:00</p>	
GPS Location	See photo for gps location data.		GPS Location	See photo for gps location data.

Field Station#	12638+00		Field Station#	12629+00	
Pic 3 Desc.	Photo shows ROW condition. ECDs are installed and functioning as designed.		Pic 4 Desc.	Photo shows ROW condition. ECDs are installed and functioning as designed.

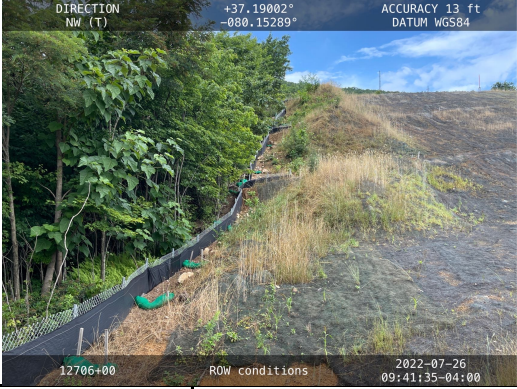
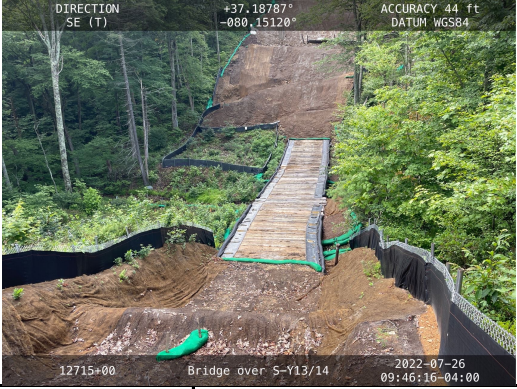
GPS Location	See photo for gps location data.		GPS Location	See photo for gps location data.	
Field Station#	12706+00		Field Station#	12715+00	
Pic 13 Desc.	Photo shows ROW condition. ECDs are installed and functioning as designed.		Pic 14 Desc.	Photo shows ROW condition. ECDs are installed and functioning as designed.

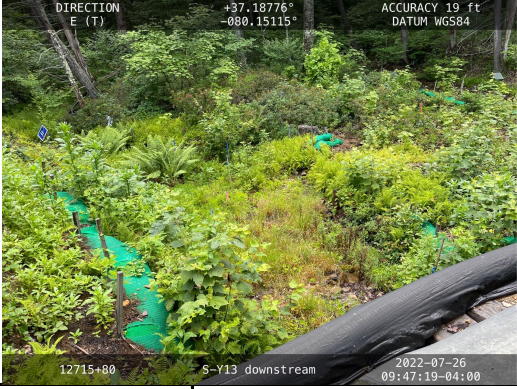
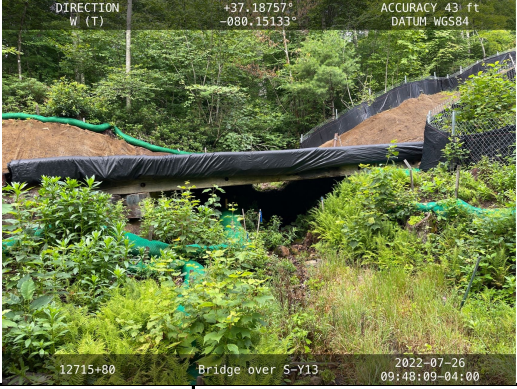
GPS Location	See photo for gps location data.		GPS Location	See photo for gps location data.	
Field Station#	12715+80		Field Station#	12715+80	
Pic 15 Desc.	Photo shows S-Y13 downstream from the bridge.		Pic 16 Desc.	Photo shows the bridge over stream S-Y13.

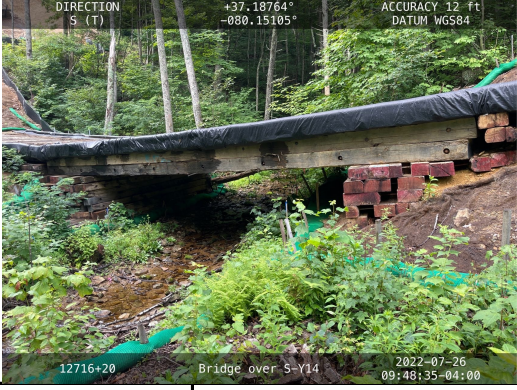
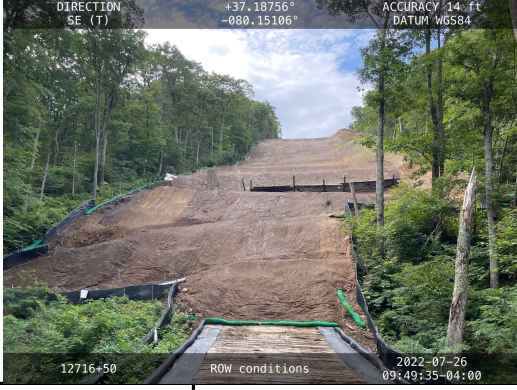
GPS Location	See photo for gps location data.		GPS Location	See photo for gps location data.	
Field Station#	12716+20		Field Station#	12716+50	
Pic 17 Desc.	Photo shows the bridge over stream S-Y14.		Pic 18 Desc.	Photo shows ROW condition. ECDs are installed and functioning as designed.

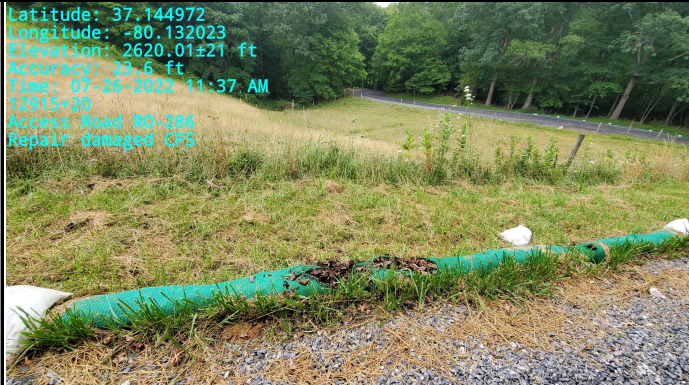
GPS Location	See pic.		GPS Location	See pic.	
Field Station#	12915+20		Field Station#	12915+20	
Pic 13 Desc.	Current condition of the access road.		Pic 14 Desc.	Holes in the CFS along access road RO-286 to be repaired by the contractor.	
<div>Latitude: 37.154784 Longitude: -80.128976 Elevation: 2601.51±16 ft Accuracy: 12.5 ft Time: 07-26-2022 11:51 AM 12868+00 GAS of Bottom Creek Road Stream S-ST9B Wetland W-EF86</div>  			<div>Latitude: 37.154853 Longitude: -80.129167 Elevation: 2609.96±3 ft Accuracy: 12.5 ft Time: 07-26-2022 11:52 AM 12868+00 GAS of Bottom Creek Road</div>

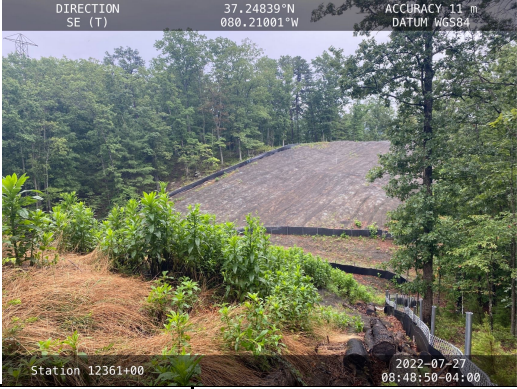
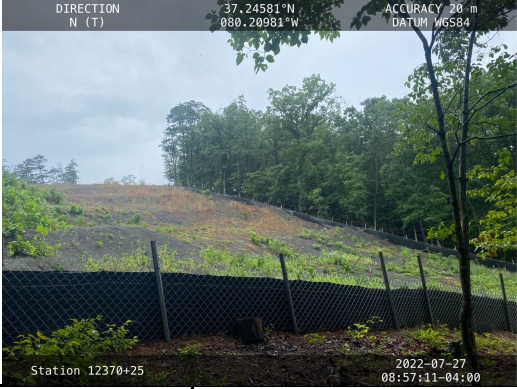
GPS Location	Please see photo for details.		GPS Location	Please see photo for details.	
Field Station#	12361+00		Field Station#	12370+25	
Pic 7 Desc.	Photo shows the stabilized ROW conditions with water bars and that all ECDs are installed and are functioning as designed.		Pic 8 Desc.	Photo shows the stabilized ROW conditions with water bars and that all ECDs are installed and are functioning as designed.

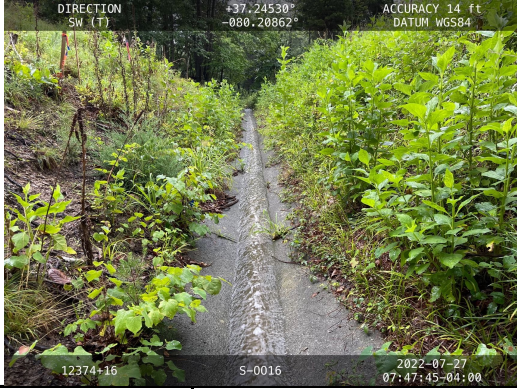
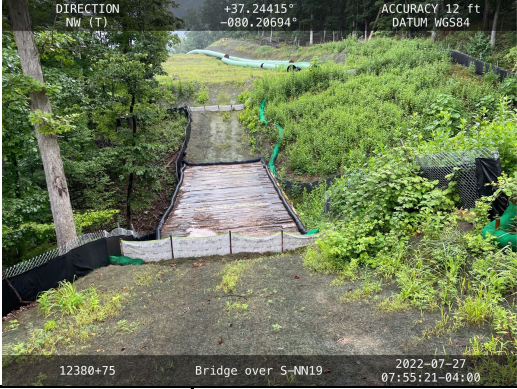
GPS Location	Please see photo for details.		GPS Location	Please see photo for details.	
Field Station#	12374+16		Field Station#	12380+75	
Pic 9 Desc.	Photo shows view of Stream S-0016 from the upstream end.		Pic 10 Desc.	Photo shows overview of Stream S-NN19 and its buffer zone along with the equipment bridge spanning the stream channel.

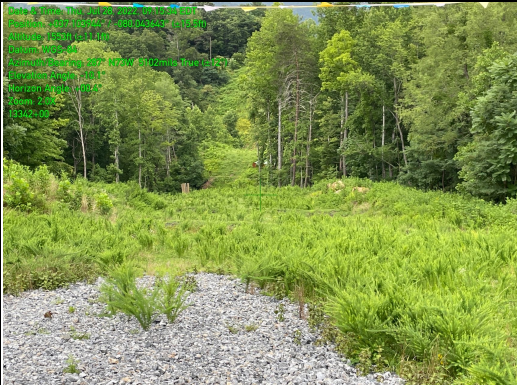
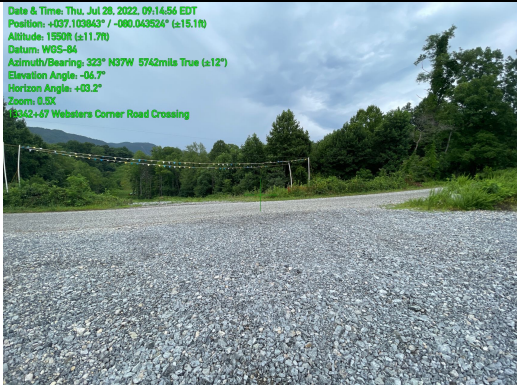
GPS Location		0		GPS Location		0	
Field Station#		13342+00		Field Station#		13342+67	
Pic 7 Desc.		ROW and ECDs In good condition and stable		Pic 8 Desc.		Websters Corner Road Crossing in good condition

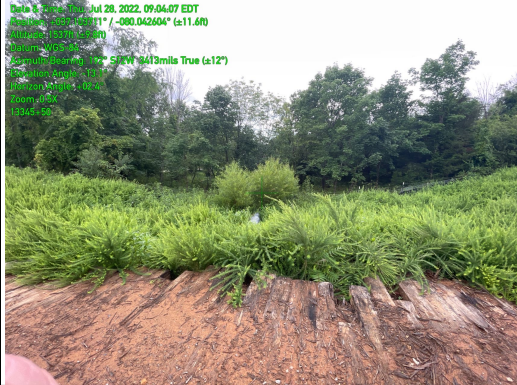
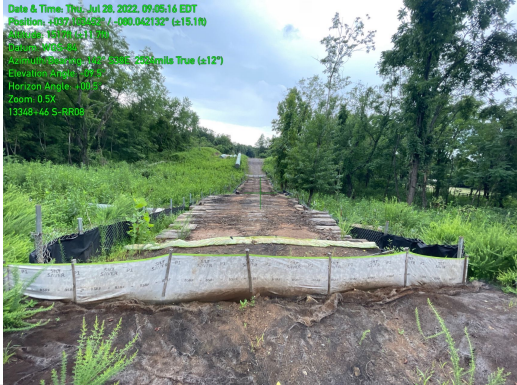
GPS Location		0		GPS Location		0	
Field Station#		13345+50		Field Station#		13348+46	
Pic 9 Desc.		Clean water diversion pipe and outlet in good condition		Pic 10 Desc.		MVP-S-RR08 and corresponding buffer zone in good condition

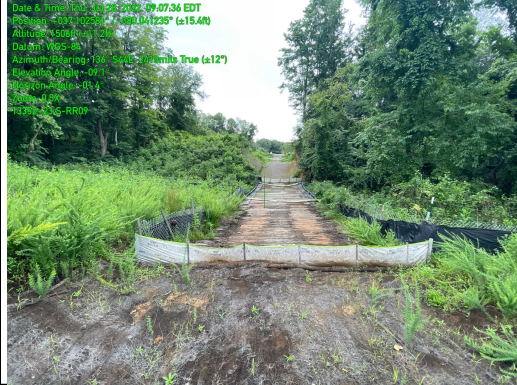
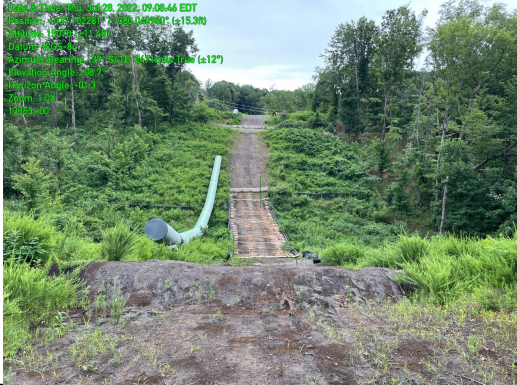
GPS Location		0		GPS Location		0	
Field Station#		13352+23		Field Station#		13353+00	
Pic 11 Desc.		MVP-S-RR09 and corresponding buffer zone in good condition		Pic 12 Desc.		ROW and ECDs In good condition and stable

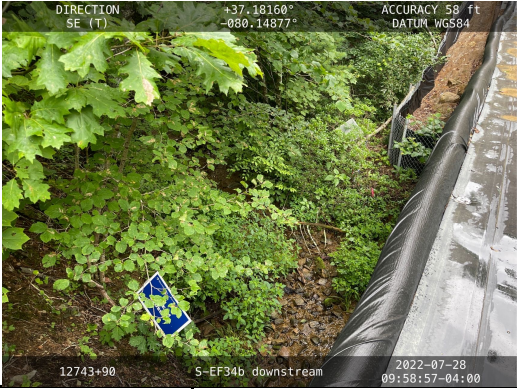
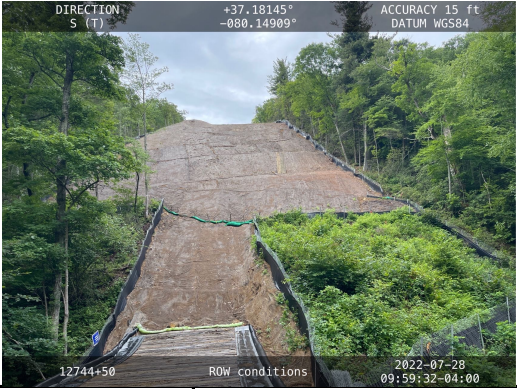
GPS Location	See photo for gps location data.		GPS Location	See photo for gps location data.	
Field Station#	12743+90		Field Station#	12744+50	
Pic 15 Desc.	Photo shows S-EF34b downstream from the bridge		Pic 16 Desc.	Photo shows the ROW condition. ECDs are installed and functioning as designed.

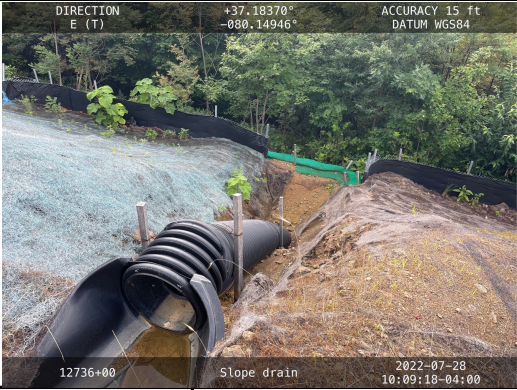
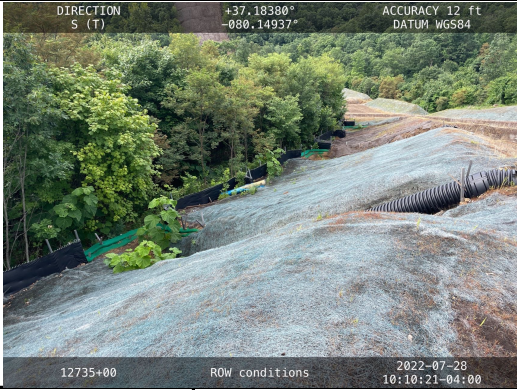
GPS Location	See photo for gps location data.		GPS Location	See photo for gps location data.	
Field Station#	12736+00		Field Station#	12735+00	
Pic 17 Desc.	Photo shows the slope drain.		Pic 18 Desc.	Photo shows the ROW condition. ECDs are installed and functioning as designed.

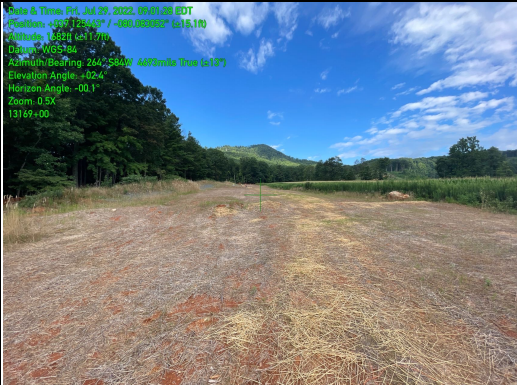
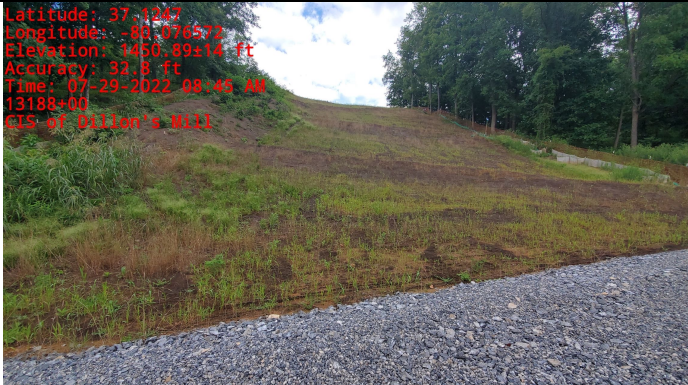
GPS Location	0	GPS Location	0		
Field Station#	13169+00	Field Station#	13188+00		
Pic 7 Desc.	ROW and ECDs In good condition and stable	Pic 8 Desc.	ROW and ECDs In good condition and stable

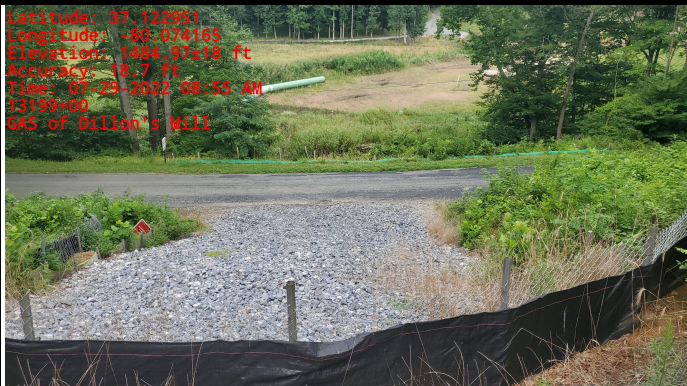
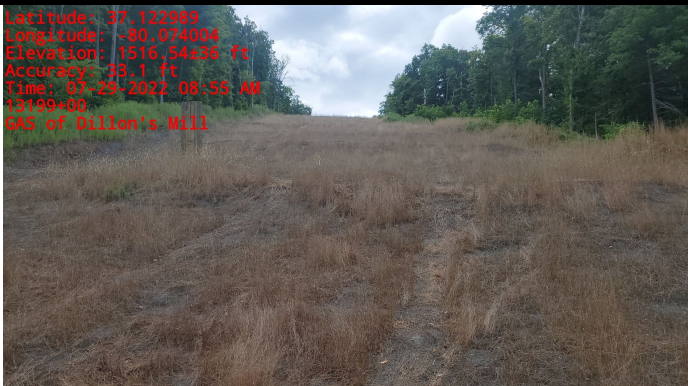
GPS Location	0	GPS Location	0		
Field Station#	13199+00	Field Station#	13199+00		
Pic 9 Desc.	Dillion Mill Road Crossing in good condition	Pic 10 Desc.	ROW and ECDs In good condition and stable

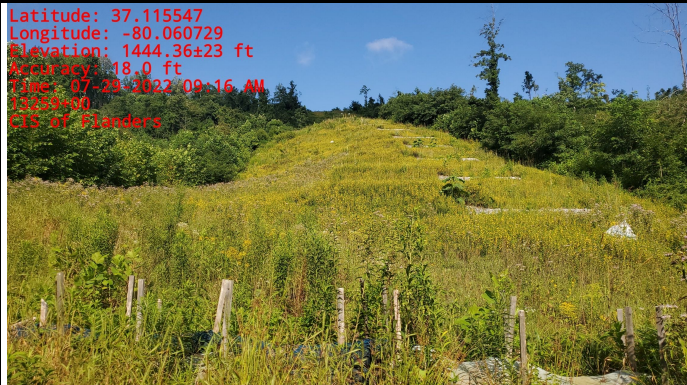
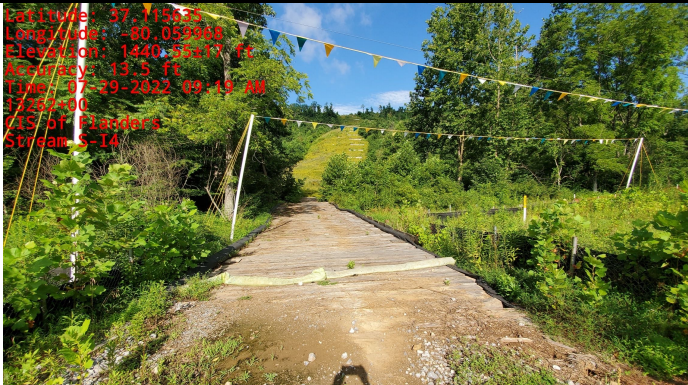
GPS Location	0	GPS Location	0		
Field Station#	13259+00	Field Station#	13262+00		
Pic 11 Desc.	ROW and ECDs In good condition and stable	Pic 12 Desc.	MVP-S-II4 and corresponding buffer zone in good condition
