# Visual Site Inspection Report

<b>Project Name</b>	H-600 Pipeline Spread I	<b>AFE</b>	124300139	<b>Spread</b>	H-600 Pipeline Spread I
<b>Contractor</b>	Precision			<b>Report #</b>	39673
<b>Inspector</b>	Ben Farmer			<b>Date/Time</b>	7/11/2022 1:49 PM
<b>Permit #</b>	TBD	<b>Inspection Type</b>	VA SWPP	<b>Station Begin</b>	13958+31
<b>State</b>	VA	<b>Inspection Area</b>	Partial	<b>Station End</b>	14062+17
<b>County</b>	Franklin	<b>Ground</b>	Damp	<b>Temperature (°F)</b>	65.00
<b>Municipality</b>	N/A	<b>Weather</b>	Sunny	<b>Rain Gauge (in)</b>	0.80
				<b>Rain Accumulation Time (days)</b>	0.00

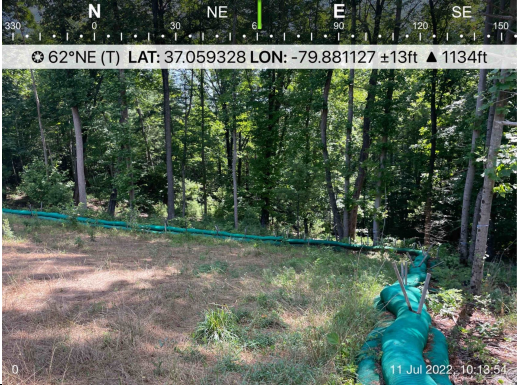
<b>GPS Location</b>	See photo		<b>GPS Location</b>	See photo	
<b>Field Station#</b>	14027+00		<b>Field Station#</b>	14033+00	
<b>Pic 7 Desc.</b>	Perimeter CFS in good condition		<b>Pic 8 Desc.</b>	Waterbars are in good condition

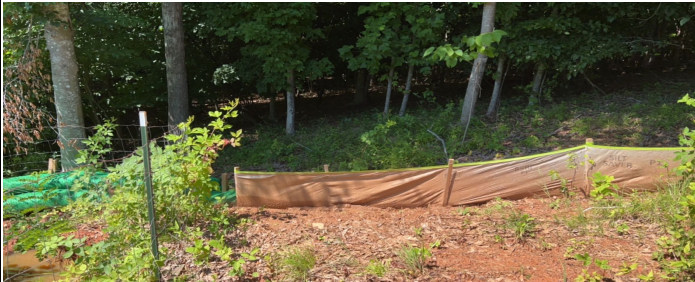
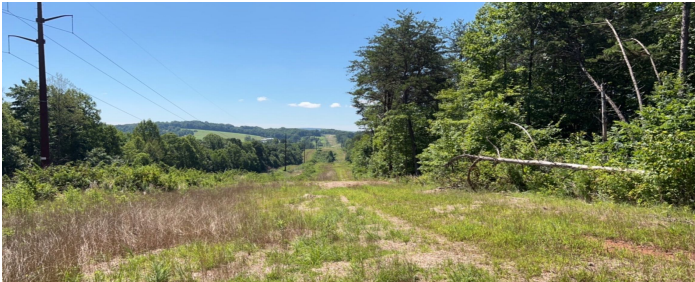
37°1'11" N 79°45'44" W 239°SW COURSE 268° GPS Glade Hill, VA 24092, United States 07.11.2022 11:22:43 Accur +/-32.4 Ft ALT 950 Ft			37°1'25" N 79°45'55" W 176°S COURSE 317° GPS Glade Hill, VA 24092, United States 07.11.2022 11:14:43 Accur +/-49.5 Ft ALT 948 Ft		
GPS Location	1		GPS Location	2	
Field Station#	14485+00		Field Station#	14464+00	
Pic 1 Desc.	Routine maintenance. Replace perimeter P1 silt fence beyond effective lifespan.		Pic 2 Desc.	ROW stabilized and vegetated in temporary area.

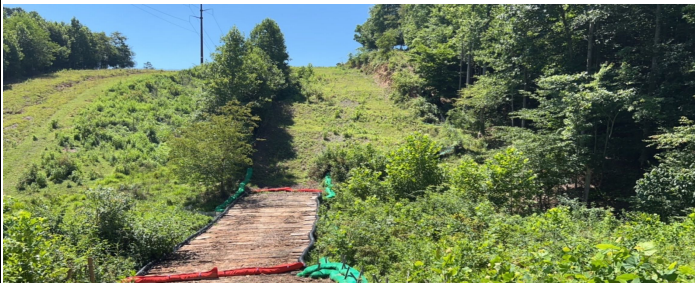
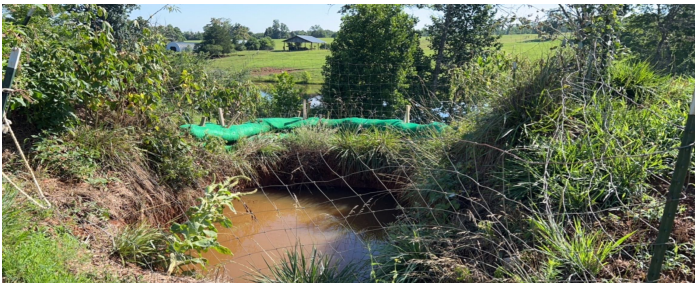
Pic 3 Desc.	Equipment bridge and surrounding ECDs in place and functional at stream crossing and resource buffer.		Pic 4 Desc.	Sump pit and CFS end treatment performing intended functions.

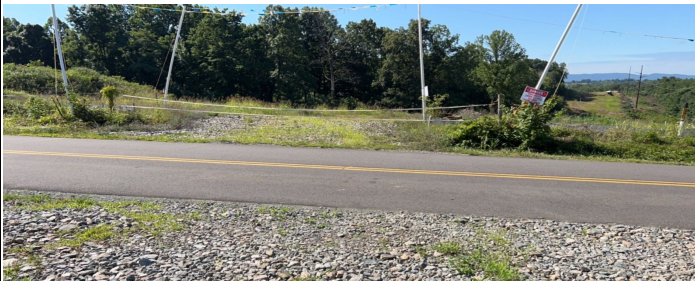
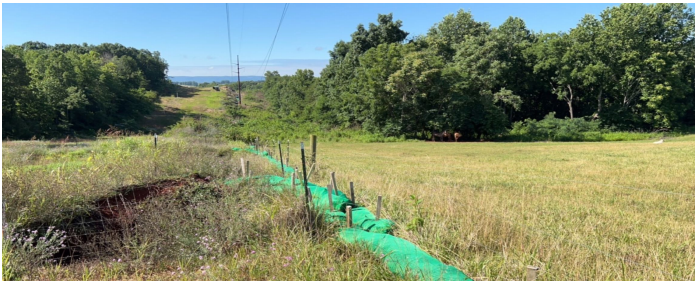
37°0'40" N 79°45'15" W 170°S COURSE 147° GPS 1705 SR-674, Glade Hill, VA 24092, United States 07.11.2022 09:56:24 Accur +/-11.6 Ft ALT 1065 Ft			37°0'38" N 79°45'16" W 272°W COURSE 231° GPS 1705 SR-674, Glade Hill, VA 24092, United States 07.11.2022 09:58:05 Accur +/-15.5 Ft ALT 1055 Ft		
GPS Location	5		GPS Location	6	
Field Station#	14524+76		Field Station#	14527+00	
Pic 5 Desc.	RCE at Timber Ridge Rd in good condition.		Pic 6 Desc.	Perimeter CFS in place and functional.

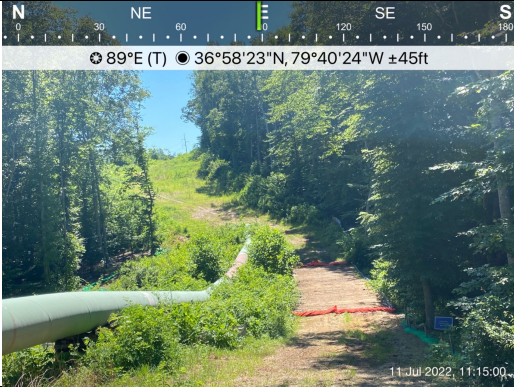
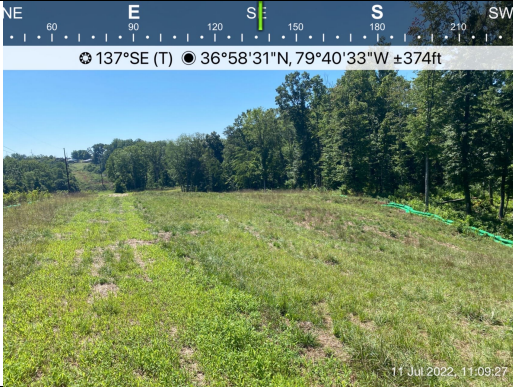
<b>GPS Location</b>	0	<b>GPS Location</b>	0		
<b>Field Station#</b>	14823+54	<b>Field Station#</b>	14812+00		
<b>Pic 1 Desc.</b>	Approximately 14823+54. Overview of stream crossing, equipment bridge and ECDs at stream S-A13.		<b>Pic 2 Desc.</b>	Approximately 14812+00. Overview of ROW. Permanent vegetation.

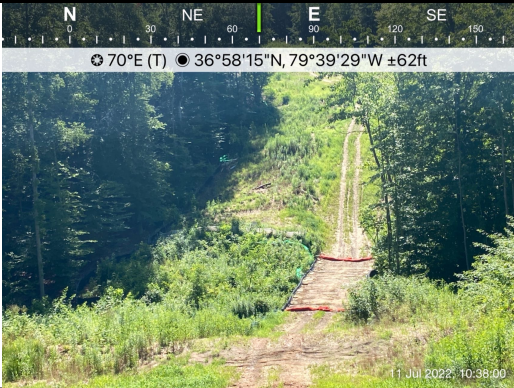
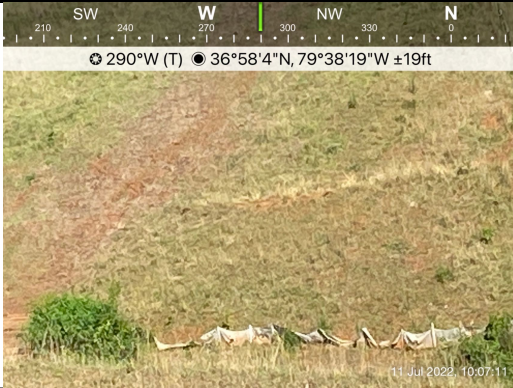
<b>GPS Location</b>	0	<b>GPS Location</b>	0		
<b>Field Station#</b>	14870+00	<b>Field Station#</b>	14925+00		
<b>Pic 5 Desc.</b>	Approximately 14870+00. Overview of ROW.		<b>Pic 6 Desc.</b>	Approximately 14925+00. P-1 requires maintenance. Damaged by livestock.

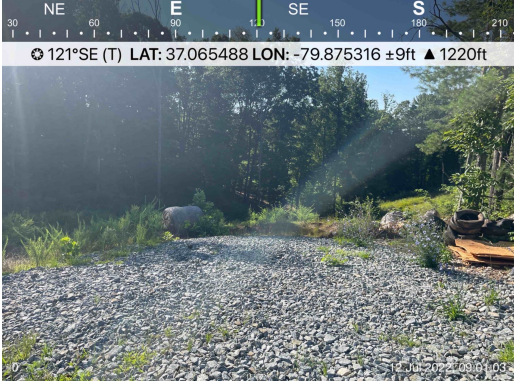
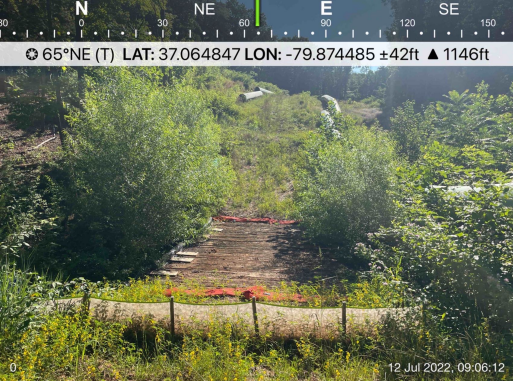
<b>GPS Location</b>	See photo		<b>GPS Location</b>	See photo	
<b>Field Station#</b>	14062+17		<b>Field Station#</b>	14066+77	
<b>Pic 1 Desc.</b>	RCEs are in good condition at all road crossings		<b>Pic 2 Desc.</b>	Equipment bridge ECDs are in good condition

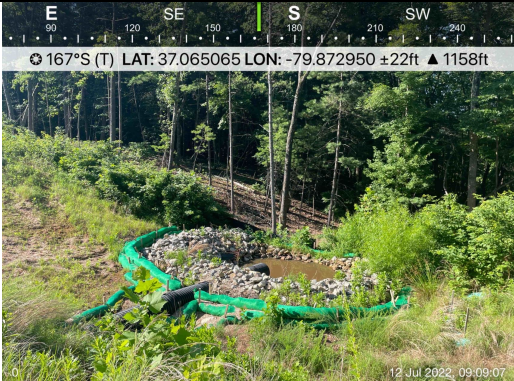
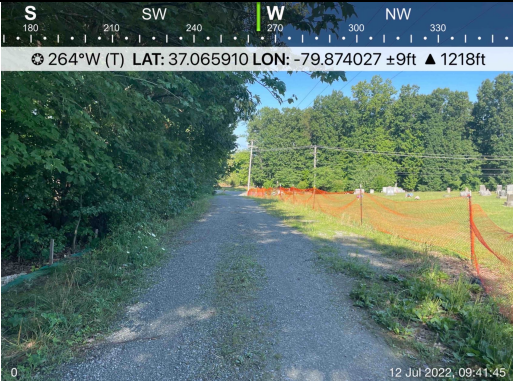
<b>GPS Location</b>	See photo		<b>GPS Location</b>	See photo	
<b>Field Station#</b>	14070+00		<b>Field Station#</b>	14081+53	
<b>Pic 3 Desc.</b>	CWDs are functioning as intended		<b>Pic 4 Desc.</b>	MVP-FR-309.05 is in good condition with controls in place

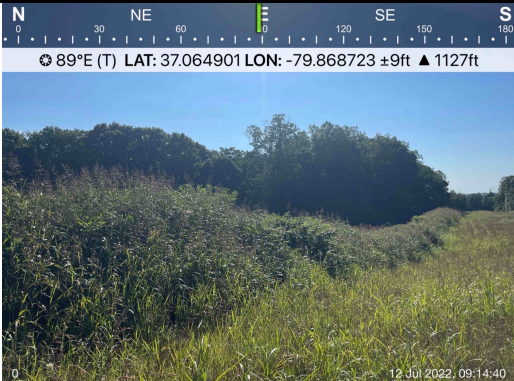
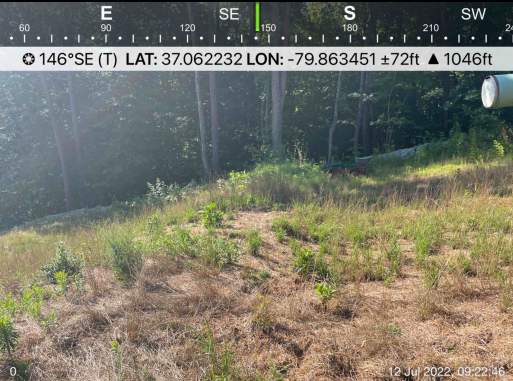
<b>GPS Location</b>	See photo		<b>GPS Location</b>	See photo	
<b>Field Station#</b>	14090+00		<b>Field Station#</b>	14103+00	
<b>Pic 5 Desc.</b>	Topsoil berms remain stabilized		<b>Pic 6 Desc.</b>	Waterbars are in good condition

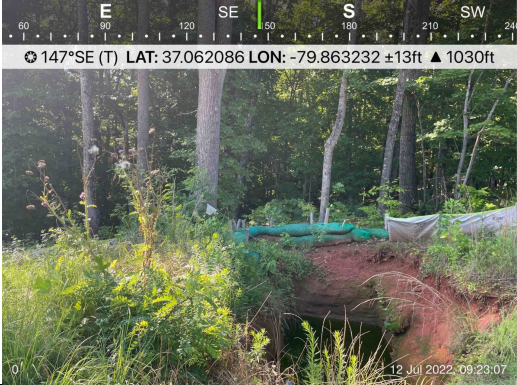
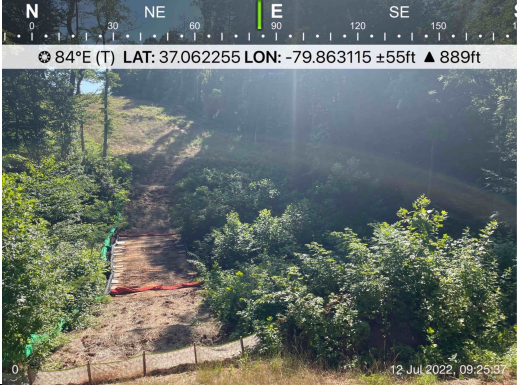
<b>GPS Location</b>	See photo		<b>GPS Location</b>	See photo	
<b>Field Station#</b>	14103+00		<b>Field Station#</b>	14105+00	
<b>Pic 7 Desc.</b>	End treatments are functioning as intended		<b>Pic 8 Desc.</b>	Resource buffers remain well vegetated

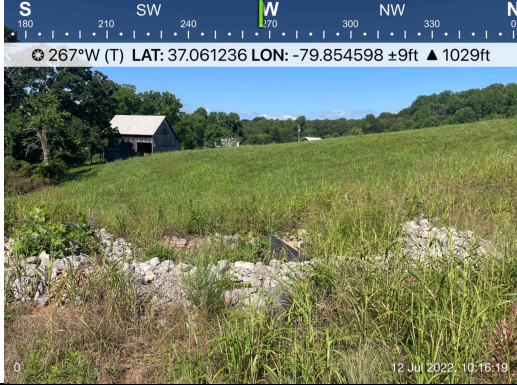
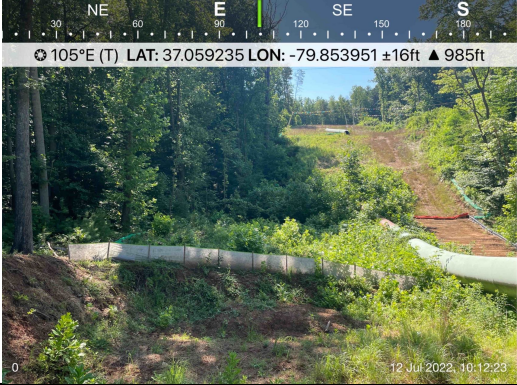
<b>GPS Location</b>	See photo		<b>GPS Location</b>	See photo	
<b>Field Station#</b>	14132+00		<b>Field Station#</b>	14141+62	
<b>Pic 9 Desc.</b>	CWDs are functioning as intended		<b>Pic 10 Desc.</b>	P1 is in good condition at all stream and wetland buffers

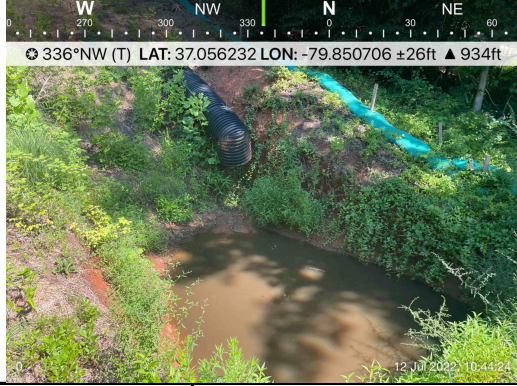
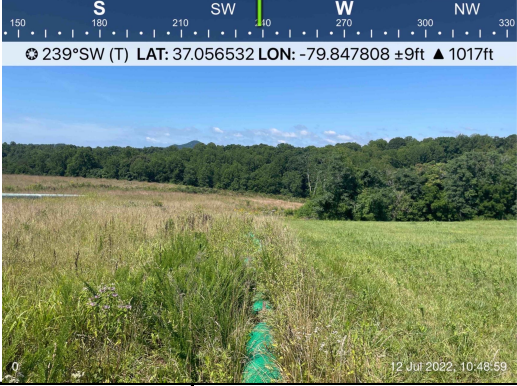
<b>GPS Location</b>	See photo		<b>GPS Location</b>	See photo	
<b>Field Station#</b>	14156+00		<b>Field Station#</b>	14165+00	
<b>Pic 11 Desc.</b>	Slope drain is in good condition and functioning		<b>Pic 12 Desc.</b>	CFS is in good condition throughout this section

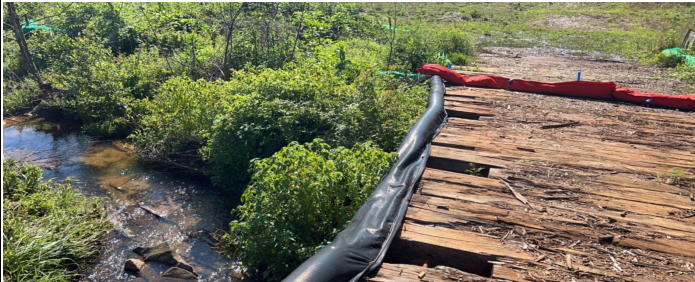
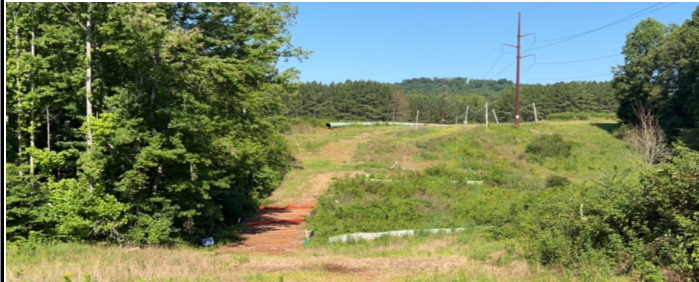
37°01' N 79°44'34" W 141°SE COURSE 358° GPS Glade Hill, VA 24092, United States 07.12.2022 09:55:14 Accur +/-84.0 Ft ALT 835 Ft			37°03' N 79°44'49" W 326°NW COURSE 116° GPS Glade Hill, VA 24092, United States 07.12.2022 10:01:21 Accur +/-11.6 Ft ALT 871 Ft		
GPS Location	1	GPS Location	2		
Field Station#	14582+85	Field Station#	14568+10		
Pic 1 Desc.	Routine maintenance. Repair side boards on equipment bridge.		Pic 2 Desc.	Equipment bridge and surrounding ECDs in place and functional at stream crossing and resource buffer; signage visible and intact.

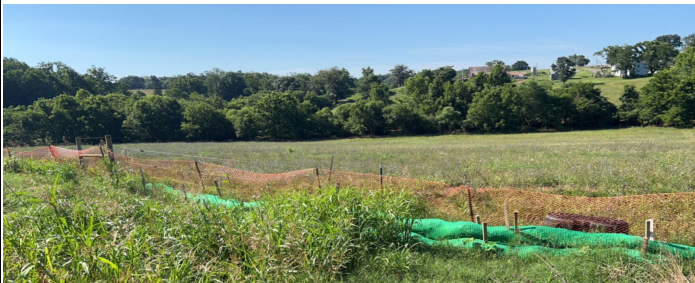
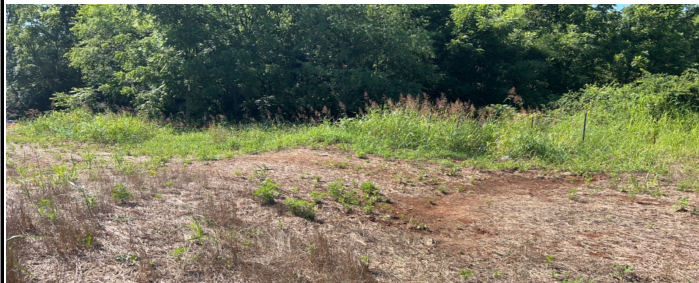
GPS Location	3	GPS Location	4		
Field Station#	14575+00	Field Station#	14580+00		
Pic 3 Desc.	Perimeter CFS triple stack in good condition.		Pic 4 Desc.	Water bar performing intended function.

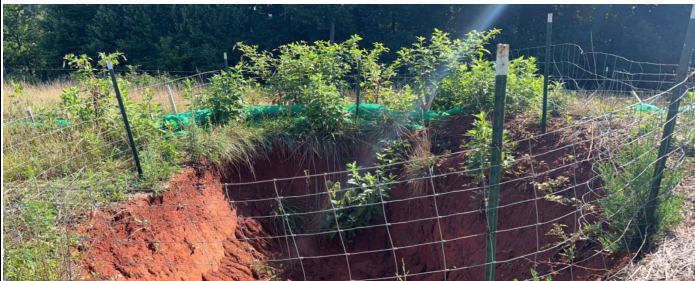
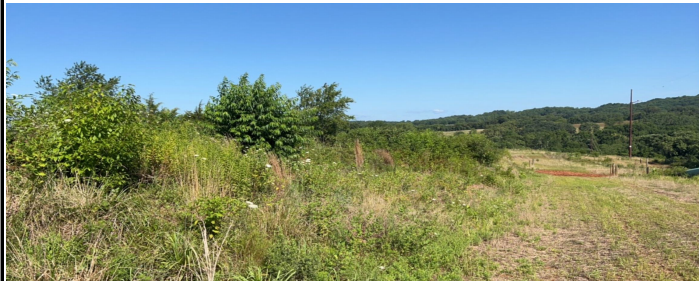
36°59'57" N 79°44'25" W 9°N COURSE 327° GPS 753 Simmons Creek Rd, Union Hall, VA 24176, United States 07.12.2022 09:50:13 Accur +/-11.6 Ft ALT 916 Ft			36°59'54" N 79°44'21" W 337°NW COURSE -1° GPS 753 Simmons Creek Rd, Union Hall, VA 24176, United States 07.12.2022 09:47:46 Accur +/-50.4 Ft ALT 942 Ft		
GPS Location	5	GPS Location	6		
Field Station#	14586+00	Field Station#	14593+00		
Pic 5 Desc.	Sump pit and CFS end treatment performing intended functions.		Pic 6 Desc.	Temporary diversion berm stabilized and vegetated.

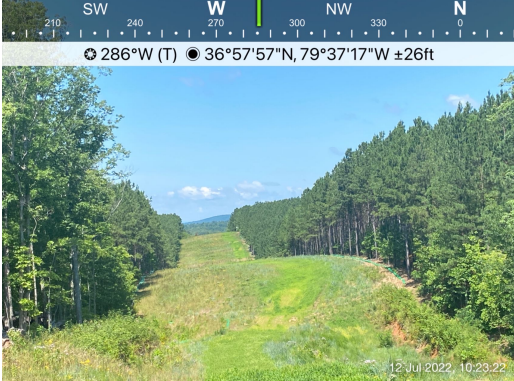
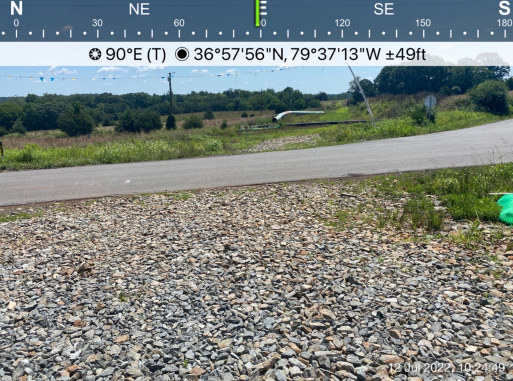
<b>GPS Location</b>	0	<b>GPS Location</b>	0		
<b>Field Station#</b>	14968+00	<b>Field Station#</b>	14981+55		
<b>Pic 1 Desc.</b>	Approximately 14968+00. Overview of ROW. Permanent vegetation.		<b>Pic 2 Desc.</b>	Approximately 14981+55. Overview of road crossing and RCEs.

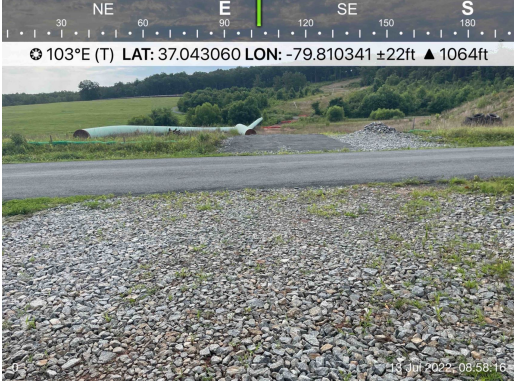
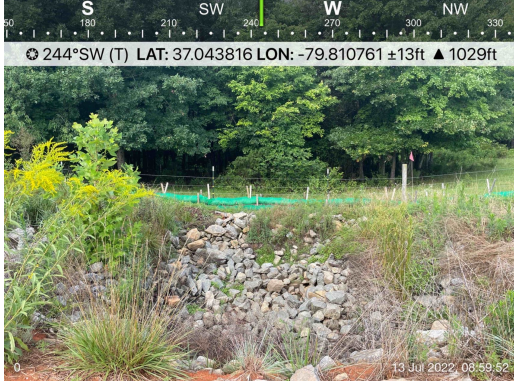
<b>GPS Location</b>	See photo		<b>GPS Location</b>	See photo	
<b>Field Station#</b>	14311+57		<b>Field Station#</b>	14310+00	
<b>Pic 1 Desc.</b>	RCEs are in good condition at all road crossings.		<b>Pic 2 Desc.</b>	CWDs are functioning as intended

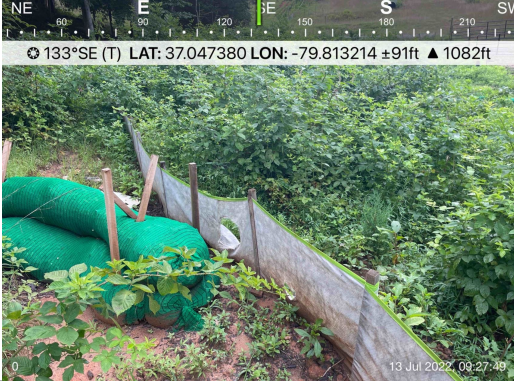
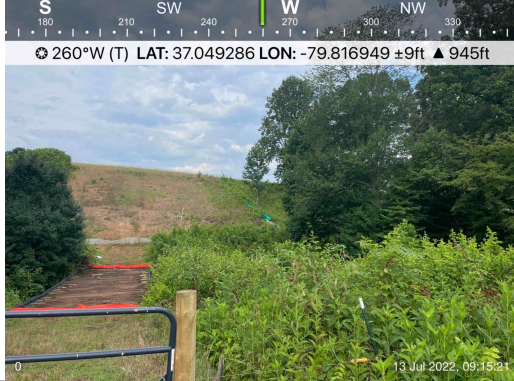
<b>GPS Location</b>	See photo		<b>GPS Location</b>	See photo	
<b>Field Station#</b>	14294+00		<b>Field Station#</b>	14279+50	
<b>Pic 3 Desc.</b>	P1 has been damaged by livestock and needs to be replaced		<b>Pic 4 Desc.</b>	Resource buffers remain well vegetated

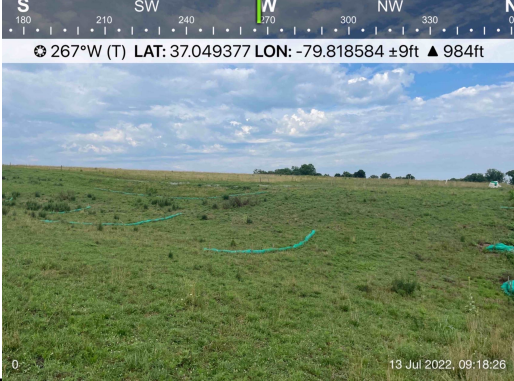
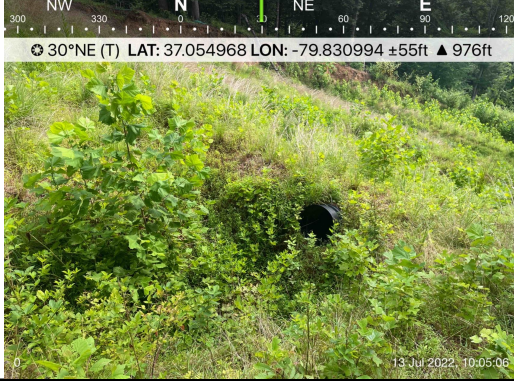
<b>GPS Location</b>	See photo		<b>GPS Location</b>	See photo	
<b>Field Station#</b>	14273+00		<b>Field Station#</b>	14232+00	
<b>Pic 5 Desc.</b>	CFS is in good condition throughout this section		<b>Pic 6 Desc.</b>	Slope drain is functioning as intended

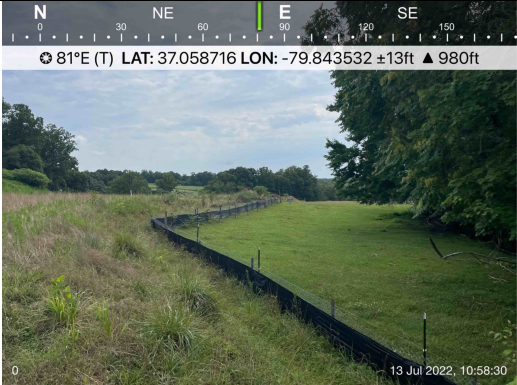
<b>GPS Location</b>	See photo		<b>GPS Location</b>	See photo	
<b>Field Station#</b>	14185+00		<b>Field Station#</b>	14181+00	
<b>Pic 11 Desc.</b>	End treatments are functioning as intended		<b>Pic 12 Desc.</b>	SSF is in good condition

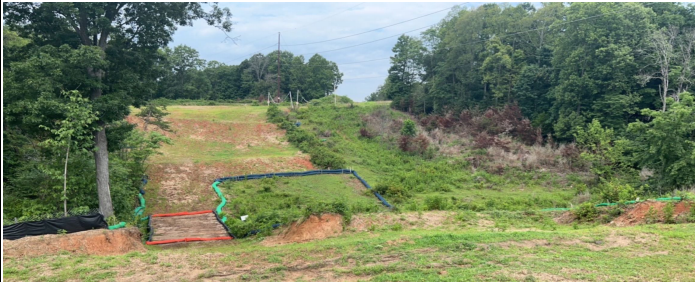
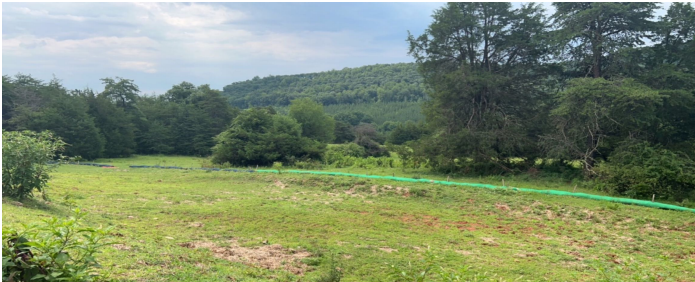
36°59'16" N 79°43'1" W 34°NE COURSE -1' GPS Union Hall, VA 24176, United States 07.13.2022 10:55:47 Accur +/-15.5 Ft ALT 950 Ft			36°59'16" N 79°43'0" W 237°SW COURSE -1' GPS Union Hall, VA 24176, United States 07.13.2022 10:55:06 Accur +/-14.0 Ft ALT 946 Ft		
<b>GPS Location</b>	1	<b>GPS Location</b>	2		
<b>Field Station#</b>	14673+10	<b>Field Station#</b>	14676+00		
<b>Pic 1 Desc.</b>	Equipment bridge and surrounding ECDs in place and functional at stream crossing and resource; signage visible and intact.		<b>Pic 2 Desc.</b>	Perimeter CFS in good condition in extra workspace.

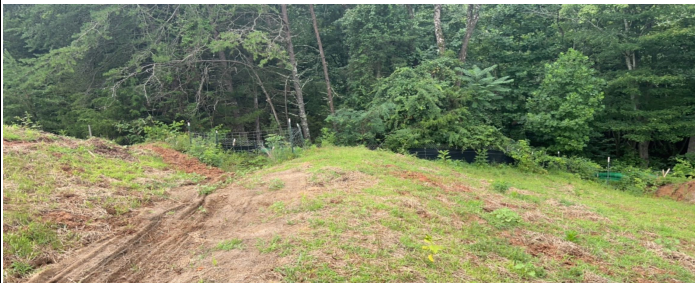
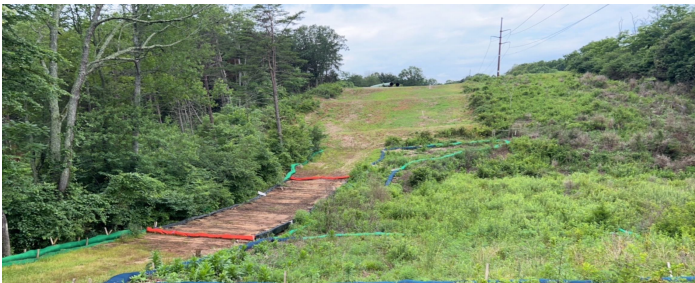
<b>GPS Location</b>	3	<b>GPS Location</b>	4		
<b>Field Station#</b>	14684+00	<b>Field Station#</b>	14680+29		
<b>Pic 3 Desc.</b>	Water bar and erosion control blanket in place and functional.		<b>Pic 4 Desc.</b>	Equipment bridge and surrounding ECDs in place and functional at stream crossing and resource; signage visible and intact.

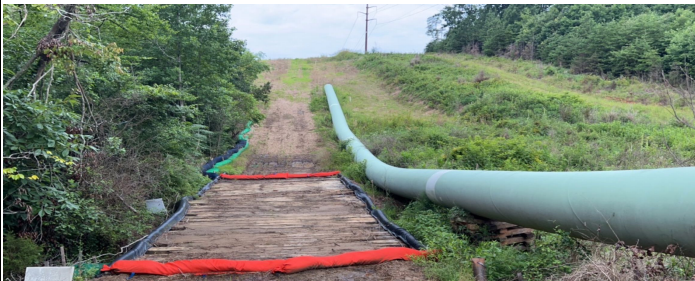
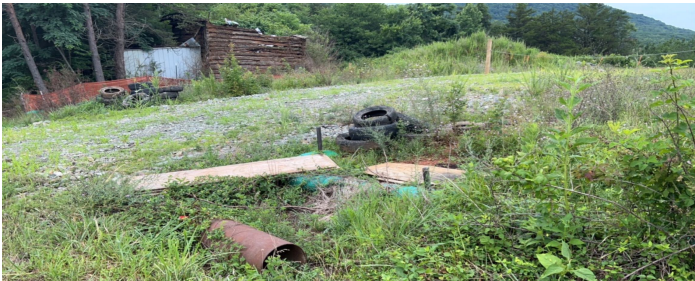
36°59'16" N 79°42'42" W 316°NW COURSE -1' GPS Sorry no results found 07.13.2022 10:46:09 Accur +/-39.3 Ft ALT 904 Ft			36°59'17" N 79°42'36" W 221°SW COURSE -1' GPS 1558-2498 Jacks Creek Rd, Union Hall, VA 24176, United States 07.13.2022 10:41:54 Accur +/-15.1 Ft ALT 936 Ft		
<b>GPS Location</b>	5	<b>GPS Location</b>	6		
<b>Field Station#</b>	14689+36	<b>Field Station#</b>	14694+77		
<b>Pic 5 Desc.</b>	Equipment bridge and surrounding ECDs in place and functional at stream crossing and resource; signage visible and intact.		<b>Pic 6 Desc.</b>	Culvert and RCE in good condition.

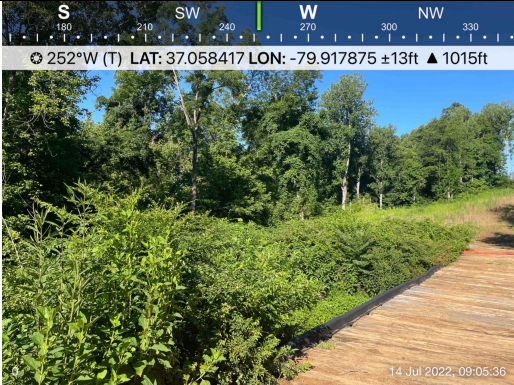
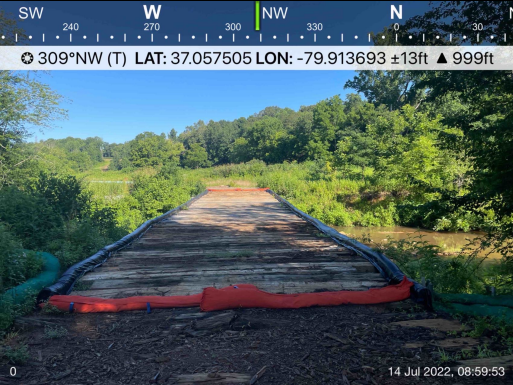
<b>GPS Location</b>	See photo		<b>GPS Location</b>	See photo	
<b>Field Station#</b>	13863+01		<b>Field Station#</b>	13875+16	
<b>Pic 1 Desc.</b>	Resource buffers remain well vegetated		<b>Pic 2 Desc.</b>	Equipment bridge ECDs are functioning as intended

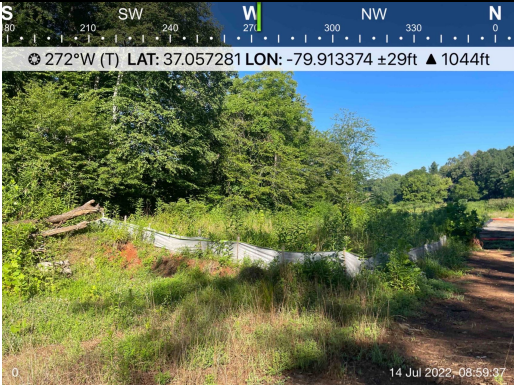
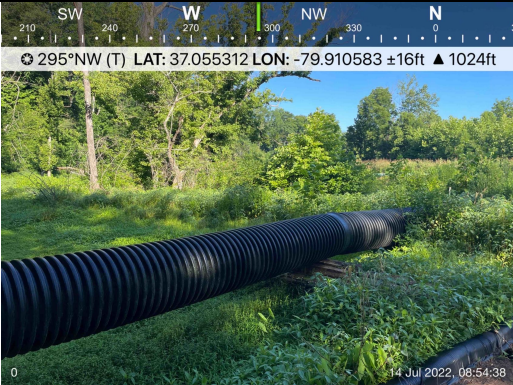
<b>GPS Location</b>	See photo		<b>GPS Location</b>	See photo	
<b>Field Station#</b>	13876+00		<b>Field Station#</b>	13888+50	
<b>Pic 3 Desc.</b>	P1 is in good condition at all stream and wetland buffers		<b>Pic 4 Desc.</b>	Slope drain is functioning as intended

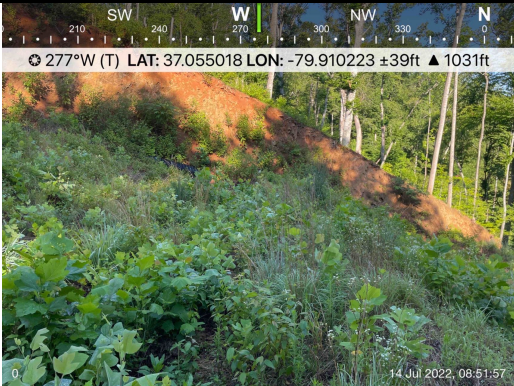
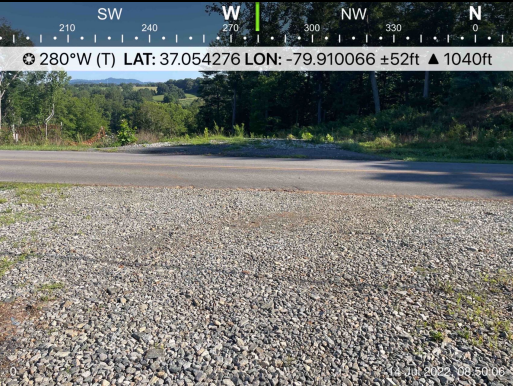
<b>GPS Location</b>	See photo		<b>GPS Location</b>	See photo	
<b>Field Station#</b>	13890+00		<b>Field Station#</b>	13892+45	
<b>Pic 5 Desc.</b>	Waterbars are in good condition		<b>Pic 6 Desc.</b>	RCEs are in good condition at all road crossings

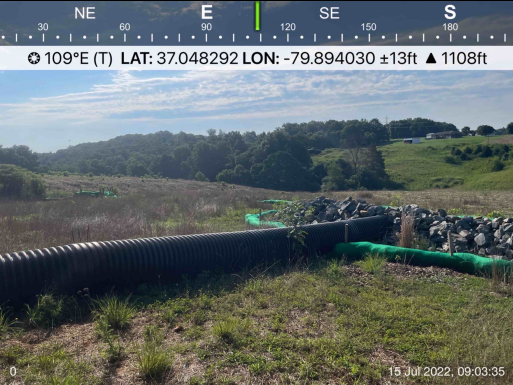
<b>GPS Location</b>	See photo	<b>GPS Location</b>	See photo		
<b>Field Station#</b>	13958+31	<b>Field Station#</b>	13960+00		
<b>Pic 1 Desc.</b>	RCEs are in good condition at all road crossings	<b>Pic 2 Desc.</b>	CWDs are functioning as intended

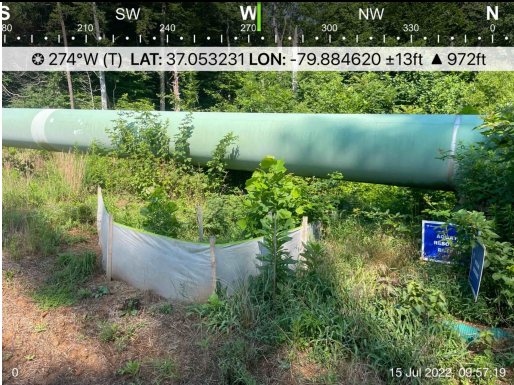
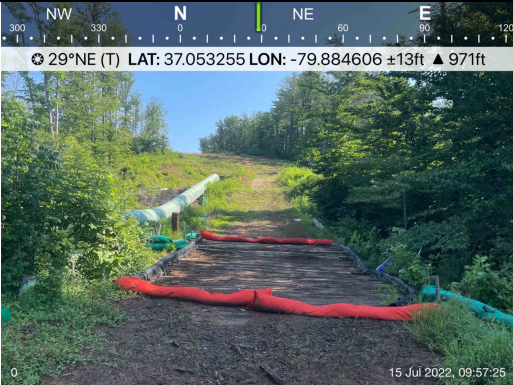
<b>GPS Location</b>	See photo	<b>GPS Location</b>	See photo		
<b>Field Station#</b>	13997+50	<b>Field Station#</b>	13998+15		
<b>Pic 3 Desc.</b>	P1 is in good condition at all stream and wetland buffers	<b>Pic 4 Desc.</b>	Equipment bridge ECDs are in good condition and functioning

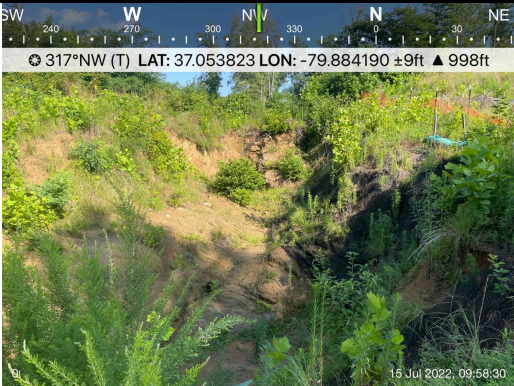
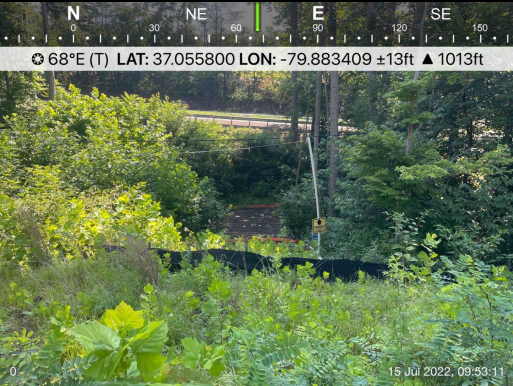
<b>GPS Location</b>	See photo	<b>GPS Location</b>	See photo		
<b>Field Station#</b>	14000+00	<b>Field Station#</b>	14009+11		
<b>Pic 5 Desc.</b>	No evidence of 3rd party pond discharging onto ROW	<b>Pic 6 Desc.</b>	SSF is in good condition

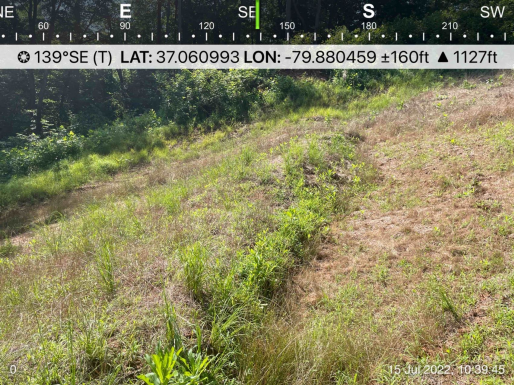
<b>GPS Location</b>	See photo		<b>GPS Location</b>	See photo	
<b>Field Station#</b>	14027+00		<b>Field Station#</b>	14033+00	
<b>Pic 7 Desc.</b>	CFS is in good condition throughout this section		<b>Pic 8 Desc.</b>	Waterbars are in good condition

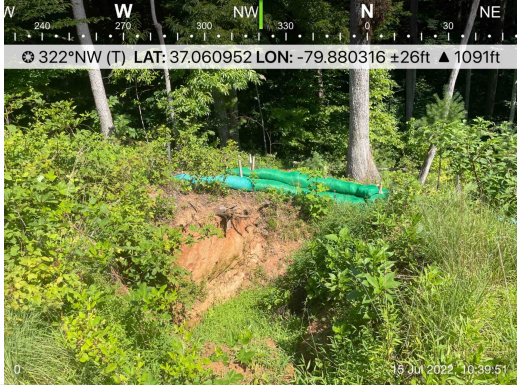
<b>GPS Location</b>	See photo		<b>GPS Location</b>	See photo	
<b>Field Station#</b>	14033+00		<b>Field Station#</b>	14035+00	
<b>Pic 9 Desc.</b>	End treatments are functioning as intended		<b>Pic 10 Desc.</b>	Resource buffers remain well vegetated

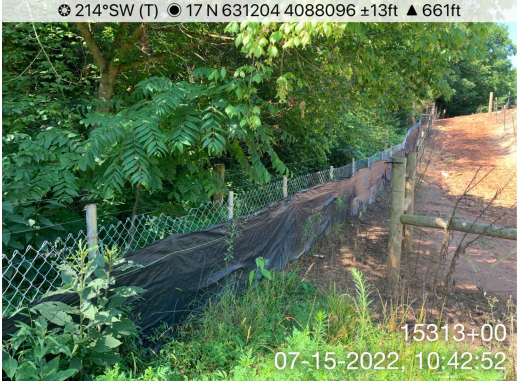
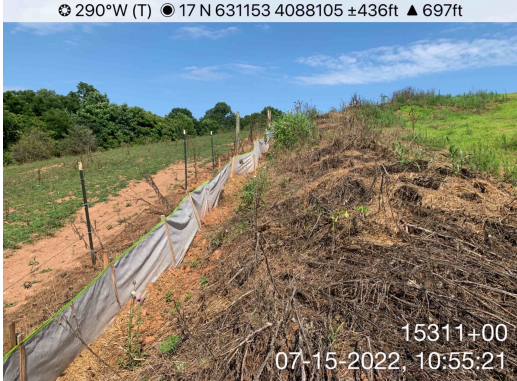
<b>GPS Location</b>	0	<b>GPS Location</b>	0		
<b>Field Station#</b>	15313+00	<b>Field Station#</b>	15311+00		
<b>Pic 7 Desc.</b>	Super silt fence in acceptable condition	<b>Pic 8 Desc.</b>	P1 silt fence in acceptable condition

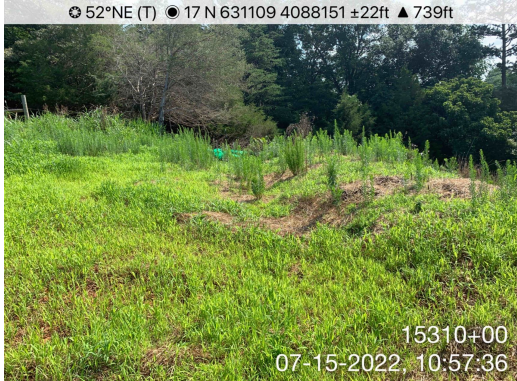
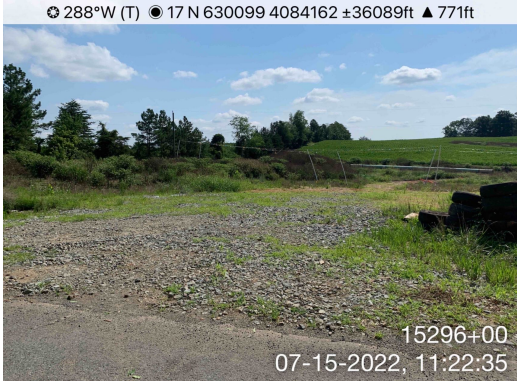
<b>GPS Location</b>	0	<b>GPS Location</b>	0		
<b>Field Station#</b>	15310+00	<b>Field Station#</b>	15296+00		
<b>Pic 9 Desc.</b>	Waterbar in acceptable condition	<b>Pic 10 Desc.</b>	Rock construction entrance in acceptable condition		
Insert image here		Insert image here			
<b>GPS Location</b>		<b>GPS Location</b>			
<b>Field Station#</b>		<b>Field Station#</b>			
<b>Pic 11 Desc.</b>		<b>Pic 12 Desc.</b>

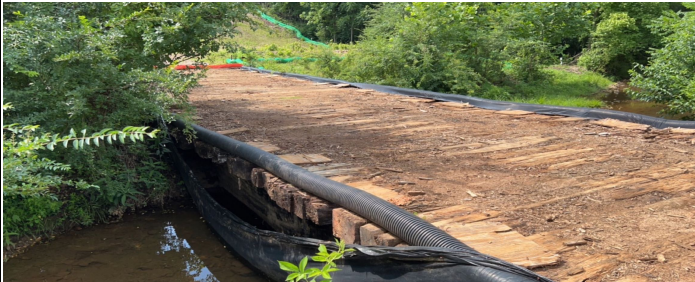
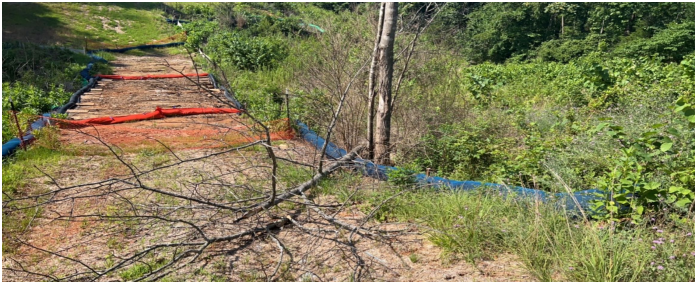
37°13' N 79°45'35" W 220°SW COURSE 151° GPS 1979 SR-674, Glade Hill, VA 24092, United States 07.15.2022 10:58:48 Accur +/-11.6 Ft ALT 867 Ft			37°033' N 79°45'15" W 228°SW COURSE 289° GPS Glade Hill, VA 24092, United States 07.15.2022 10:31:57 Accur +/-15.4 Ft ALT 994 Ft		
GPS Location	1	GPS Location	2		
Field Station#	14496+58	Field Station#	14531+00		
Pic 1 Desc.	Routine maintenance. Repair side boards on equipment bridge.		Pic 2 Desc.	Routine maintenance. Fallen tree down on perimeter CFS in resource buffer.

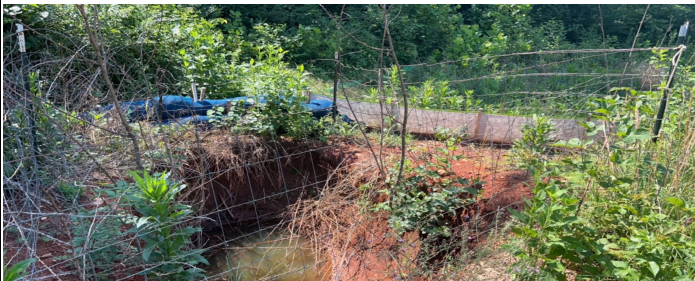
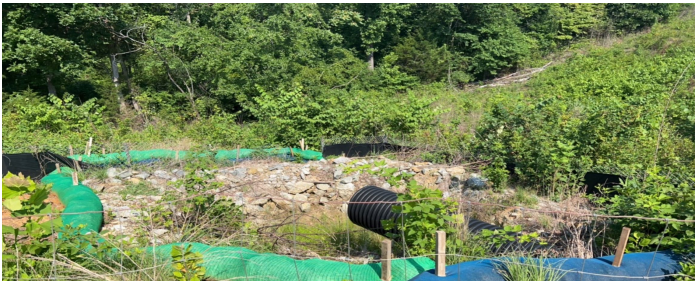
37°034' N 79°45'14" W 195°S COURSE -1° GPS Glade Hill, VA 24092, United States 07.15.2022 10:31:37 Accur +/-14.0 Ft ALT 992 Ft			37°032' N 79°45'15" W 298°NW COURSE 249° GPS Glade Hill, VA 24092, United States 07.15.2022 10:33:29 Accur +/-15.5 Ft ALT 1004 Ft		
GPS Location	5	GPS Location	6		
Field Station#	14530+00	Field Station#	14533+00		
Pic 5 Desc.	Sump pit and CFS end treatment performing intended functions; P1 silt fence in good condition.		Pic 6 Desc.	Plunge pool performing intended function.

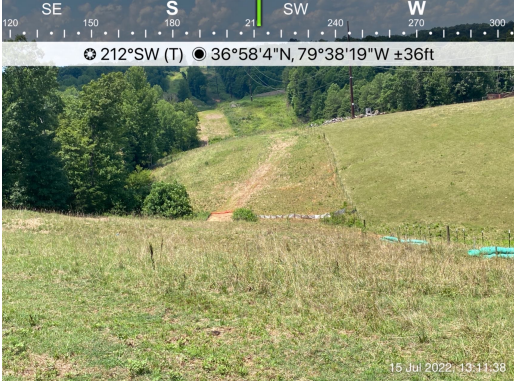
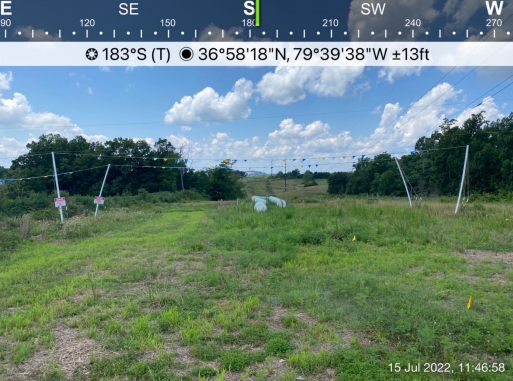
<b>GPS Location</b>	0	<b>GPS Location</b>	0		
<b>Field Station#</b>	14925+00	<b>Field Station#</b>	14860+00		
<b>Pic 1 Desc.</b>	Approximately 15925+00. Overview of ROW. Permanent vegetation.		<b>Pic 2 Desc.</b>	Approximately 14860+00. Overview of ROW.
