Visual Site Inspection Report

Project Name	H-600 Pipeline Spread I	AFE	124300139	Spread	H-600 Pipeline Spread I
Contractor	Precision			Report #	39955
Inspector	Ben Farmer			Date/Time	7/18/2022 12:53 PM
Permit #	TBD	Inspection Type	VA SWPP	Station Begin	14062+17
State	VA	Inspection Area	Partial	Station End	14171+36
County	Franklin	Ground	Dry	Temperature (°F)	75.00
Municipality	N/A	Weather	Sunny	Rain Gauge (in)	0.00
				Rain Accumulation Time (days)	0.00

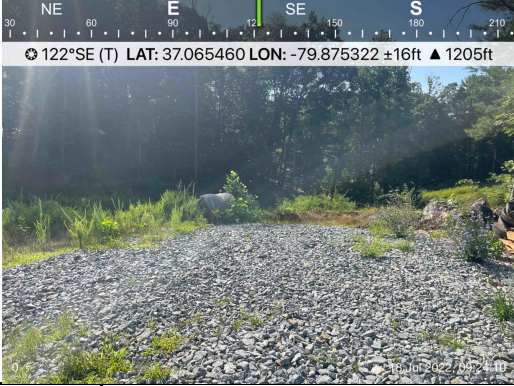
GPS Location	See photo		GPS Location	See photo	
Field Station#	14062+17		Field Station#	14066+77	
Pic 1 Desc.	RCEs are in good condition at all road crossings		Pic 2 Desc.	Equipment bridge ECDs are in good condition and functioning

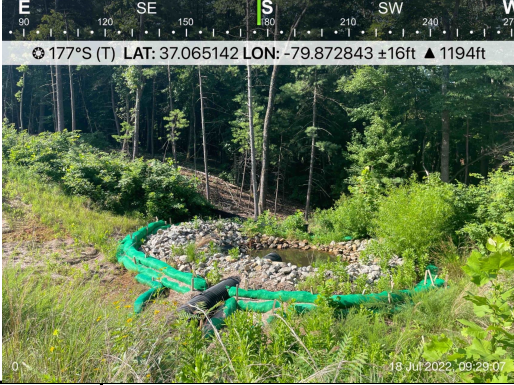
GPS Location	See photo		GPS Location	See photo	
Field Station#	14070+00		Field Station#	14081+53	
Pic 3 Desc.	CWDs are functioning as intended		Pic 4 Desc.	MVP-FR-309.05 is in good condition with controls in place.

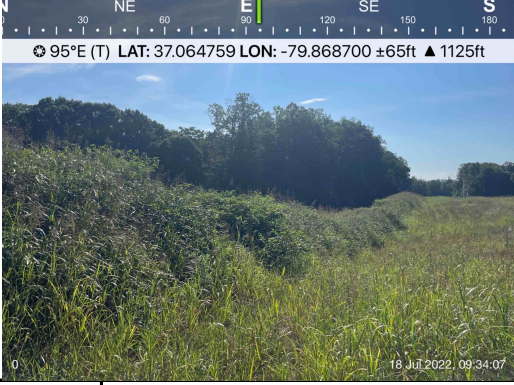
GPS Location	See photo		GPS Location	See photo	
Field Station#	14085+00		Field Station#	14105+32	
Pic 5 Desc.	Topsoil berms remain stabilized		Pic 6 Desc.	Resource buffers remain well vegetated

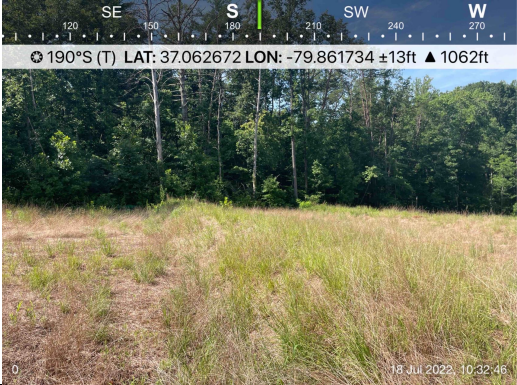
GPS Location	See photo		GPS Location	See photo	
Field Station#	14109+00		Field Station#	14109+00	
Pic 7 Desc.	Waterbars are functioning as intended		Pic 8 Desc.	End treatments are in good condition and functioning

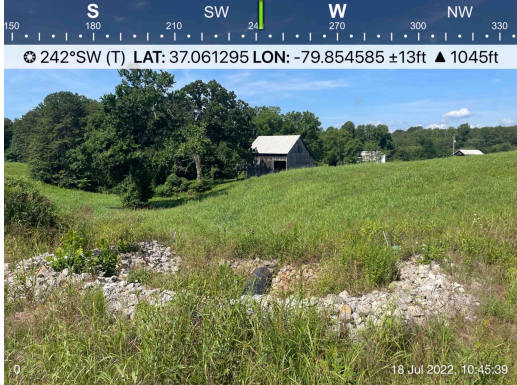
GPS Location	See photo		GPS Location	See photo	
Field Station#	14132+00		Field Station#	14141+62	
Pic 9 Desc.	CWDs are functioning as intended		Pic 10 Desc.	P1 is in good condition at all stream and wetland buffers

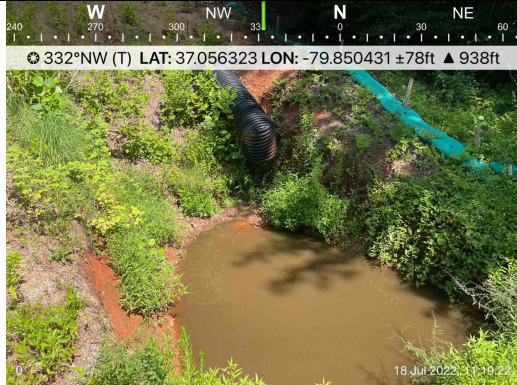
GPS Location	See photo		GPS Location	See photo	
Field Station#	14156+00		Field Station#	14171+36	
Pic 11 Desc.	Slope drain is in good condition and functioning		Pic 12 Desc.	SSF is in good condition.

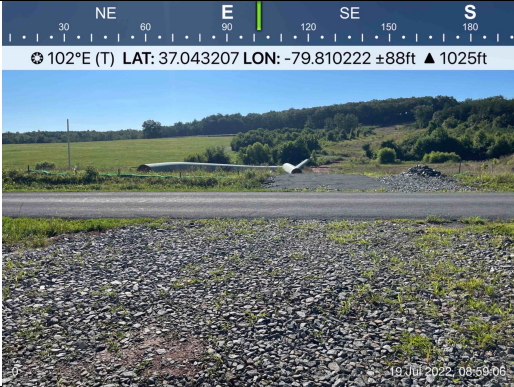
GPS Location	See photo		GPS Location	See photo	
Field Station#	14311+57		Field Station#	14309+00	
Pic 1 Desc.	RCEs are in good condition at all road crossings		Pic 2 Desc.	CWDs are functioning as intended

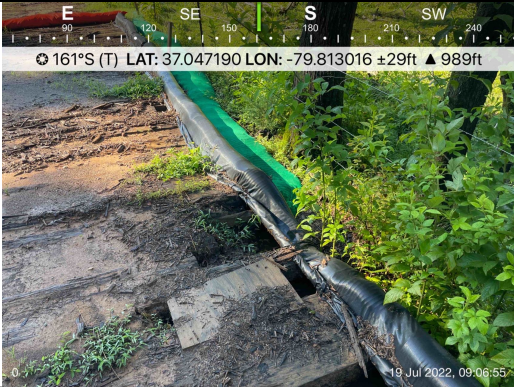
GPS Location	See photo		GPS Location	See photo	
Field Station#	14294+50		Field Station#	14279+08	
Pic 3 Desc.	Equipment bridge sideboard needs to be reattached		Pic 4 Desc.	Resource buffers remain well vegetated

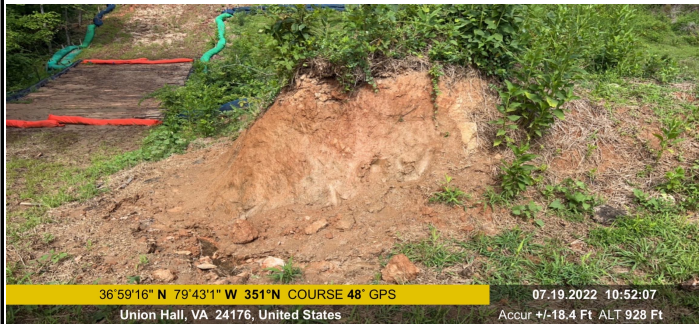
<div>36°59'16" N 79°43'21" W 351°N COURSE 48° GPS Union Hall, VA 24176, United States 07.19.2022 10:51:45 Accur +/-11.6 Ft ALT 924 Ft</div>			<div>36°59'16" N 79°43'1" W 351°N COURSE 48° GPS Union Hall, VA 24176, United States 07.19.2022 10:52:07 Accur +/-18.4 Ft ALT 928 Ft</div>		
GPS Location	1		GPS Location	2	
Field Station#	14673+10		Field Station#	14673+60	
Pic 1 Desc.	Routine maintenance. Remove sediment on equipment bridge at S-H37.		Pic 2 Desc.	Routine maintenance. Minor rill erosion occurring on slope GAS S-H37. Repair and stabilize disturbed area.

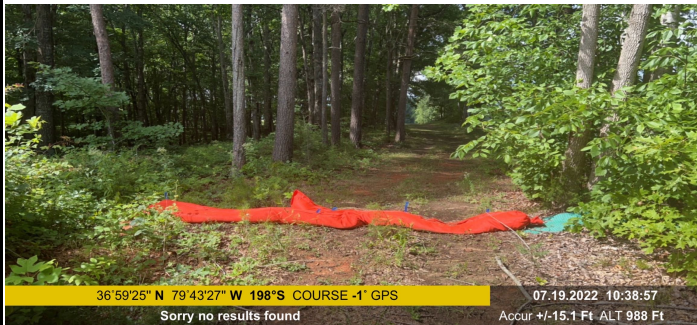
GPS Location	3		GPS Location	4	
Field Station#	14650+00		Field Station#	14654+00	
Pic 3 Desc.	Contractor replaced damaged perimeter CFS with wattles per punch list item.		Pic 4 Desc.	ROW stabilized and vegetated in final cleanup area.

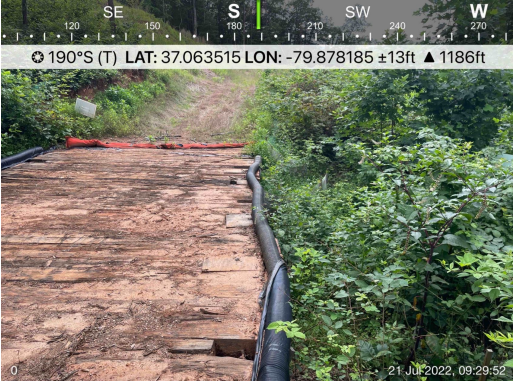
GPS Location	See photo		GPS Location	See photo	
Field Station#	14050+00		Field Station#	14045+71	
Pic 3 Desc.	Slope remains stabilized		Pic 4 Desc.	Equipment bridge fabric needs to be reattached

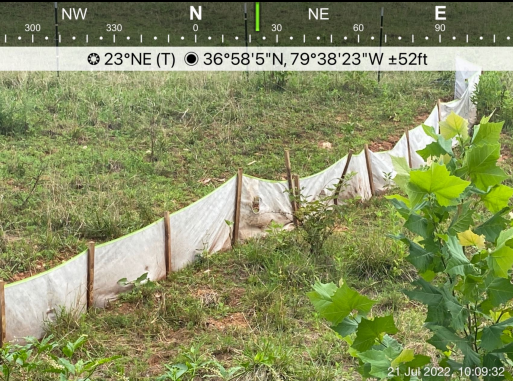
GPS Location	0	GPS Location	0		
Field Station#	14920+50	Field Station#	14925+00		
Pic 5 Desc.	Approximately 14920+50. Overview of ROW. Permanent vegetation. Livestock grazing area.		Pic 6 Desc.	Approximately 14925+00. P-1 requires maintenance. Damaged by livestock.

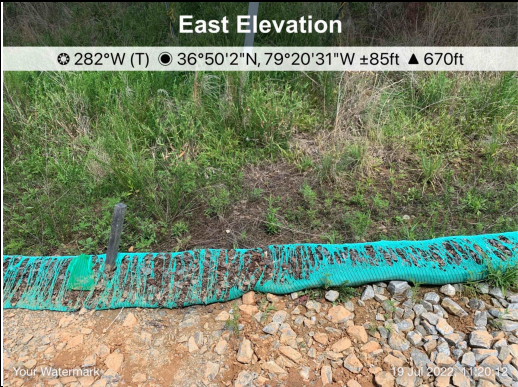
GPS Location	O	GPS Location			
Field Station#	00+00	Field Station#			
Pic 7 Desc.	Observing temporary stabilization and CFS that requires maintenance	Pic 8 Desc.			
Insert image here		Insert image here			
GPS Location		GPS Location			
Field Station#		Field Station#			
Pic 9 Desc.		Pic 10 Desc.			
Insert image here		Insert image here			
GPS Location		GPS Location			
Field Station#		Field Station#			
Pic 11 Desc.		Pic 12 Desc.
