Visual Site Inspection Report

Project Name	H-600 Pipeline Spread I	AFE	124300139	Spread	H-600 Pipeline Spread I
Contractor	Precision			Report #	40231
Inspector	Glenn Mike Renfro			Date/Time	7/25/2022 2:04 PM
Permit #	TBD	Inspection Type	VA SWPP	Station Begin	0000+00
State	VA	Inspection Area	Full	Station End	00000+00
County	Franklin	Ground	Dry	Temperature (°F)	87.00
Municipality	N/A	Weather	Cloudy	Rain Gauge (in)	0.00
				Rain Accumulation Time (days)	6.00

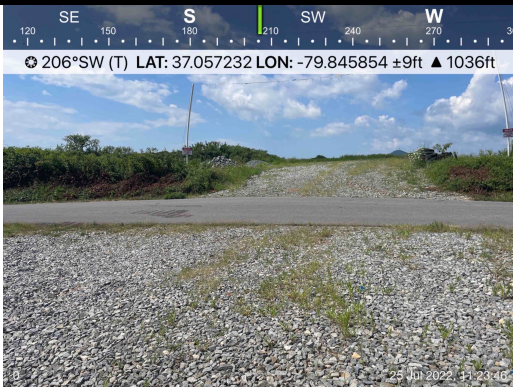
GPS Location	See photo		GPS Location	See photo	
Field Station#	14171+36		Field Station#	14180+00	
Pic 1 Desc.	RCEs are in good condition at all road crossings		Pic 2 Desc.	CWDs are functioning as intended

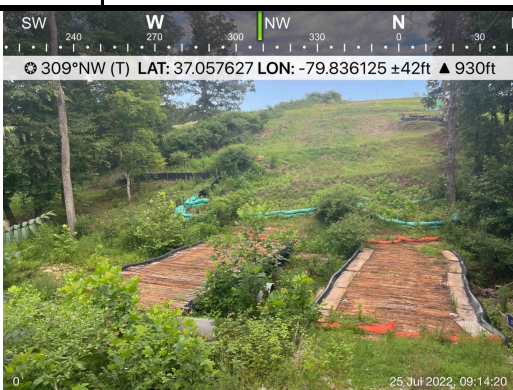
GPS Location	See photo		GPS Location	See photo	
Field Station#	14209+02		Field Station#	14214+00	
Pic 3 Desc.	Equipment bridge ECDs are in good condition and functioning		Pic 4 Desc.	SSF is in good condition

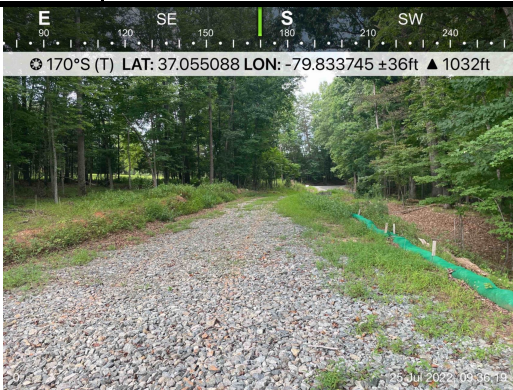
GPS Location	See photo		GPS Location	See photo	
Field Station#	14223+41		Field Station#	14232+00	
Pic 5 Desc.	MVP-FR-311 remains in good condition with controls in place		Pic 6 Desc.	Slope drain is functioning as intended

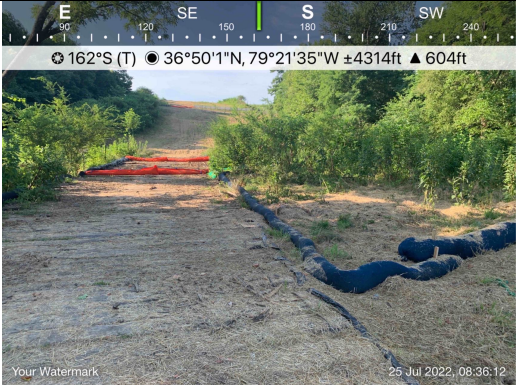
GPS Location	O	GPS Location	O		
Field Station#	15962+32	Field Station#	15965+00		
Pic 1 Desc.	Observing temporary stabilization,buffer, equipment crossing and ECD's	Pic 2 Desc.	Observing erosion that needs to be repaired (@water bar)

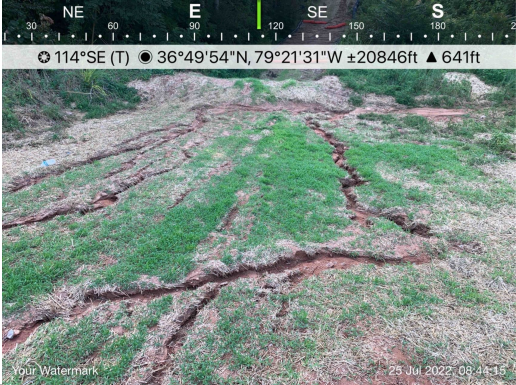
GPS Location	O	GPS Location	O		
Field Station#	15976+50	Field Station#	15976+50		
Pic 3 Desc.	Observing erosion that needs to be repaired	Pic 4 Desc.	Observing erosion that needs to be repaired

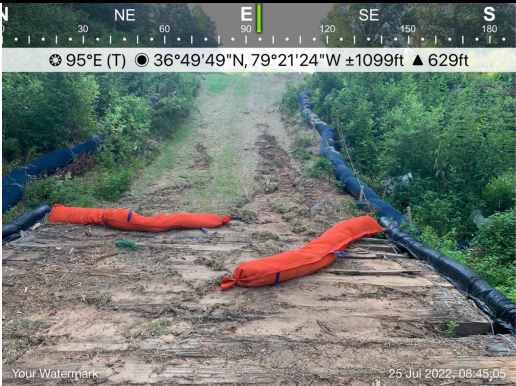
GPS Location	O	GPS Location	O		
Field Station#	15976+50	Field Station#	15978+50		
Pic 5 Desc.	Observing erosion that needs to be repaired and bridge cleaned	Pic 6 Desc.	Observing erosion that needs to be repaired

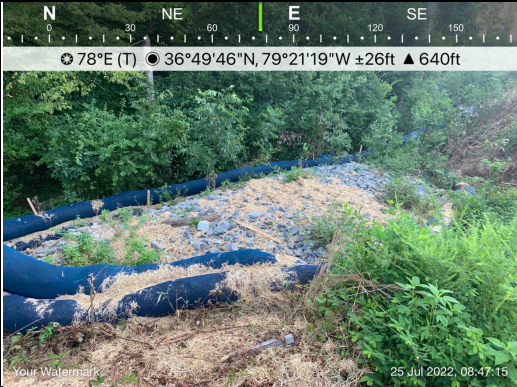
ert image here	
GPS Location	O		GPS Location	O	
Field Station#	15982+00		Field Station#	15986+00	
Pic 7 Desc.	Observing temporary stabilization,CWD outlet and ECD's		Pic 8 Desc.	Observing erosion that needs to be repaired (@water bar)

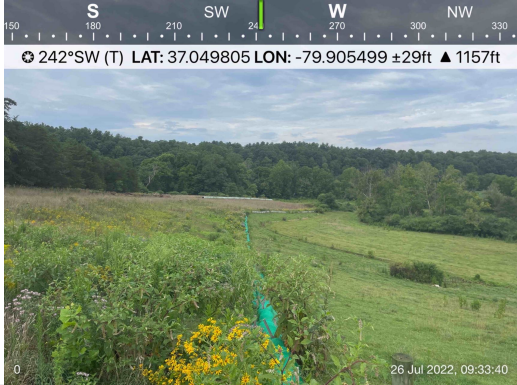
GPS Location	See photo		GPS Location	See photo	
Field Station#	13925+00		Field Station#	13939+50	
Pic 9 Desc.	CFS is in good condition throughout this section		Pic 10 Desc.	Travel lane needs additional stabilization

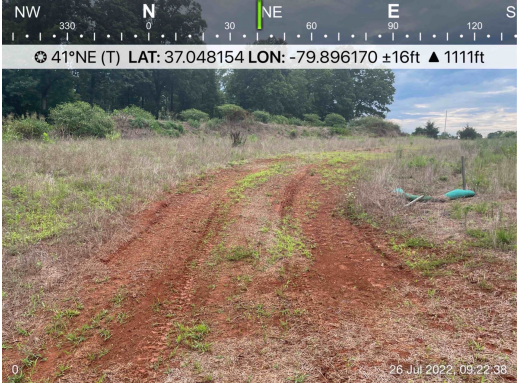
GPS Location	See photo	GPS Location			
Field Station#	13953+00	Field Station#			
Pic 13 Desc.	Travel lane needs additional stabilization.	Pic 14 Desc.			
Insert image here		Insert image here			
GPS Location		GPS Location			
Field Station#		Field Station#			
Pic 15 Desc.		Pic 16 Desc.			
Insert image here		Insert image here			
GPS Location		GPS Location			
Field Station#		Field Station#			
Pic 17 Desc.		Pic 18 Desc.

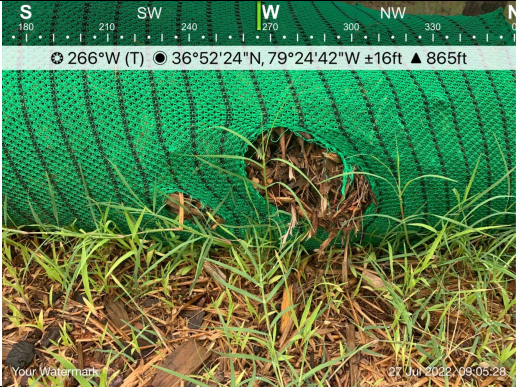
GPS Location	O	GPS Location	O		
Field Station#	15734+35	Field Station#	15734+35		
Pic 1 Desc.	Observing CFS that requires maintenance	Pic 2 Desc.	Observing CFS that requires maintenance

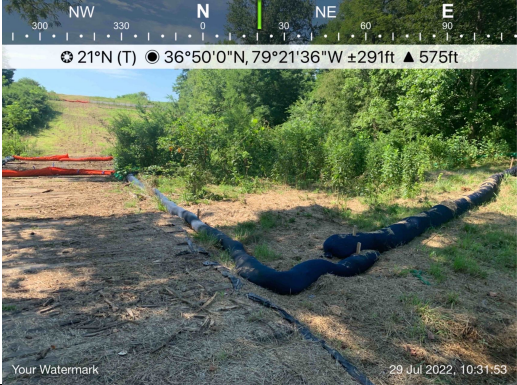
GPS Location	O	GPS Location	O		
Field Station#	15962+00	Field Station#	16024+00		
Pic 7 Desc.	Observing temporary stabilization,buffer, equipment crossing and ECD's	Pic 8 Desc.	Observing ruts that need to be repaired and restabilized
