# Visual Site Inspection Report

<b>Project Name</b>	H-600 Pipeline Spread I	<b>AFE</b>	124300139	<b>Spread</b>	H-600 Pipeline Spread I
<b>Contractor</b>	Precision			<b>Report #</b>	39476
<b>Inspector</b>	Ben Farmer			<b>Date/Time</b>	7/5/2022 1:26 PM
<b>Permit #</b>	TBD	<b>Inspection Type</b>	VA SWPP	<b>Station Begin</b>	13958+31
<b>State</b>	VA	<b>Inspection Area</b>	Partial	<b>Station End</b>	14062+17
<b>County</b>	Franklin	<b>Ground</b>	Dry	<b>Temperature (°F)</b>	75.00
<b>Municipality</b>	N/A	<b>Weather</b>	Sunny	<b>Rain Gauge (in)</b>	0.00
				<b>Rain Accumulation Time (days)</b>	0.00

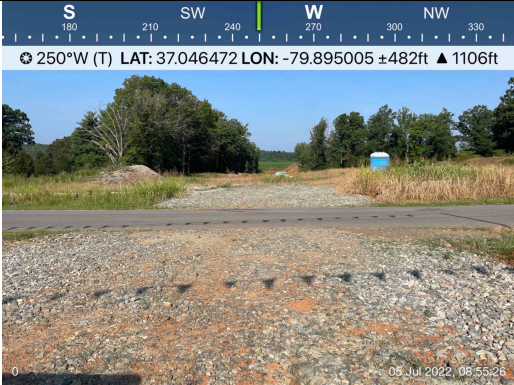
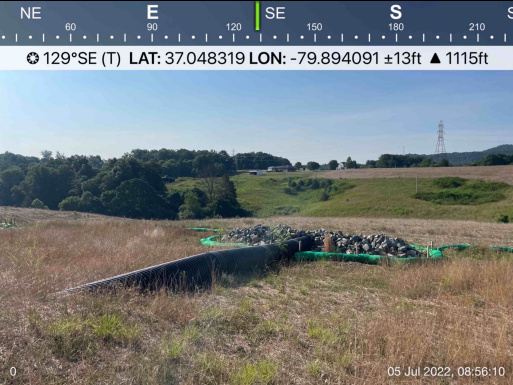
<b>GPS Location</b>	See photo	<b>GPS Location</b>	See photo		
<b>Field Station#</b>	13958+31	<b>Field Station#</b>	13960+00		
<b>Pic 1 Desc.</b>	RCEs are in good condition at all road crossings	<b>Pic 2 Desc.</b>	CWDs are functioning as intended

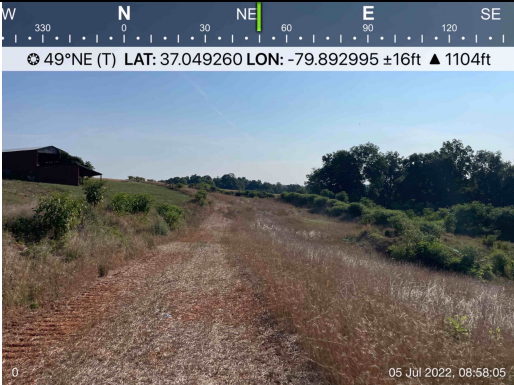
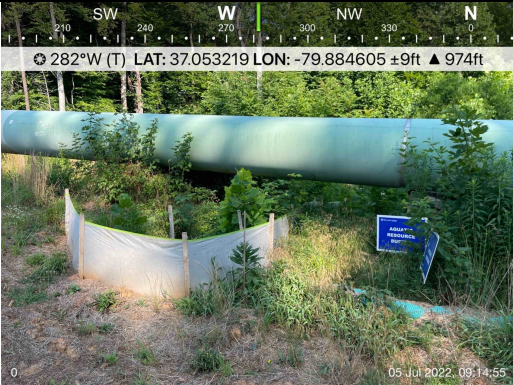
<b>GPS Location</b>	See photo	<b>GPS Location</b>	See photo		
<b>Field Station#</b>	13970+00	<b>Field Station#</b>	13997+50		
<b>Pic 3 Desc.</b>	Vegetation continues to fill in throughout this section	<b>Pic 4 Desc.</b>	P1 is in good condition at all stream and wetland buffers

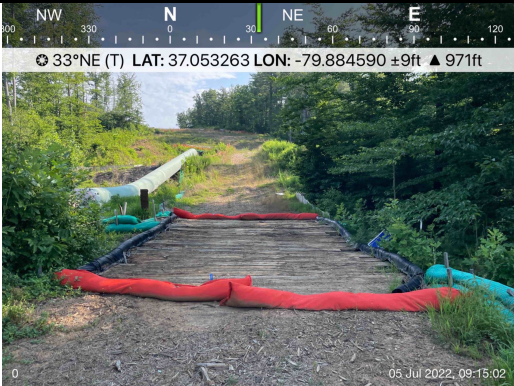
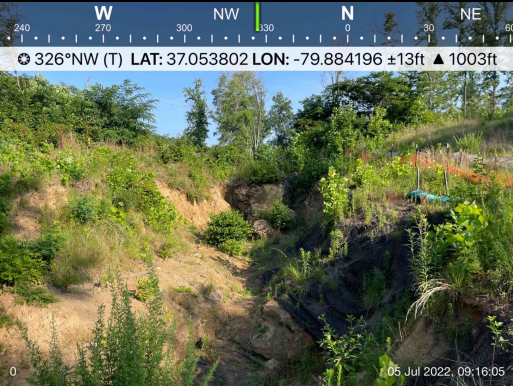
<b>GPS Location</b>	See photo	<b>GPS Location</b>	See photo		
<b>Field Station#</b>	13998+15	<b>Field Station#</b>	14000+00		
<b>Pic 5 Desc.</b>	Equipment bridge ECDs are functioning as intended	<b>Pic 6 Desc.</b>	No evidence of 3rd party pond discharging onto ROW

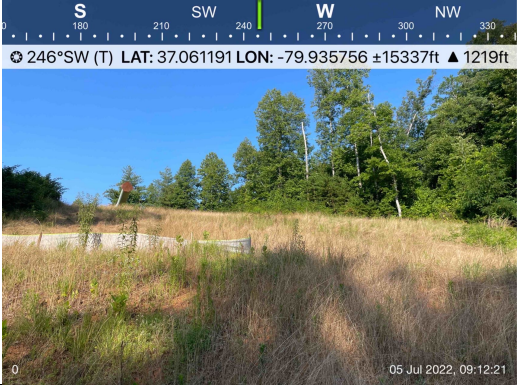
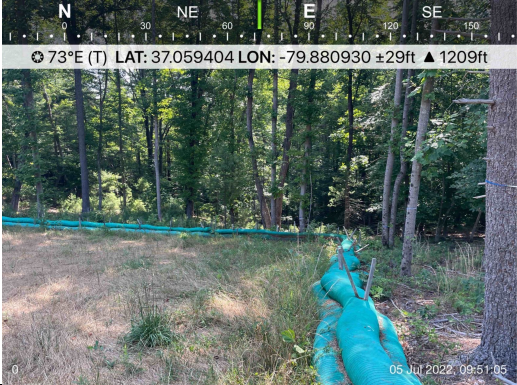
<b>GPS Location</b>	See photo	<b>GPS Location</b>	See photo		
<b>Field Station#</b>	14009+11	<b>Field Station#</b>	14027+00		
<b>Pic 7 Desc.</b>	Slope remains stabilized	<b>Pic 8 Desc.</b>	CFS is in good condition throughout this section

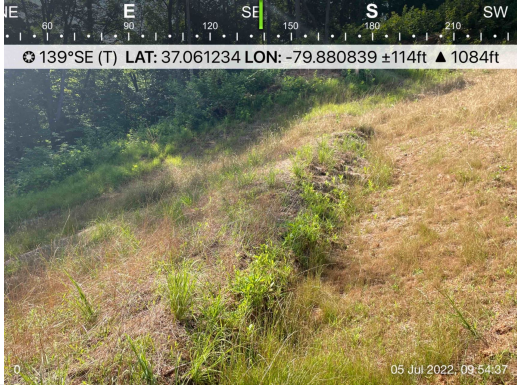
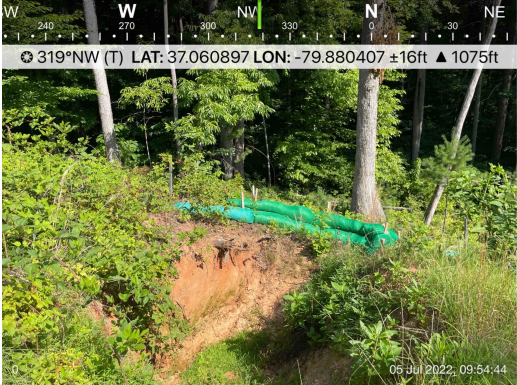
<b>GPS Location</b>	See photo	<b>GPS Location</b>	See photo		
<b>Field Station#</b>	14033+00	<b>Field Station#</b>	14033+00		
<b>Pic 9 Desc.</b>	Waterbars are in good condition	<b>Pic 10 Desc.</b>	End treatments are functioning as intended

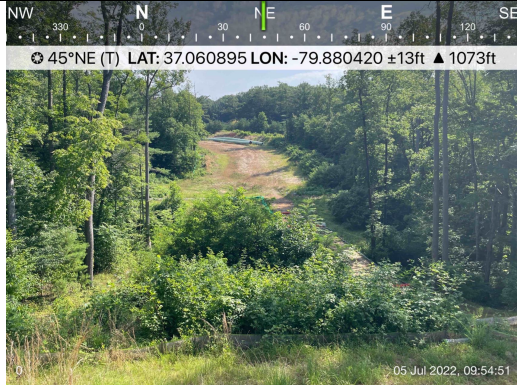
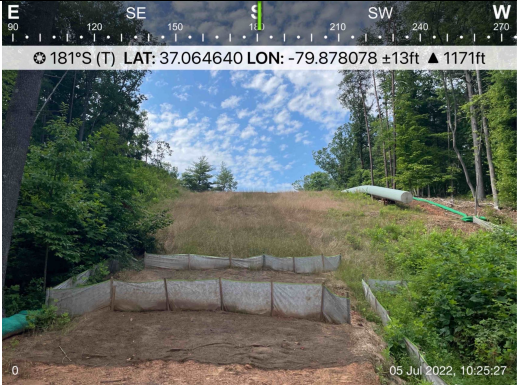
<b>GPS Location</b>	See photo	<b>GPS Location</b>	See photo		
<b>Field Station#</b>	14035+00	<b>Field Station#</b>	14050+00		
<b>Pic 11 Desc.</b>	Resource buffers remain well vegetated	<b>Pic 12 Desc.</b>	Slope remains stabilized with controls in place

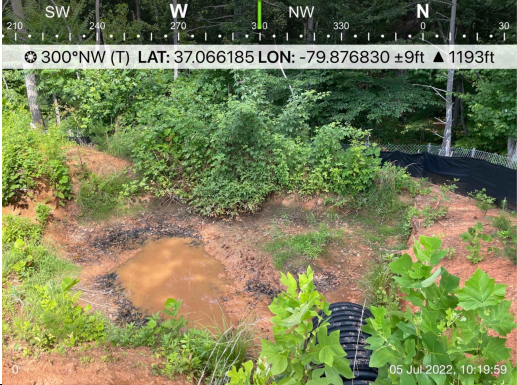
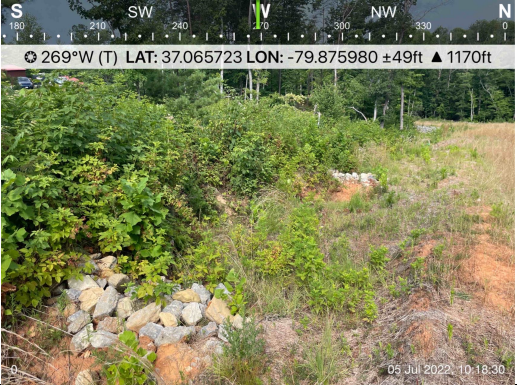
<b>GPS Location</b>	See photo		<b>GPS Location</b>	See photo	
<b>Field Station#</b>	14057+00		<b>Field Station#</b>	14060+00	
<b>Pic 13 Desc.</b>	Slope drain is functioning as intended		<b>Pic 14 Desc.</b>	Rock check dams are in good condition and functioning	
Insert image here			Insert image here		
<b>GPS Location</b>			<b>GPS Location</b>		
<b>Field Station#</b>			<b>Field Station#</b>		
<b>Pic 15 Desc.</b>			<b>Pic 16 Desc.</b>		
Insert image here			Insert image here		
<b>GPS Location</b>			<b>GPS Location</b>		
<b>Field Station#</b>			<b>Field Station#</b>		
<b>Pic 17 Desc.</b>			<b>Pic 18 Desc.</b>

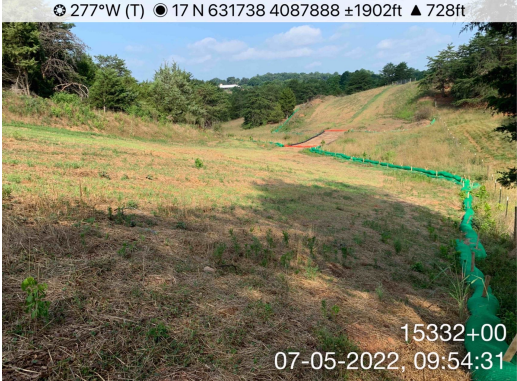
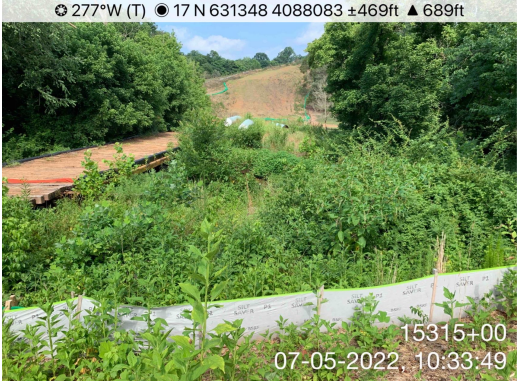
<b>GPS Location</b>	0	<b>GPS Location</b>	0		
<b>Field Station#</b>	15332+00	<b>Field Station#</b>	15315+00		
<b>Pic 7 Desc.</b>	Perimeter CFS and temporary vegetative stabilization in acceptable conditions		<b>Pic 8 Desc.</b>	P1 silt fence and sensitive resource buffer in acceptable conditions

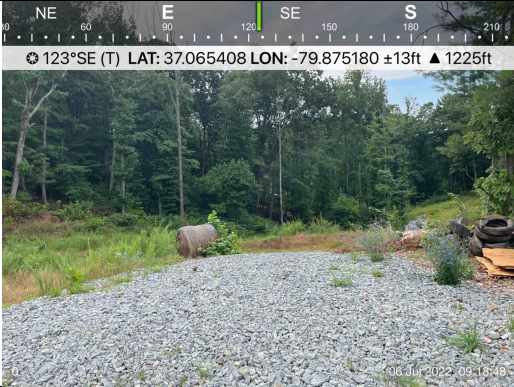
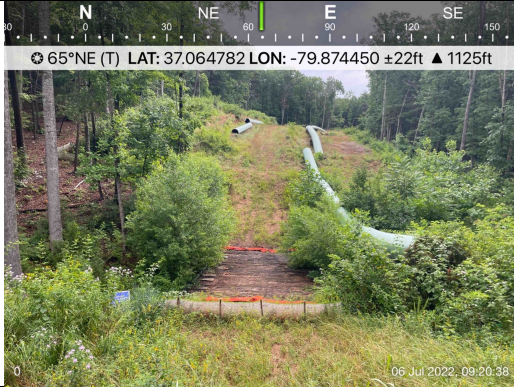
<b>GPS Location</b>	See photo		<b>GPS Location</b>	See photo	
<b>Field Station#</b>	14062+17		<b>Field Station#</b>	14066+77	
<b>Pic 1 Desc.</b>	RCEs are in good condition at all road crossings		<b>Pic 2 Desc.</b>	Equipment bridge ECDs are in good condition and functioning

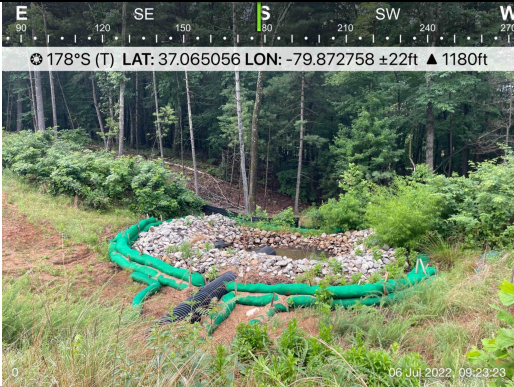
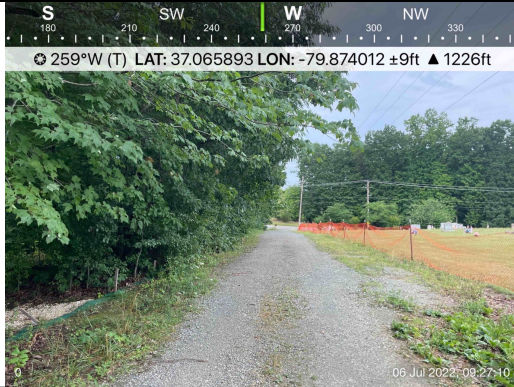
<b>GPS Location</b>	See photo		<b>GPS Location</b>	See photo	
<b>Field Station#</b>	14070+00		<b>Field Station#</b>	14081+46	
<b>Pic 3 Desc.</b>	CWDs are functioning as intended		<b>Pic 4 Desc.</b>	MVP-FR-309.05 is in good condition with controls in place

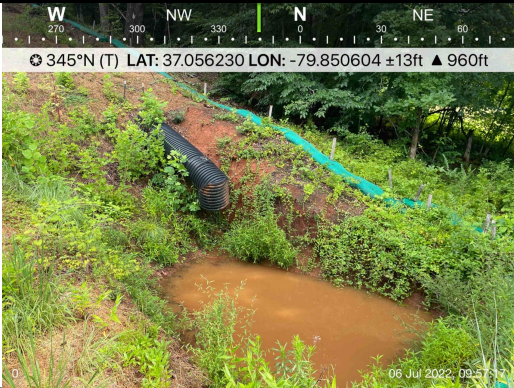
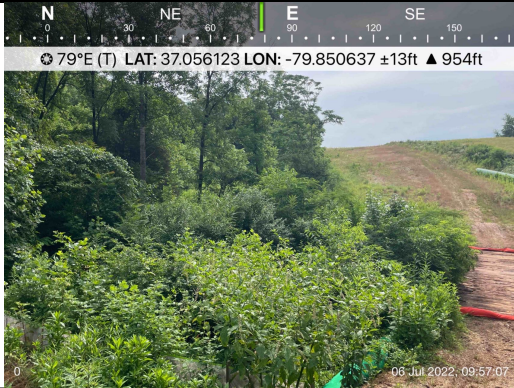
<b>GPS Location</b>	See photo		<b>GPS Location</b>	See photo	
<b>Field Station#</b>	14156+00		<b>Field Station#</b>	14157+55	
<b>Pic 5 Desc.</b>	Slope drain is in good condition and functioning		<b>Pic 6 Desc.</b>	Resource buffers remain well vegetated

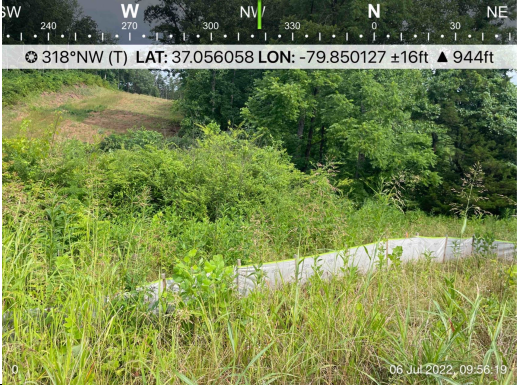
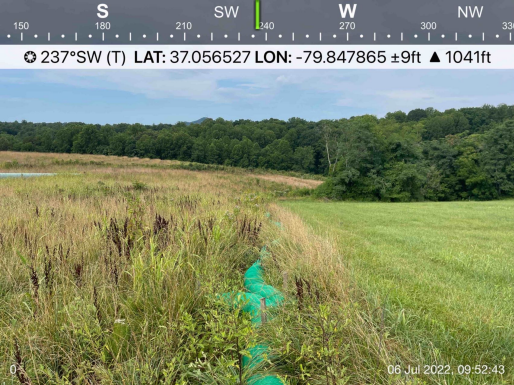
<b>GPS Location</b>	See photo		<b>GPS Location</b>	See photo	
<b>Field Station#</b>	14158+00		<b>Field Station#</b>	14165+00	
<b>Pic 7 Desc.</b>	P1 is in good condition at all stream and wetland buffers		<b>Pic 8 Desc.</b>	CFS is in good condition throughout this section	
 				Insert image here	
<b>GPS Location</b>	See photo		<b>GPS Location</b>		
<b>Field Station#</b>	14168+00		<b>Field Station#</b>		
<b>Pic 9 Desc.</b>	Topsoil berms remain stabilized		<b>Pic 10 Desc.</b>		
Insert image here			Insert image here		
<b>GPS Location</b>			<b>GPS Location</b>		
<b>Field Station#</b>			<b>Field Station#</b>		
<b>Pic 11 Desc.</b>			<b>Pic 12 Desc.</b>

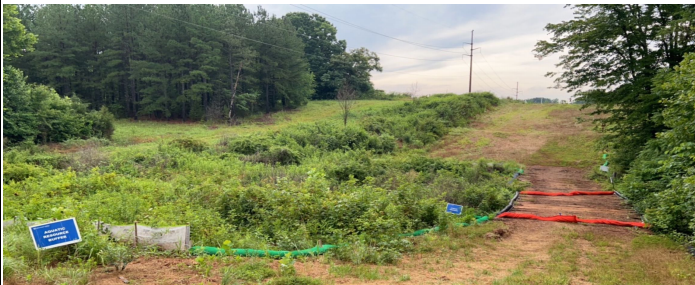
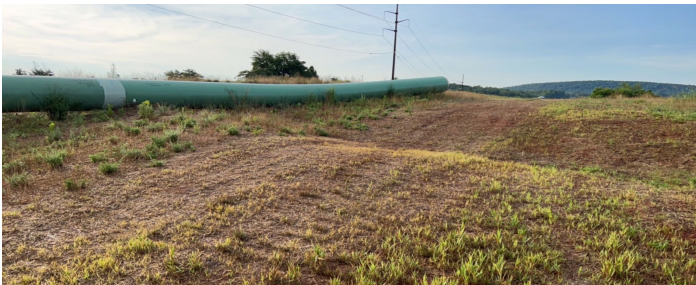
<b>Field Station#</b>	14568+10	<b>Field Station#</b>	14595+00		
<b>Pic 3 Desc.</b>	Equipment bridge and surrounding ECDs in place and functional; signage visible and intact.	<b>Pic 4 Desc.</b>	Water bars performing intended functions.

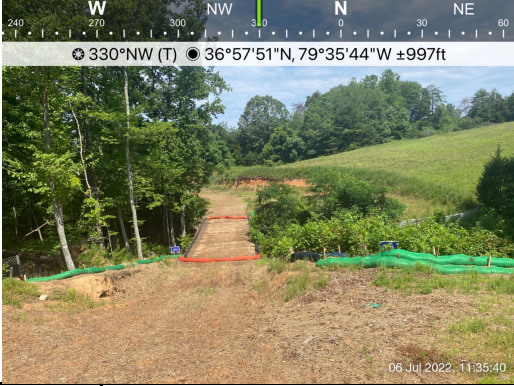
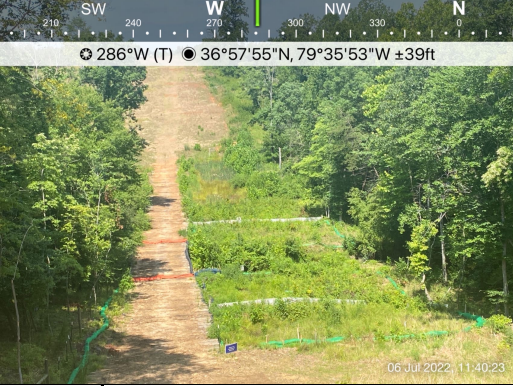
<b>GPS Location</b>	0	<b>GPS Location</b>	0		
<b>Field Station#</b>	15055+80	<b>Field Station#</b>	15044+90		
<b>Pic 1 Desc.</b>	Approximately 15055+80. Overview of stream crossing, equipment bridge and ECDs at stream S-D2-EPH.		<b>Pic 2 Desc.</b>	Approximately 15044+90. Overview of stream crossing, equipment bridge and ECDs at stream S-D2.

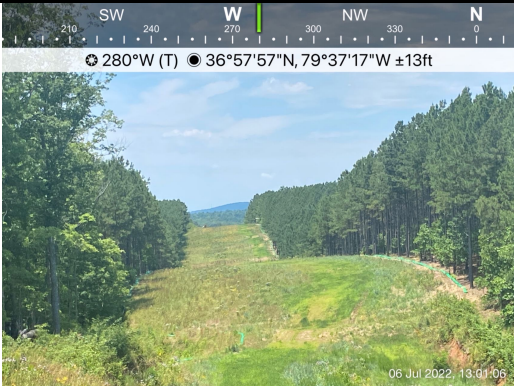
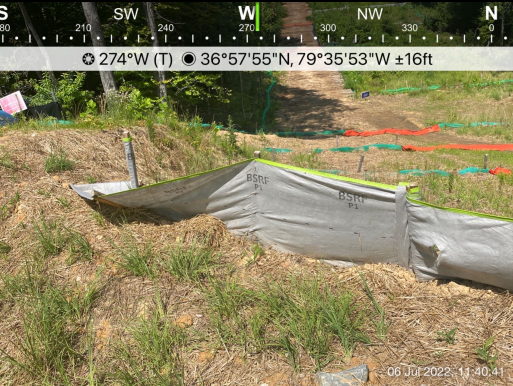
<b>GPS Location</b>	0	<b>GPS Location</b>	0		
<b>Field Station#</b>	14968+00	<b>Field Station#</b>	15047+50		
<b>Pic 5 Desc.</b>	Approximately 14968+00. Overview of ROW. Permanent vegetation.		<b>Pic 6 Desc.</b>	Approximately 15047+50. P-1 requires maintenance. Damaged by livestock/wildlife.

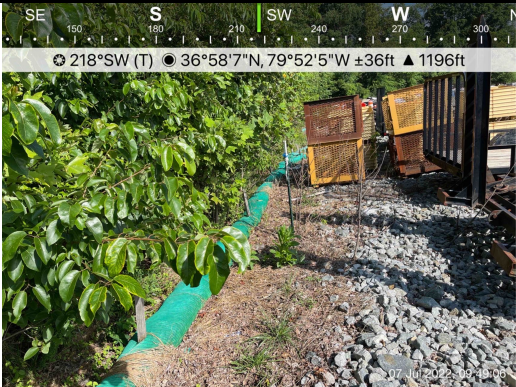
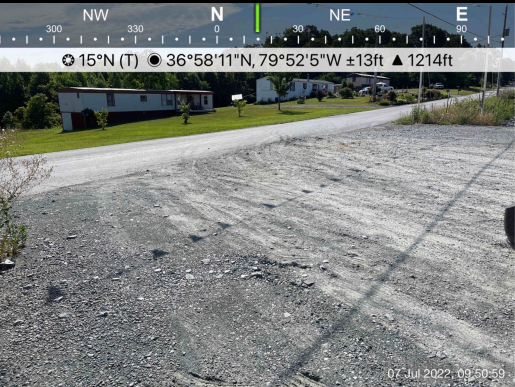
GPS Location	See picture		GPS Location	See picture	
Field Station#	0000+00		Field Station#	0000+00	
Pic 1 Desc.	Perimeter ECD's on west side of LY-045 near employee parking area in good condition.		Pic 2 Desc.	RCE at LY-045 in good condition.

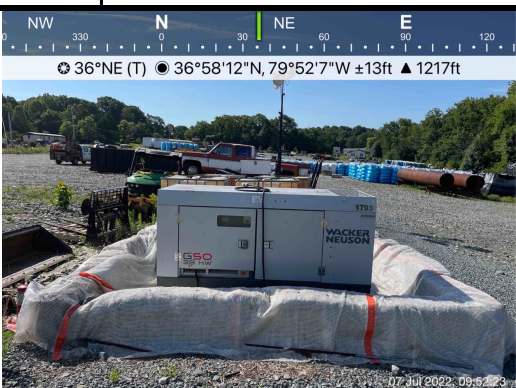
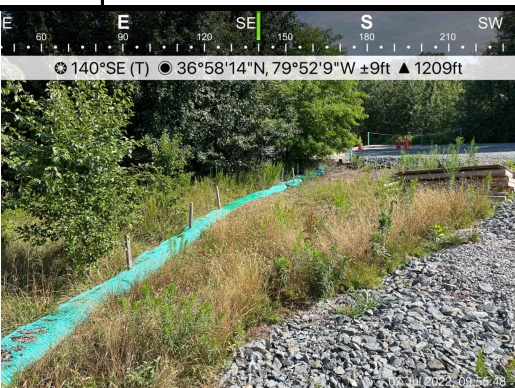
GPS Location	See picture		GPS Location	See picture	
Field Station#	0000+00		Field Station#	0000+00	
Pic 3 Desc.	Secondary containment structure on south end of tent at LY-045 in good condition.		Pic 4 Desc.	Perimeter ECD's on north end of LY-045 in good condition.

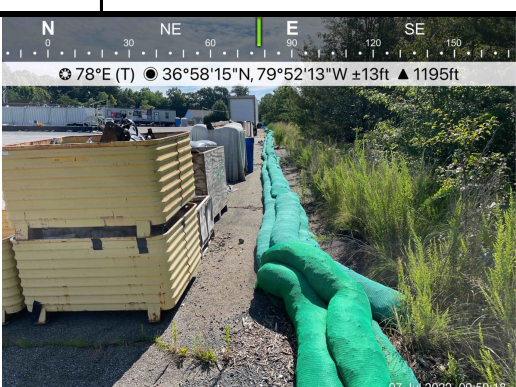
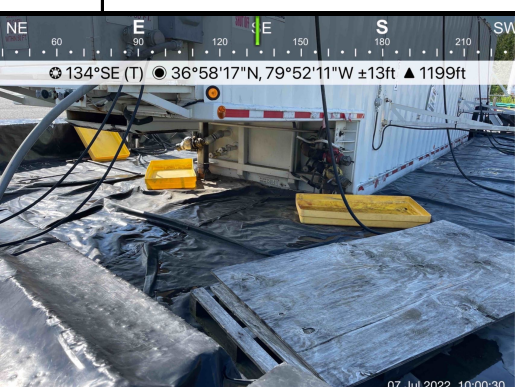
GPS Location	See picture		GPS Location	See picture	
Field Station#	0000+00		Field Station#	0000+00	
Pic 5 Desc.	Perimeter ECD's on south end of LY-046 in good condition.		Pic 6 Desc.	Secondary containment structure for fuel cell at LY-046 in good condition.

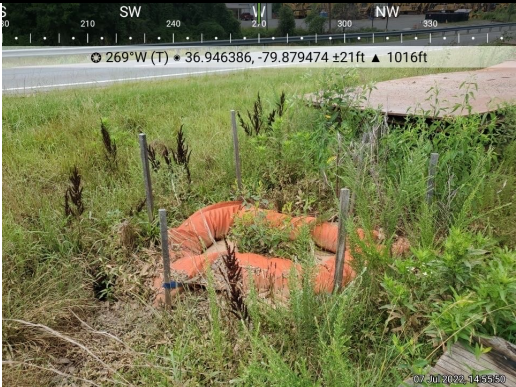
GPS Location	0	GPS Location	0		
Field Station#	0+00	Field Station#	0+00		
Pic 1 Desc.	LY-033 Stormwater drain inlet protection		Pic 2 Desc.	LY-032 Secondary containment

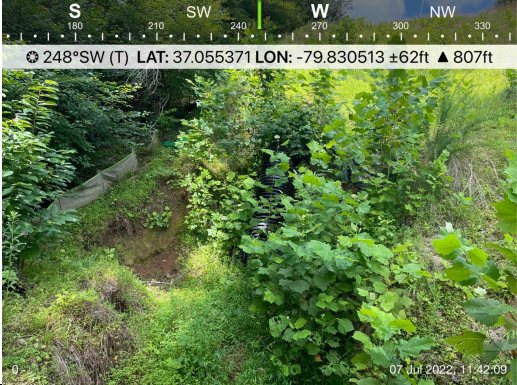
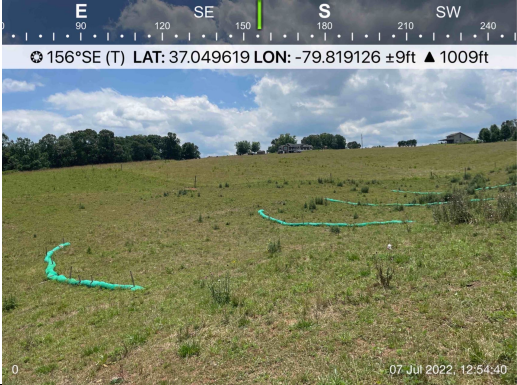
<b>GPS Location</b>	See photo		<b>GPS Location</b>	See photo	
<b>Field Station#</b>	14232+00		<b>Field Station#</b>	14273+00	
<b>Pic 7 Desc.</b>	Slope drain is functioning as intended		<b>Pic 8 Desc.</b>	CFS is in good condition throughout this section

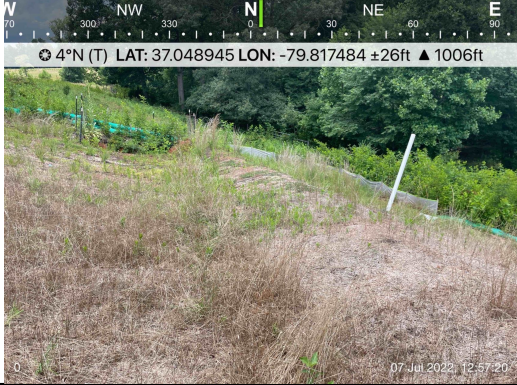
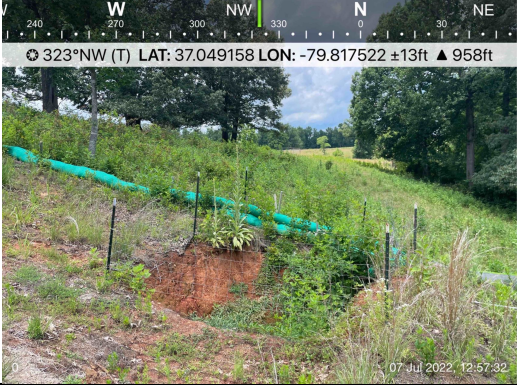
<b>GPS Location</b>	See photo		<b>GPS Location</b>	See photo	
<b>Field Station#</b>	14277+00		<b>Field Station#</b>	14277+00	
<b>Pic 9 Desc.</b>	Waterbars are in good condition		<b>Pic 10 Desc.</b>	End treatments are functioning as intended

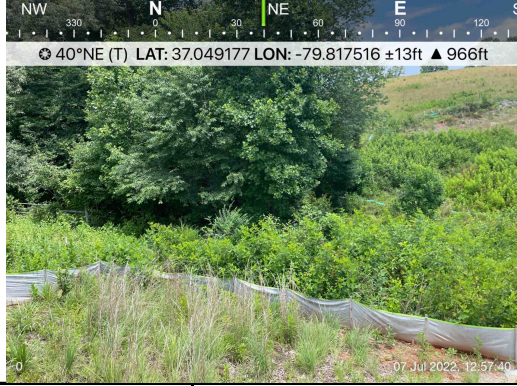
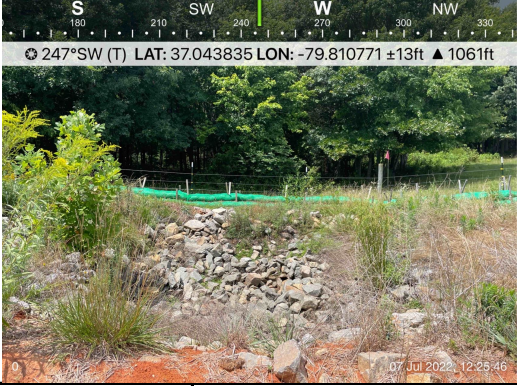
<b>GPS Location</b>	See photo		<b>GPS Location</b>	See photo	
<b>Field Station#</b>	14278+50		<b>Field Station#</b>	14305+00	
<b>Pic 11 Desc.</b>	P1 is in good condition at all stream and wetland buffers		<b>Pic 12 Desc.</b>	CWDs are functioning as intended

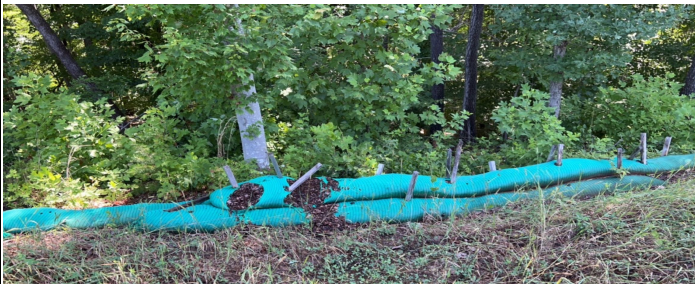
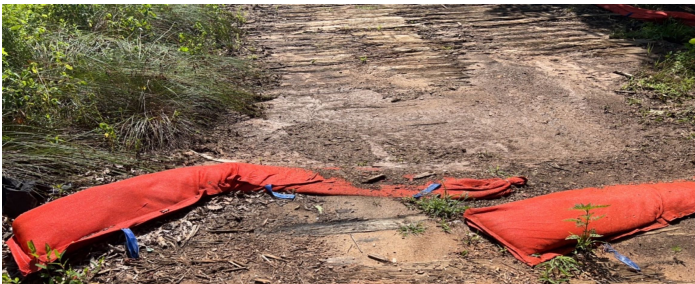
36°59'25" N 79°43'24" W 81°E COURSE 195° GPS Sorry no results found 07.07.2022 10:26:09 Accur +/-15.4 Ft ALT 992 Ft			36°59'21" N 79°43'19" W 117°SE COURSE 96° GPS Sorry no results found 07.07.2022 10:29:10 Accur +/-15.4 Ft ALT 942 Ft		
<b>GPS Location</b>	1	<b>GPS Location</b>	2		
<b>Field Station#</b>	14652+00	<b>Field Station#</b>	14656+87		
<b>Pic 1 Desc.</b>	Routine maintenance. Repair/replace damaged perimeter CFS.		<b>Pic 2 Desc.</b>	Routine maintenance. Replace all bridge wattles at S-H38.

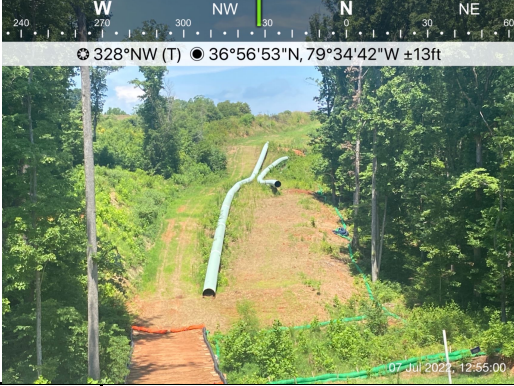
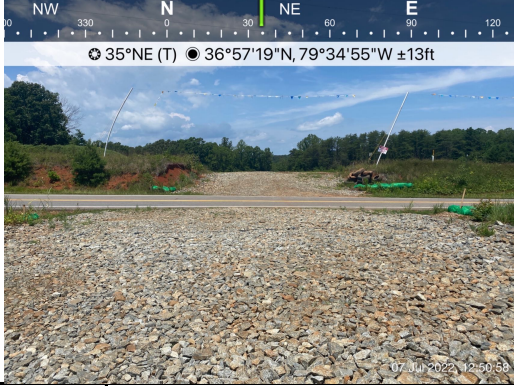
<b>GPS Location</b>	0	<b>GPS Location</b>	0		
<b>Field Station#</b>	15138+00	<b>Field Station#</b>	15113+50		
<b>Pic 1 Desc.</b>	Approximately 15138+00. Overview of ROW.	<b>Pic 2 Desc.</b>	Approximately 15113+50. Overview of road crossing and RCEs.

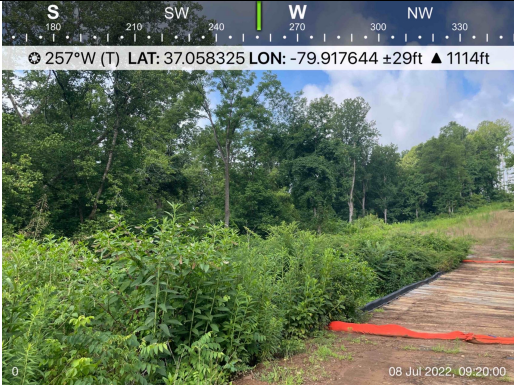
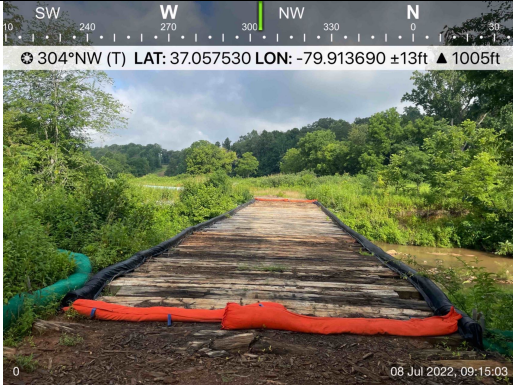
<b>GPS Location</b>	See photo		<b>GPS Location</b>	See photo	
<b>Field Station#</b>	13863+00		<b>Field Station#</b>	13875+73	
<b>Pic 1 Desc.</b>	Resource buffers remain well vegetated		<b>Pic 2 Desc.</b>	Equipment bridge ECDs are functioning as intended

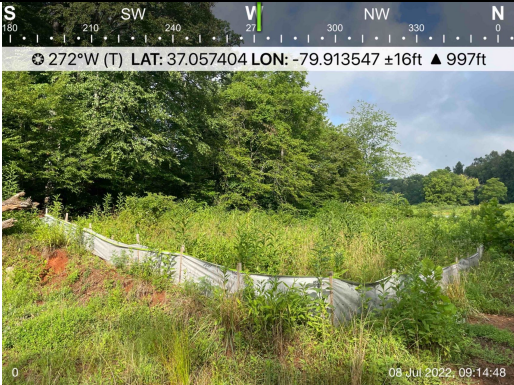
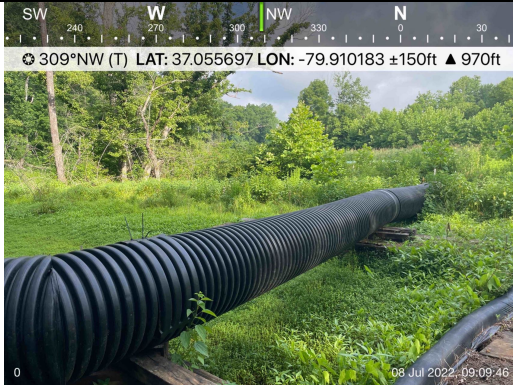
<b>GPS Location</b>	See photo		<b>GPS Location</b>	See photo	
<b>Field Station#</b>	13876+00		<b>Field Station#</b>	13888+00	
<b>Pic 3 Desc.</b>	P1 is in good condition at all stream and wetland buffers		<b>Pic 4 Desc.</b>	Slope drain is in good condition and functioning

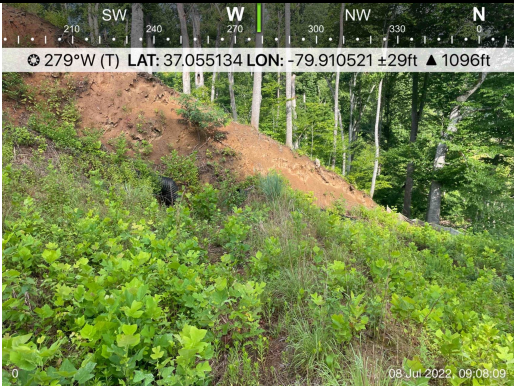
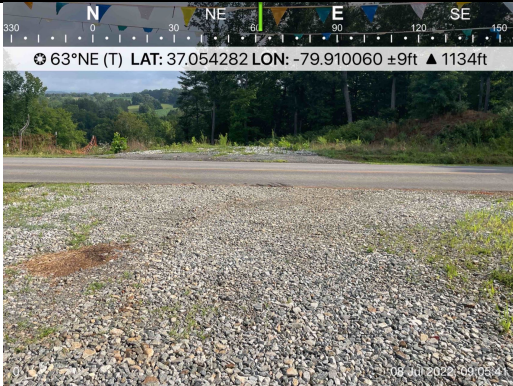
<b>GPS Location</b>	See photo		<b>GPS Location</b>	See photo	
<b>Field Station#</b>	13890+00		<b>Field Station#</b>	13892+45	
<b>Pic 5 Desc.</b>	Waterbars are in good condition		<b>Pic 6 Desc.</b>	RCEs are in good condition at all road crossings

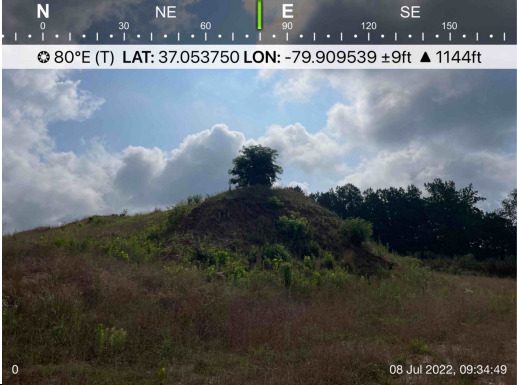
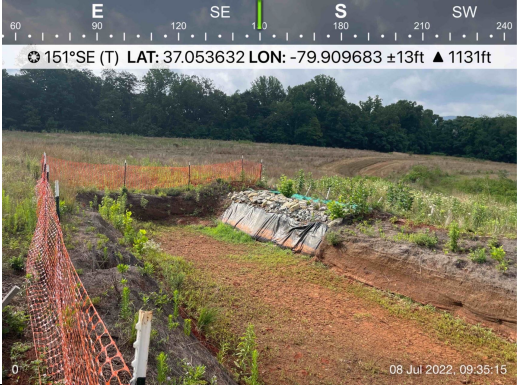
<b>GPS Location</b>	See photo		<b>GPS Location</b>	See photo	
<b>Field Station#</b>	13897+00		<b>Field Station#</b>	13897+00	
<b>Pic 7 Desc.</b>	Topsoil berms remain stabilized		<b>Pic 8 Desc.</b>	Sediment trap is functioning as intended

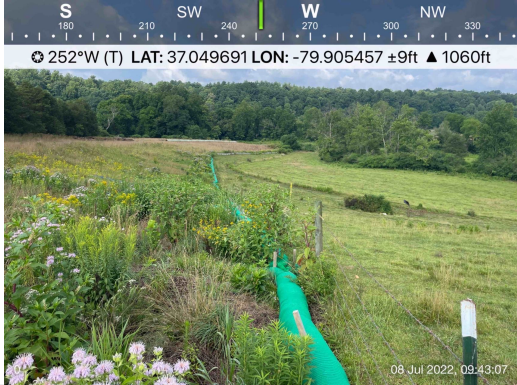
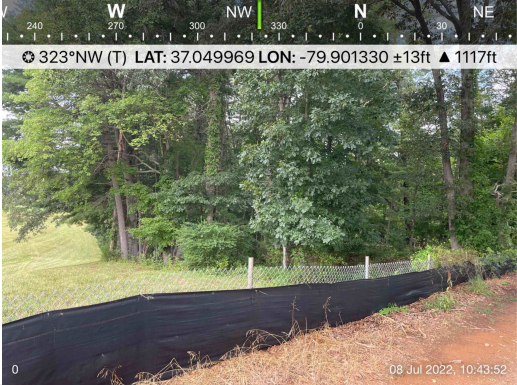
<b>GPS Location</b>	See photo		<b>GPS Location</b>	See photo	
<b>Field Station#</b>	13925+00		<b>Field Station#</b>	13939+50	
<b>Pic 9 Desc.</b>	CFS is in good condition throughout this section		<b>Pic 10 Desc.</b>	SSF is in good condition

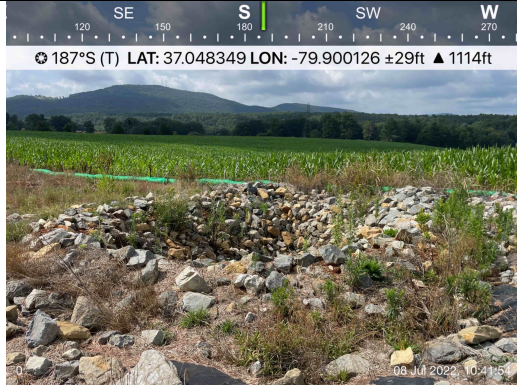
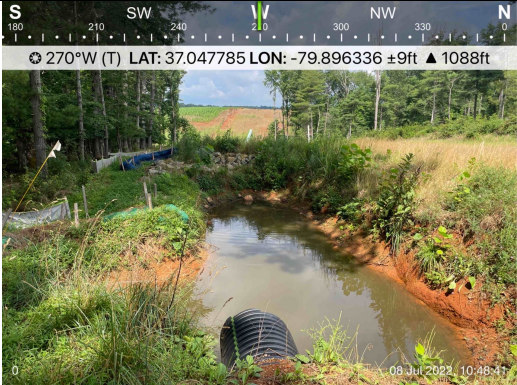
<b>GPS Location</b>	See photo		<b>GPS Location</b>	See photo	
<b>Field Station#</b>	13942+00		<b>Field Station#</b>	13953+00	
<b>Pic 11 Desc.</b>	CWDs are in good condition and functioning		<b>Pic 12 Desc.</b>	Slope drain outlet is functioning as intended.

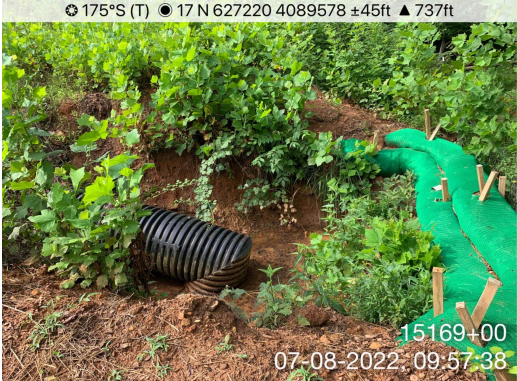
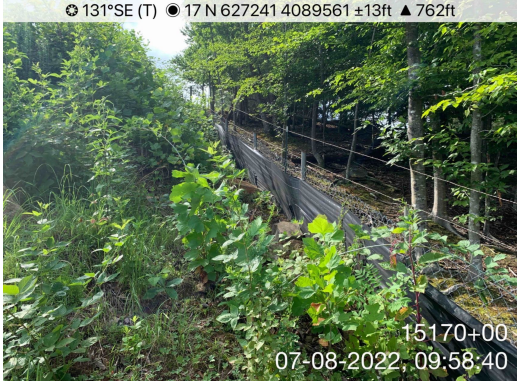
<b>GPS Location</b>	0	<b>GPS Location</b>	0		
<b>Field Station#</b>	15169+00	<b>Field Station#</b>	15170+00		
<b>Pic 7 Desc.</b>	Slope drain pipe and sump pit in acceptable conditions		<b>Pic 8 Desc.</b>	Super silt fence in acceptable condition
