## Baseline Assessment – Stream Attributes

### Reach S-MN11-Downstream/Upstream (Temporary Access Road) Ephemeral Spread G Giles County, Virginia

## Spread G Stream S-MN11-Downstream/Upstream (Temporary AR) Giles County

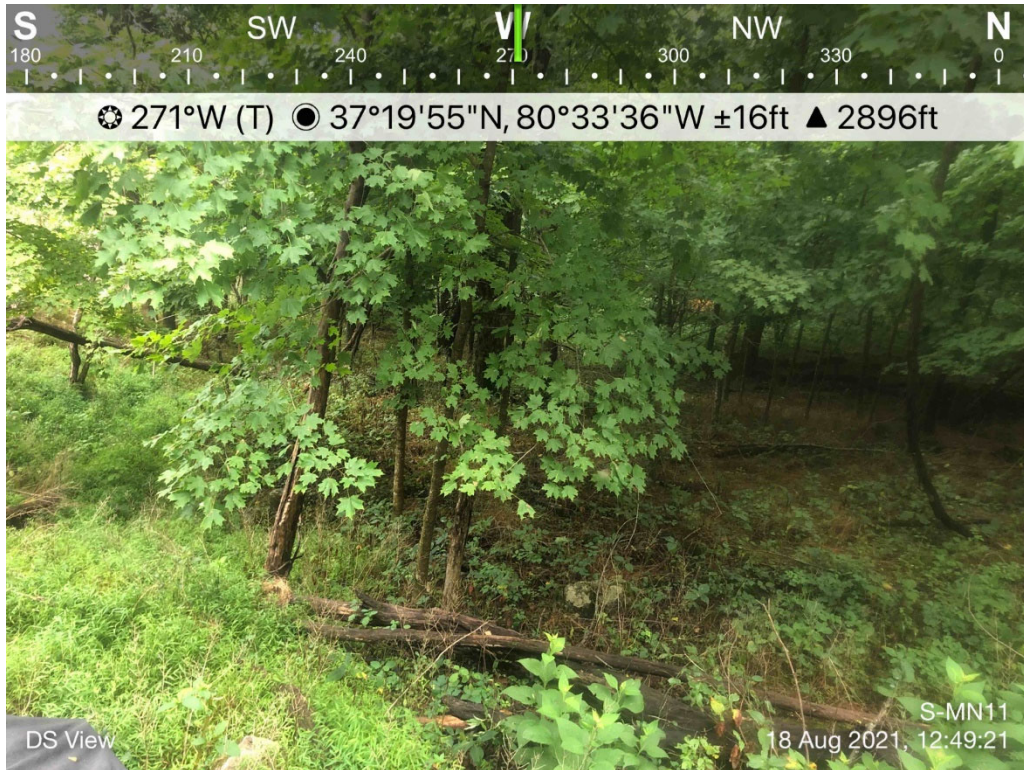
Photo Type: DS View

Location, Orientation, Photographer Initials: Upstream at LOD looking SW downstream, KB

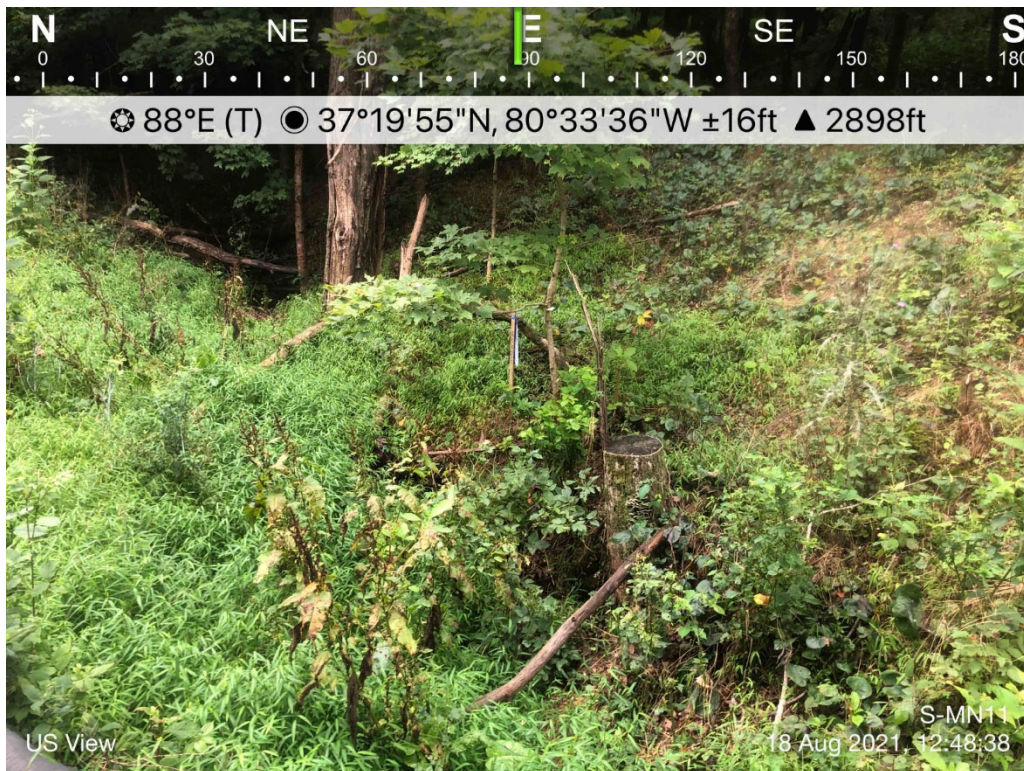
Photo Type: US View

Location, Orientation, Photographer Initials: Downstream at LOD looking E upstream, KB

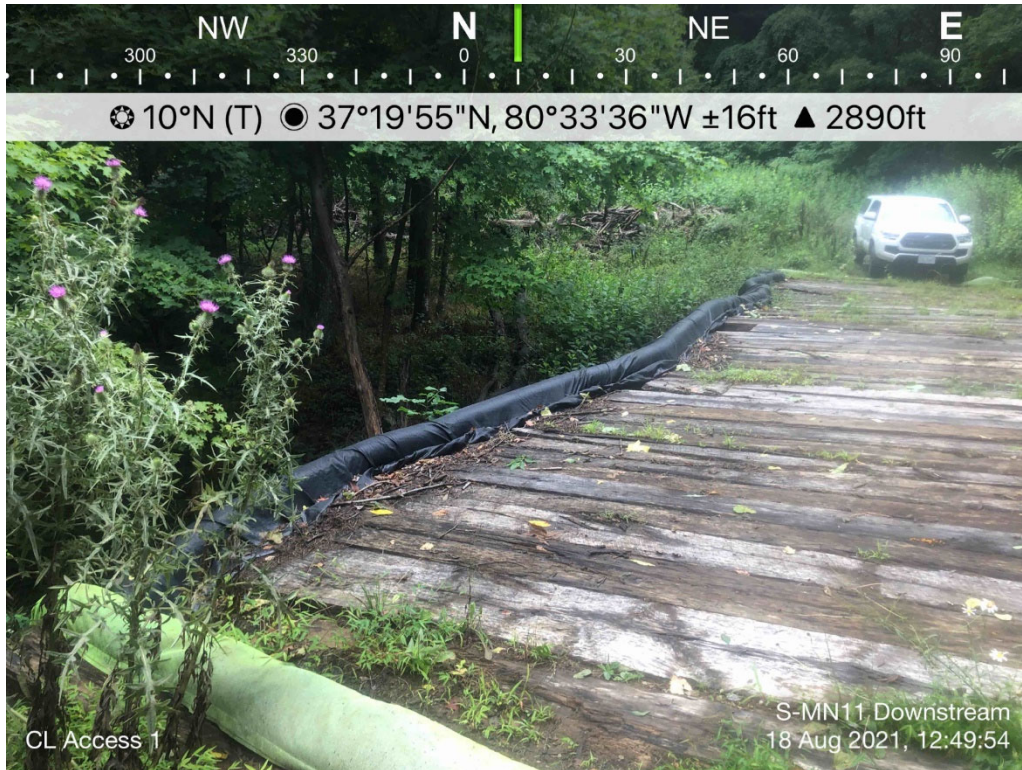
Photo Type: CL ACCESS 1  
Location, Orientation, Photographer Initials: Standing in Access Road looking N, KB

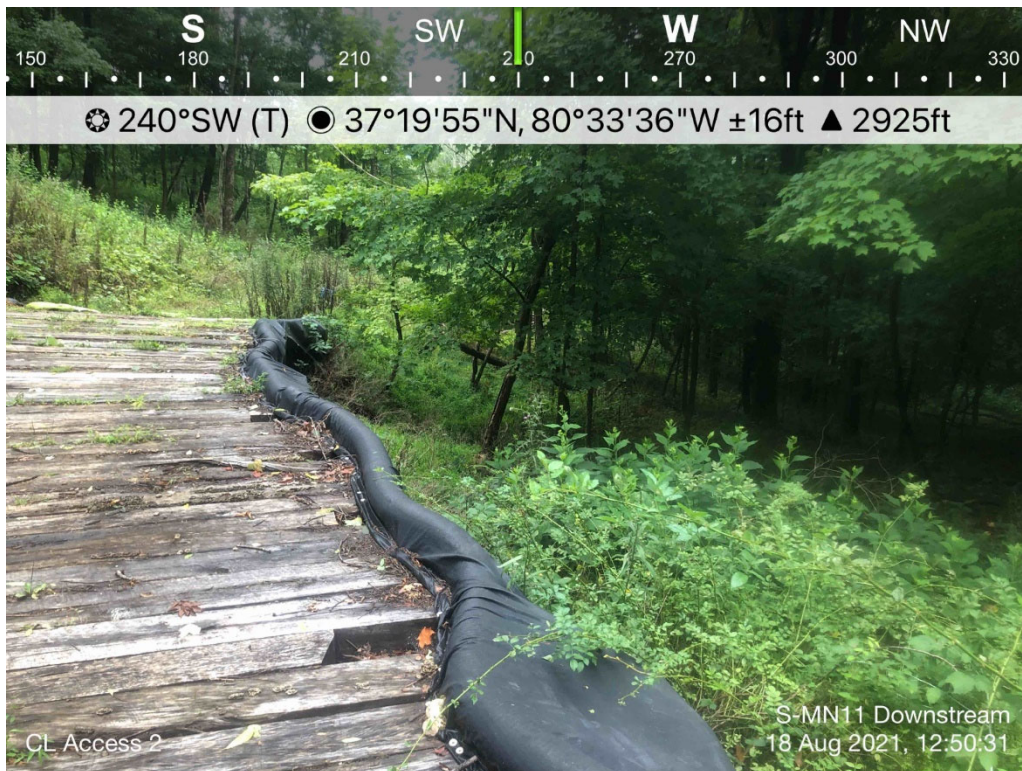
Photo Type: CL ACCESS 2  
Location, Orientation, Photographer Initials: Standing in Access Road looking SW, KB

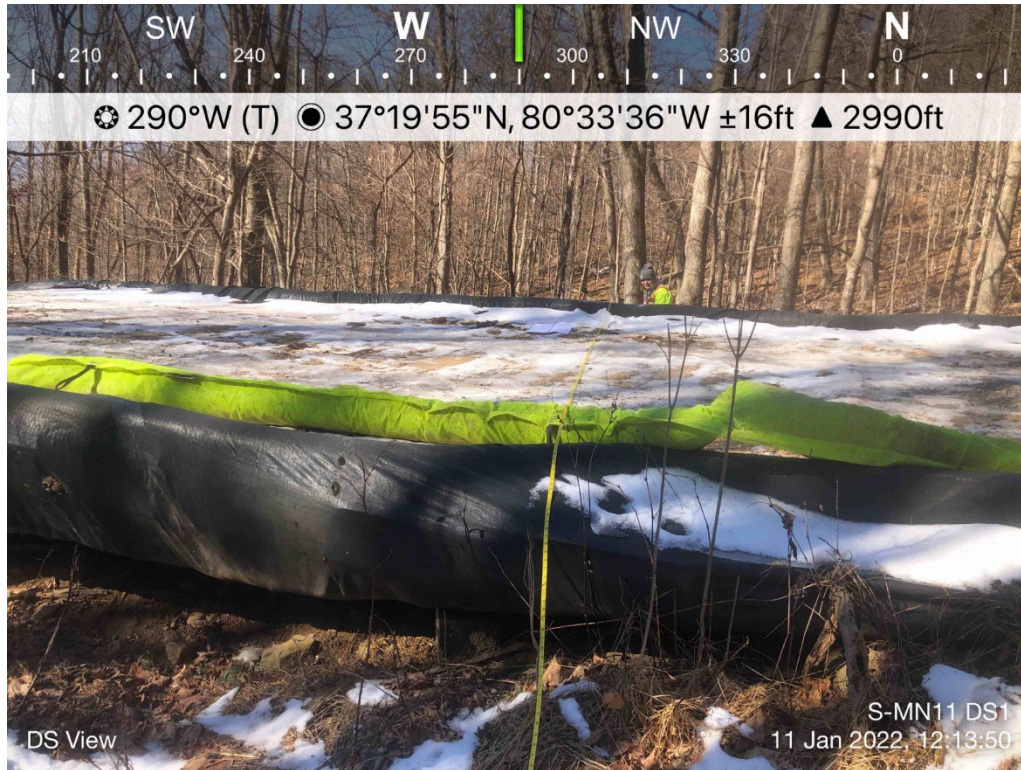
Photo Type: DS VIEW

Location, Orientation, Photographer Initials: Downstream view of LOC looking W/NW, KB

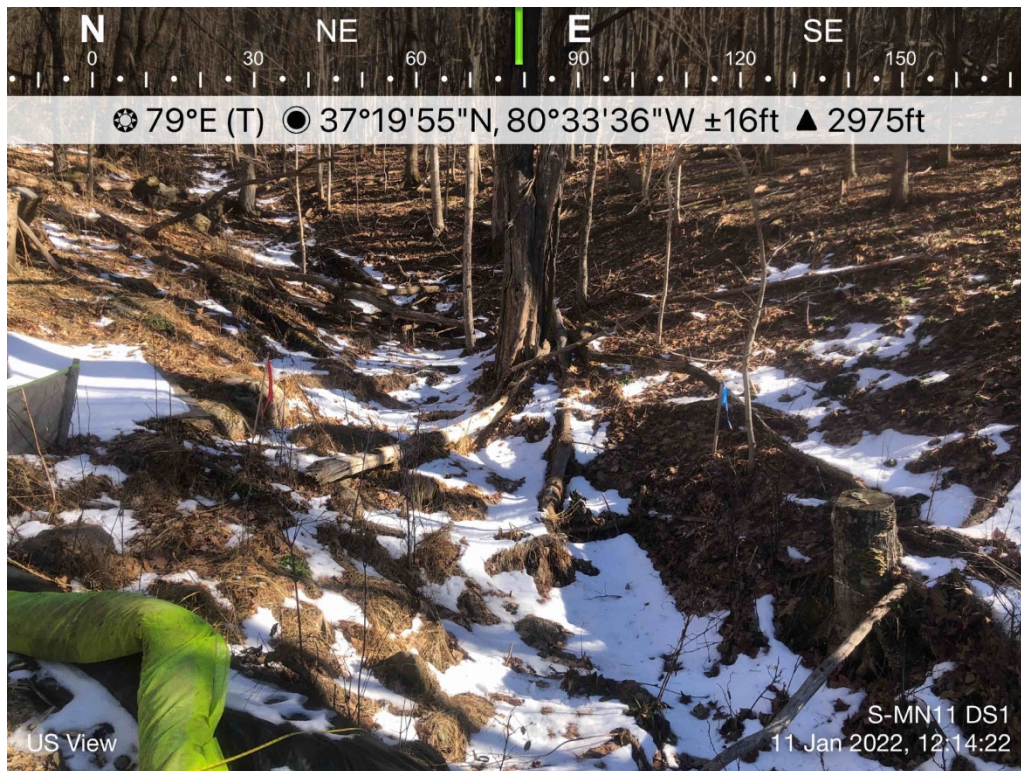
Photo Type: US VIEW

Location, Orientation, Photographer Initials: Upstream view of LOC looking E, KB

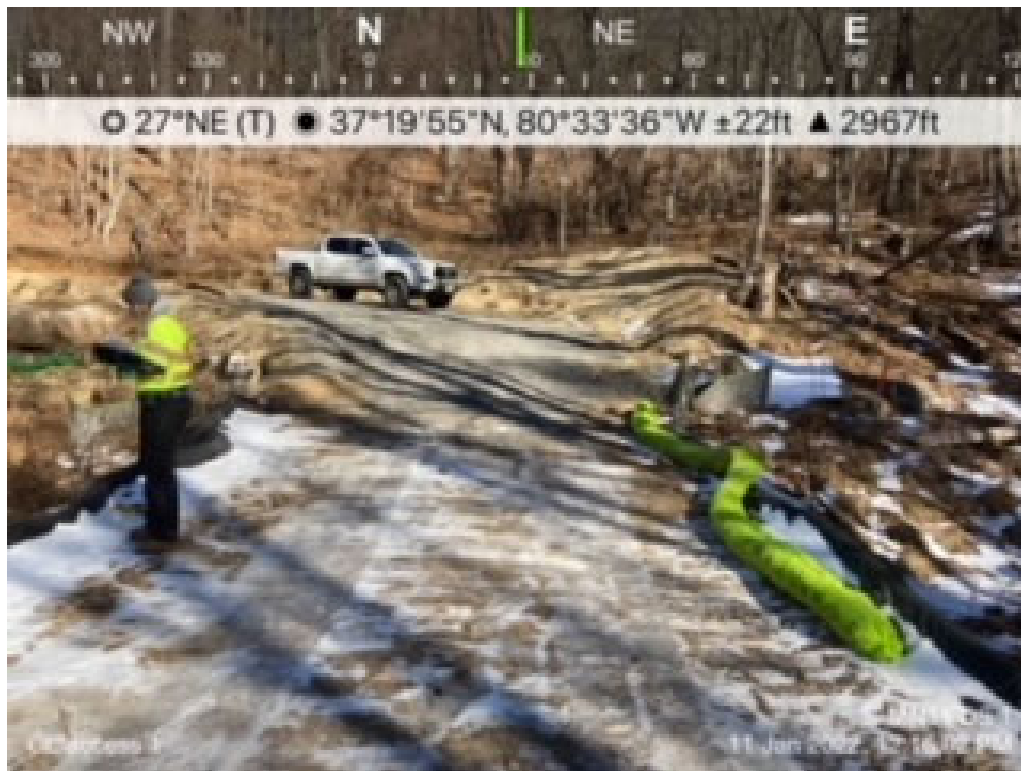
Photo Type: CL ACCESS 1

Location, Orientation, Photographer Initials: Standing in Access Road looking N/ NE, KB

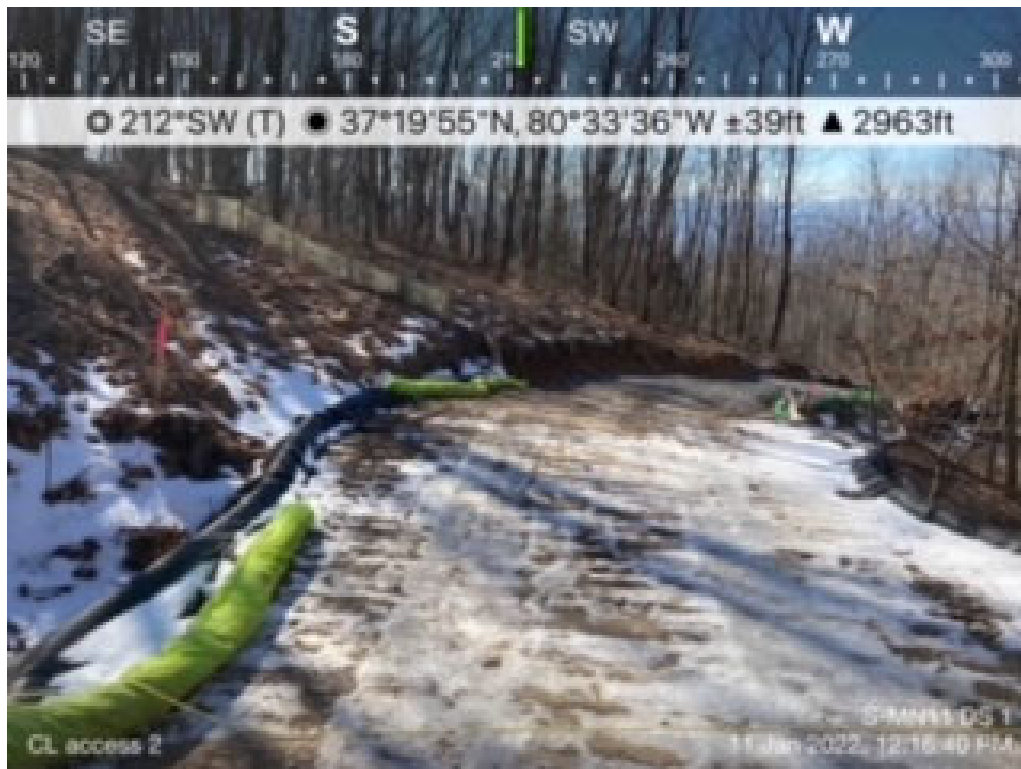
Photo Type: CL ACCESS 2

Location, Orientation, Photographer Initials: Standing in Access Road looking S/SW, KB

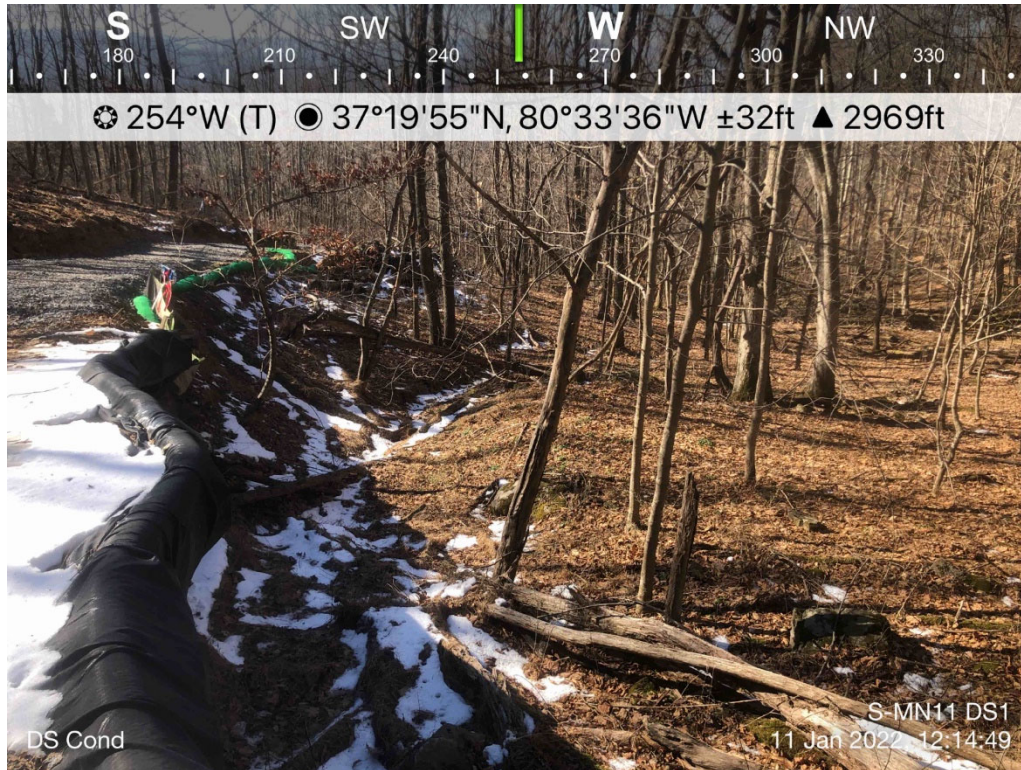
Photo Type: DS COND

Location, Orientation, Photographer Initials: Downstream conditions outside of LOC looking W/SW, KB

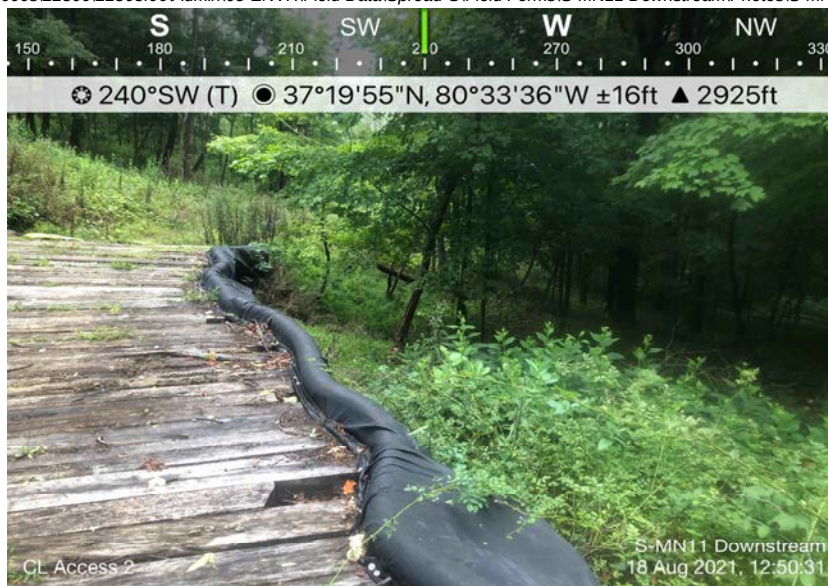
Looking SW from within the access road. Assessment is limited to areas within the temporary ROW.

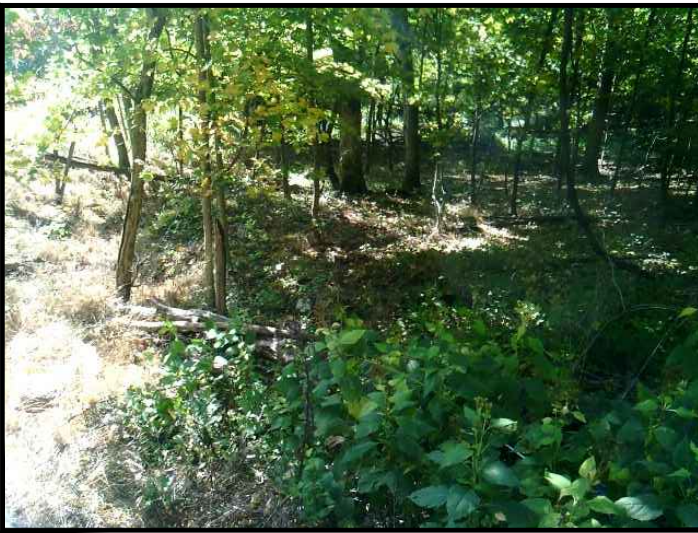
PHOTO TAKEN OCTOBER 15, 2021 LOOKING  
DOWNSTREAM FROM UPSTREAM IMPACT LIMITS

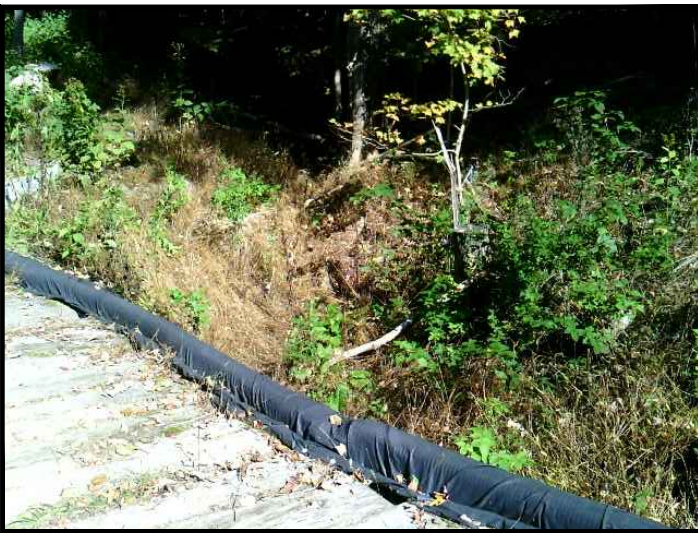
PHOTO TAKEN OCTOBER 15, 2021 LOOKING  
UPSTREAM FROM DOWNSTREAM IMPACT LIMITS
