Baseline Assessment – Stream Attributes

Reach S-Q13 (Pipeline ROW) *

Spread G

Giles County, Virginia

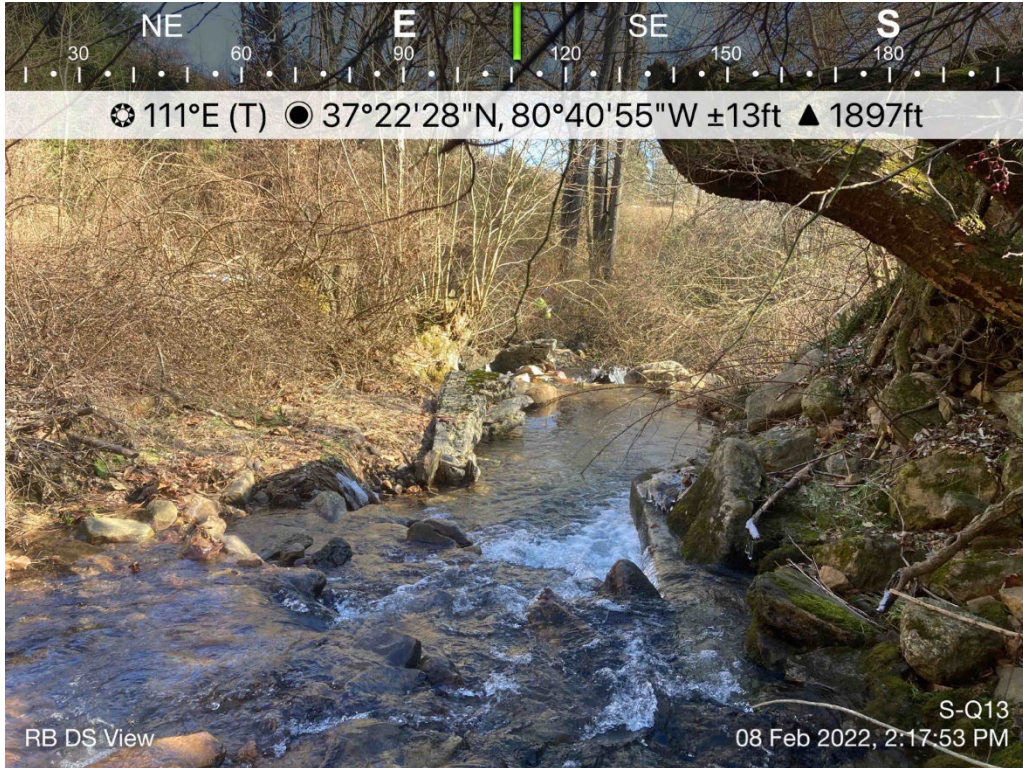
Photo Type: DS VIEW

Location, Orientation, Photographer Initials: Downstream view of LOC looking E/SE, KB

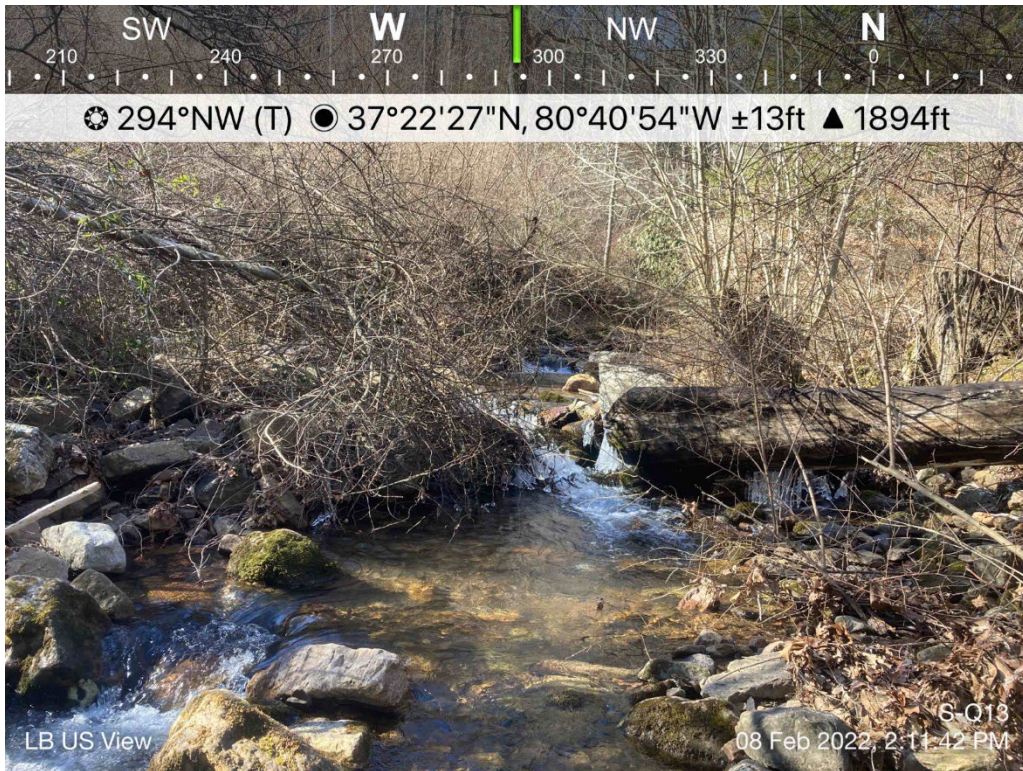
Photo Type: US VIEW

Location, Orientation, Photographer Initials: Upstream view of LOC looking W/NW, KB

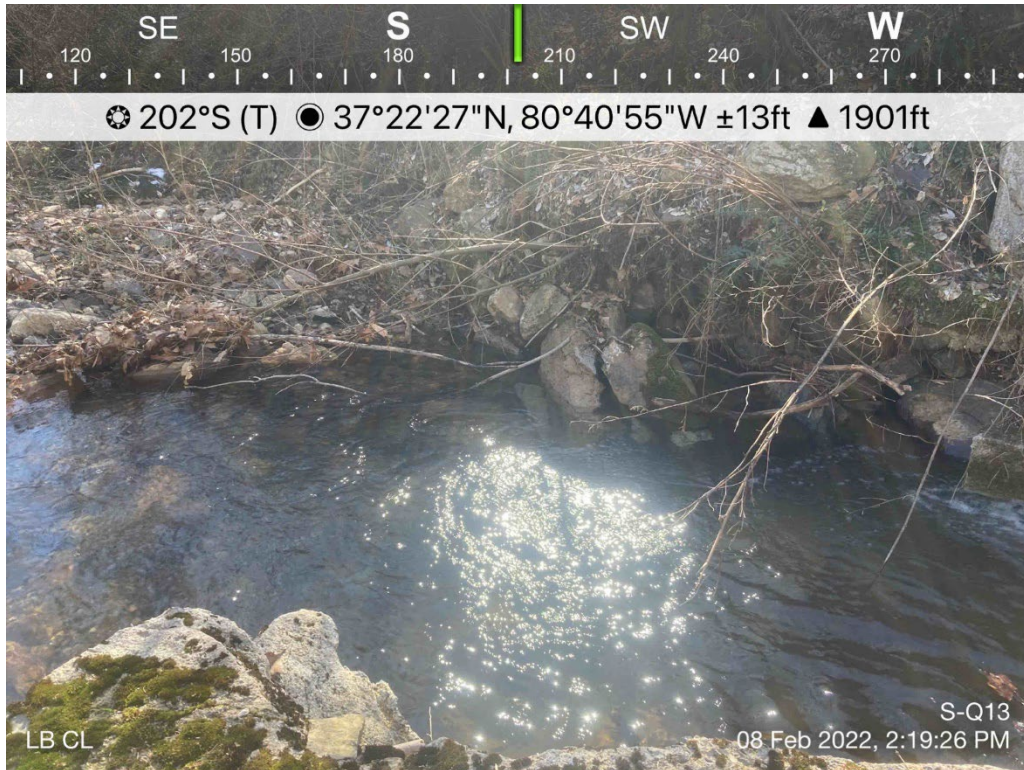
Photo Type: LB CL

Location, Orientation, Photographer Initials: Standing on LB looking at RB along pipe centerline looking S/SW, KB

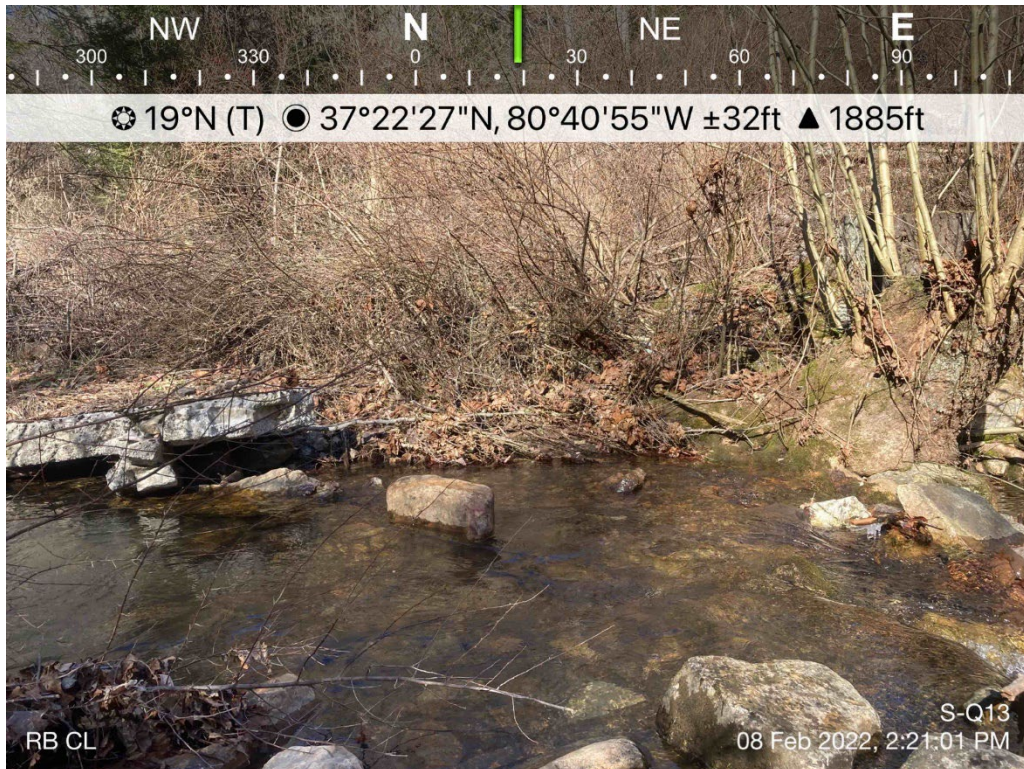
Photo Type: RB CL

Location, Orientation, Photographer Initials: Standing on RB looking at LB along pipe centerline looking N/NE, KB

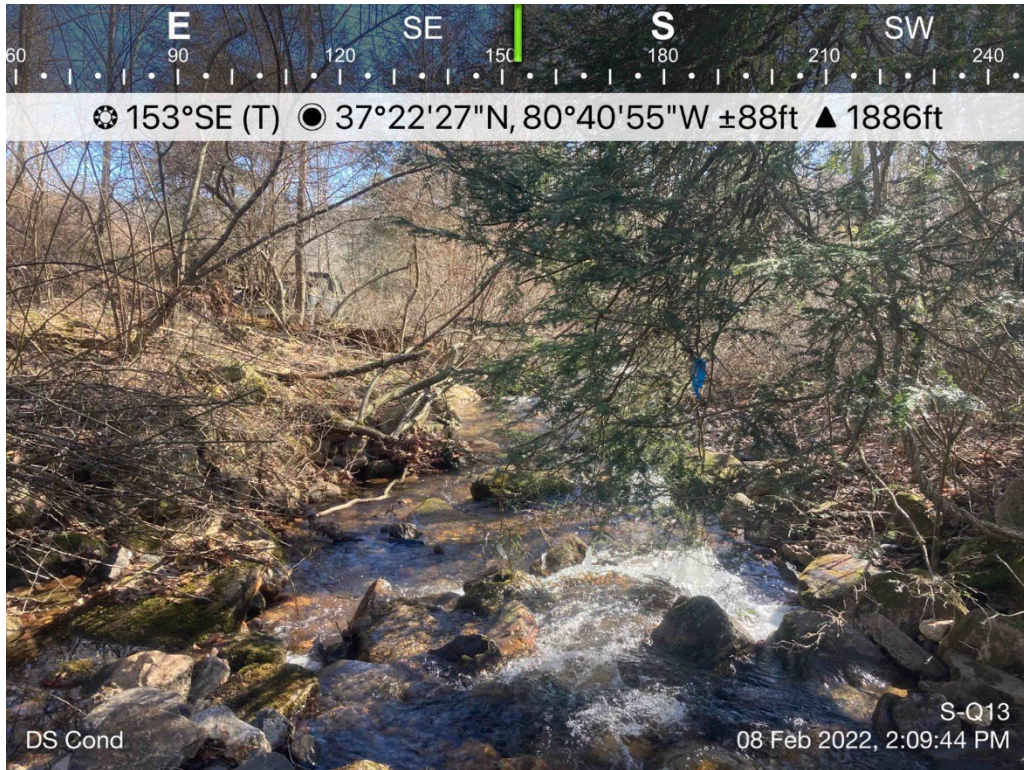
Photo Type: DS COND

Location, Orientation, Photographer Initials: Downstream conditions outside of LOC looking S/SE, KB

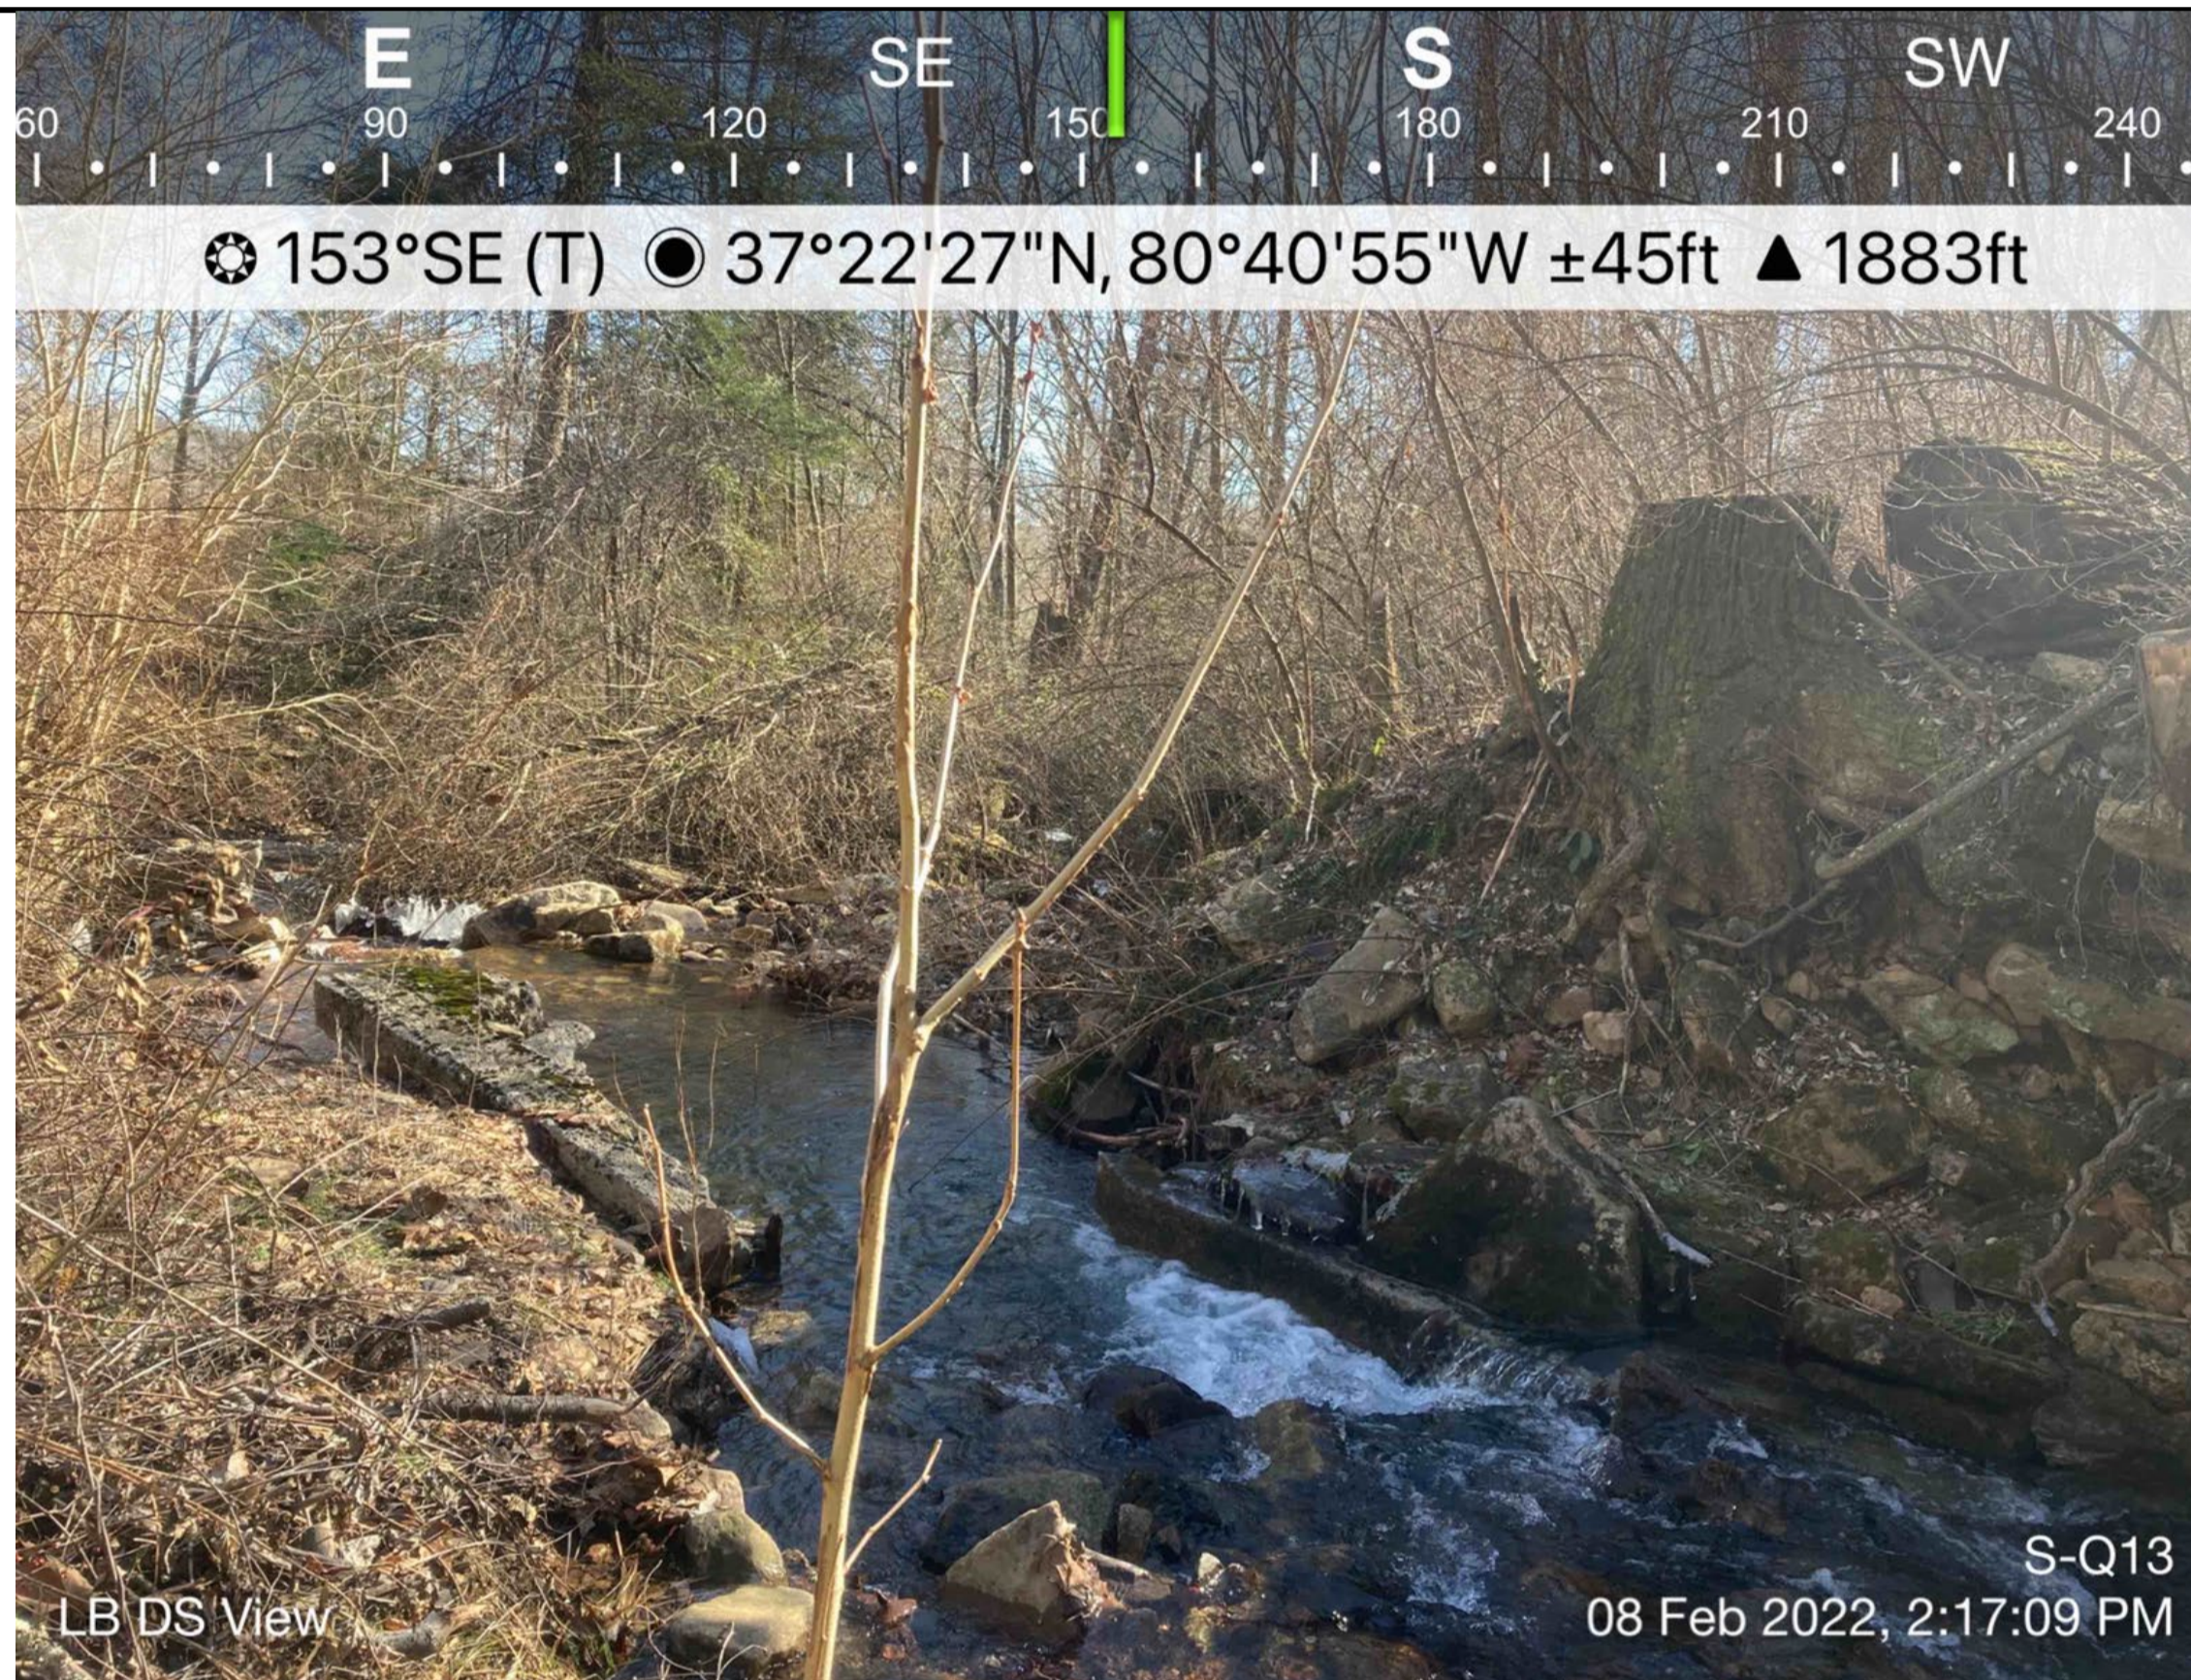
There is dense re-growth in the ROW which was cleared several years prior.
