Baseline Assessment – Stream Attributes

Reach S-C36 Downstream (Pipeline ROW) Intermittent Spread H Montgomery County, Virginia

Unified Stream Methodology for use in Virginia

Project #	Project Name (Applicant)	Locality	Cowardin Class.	HUC	Date	SAR #	Impact Length	Impact Factor		
22865.06	Mountain Valley Pipeline (Mountain Valley Pipeline, LLC)	Montgomery County	R4	03010101	8/6/21	S-C36 DS	36	1		
Name(s) of Evaluator(s)		Stream Name and Information					SAR Length			
TC, SB, ES		UNT to Flatwoods Branch					44

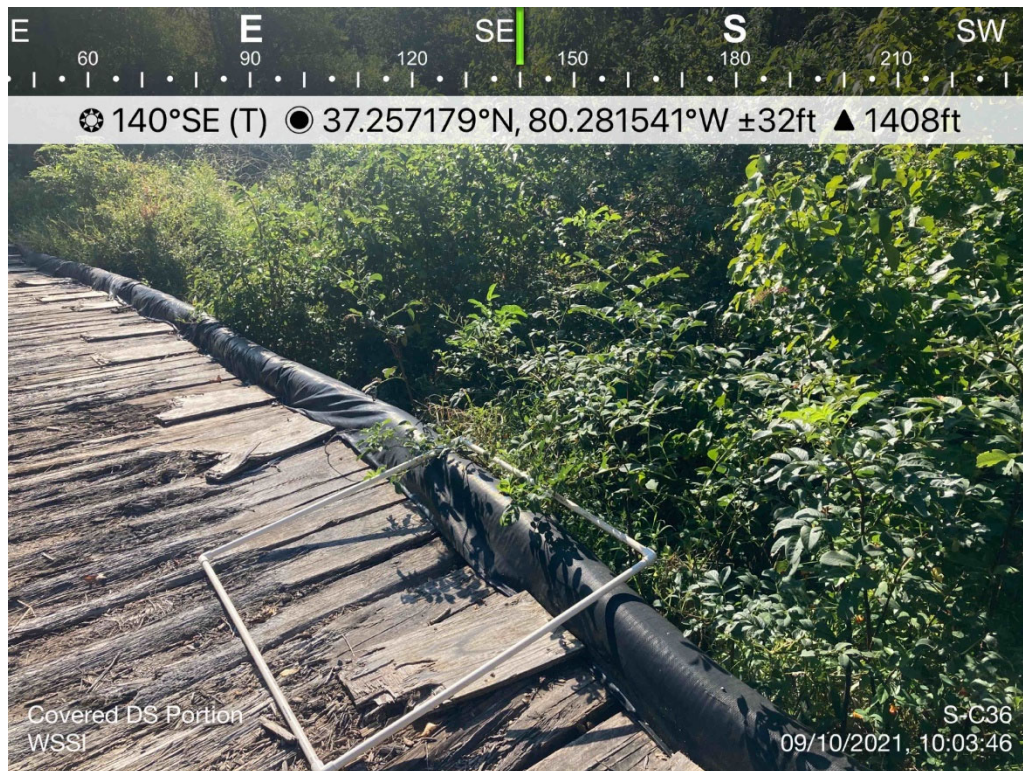
Photo Type: SE VIEW

Location, Orientation, Photographer Initials: View of ROW looking SE, ES

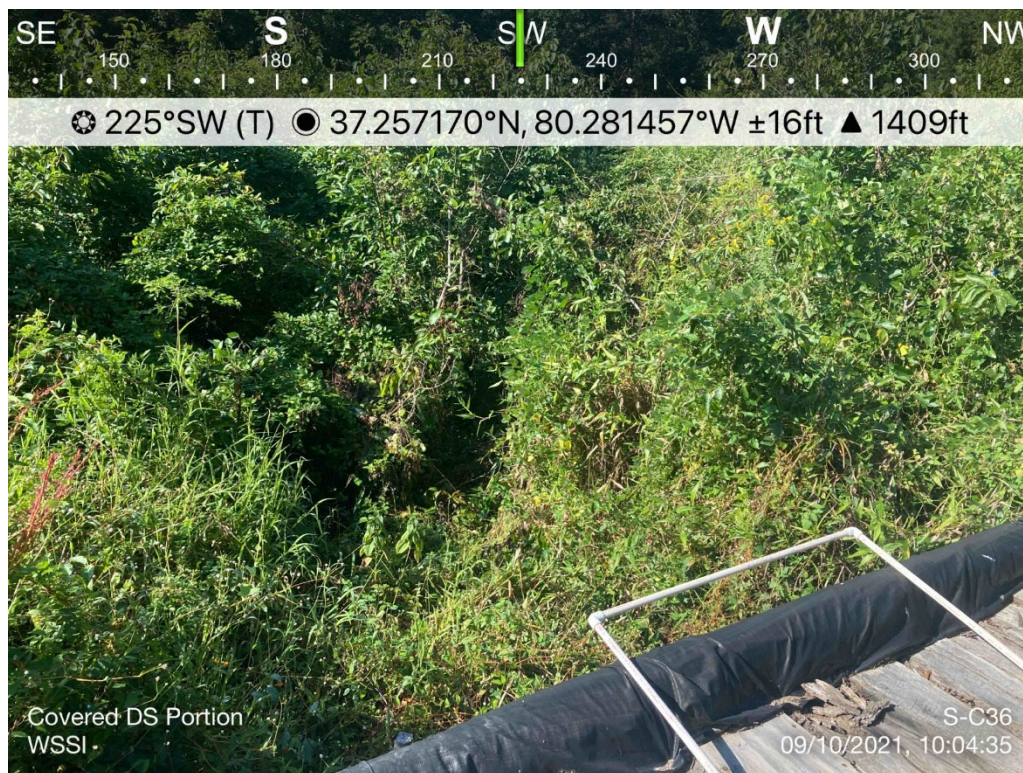
Photo Type: SW VIEW

Location, Orientation, Photographer Initials: View of ROW looking SW, ES

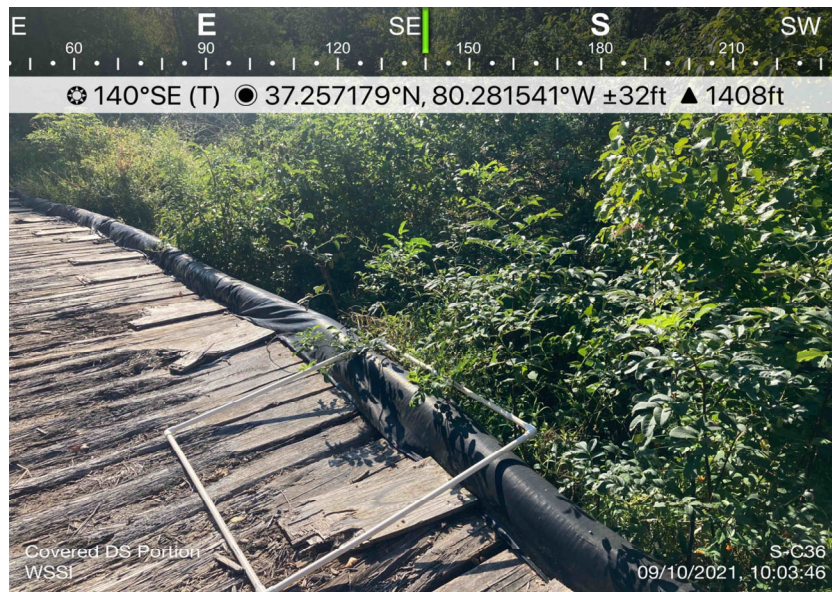
View of ROW; stream does not cross pipe centerline. Timber mat bridge covers majority of reach, which is mostly vegetated and located within a wetland area. Assessment is limited to areas within the temporary ROW.
