Visual Site Inspection Report

Project Name H-600 Pipeline Spread H		AFE 124300138	Spread H-600 Pipeline Spread H
Contractor Precision		Report # 40745	
Inspector Jonathan Altizer		Date/Time 8/8/2022 3:16 PM	
Permit # TBD	Inspection Type VA SWPP	Station Begin 12284+75	
State VA	Inspection Area Partial	Station End 12443+75	
County Montgomery	Ground Wet	Temperature (°F) 90.00	
Municipality N/A	Weather Sunny	Rain Gauge (in) 3.20	
			Rain Accumulation Time (days) 2.00

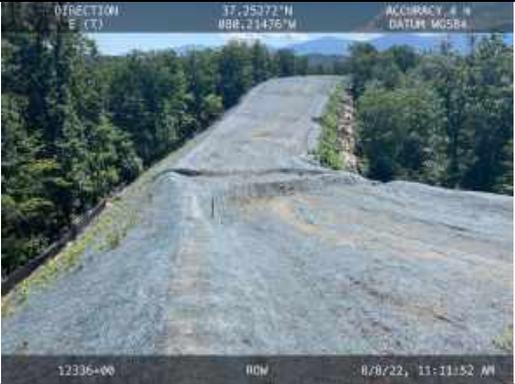
GPS Location	See photo			GPS Location	See photo
Field Station#	12330+00			Field Station#	12336+00
Pic 7 Desc.	Slope drain is functional			Pic 8 Desc.	Current ROW conditions. ROW is stable and ECDs are functional.

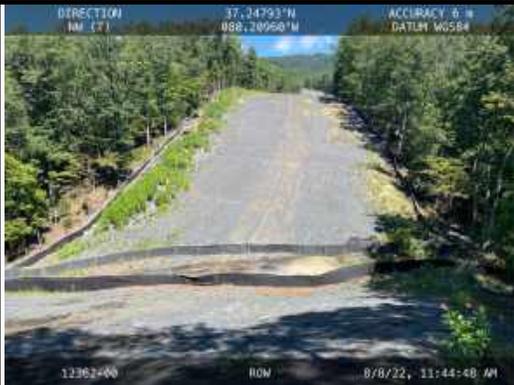
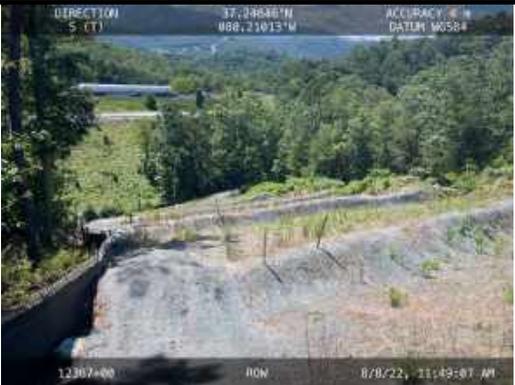
GPS Location	See photo			GPS Location	See photo
Field Station#	12362+00			Field Station#	12367+00
Pic 9 Desc.	Current ROW conditions. ROW is stable and ECDs are functional.			Pic 10 Desc.	Current ROW conditions. ROW is stable and ECDs are functional.

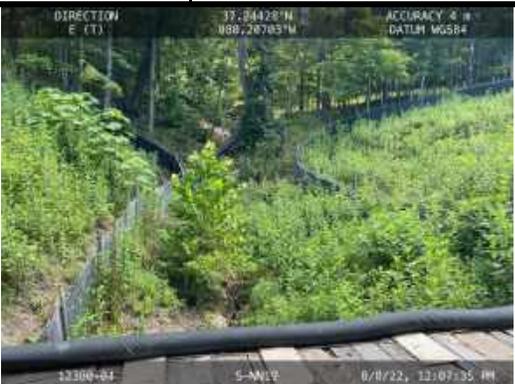
GPS Location	See photo			GPS Location	See photo
Field Station#	12374+16			Field Station#	12380+04
Pic 11 Desc.	Looking downstream at Stream S-0016			Pic 12 Desc.	Upstream of crossing at Stream S-NN19

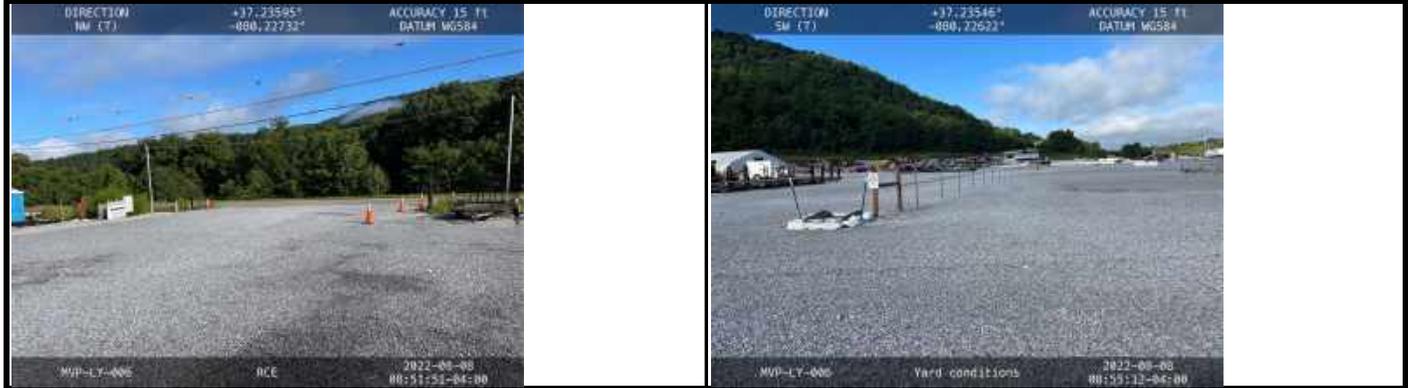
GPS Location	See photo for gps location data.	GPS Location	See photo for gps location data.
Field Station#	+0	Field Station#	+0
Pic 7 Desc.	Photo shows the RCE for yard PY-006.	Pic 8 Desc.	Photo shows the lay down yard conditions. No environmental issues were observed.

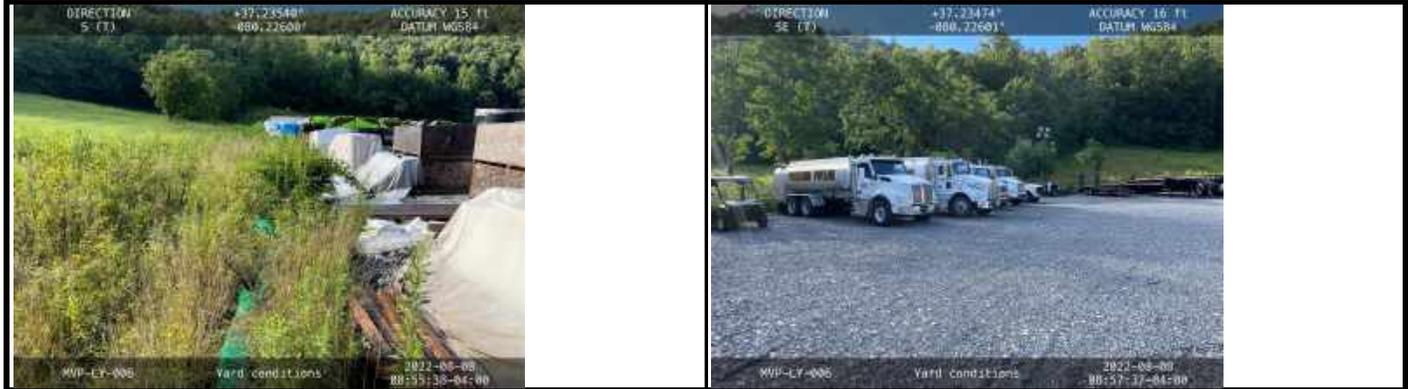
GPS Location	See photo for gps location data.	GPS Location	See photo for gps location data.
Field Station#	+0	Field Station#	+0
Pic 9 Desc.	Photo shows the perimeter ECDs.	Pic 10 Desc.	Photo shows the lay down yard conditions. No environmental issues were observed.

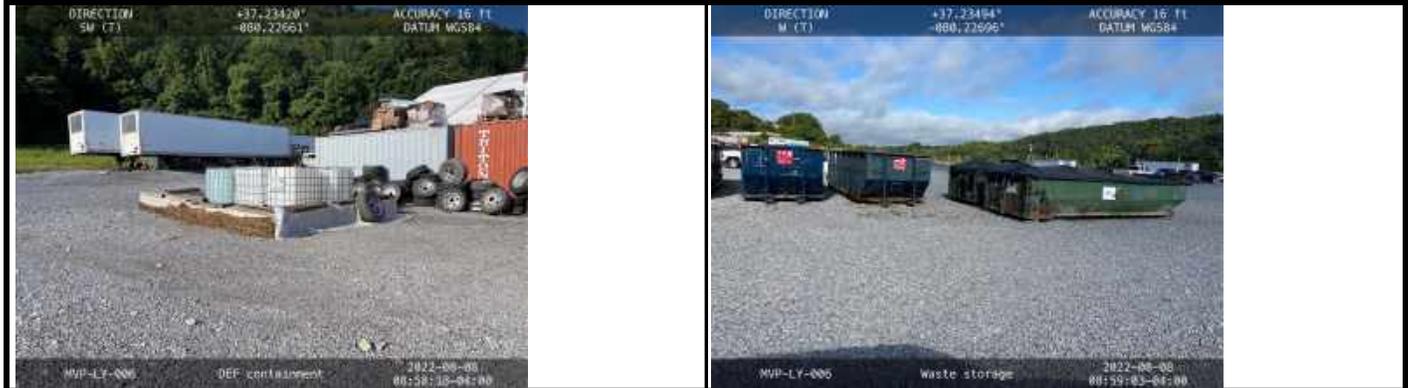
GPS Location	See photo for gps location data.	GPS Location	See photo for gps location data.
Field Station#	+0	Field Station#	+0
Pic 11 Desc.	Photo shows the DEF fluid storage and containment.	Pic 12 Desc.	Photo shows the solid waste containers.

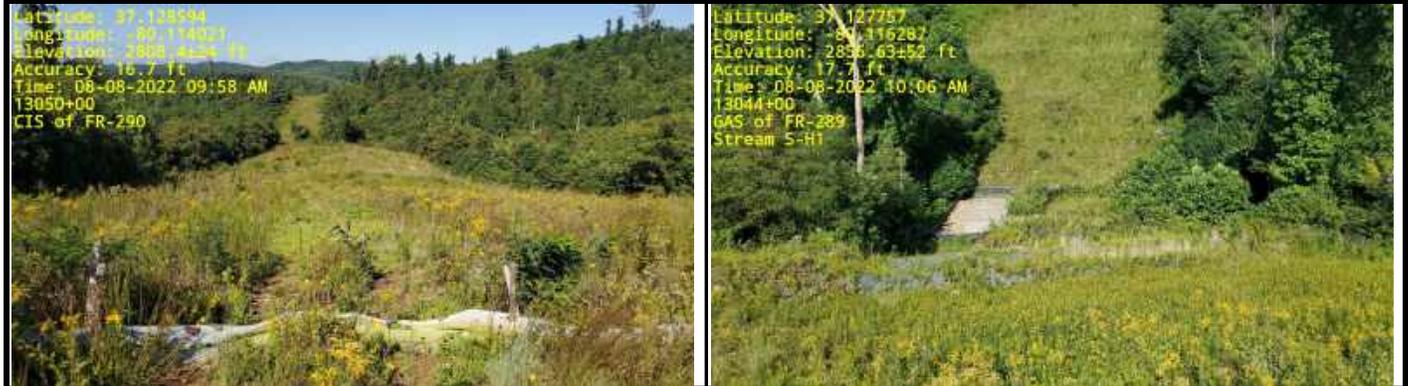
GPS Location	See pic.	GPS Location	See pic.
Field Station#	13050+00	Field Station#	13044+00
Pic 7 Desc.	Current ROW conditions.	Pic 8 Desc.	Stream crossing S-H1 from the GAS.

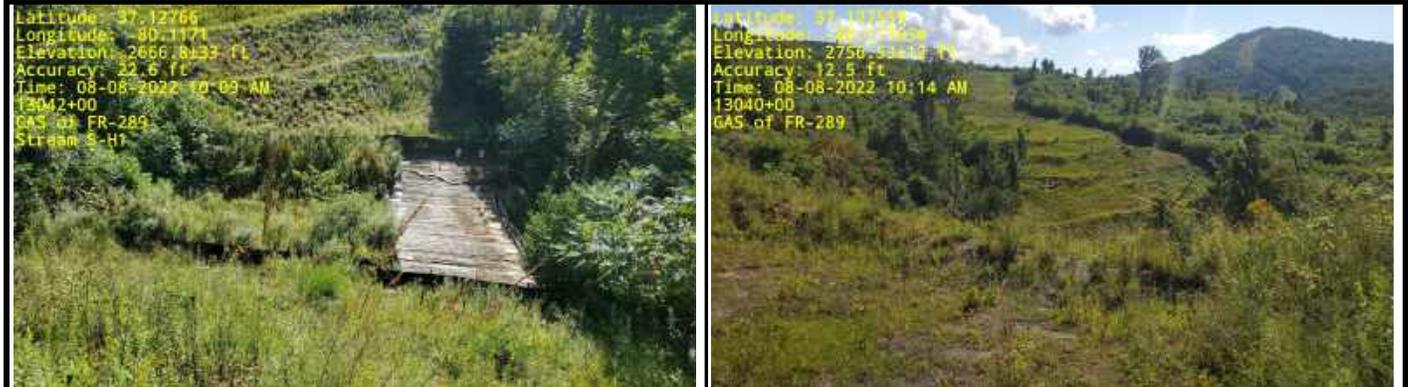
GPS Location	See pic.	GPS Location	See pic.
Field Station#	13042+00	Field Station#	13040+00
Pic 9 Desc.	Stream crossing S-H1 from the CIS.	Pic 10 Desc.	Current ROW conditions.

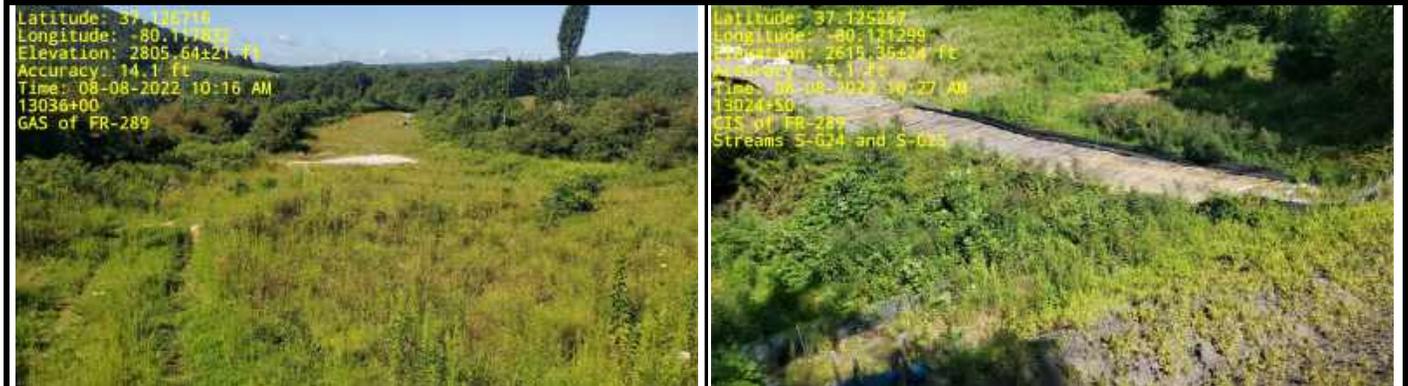
GPS Location	See pic.	GPS Location	See pic.
Field Station#	13036+00	Field Station#	13024+50
Pic 11 Desc.	Current ROW conditions.	Pic 12 Desc.	Streams S-G24 and S-G25 from the GAS.

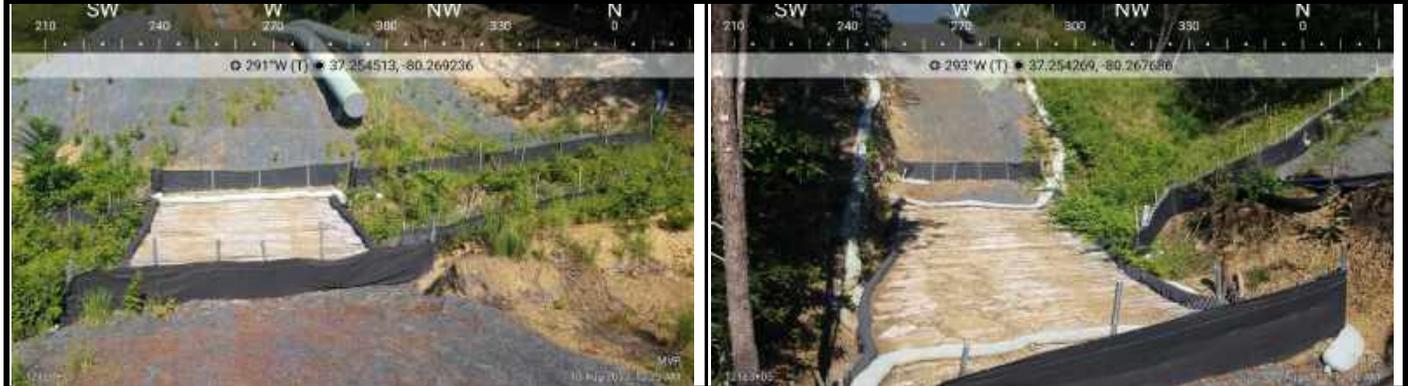
GPS Location	See Above
Field Station#	12158+75
Pic 7 Desc.	ROW Overview. ECDs functional and in good condition and ROW is stable.
GPS Location	See Above
Field Station#	12163+05
Pic 8 Desc.	Overview of Waterbody S-C25. ECDs functional and in good condition.

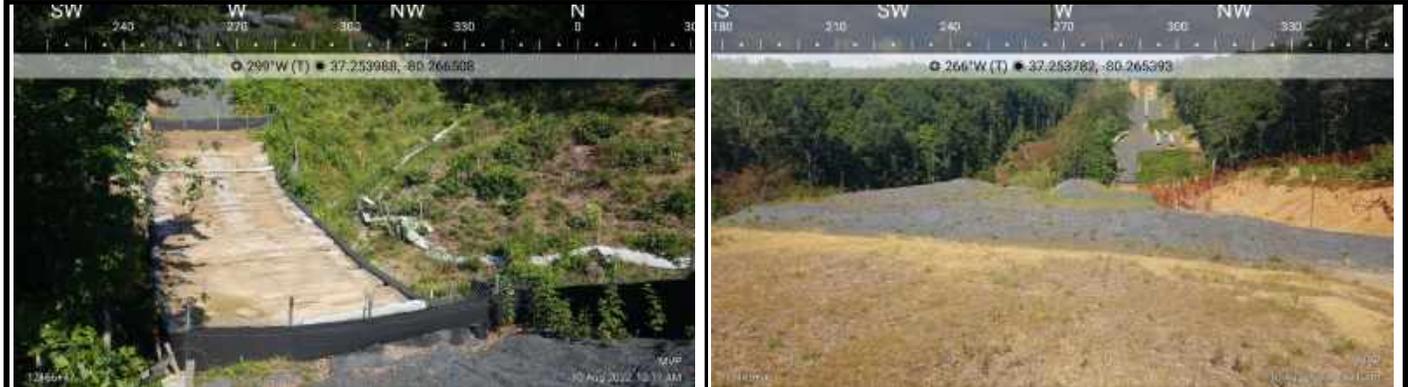
GPS Location	See Above
Field Station#	12166+47
Pic 9 Desc.	Overview of Waterbody S-C24. ECDs functional and in good condition.
GPS Location	See Above
Field Station#	12170+00
Pic 10 Desc.	ROW Overview. ECDs functional and in good condition and ROW is stable.

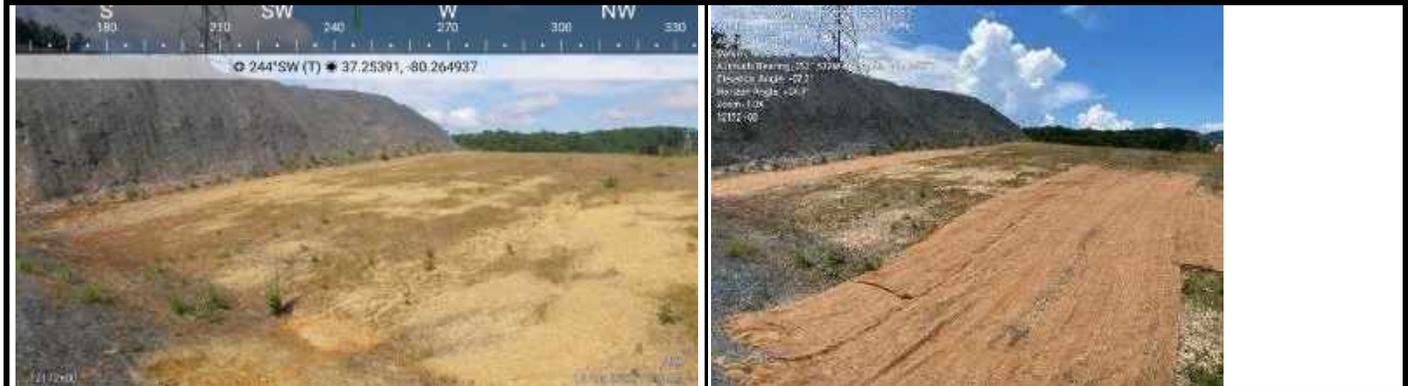
GPS Location	See Above
Field Station#	12172+00
Pic 11 Desc.	Punchlist Item: Repair rills and stabilize area.
GPS Location	See Above
Field Station#	12172+00
Pic 12 Desc.	Punchlist Item Completed: Repair rills and stabilize area.

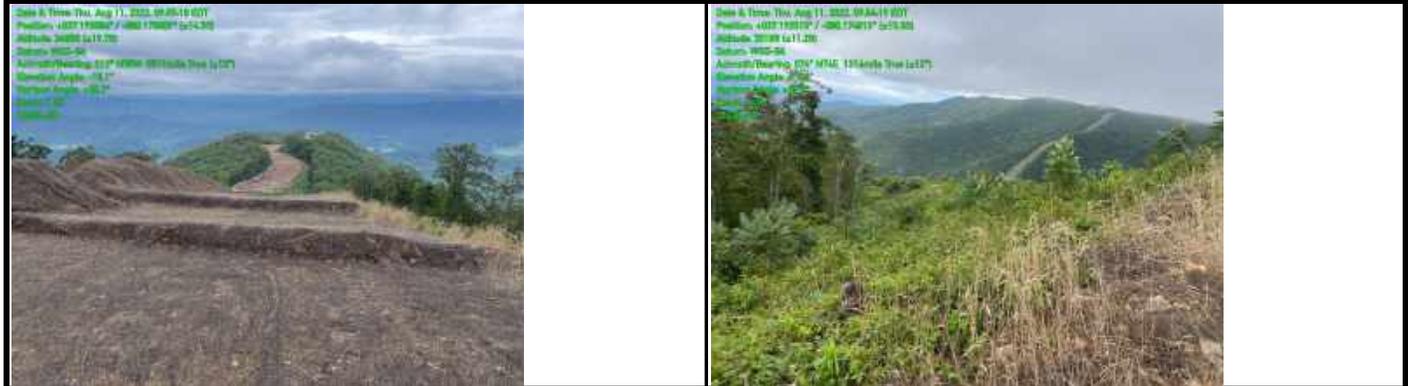
GPS Location	0	GPS Location	0
Field Station#	12635+00	Field Station#	12638+00
Pic 7 Desc.	Photo shows the ROW condition. ECDs are installed and functioning as designed.	Pic 8 Desc.	Photo shows the ROW condition. ECDs are installed and functioning as designed.

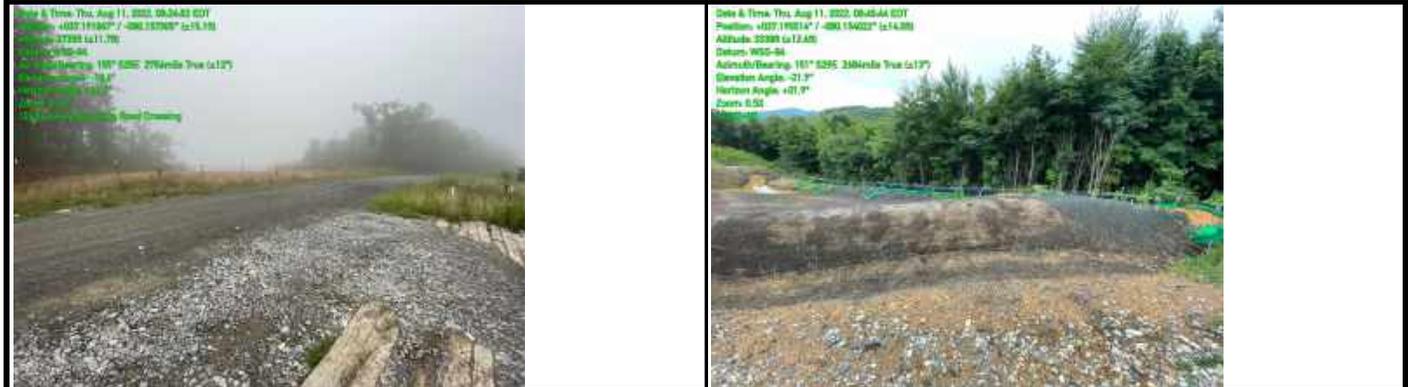
GPS Location	0	GPS Location	0
Field Station#	12690+43	Field Station#	12702+00
Pic 9 Desc.	Photo shows Honeysuckle Road Crossing	Pic 10 Desc.	Photo shows the ROW condition. ECDs are installed and functioning as designed.

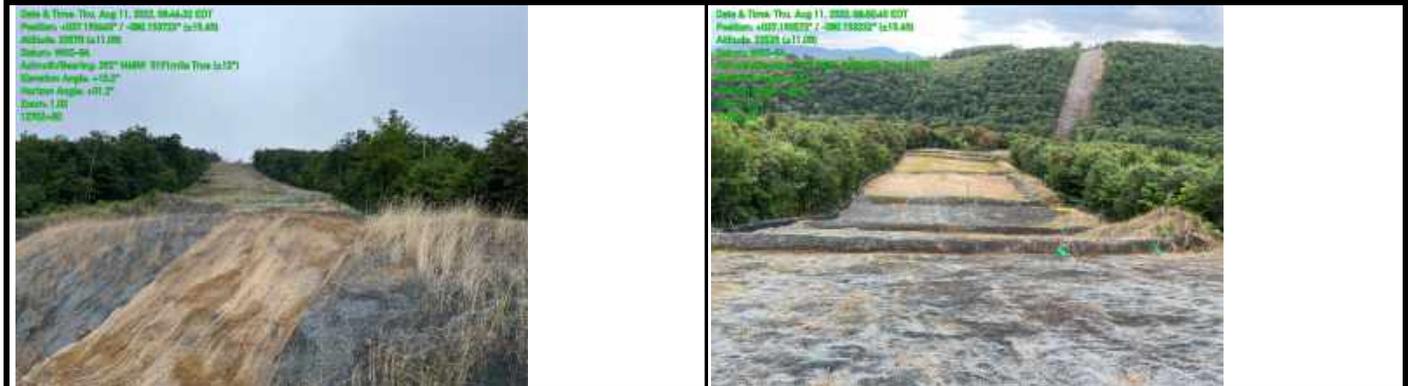
GPS Location	0	GPS Location	0
Field Station#	12702+00	Field Station#	12704+00
Pic 11 Desc.	Photo shows the ROW condition. ECDs are installed and functioning as designed.	Pic 12 Desc.	Photo shows the ROW condition. ECDs are installed and functioning as designed.

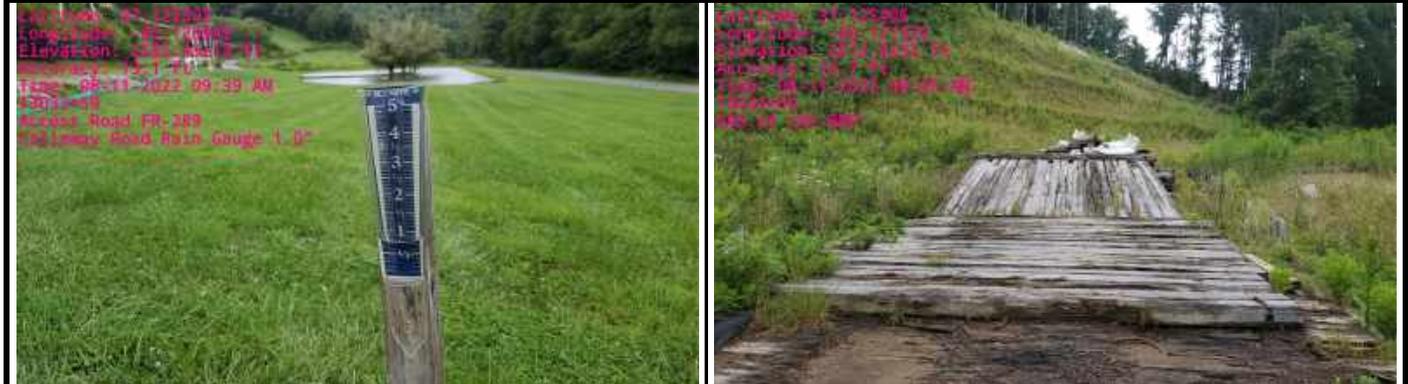
GPS Location	See pic.	GPS Location	See pic.
Field Station#	13033+59	Field Station#	13024+00
Pic 1 Desc.	1.0" total precipitation at Callaway Road.	Pic 2 Desc.	Current ROW conditions.

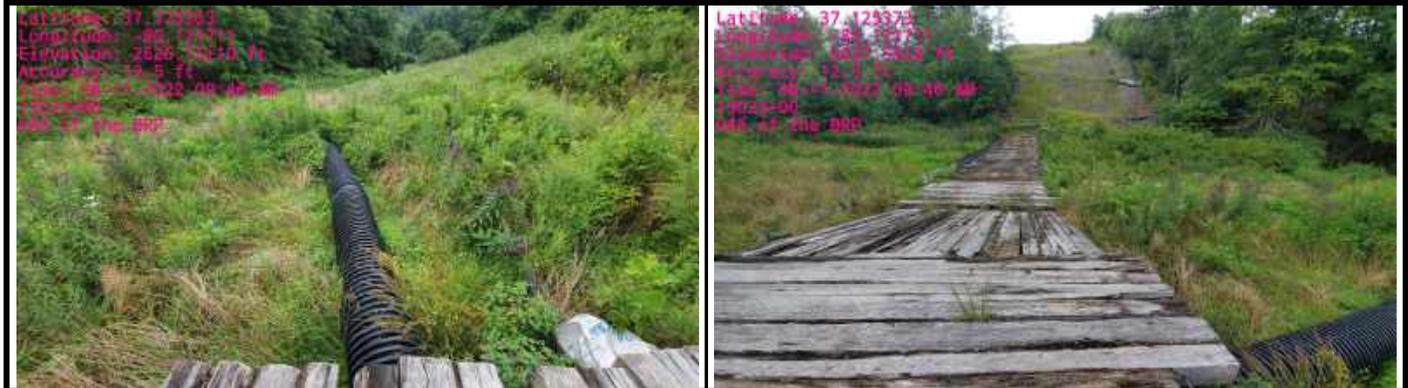
GPS Location	See pic.	GPS Location	See pic.
Field Station#	13023+00	Field Station#	13023+00
Pic 3 Desc.	CWDP and Plunge Pool.	Pic 4 Desc.	Current ROW conditions.

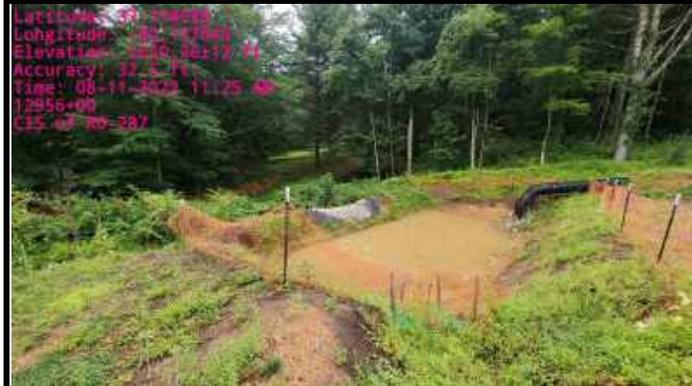
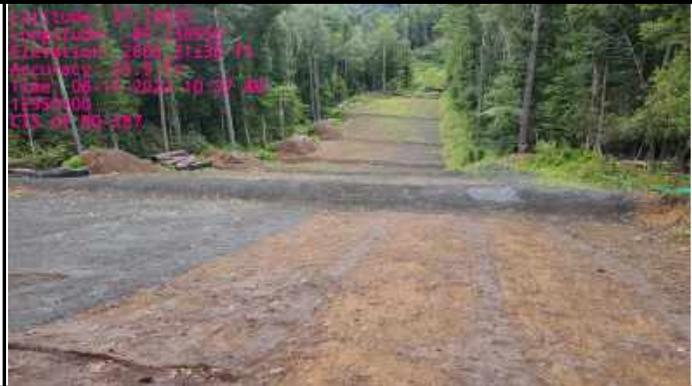
GPS Location	See pic.
Field Station#	12956+00
Pic 13 Desc.	Large sediment trap on the CIS of RO-287.

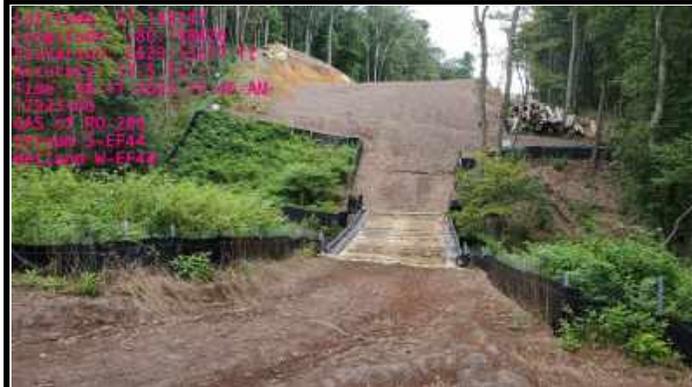
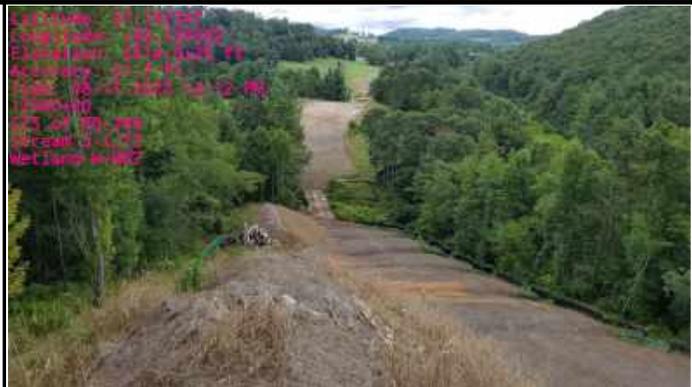
GPS Location	See pic.
Field Station#	12923+00
Pic 15 Desc.	Stream crossing S-EF44 from the CIS.

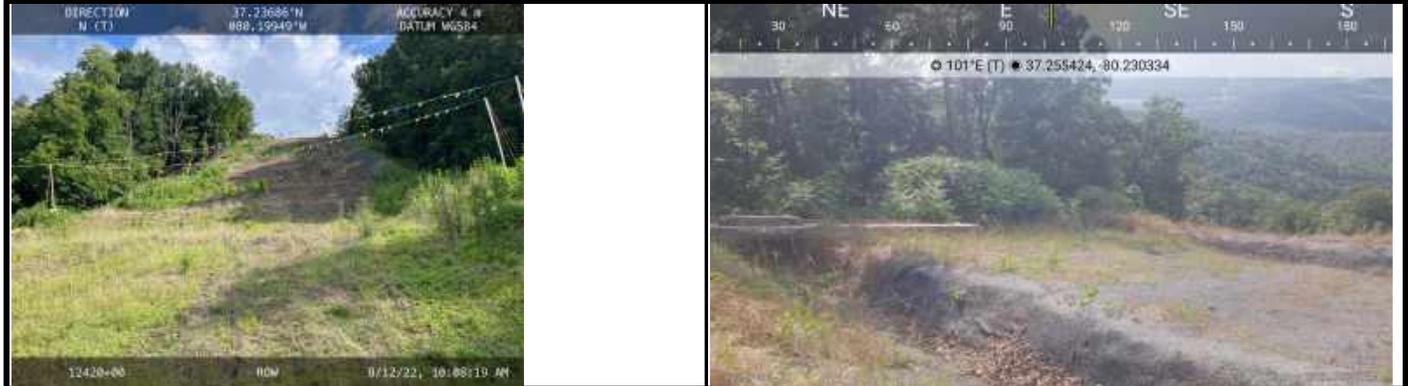
GPS Location	See photo	GPS Location	See photo
Field Station#	12420+00	Field Station#	12287+00
Pic 13 Desc.	Current ROW conditions. ROW is stable and ECDs are functional	Pic 14 Desc.	Current ROW conditions. ROW is stable and ECDs are functional

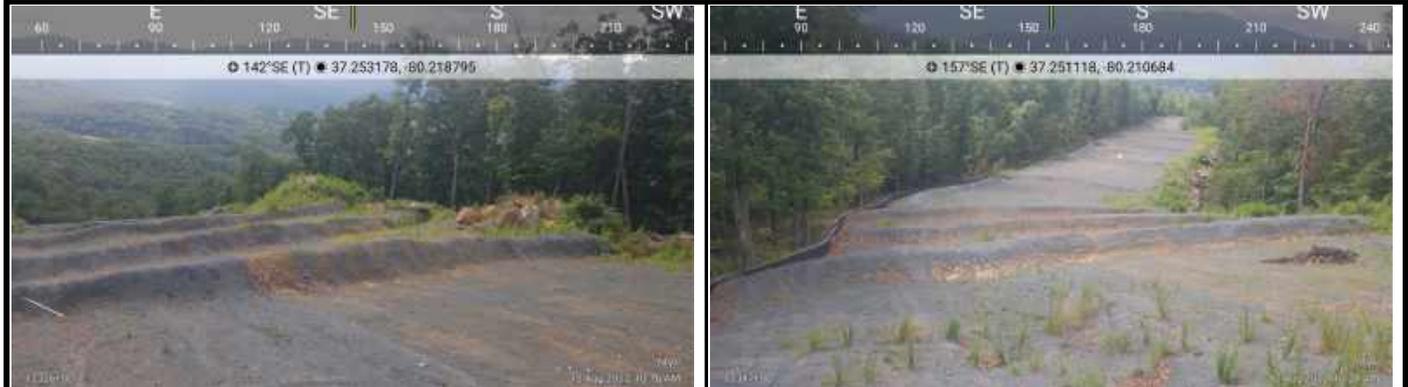
GPS Location	See photo	GPS Location	See photo
Field Station#	12326+00	Field Station#	12347+00
Pic 15 Desc.	Current ROW conditions. ROW is stable and ECDs are functional	Pic 16 Desc.	Current ROW conditions. ROW is stable and ECDs are functional

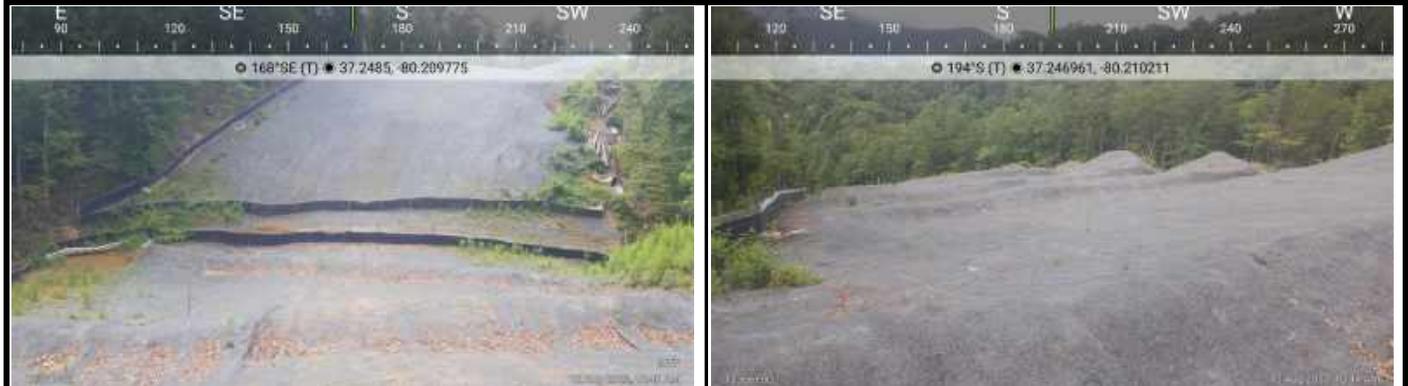
GPS Location	See photo	GPS Location	See photo
Field Station#	12361+00	Field Station#	12366+00
Pic 17 Desc.	Current ROW conditions. ROW is stable and ECDs are functional	Pic 18 Desc.	Current ROW conditions. ROW is stable and ECDs are functional

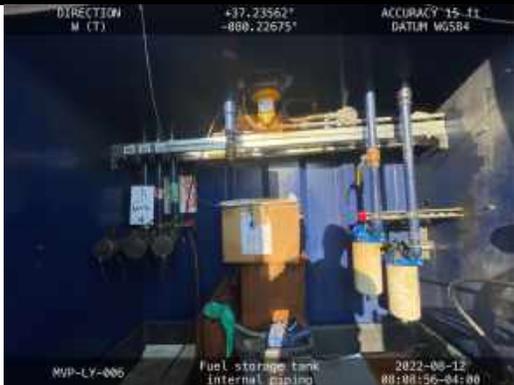
<p>DIRECTION: M (T) +37.23562° -888.22675° ACCURACY 15 FT DATUM WGS84 MVP-LY-006 Fuel storage tank Internal piping 2022-08-12 08:08:56-04:00</p>	
GPS Location	See photo for gps location data.		GPS Location	See photo for gps location data.	
Field Station#	+0		Field Station#	+0	
Pic 5 Desc.	Photo shows the bulk fuel storage tank. No leaks or spills were observed.		Pic 6 Desc.	Photo shows the bulk fuel storage tank internal piping. No leaks were observed.

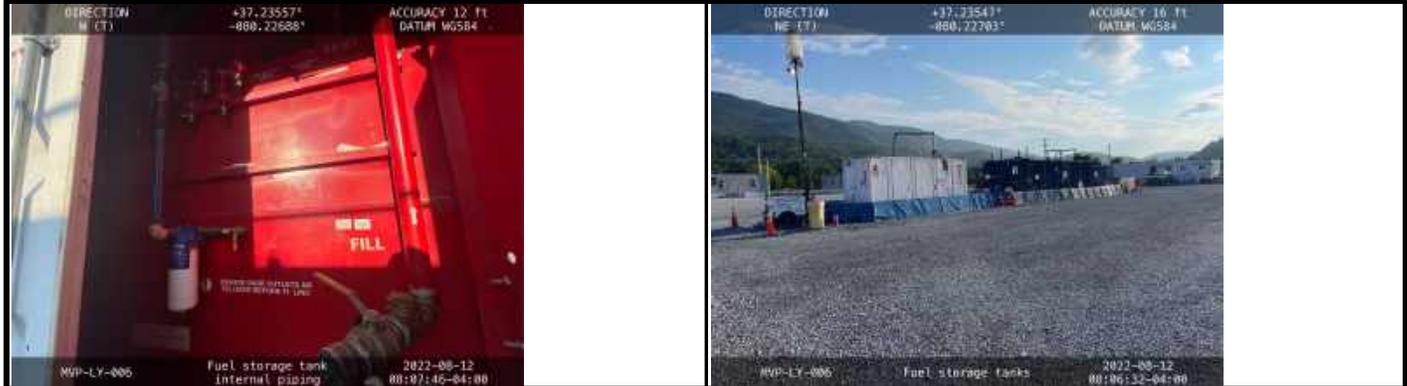
GPS Location	See photo for gps location data.	GPS Location	See photo for gps location data.
Field Station#	+0	Field Station#	+0
Pic 7 Desc.	Photo shows the bulk fuel storage tank internal piping. No leaks were observed.	Pic 8 Desc.	Photo shows the bulk fuel storage tanks. No leaks or spills were observed.

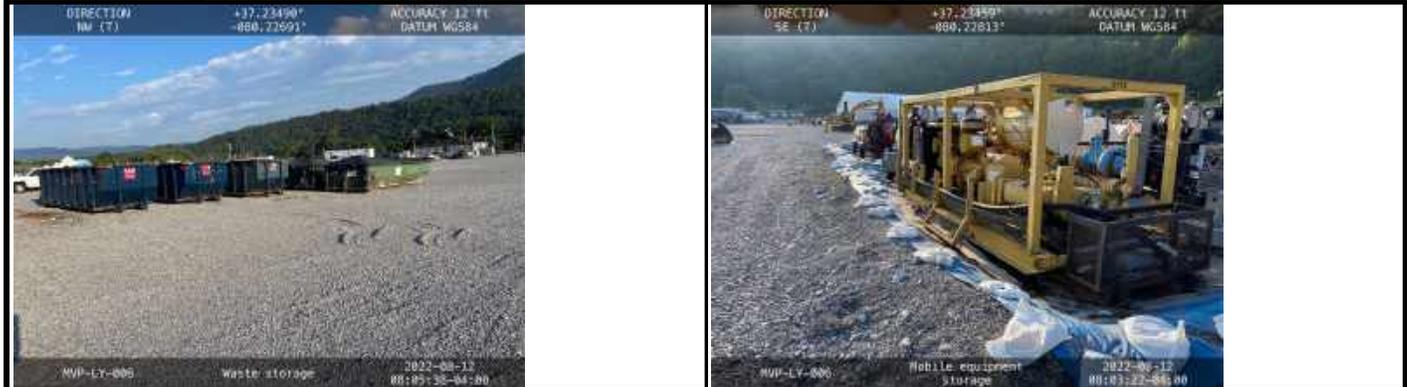
GPS Location	See photo for gps location data.	GPS Location	See photo for gps location data.
Field Station#	+0	Field Station#	+0
Pic 9 Desc.	Photo shows the waste storage area.	Pic 10 Desc.	Photo shows the mobile equipment storage area and containment.
