# Visual Site Inspection Report

<b>Project Name</b>	H-600 Pipeline Spread I	<b>AFE</b>	124300139	<b>Spread</b>	H-600 Pipeline Spread I
<b>Contractor</b>	Precision			<b>Report #</b>	41006
<b>Inspector</b>	Justin Burch			<b>Date/Time</b>	8/15/2022 11:57 AM
<b>Permit #</b>	TBD	<b>Inspection Type</b>	VA SWPP	<b>Station Begin</b>	15370+62
<b>State</b>	VA	<b>Inspection Area</b>	Full	<b>Station End</b>	15480+67
<b>County</b>	Pittsylvania	<b>Ground</b>	Wet	<b>Temperature (°F)</b>	72.00
<b>Municipality</b>	Chatham	<b>Weather</b>	Cloudy	<b>Rain Gauge (in)</b>	0.20
				<b>Rain Accumulation Time (days)</b>	6.00

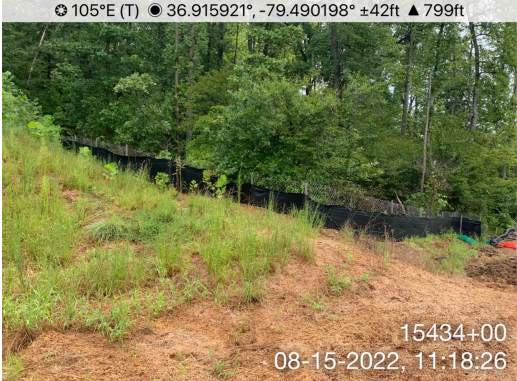
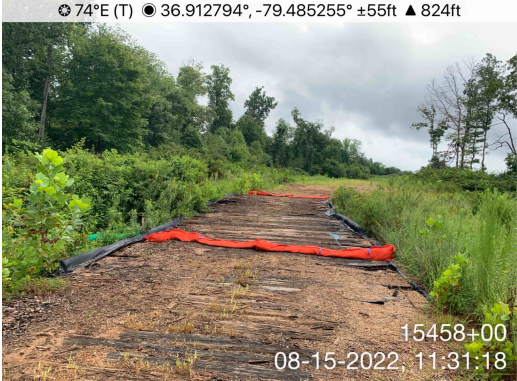
<b>GPS Location</b>	0	<b>GPS Location</b>	0		
<b>Field Station#</b>	15434+00	<b>Field Station#</b>	15458+00		
<b>Pic 7 Desc.</b>	Super silt fence in acceptable condition	<b>Pic 8 Desc.</b>	Equipment bridge in acceptable condition

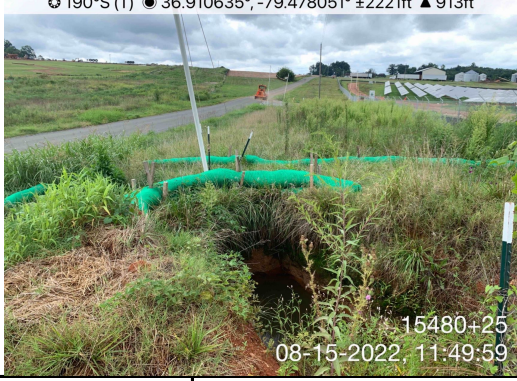
<b>GPS Location</b>	0	<b>GPS Location</b>	0		
<b>Field Station#</b>	15480+25	<b>Field Station#</b>	15479+00		
<b>Pic 9 Desc.</b>	Sump pit in acceptable condition	<b>Pic 10 Desc.</b>	Solar farm perimeter ECDs appear to be in acceptable conditions		
Insert image here		Insert image here			
<b>GPS Location</b>		<b>GPS Location</b>			
<b>Field Station#</b>		<b>Field Station#</b>			
<b>Pic 11 Desc.</b>		<b>Pic 12 Desc.</b>

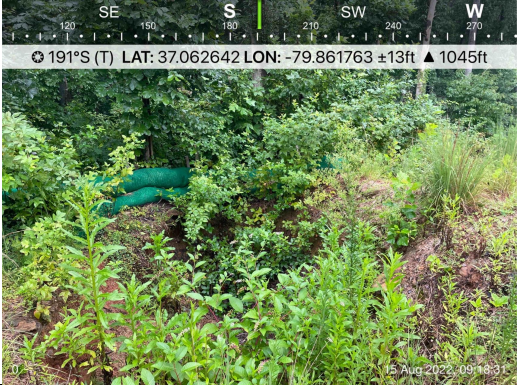
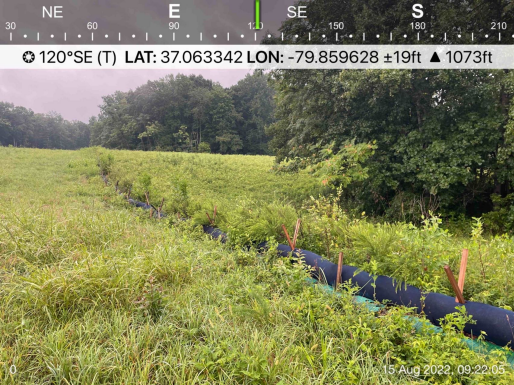
<b>GPS Location</b>	See photo	<b>GPS Location</b>	See photo		
<b>Field Station#</b>	14110+00	<b>Field Station#</b>	14120+00		
<b>Pic 7 Desc.</b>	End treatments are functioning as intended	<b>Pic 8 Desc.</b>	CFS is in good condition throughout this section

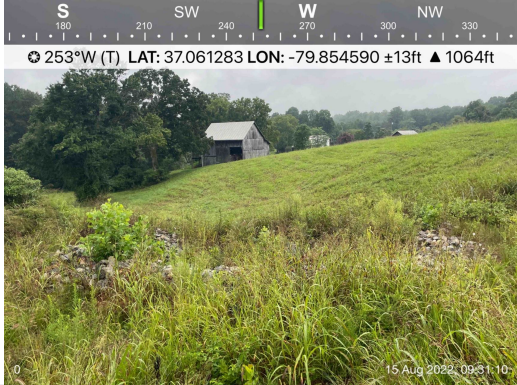
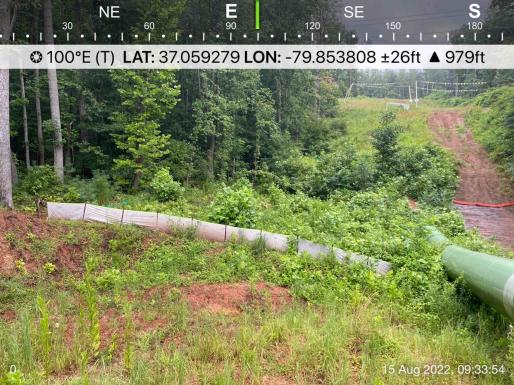
<b>GPS Location</b>	See photo	<b>GPS Location</b>	See photo		
<b>Field Station#</b>	14132+00	<b>Field Station#</b>	14141+00		
<b>Pic 9 Desc.</b>	CWD is functioning as intended	<b>Pic 10 Desc.</b>	P1 is in good condition at all stream and wetland buffers

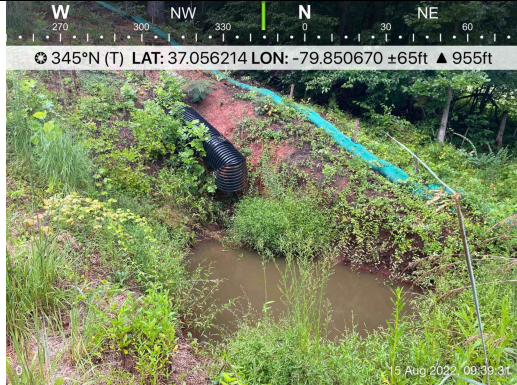
Insert image here			
<b>GPS Location</b>	See photo	<b>GPS Location</b>			
<b>Field Station#</b>	14156+00	<b>Field Station#</b>			
<b>Pic 11 Desc.</b>	Slope drain is functioning as intended	<b>Pic 12 Desc.</b>

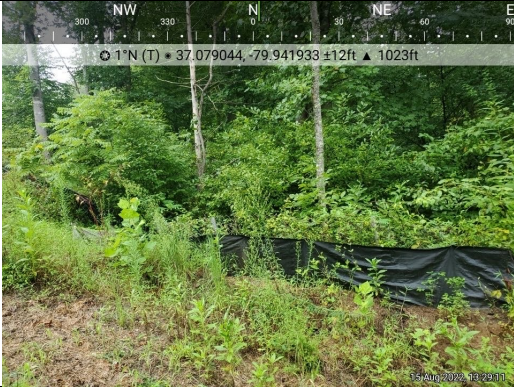
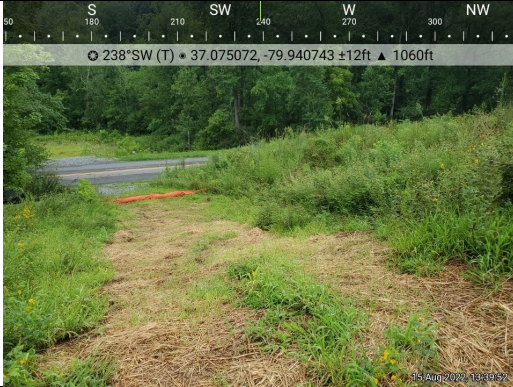
<b>GPS Location</b>	0	<b>GPS Location</b>	0		
<b>Field Station#</b>	13727+50	<b>Field Station#</b>	13747+00		
<b>Pic 1 Desc.</b>	Super silt fence along travel lane	<b>Pic 2 Desc.</b>	Travel lane stabilization CIS Green Level Rd

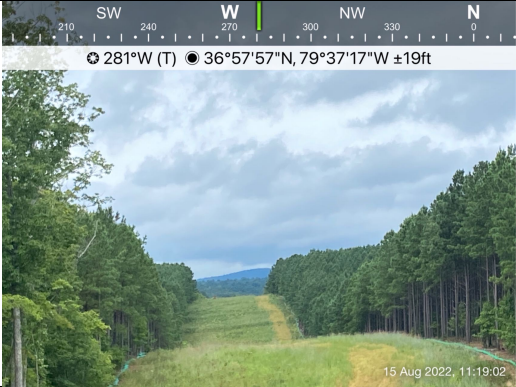
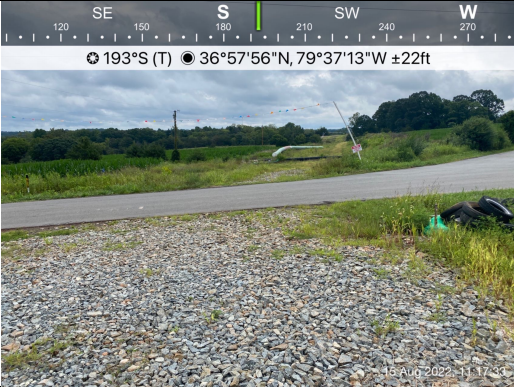
<b>GPS Location</b>	0	<b>GPS Location</b>	0		
<b>Field Station#</b>	14973+00	<b>Field Station#</b>	14981+00		
<b>Pic 1 Desc.</b>	Approximately 14973+00. Overview of ROW. Permanent vegetation.	<b>Pic 2 Desc.</b>	Approximately 14981+00. Overview of road crossing and RCEs.

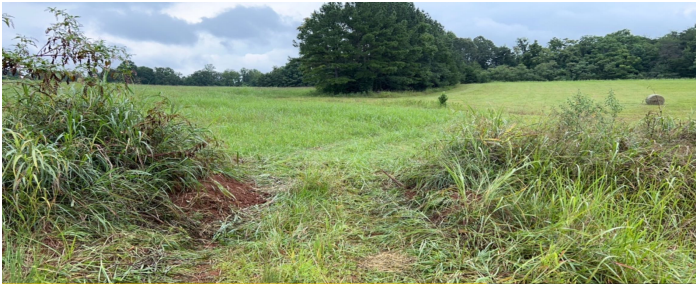
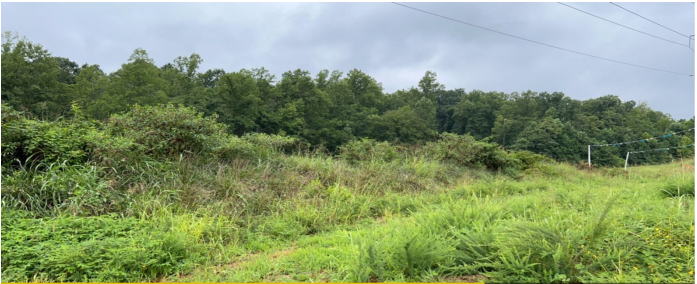
<p>37°0'9" N 79°44'59" W 125°SE COURSE -1' GPS 08.15.2022 11:10:52 Sorry no results found Accur +/-15.1 Ft ALT 921 Ft</p>			<p>37°0'14" N 79°45'6" W 353°N COURSE -1' GPS 08.15.2022 11:06:39 Sorry no results found Accur +/-15.1 Ft ALT 928 Ft</p>		
<b>GPS Location</b>	1		<b>GPS Location</b>	2	
<b>Field Station#</b>	14563+00		<b>Field Station#</b>	14550+00	
<b>Pic 1 Desc.</b>	Routine maintenance. Install missing perimeter ECD where landowner gap has been created.		<b>Pic 2 Desc.</b>	Temporary diversion berm stabilized and vegetated.

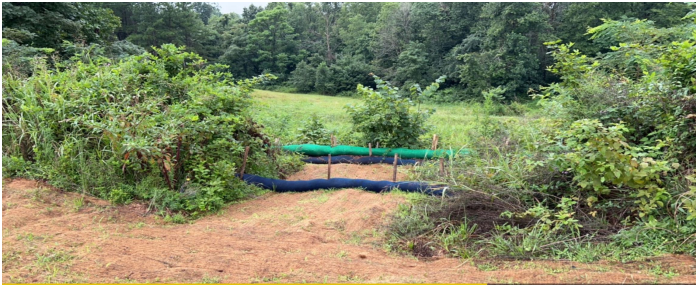
<b>Field Station#</b>	14558+00		<b>Field Station#</b>	14568+10	
<b>Pic 3 Desc.</b>	Contractor installed erosion control blanket and CFS check dams per punch list item.		<b>Pic 4 Desc.</b>	Equipment bridge and surrounding ECDs in place and functional at stream crossing and resource buffer.

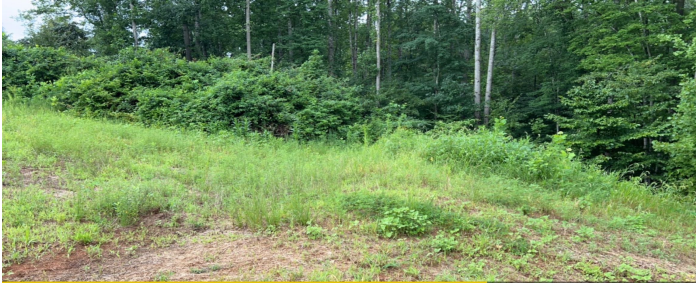
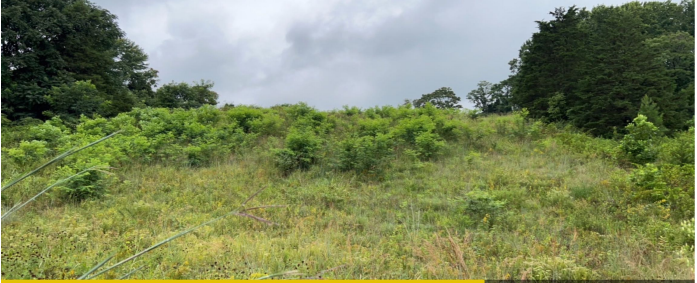
<p>37°0'3" N 79°44'50" W 205°SW COURSE -1' GPS 08.15.2022 11:16:24 Sorry no results found Accur +/-20.2 Ft ALT 914 Ft</p>			<p>36°59'27" N 79°43'26" W 339°NW COURSE 39' GPS 08.15.2022 11:33:54 9400-9598 Old Franklin Tpke, Union Hall, VA 24176, United States Accur +/-15.5 Ft ALT 982 Ft</p>		
<b>GPS Location</b>	5		<b>GPS Location</b>	6	
<b>Field Station#</b>	14580+00		<b>Field Station#</b>	14647+00	
<b>Pic 5 Desc.</b>	Water bar performing intended function.		<b>Pic 6 Desc.</b>	ROW stabilized and vegetated in final cleanup area.

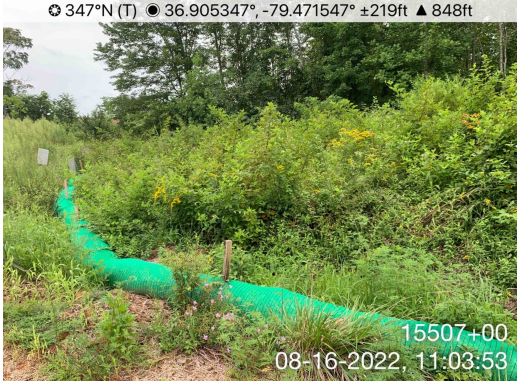
<b>GPS Location</b>	0	<b>GPS Location</b>	0		
<b>Field Station#</b>	15528+00	<b>Field Station#</b>	15507+00		
<b>Pic 7 Desc.</b>	P1 silt fence and sensitive resource buffer in acceptable conditions		<b>Pic 8 Desc.</b>	CFS and sensitive resource buffer in acceptable conditions

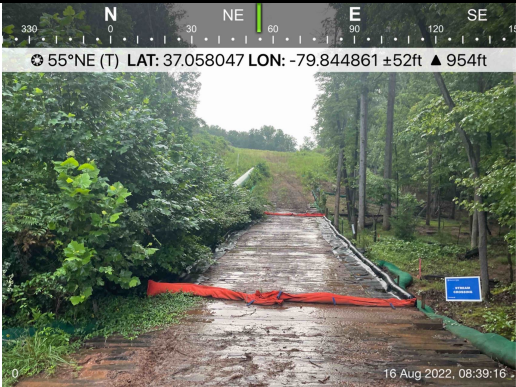
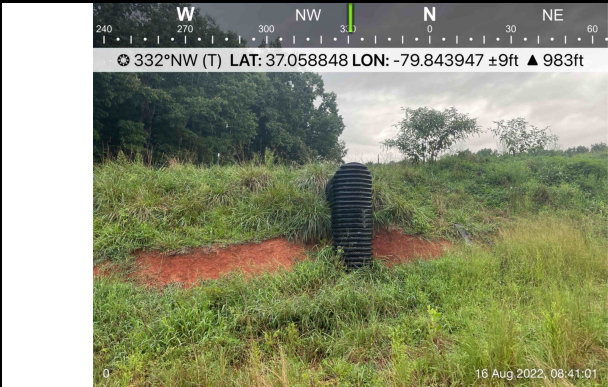
GPS Location	See photo		GPS Location	See photo	
Field Station#	14176+09		Field Station#	14180+00	
Pic 1 Desc.	Equipment bridge ECDs are in good condition and functioning		Pic 2 Desc.	CWDs are functioning as intended

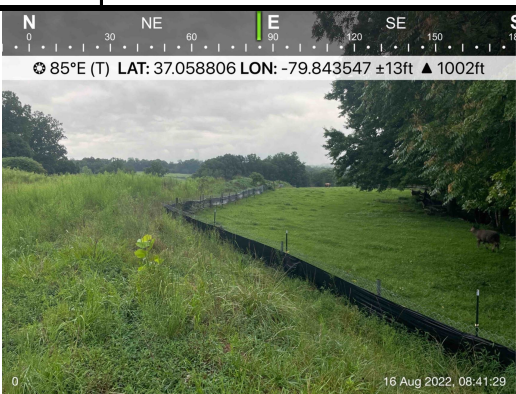
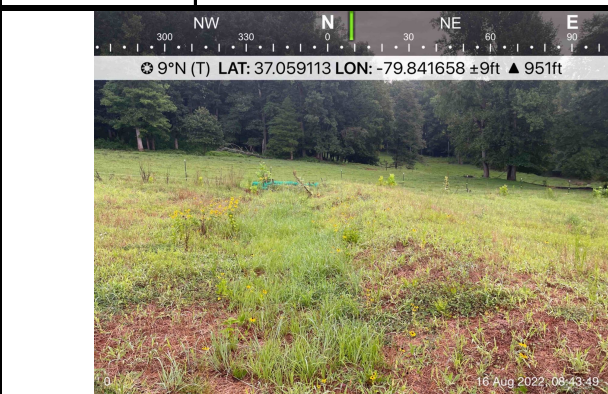
GPS Location	See photo		GPS Location	See photo	
Field Station#	14181+00		Field Station#	14185+00	
Pic 3 Desc.	SSF is in good condition		Pic 4 Desc.	Waterbars are in good condition and functioning

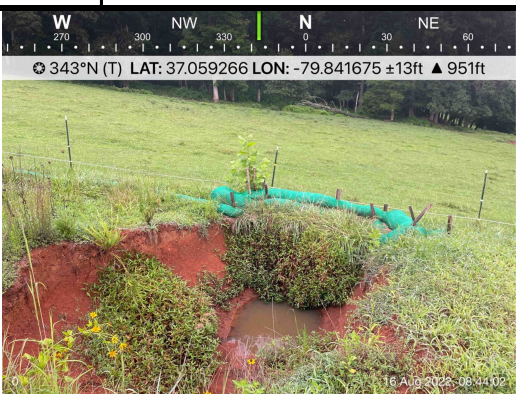
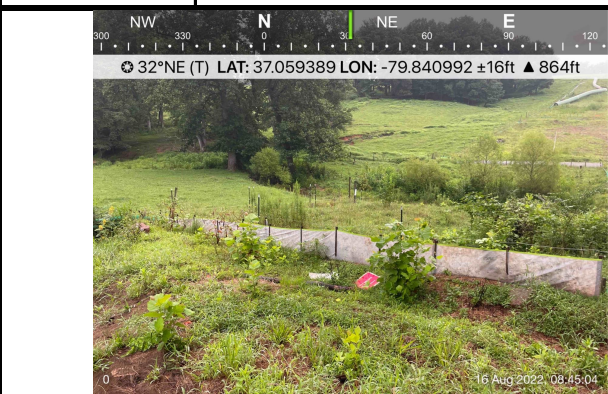
GPS Location	See photo		GPS Location	See photo	
Field Station#	14185+00		Field Station#	14190+00	
Pic 5 Desc.	End treatments are functioning as intended		Pic 6 Desc.	P1 is in good condition at all stream and wetland buffers

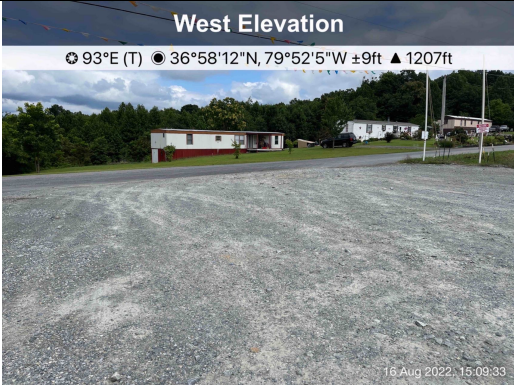
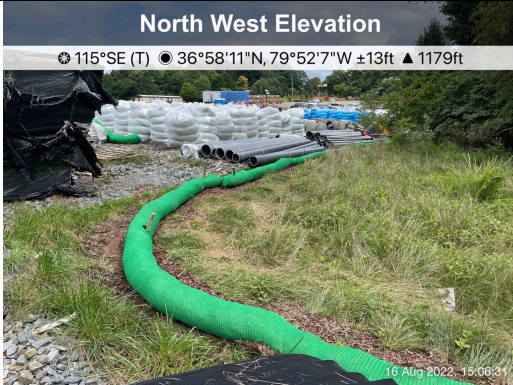
<b>GPS Location</b>	See picture		<b>GPS Location</b>	See picture	
<b>Field Station#</b>	0000+00		<b>Field Station#</b>	0000+00	
<b>Pic 1 Desc.</b>	RCE at LY-045 in good condition.		<b>Pic 2 Desc.</b>	Perimeter ECD's on west side of LY-045 in good condition.	
	<b>South East Elevation</b> 303°NW (T) 36°58'13"N, 79°52'9"W ±49ft ▲ 1187ft

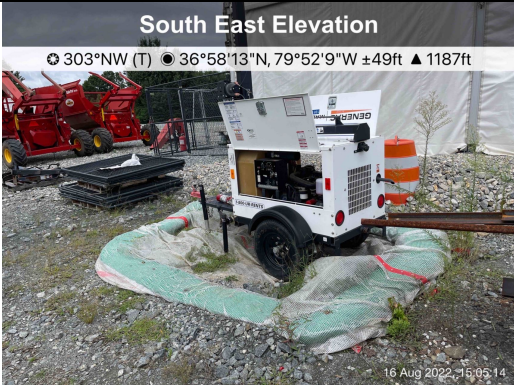
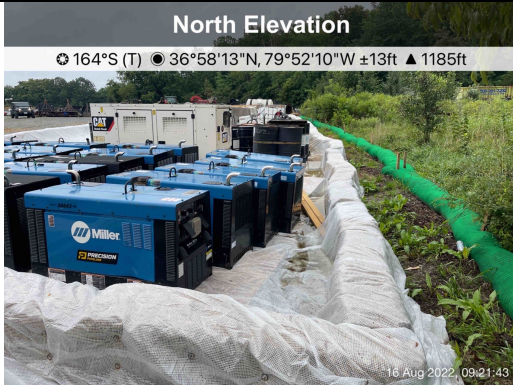
<b>GPS Location</b>	See picture		<b>GPS Location</b>	See picture	
<b>Field Station#</b>	0000+00		<b>Field Station#</b>	0000+00	
<b>Pic 3 Desc.</b>	Liner needs replacing on secondary containment structure on northwest corner of LY-045.		<b>Pic 4 Desc.</b>	Perimeter ECD's and secondary containment structure on north end of LY-045 in good condition.

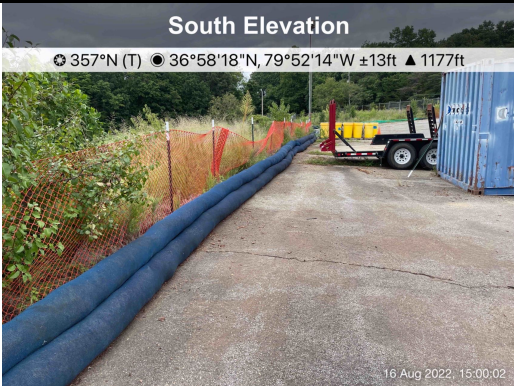
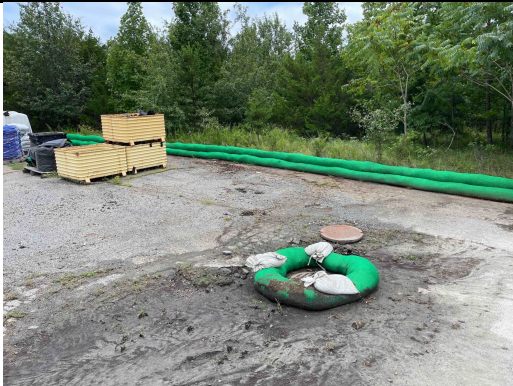
<b>GPS Location</b>	See picture		<b>GPS Location</b>	See picture	
<b>Field Station#</b>	0000+00		<b>Field Station#</b>	0000+00	
<b>Pic 5 Desc.</b>	Perimeter ECD's on west side of LY-046 in good condition.		<b>Pic 6 Desc.</b>	Perimeter ECD's and inlet protection on southwest corner of LY-046 in good condition.

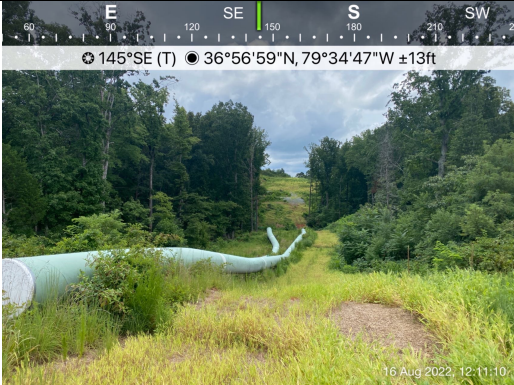
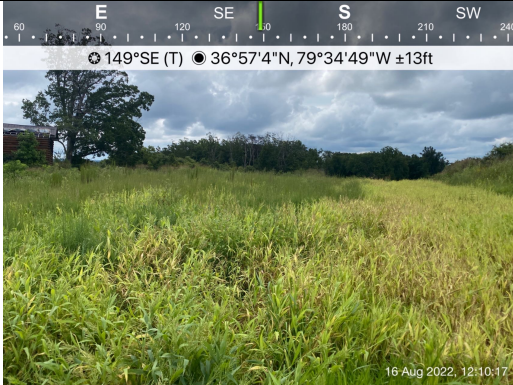
<b>GPS Location</b>	0	<b>GPS Location</b>	0		
<b>Field Station#</b>	15138+00	<b>Field Station#</b>	15131+00		
<b>Pic 1 Desc.</b>	Approximately 15138+00. Overview of ROW.		<b>Pic 2 Desc.</b>	Approximately 15131+00. Overview of ROW.

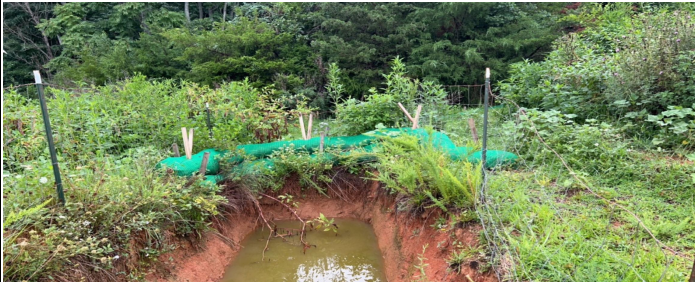
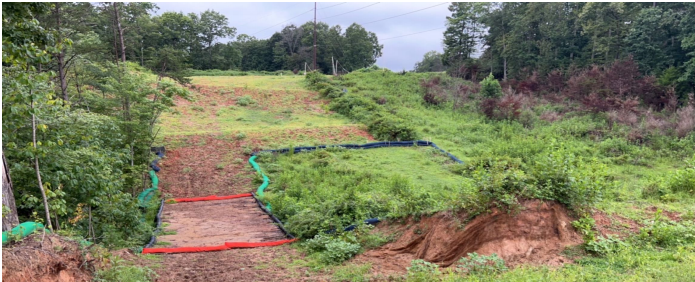
36°59'17" N 79°43'0" W 71°E COURSE 340' GPS 10196 Old Franklin Turnpike, Union Hall, VA 24176, United States 08.15.2022 09:36:19 Accur +/-15.4 Ft ALT 964 Ft			36°59'16" N 79°43'1" W 355°N COURSE 284' GPS 10196 Old Franklin Turnpike, Union Hall, VA 24176, United States 08.15.2022 09:35:38 Accur +/-15.5 Ft ALT 957 Ft		
GPS Location	1		GPS Location	2	
Field Station#	14669+00		Field Station#	14673+10	
Pic 1 Desc.	Sump pit and CFS end treatment performing intended functions.		Pic 2 Desc.	Equipment bridge and surrounding ECDs in place and functional at stream crossing and resource buffer.

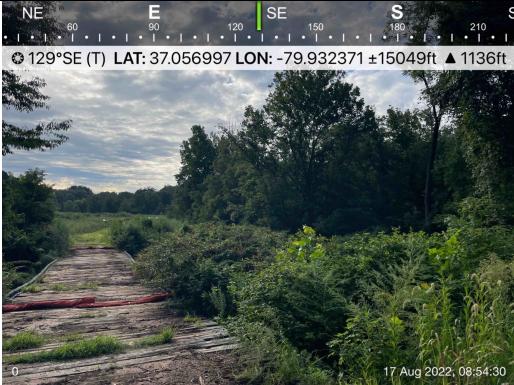
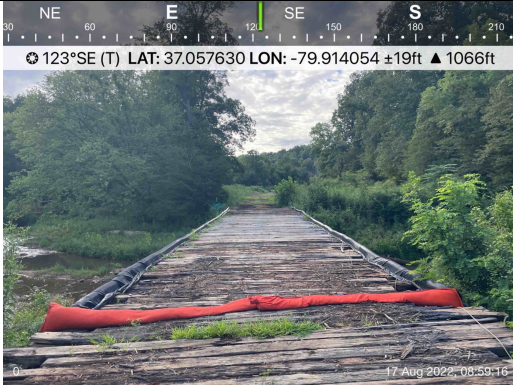
<b>GPS Location</b>	See photo	<b>GPS Location</b>	See photo		
<b>Field Station#</b>	13863+00	<b>Field Station#</b>	13875+73		
<b>Pic 1 Desc.</b>	Resource buffers remain well vegetated	<b>Pic 2 Desc.</b>	Equipment bridge ECDs are in good condition and functioning

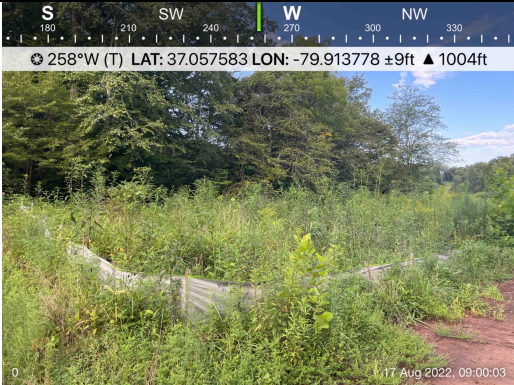
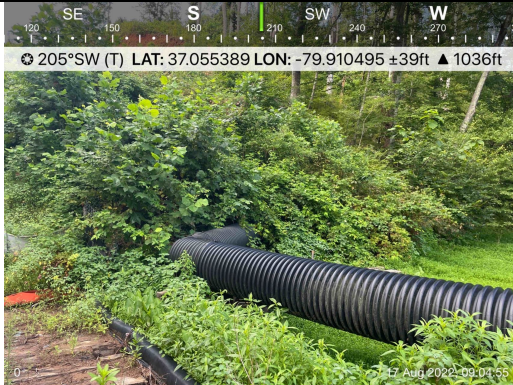
<b>GPS Location</b>	See photo	<b>GPS Location</b>	See photo		
<b>Field Station#</b>	13876+00	<b>Field Station#</b>	13888+00		
<b>Pic 3 Desc.</b>	P1 is in good condition at all stream and wetland buffers	<b>Pic 4 Desc.</b>	Slope drain is in good condition and functioning

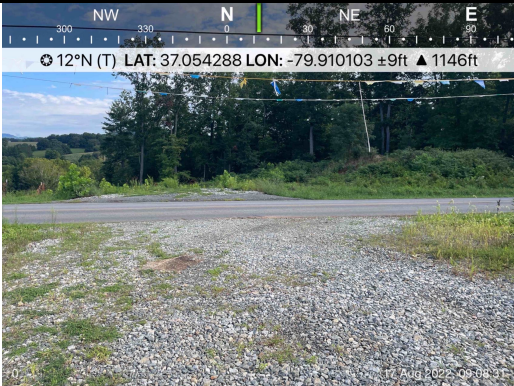
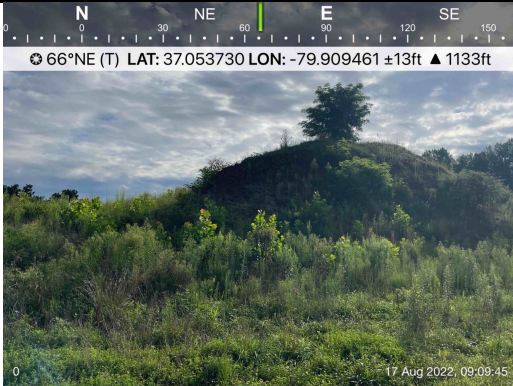
<b>GPS Location</b>	See photo	<b>GPS Location</b>	See photo		
<b>Field Station#</b>	13892+45	<b>Field Station#</b>	13897+00		
<b>Pic 5 Desc.</b>	RCEs are in good condition at all road crossings	<b>Pic 6 Desc.</b>	Topsoil pile remains stabilized

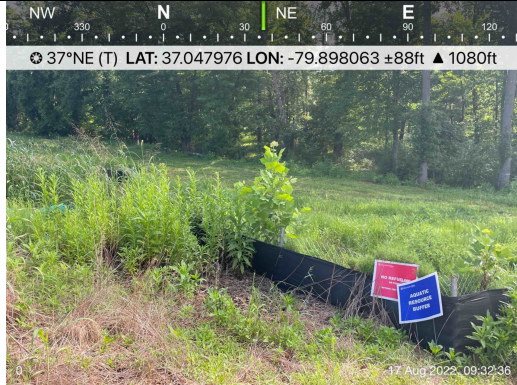
<b>GPS Location</b>	See photo		<b>GPS Location</b>	See photo	
<b>Field Station#</b>	13948+00		<b>Field Station#</b>	13955+00	
<b>Pic 11 Desc.</b>	SSF is in good condition		<b>Pic 12 Desc.</b>	Waterbars are in good condition throughout this section

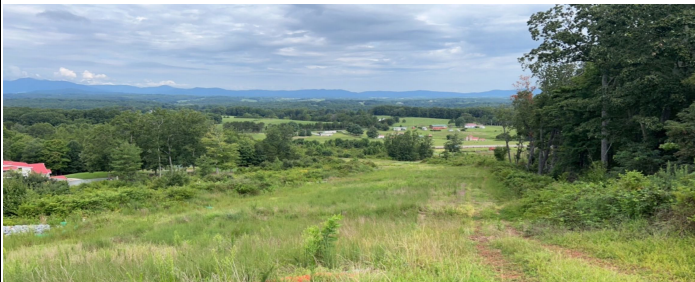
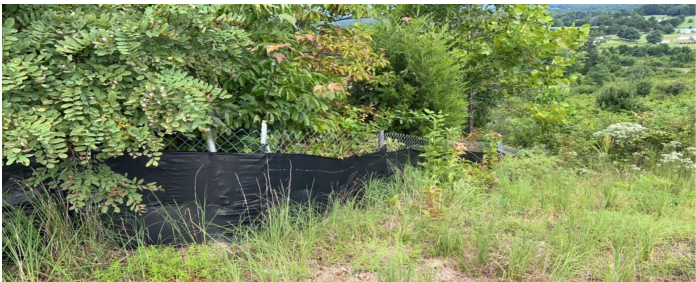
37°2'24" N 79°48'20" W 59°NE COURSE 2' GPS 1807 Golden View Rd, Glade Hill, VA 24092, United States 08.17.2022 10:14:52 Accur +/-11.6 Ft ALT 1225 Ft			37°2'23" N 79°48'21" W 28°NE COURSE 288' GPS 1807 Golden View Rd, Glade Hill, VA 24092, United States 08.17.2022 10:15:21 Accur +/-11.6 Ft ALT 1220 Ft		
<b>GPS Location</b>	1		<b>GPS Location</b>	2	
<b>Field Station#</b>	14325+00		<b>Field Station#</b>	14329+00	
<b>Pic 1 Desc.</b>	ROW stabilized and vegetated in temporary area.		<b>Pic 2 Desc.</b>	Perimeter SSF in place and functional.

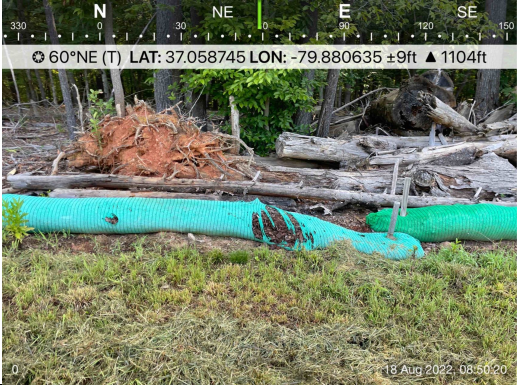
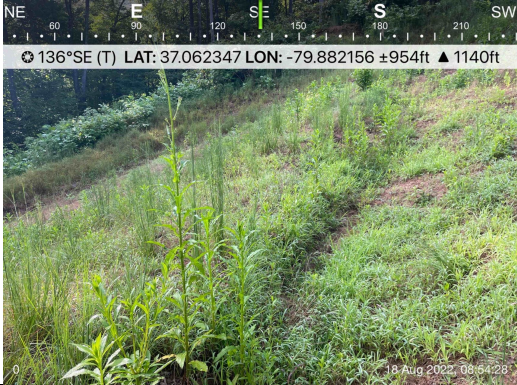
<b>GPS Location</b>	See photo		<b>GPS Location</b>	See photo	
<b>Field Station#</b>	14025+00		<b>Field Station#</b>	14033+00	
<b>Pic 7 Desc.</b>	CFS has been damaged by 3rd party mowing.		<b>Pic 8 Desc.</b>	Waterbars are in good condition

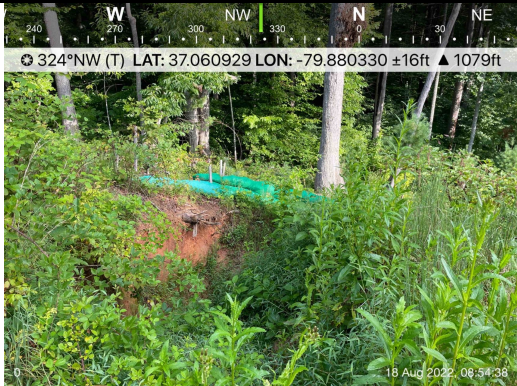
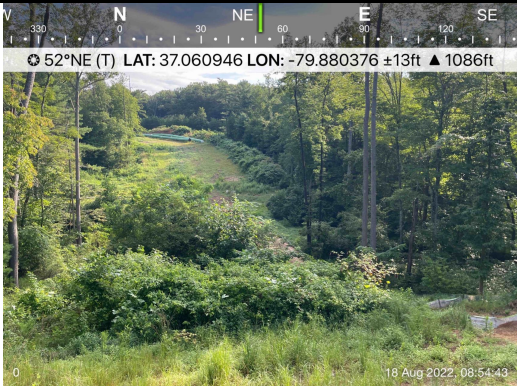
<b>GPS Location</b>	See photo		<b>GPS Location</b>	See photo	
<b>Field Station#</b>	14033+00		<b>Field Station#</b>	14035+00	
<b>Pic 9 Desc.</b>	End treatments are functioning as intended		<b>Pic 10 Desc.</b>	Resource buffers remain well vegetated

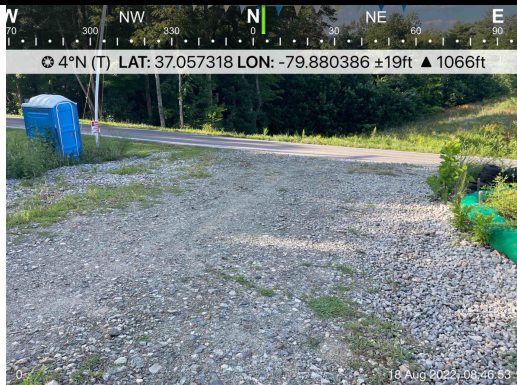
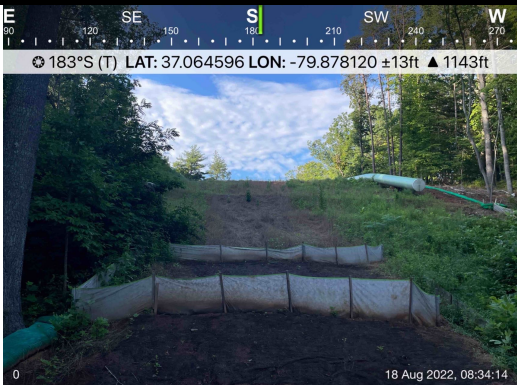
<b>GPS Location</b>	See photo		<b>GPS Location</b>	See photo	
<b>Field Station#</b>	14018+47		<b>Field Station#</b>	14050+00	
<b>Pic 11 Desc.</b>	RCEs are in good condition at all road crossings		<b>Pic 12 Desc.</b>	Slope remains stabilized with controls in place.

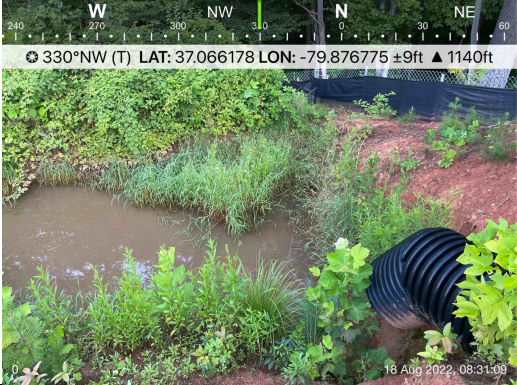
Insert image here			
<b>GPS Location</b>	See photo	<b>GPS Location</b>			
<b>Field Station#</b>	14057+00	<b>Field Station#</b>			
<b>Pic 13 Desc.</b>	Slope drain is functioning as intended	<b>Pic 14 Desc.</b>			
Insert image here		Insert image here			
<b>GPS Location</b>		<b>GPS Location</b>			
<b>Field Station#</b>		<b>Field Station#</b>			
<b>Pic 15 Desc.</b>		<b>Pic 16 Desc.</b>			
Insert image here		Insert image here			
<b>GPS Location</b>		<b>GPS Location</b>			
<b>Field Station#</b>		<b>Field Station#</b>			
<b>Pic 17 Desc.</b>		<b>Pic 18 Desc.</b>

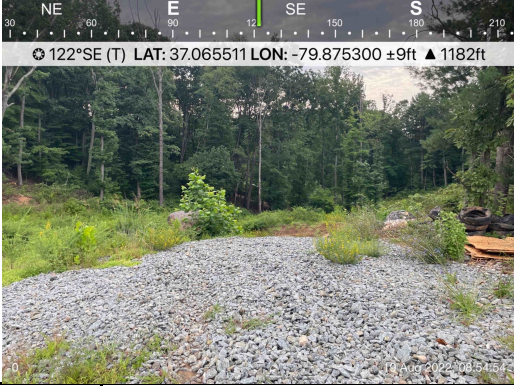
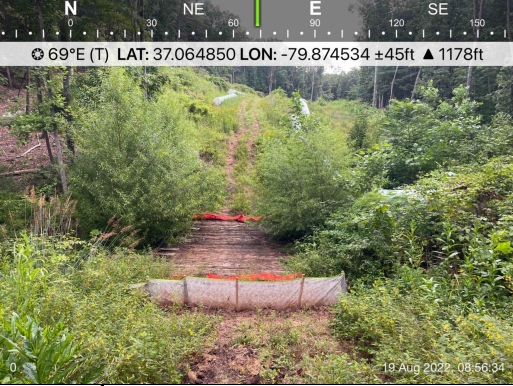
<b>GPS Location</b>	See photo		<b>GPS Location</b>	See photo	
<b>Field Station#</b>	14062+17		<b>Field Station#</b>	14066+77	
<b>Pic 1 Desc.</b>	RCEs are in good condition at all road crossings.		<b>Pic 2 Desc.</b>	Equipment bridge ECDs are in good condition and functioning

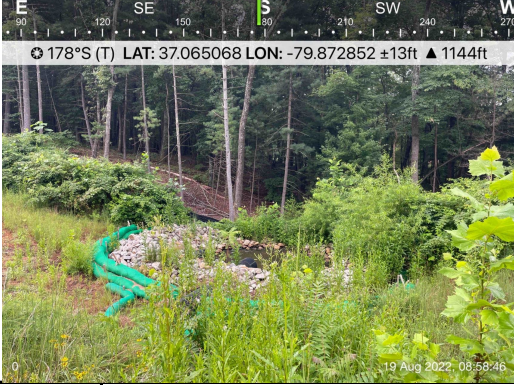
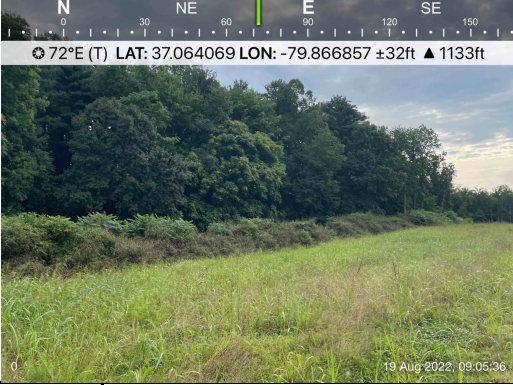
<b>GPS Location</b>	See photo		<b>GPS Location</b>	See photo	
<b>Field Station#</b>	14070+00		<b>Field Station#</b>	14085+00	
<b>Pic 3 Desc.</b>	CWDs are functioning as intended		<b>Pic 4 Desc.</b>	Topsoil berms remain stabilized

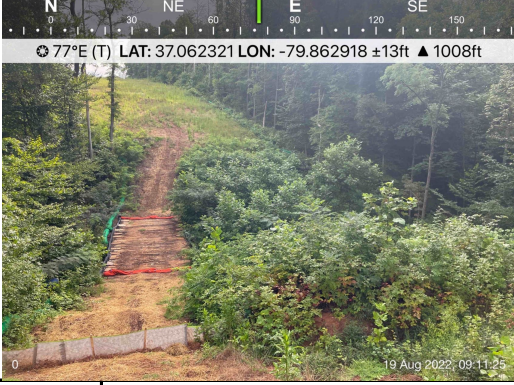
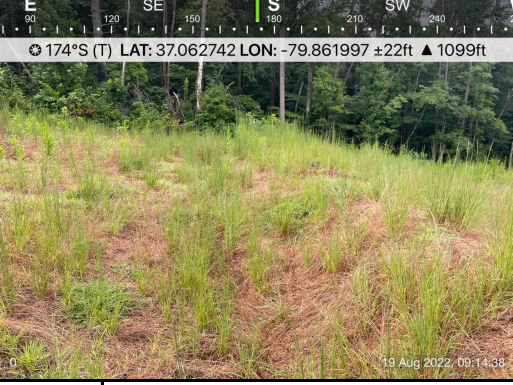
<b>GPS Location</b>	See photo		<b>GPS Location</b>	See photo	
<b>Field Station#</b>	14105+20		<b>Field Station#</b>	14110+00	
<b>Pic 5 Desc.</b>	Resource buffers remain well vegetated		<b>Pic 6 Desc.</b>	Waterbars are in good condition

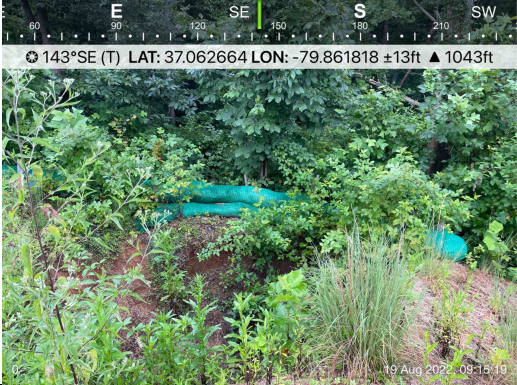
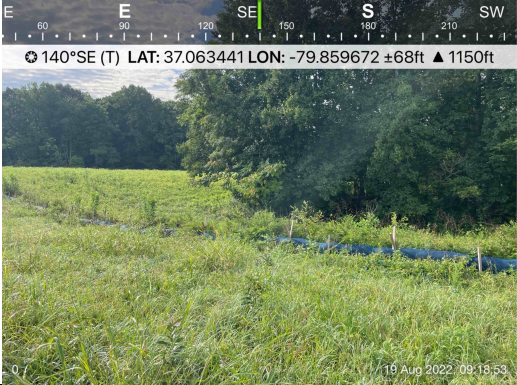
<b>GPS Location</b>	See photo		<b>GPS Location</b>	See photo	
<b>Field Station#</b>	14110+00		<b>Field Station#</b>	14120+00	
<b>Pic 7 Desc.</b>	End treatments are functioning as intended		<b>Pic 8 Desc.</b>	CFS is in good condition throughout this section

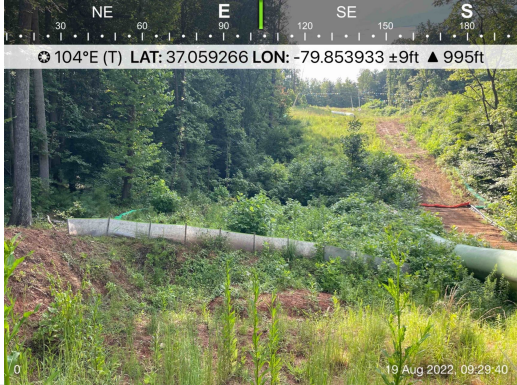
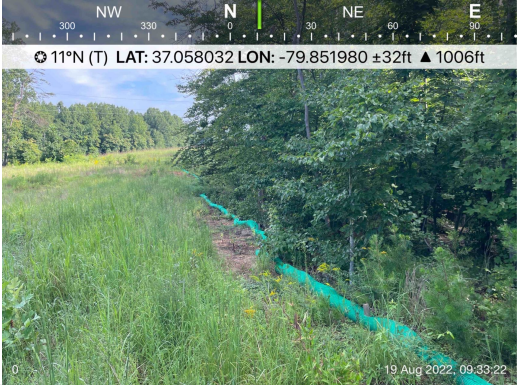
<b>GPS Location</b>	See photo		<b>GPS Location</b>	See photo	
<b>Field Station#</b>	14141+00		<b>Field Station#</b>	14150+00	
<b>Pic 9 Desc.</b>	P1 is in good condition at all stream and wetland buffers		<b>Pic 10 Desc.</b>	CFS is in good condition throughout this section

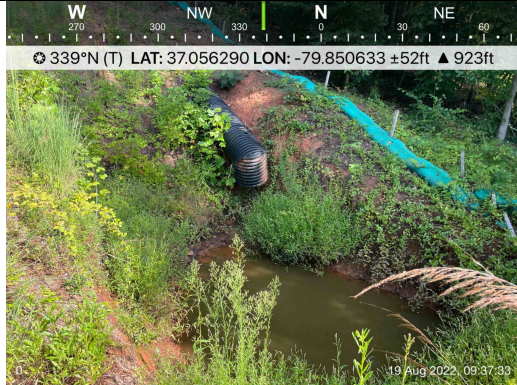
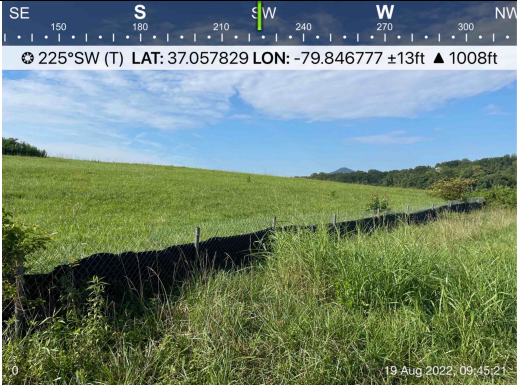
<b>GPS Location</b>	See photo		<b>GPS Location</b>	See photo	
<b>Field Station#</b>	14156+00		<b>Field Station#</b>	14171+36	
<b>Pic 11 Desc.</b>	Slope drain is in good condition and functioning		<b>Pic 12 Desc.</b>	SSF is in good condition

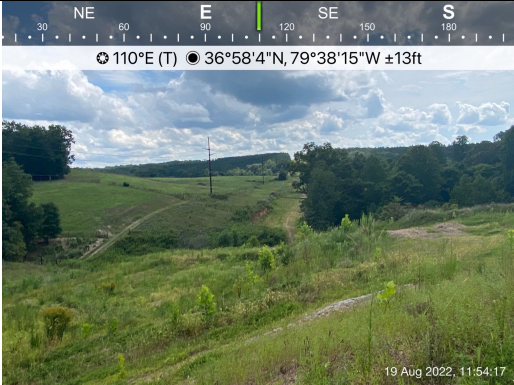
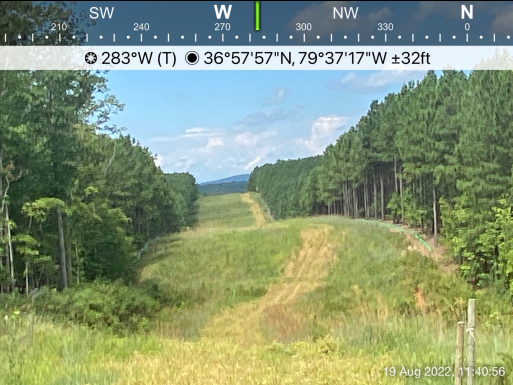
<b>GPS Location</b>	0	<b>GPS Location</b>	0		
<b>Field Station#</b>	14930+00	<b>Field Station#</b>	14975+00		
<b>Pic 1 Desc.</b>	Approximately 14930+00. Overview of ROW.		<b>Pic 2 Desc.</b>	Approximately 14975+00. Overview of ROW. Permanent vegetation.

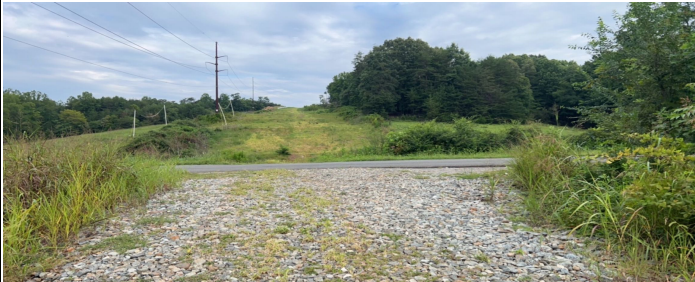
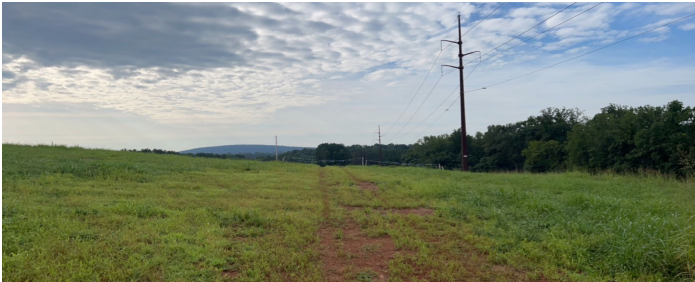
37°0'18" N 79°45'9" W 311°NW COURSE -1' GPS 08.19.2022 09:00:01 Accur +/-15.1 Ft ALT 945 Ft			37°0'18" N 79°45'9" W 216°SW COURSE 166' GPS 08.19.2022 09:00:16 594 Tobacco Rd, Glade Hill, VA 24092, United States Accur +/-15.6 Ft ALT 939 Ft		
GPS Location	1		GPS Location	2	
Field Station#	14546+75		Field Station#	14549+00	
Pic 1 Desc.	RCE in good condition at Tobacco Rd.		Pic 2 Desc.	ROW stabilized and vegetated in temporary area.
