Wetland Biological Conditions EA Report

Project Name	H-600 Pipeline Spread B	A/E	124300130	Spread	H-600 Pipeline Spread B
Contractor	Precision	Report #	18		
Environmental Auditor	Devin Jen			Date/Time	8/15/2023 8:15 AM
Wetland ID	W-115	Crossing Start Date	8/15/2023	Crossing Completion Date	8/19/2023
Milepost	55.19	Pre-Con Assessment Date	8/15/2023	Post-Con Assessment Date	8/19/2023
Station	2914+03	Cowardin Classification	PEM	Wetland Impact Area(acs)	0.0631
State	WV				
County	Lewis

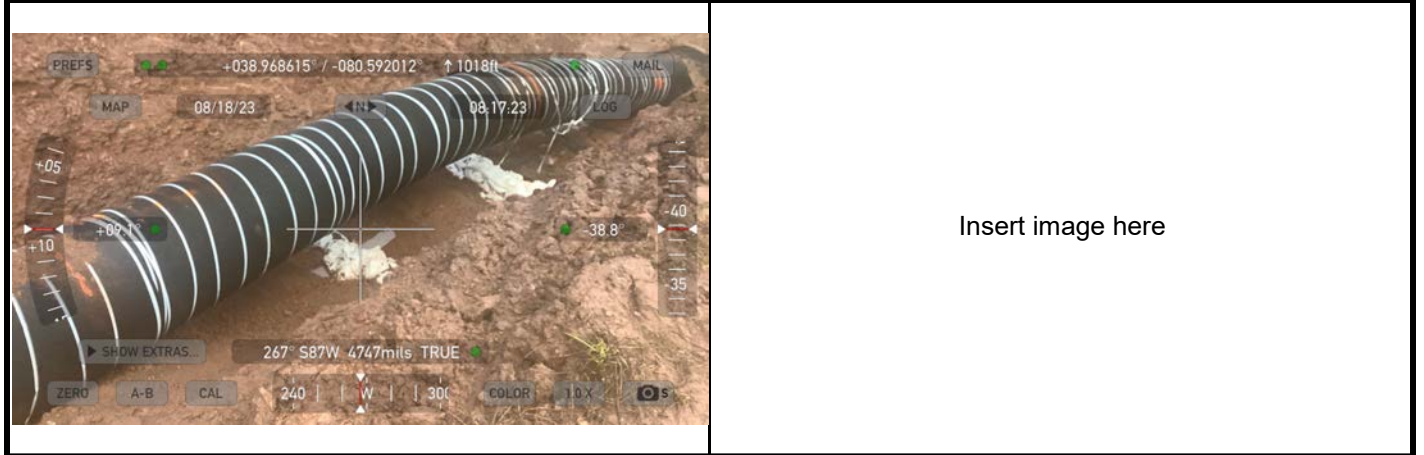
Description	View of the pipe that was placed through the wetland crossing at the start of the workday on 8/18/2023.	Description	
--------------------	---	--------------------	--
