Stream Biological Conditions EA Report

| Project Name | H-600 Pipeline Spread B | AFE | 124300130 | Spread | H-600 Pipeline Spread B |
| Stream ID | S-H165 | Crossing Start Date | 8/31/2023 | Crossing Completion Date | 9/7/2023 |

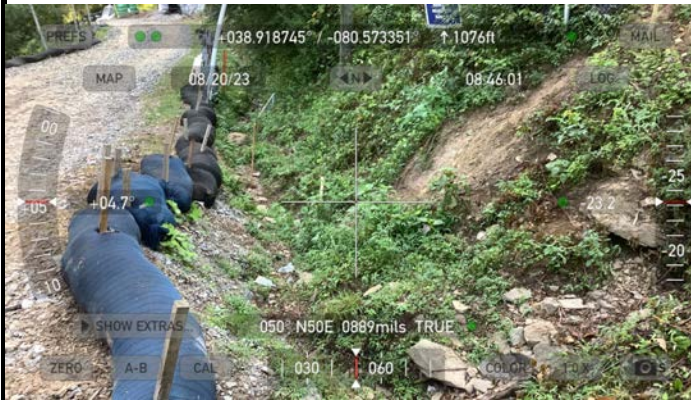
| Description | Downstream view of permitted impact area during pre-construction assessment. |

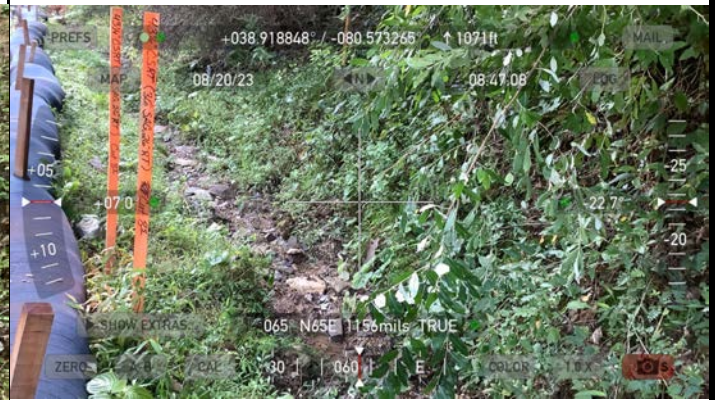
| Description | Downstream view of unimpacted area during pre-construction assessment. |

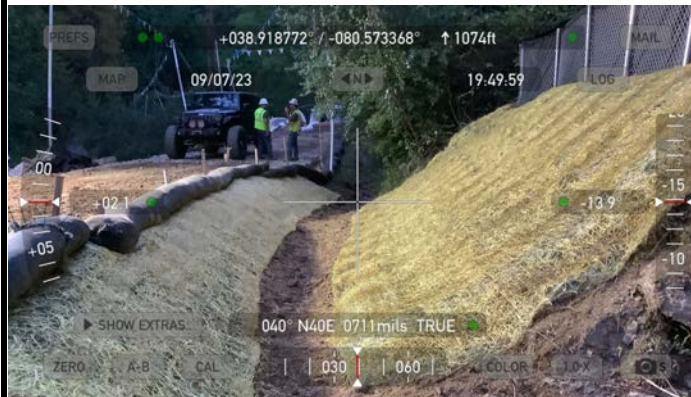
| Description | Downstream view of permitted impact area during post-construction assessment. |

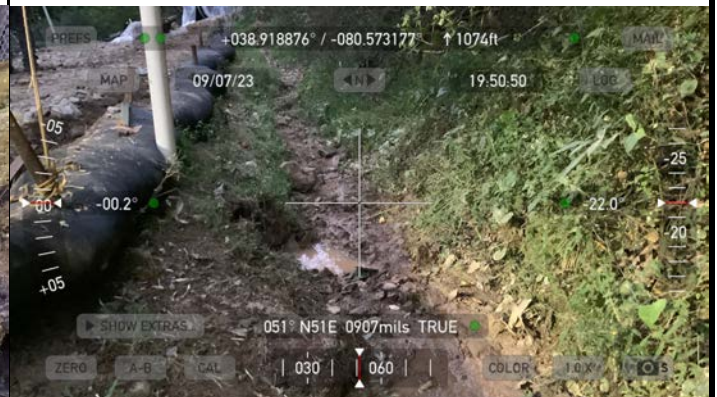
| Description | Downstream view of unimpacted area during post-construction assessment. |

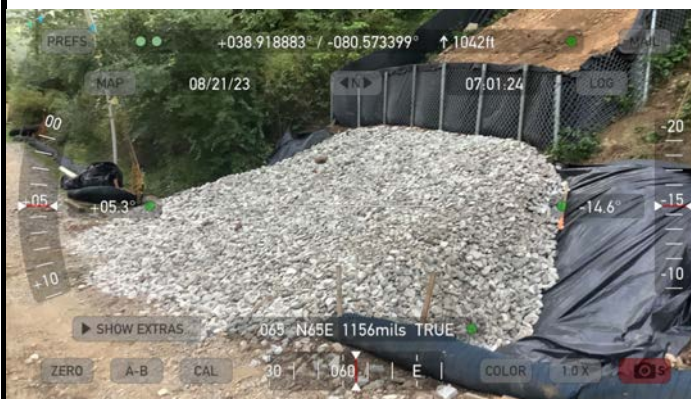
| Description | Flume was placed on 8/20/2023. The photo was taken at the beginning of the workday on 8/21/2023. Stream crossing will not start today. |

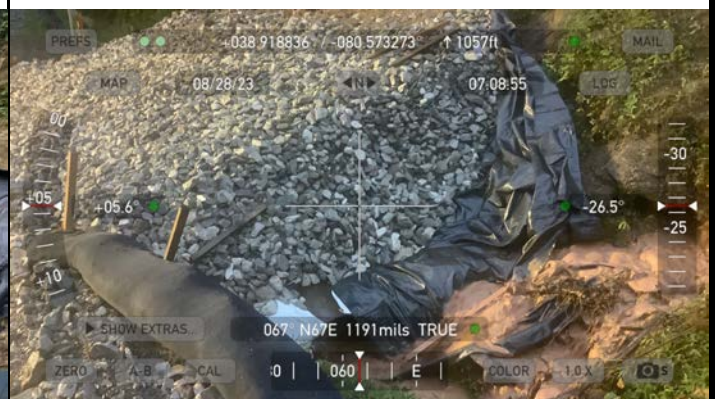
| Description | The photo was taken at the beginning of the workday on 8/28/2023. The stream crossing will not start today. |

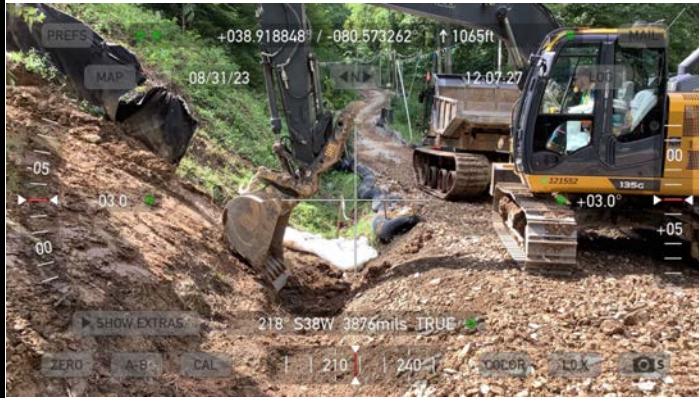
Description The photo shows the top 12 inches of streambed topsoil being removed on 8/31/2023.

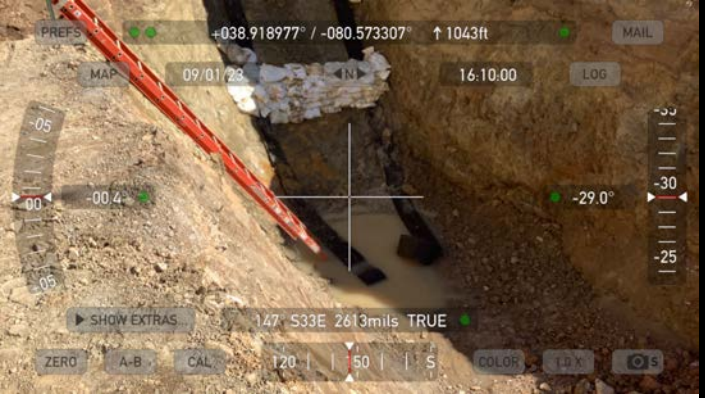
Description The photo shows the progress of the trench excavation on 9/1/2023.

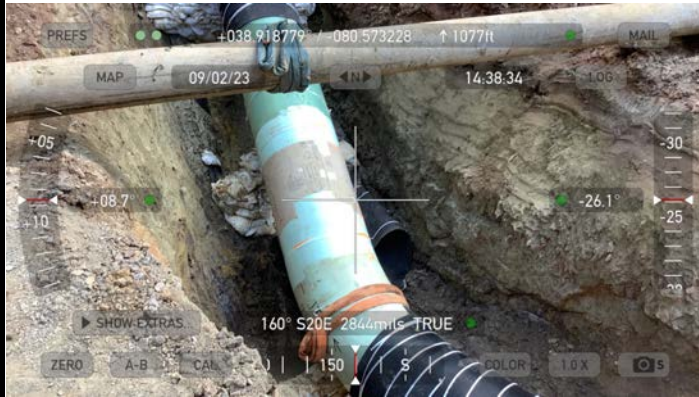
Description The photo shows the positioning of the pipe and the addition of sandbags within the area of the stream crossing on 9/2/2023.

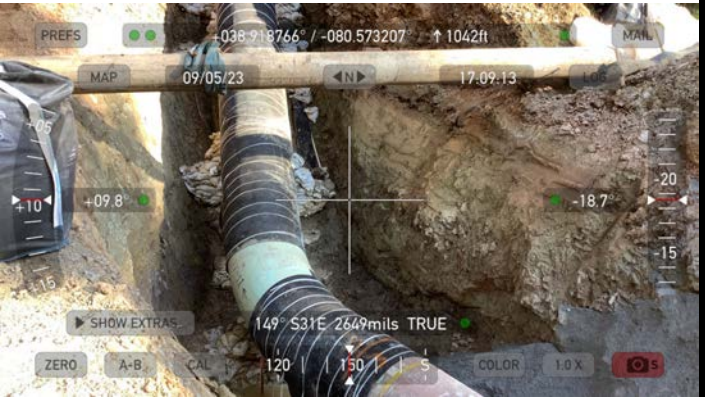
Description The photo shows the area of the stream crossing on 9/5/2023.

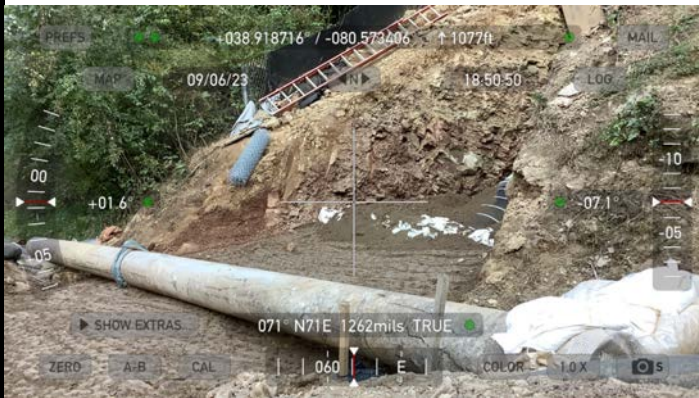
Description The photo shows the area of the stream crossing at the end of the workday on 9/6/2023.
