Stream Biological Conditions EA Report

Project Name	H-600 Pipeline Spread E	AFE	124300134	Spread	H-600 Pipeline Spread E
Contractor	Price Gregory	Report #	34		
Environmental Auditor	Charles Haden	Date/Time	8/14/2023 7:35 AM		
Stream ID	S-H67	Crossing Start Date	8/14/2023	Crossing Completion Date	8/23/2023
Milepost	131.95	Pre-Con Assessment Date	8/14/2023	Post-Con Assessment Date	8/23/2023
Station	6966+76	Bankfull Width (ft.)	6.8	Riffle:Pool Complexes Present?	No
State	WV	Stream Classification	Perennial		
County	Nicholas	303(d) Impairment Listing	N/A

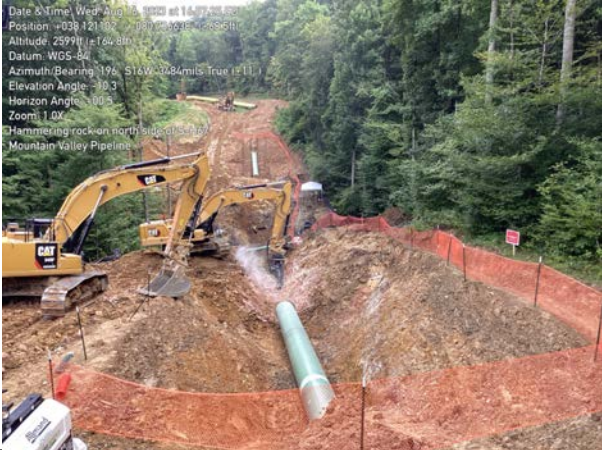
<p style="font-size: small; margin-top: 5px;">Date & Time: Wed, Aug 16, 2023 at 14:07:55 EDT Position: +038.121100, -080.736981 (-24.91h) Altitude: 2597ft (-76.81h) Datum: WGS-84 Azimuth/Bearing: 196 S16W 0.84mils True (-11) Elevation Angle: -10.3 Horizon Angle: -10.5 Zoom: 1.0X Hammering rock on north side of S-H67 Mountain Valley Pipeline</p>

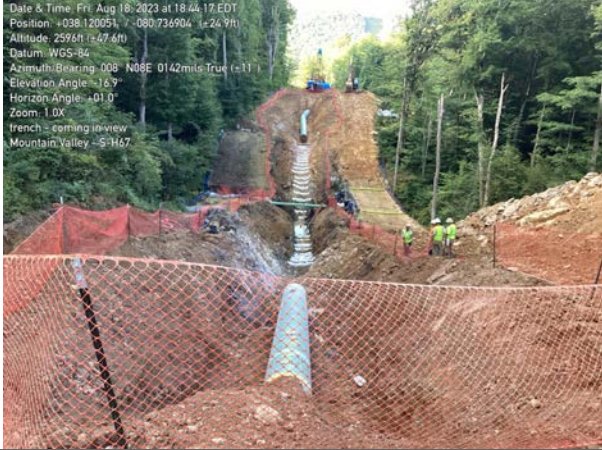
<p style="font-size: small; margin-top: 5px;">Date & Time: Fri, Aug 18, 2023 at 18:44:17 EDT Position: +038.120051, -080.736904 (-24.91h) Altitude: 2596ft (-76.81h) Datum: WGS-84 Azimuth/Bearing: 008 N08E 0.142mils True (-11) Elevation Angle: -13.7 Horizon Angle: -01.0 Zoom: 1.0X Trench - coming in view Mountain Valley - S-H67</p>
GPS Location See Photo	GPS Location See Photo
Description Photo 3. On-going hammering and excavation in trench.	Description Photo 4. Bedding placed in trench.

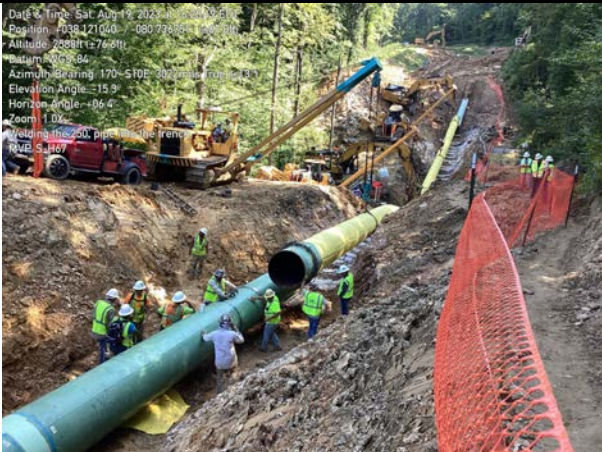
<p style="font-size: small; margin-top: 5px;">Date & Time: Sat, Aug 19, 2023 at 13:02:06 EDT Position: +038.121000, -080.736981 (-24.91h) Altitude: 2598ft (-76.81h) Datum: WGS-84 Azimuth/Bearing: 170 S10E 0.80mils True (-11) Elevation Angle: -15.9 Horizon Angle: -10.6 Zoom: 1.0X Leveling the 250 pipe into the trench MVP S-H67</p>

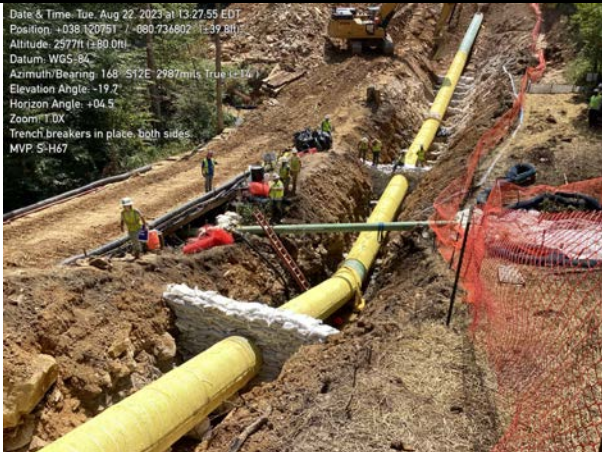
<p style="font-size: small; margin-top: 5px;">Date & Time: Tue, Aug 22, 2023 at 13:27:55 EDT Position: +038.120751, -080.736802 (-24.91h) Altitude: 2577ft (-76.81h) Datum: WGS-84 Azimuth/Bearing: 168 S12E 2.987mils True (-11) Elevation Angle: -19.7 Horizon Angle: -06.5 Zoom: 1.0X Trench breakers in place, both sides MVP S-H67</p>

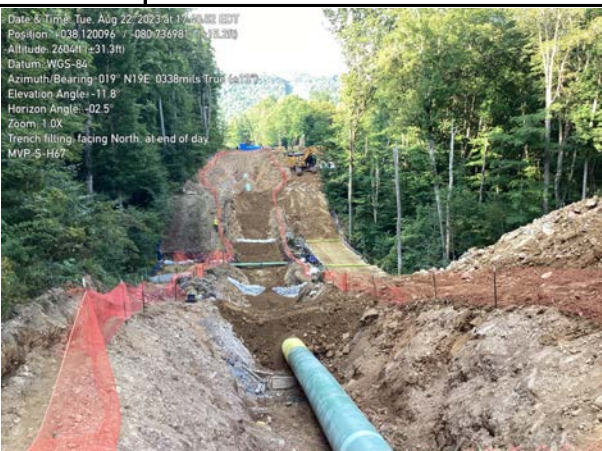
<p style="font-size: small; margin-top: 5px;">Date & Time: Tue, Aug 22, 2023 at 17:44:03 EDT Position: +038.120096, -080.736981 (-24.91h) Altitude: 2604ft (-76.81h) Datum: WGS-84 Azimuth/Bearing: 019 N19E 0.338mils True (-11) Elevation Angle: -11.8 Horizon Angle: -02.5 Zoom: 1.0X Trench filling, facing North, at end of day MVP S-H67</p>

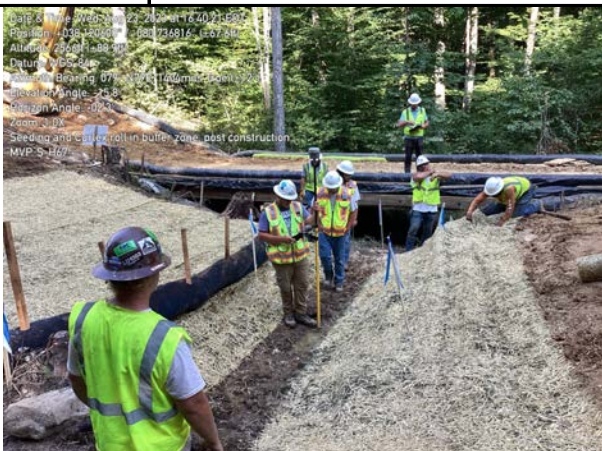
<p style="font-size: small; margin-top: 5px;">Date & Time: Wed, Aug 23, 2023 at 16:20:11 EDT Position: +038.120000, -080.736816 (-24.91h) Altitude: 2604ft (-76.81h) Datum: WGS-84 Azimuth/Bearing: 071 N07E 1.160mils True (-11) Elevation Angle: -23.0 Horizon Angle: -00.0 Zoom: 1.0X Seeding and cover roll in buffer zone, post construction MVP S-H67</p>
GPS Location See Photo	GPS Location See Photo
Description Photo 7. Backfilling of trench.	Description Photo 8. Survey of restored stream.
