Stream Biological Conditions EA Report

Project Name	H-600 Pipeline Spread C	AFE	124300131	Spread	H-600 Pipeline Spread C
Contractor	Precision	Report #	290		
Environmental Auditor	Scott Wessel	Date/Time	10/10/2023 6:03 AM		
Stream ID	S-A92	Crossing Start Date	10/10/2023	Crossing Completion Date	10/13/2023
Milepost	92.60	Pre-Con Assessment Date	9/18/2023	Post-Con Assessment Date	10/13/2023
Station	4889+28	Bankfull Width (ft.)	3.0	Riffle:Pool Complexes Present?	No
State	WV	Stream Classification	Ephemeral		
County	Webster	303(d) Impairment Listing	No

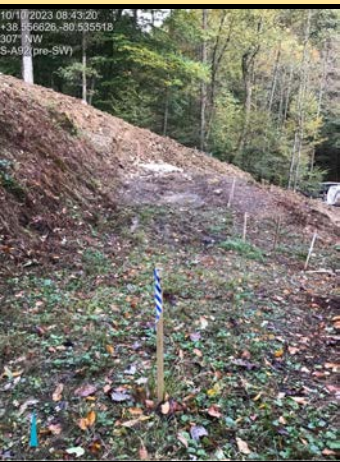
GPS Location	See GPS in above photo.
Description	Downstream view of permitted impact area during pre-construction assessment.	Description	Downstream view of unimpacted area during pre-construction assessment.

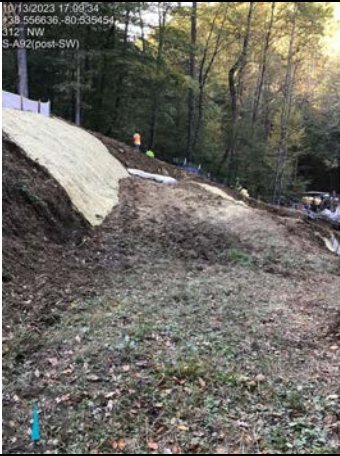
GPS Location	See GPS in above photo.	GPS Location	See GPS in above photo.	Description	Downstream view of permitted impact area during post-construction assessment.

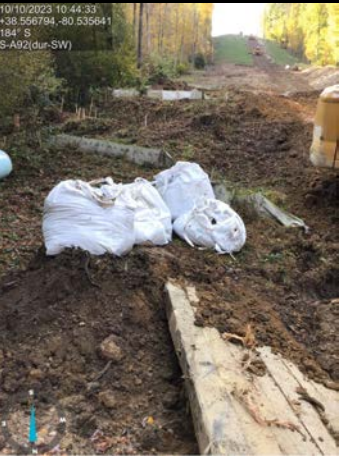
GPS Location	See GPS in above photo.
Description	Removing topsoil and stream S-A92 substrate to be segregated.	Description	Substrate material for S-A92 and S-A93 segregated into super sacks.
