# Stream Biological Conditions EA Report

<b>Project Name</b>	H-600 Pipeline Spread D	<b>AFE</b>	124300132	<b>Spread</b>	H-600 Pipeline Spread D
<b>Contractor</b>	Precision	<b>Report #</b>	235		
<b>Environmental Auditor</b>	Todd Grant	<b>Date/Time</b>	9/11/2023 9:07 PM		
<b>Stream ID</b>	S-B29	<b>Crossing Start Date</b>	9/11/2023	<b>Crossing Completion Date</b>	9/22/2023
<b>Milepost</b>	107.20	<b>Pre-Con Assessment Date</b>	9/8/2023	<b>Post-Con Assessment Date</b>	9/23/2023
<b>Station</b>	5660+38	<b>Bankfull Width (ft.)</b>	7.0	<b>Riffle:Pool Complexes Present?</b>	No
<b>State</b>	WV	<b>Stream Classification</b>	Perennial		
<b>County</b>	Webster	<b>303(d) Impairment Listing</b>	Iron

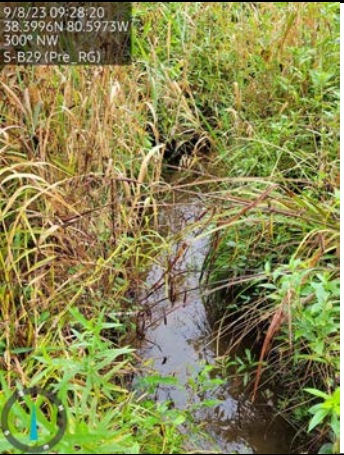
<p>9/8/23 09:28:20 +38.3996N -80.5973W 300° NW S-B29 (Pre_RG)</p>			  <p>09/11/2023 11:35:41 / +38.399659 -80.597325 348° S-B29 (Dur_DS)</p>	
<b>GPS Location</b>	See photo above	<b>GPS Location</b>	See photo above	<b>Description</b>	Downstream view of permitted impact area during pre-construction assessment. Looking downstream from upstream LOD pre-construction.
<b>Description</b>	Downstream view of permitted impact area during pre-construction assessment. Looking downstream from upstream LOD pre-construction.	<b>Description</b>	Downstream view of unimpacted area during pre-construction assessment. View of downstream flow from LOD at center of equipment bridge.	<b>GPS Location</b>	See photo above
	  <p>09/23/2023 13:53:23 +38.399123, -80.597377 351° N S-B29 (Pos_TG)</p>			  <p>09/23/2023 13:54:12 +38.399719, -80.597412 339° N S-B29 (Pos_TG)</p>

<b>GPS Location</b>	See photo above	<b>GPS Location</b>	See photo above	<b>Description</b>	Downstream view of permitted impact area during post-construction assessment. Looking downstream from upstream LOD post-construction..
<b>Description</b>	Downstream view of permitted impact area during post-construction assessment. Looking downstream from upstream LOD post-construction..	<b>Description</b>	Downstream view of unimpacted area during post-construction assessment. View of downstream flow from LOD at center of equipment bridge.	<b>GPS Location</b>	See photo above
	  <p>09/11/2023 15:41:09 +38.399606, -80.597629 151° SE S-B-29 Dur_TG)</p>			  <p>09/11/2023 17:25:58 +38.399659, -80.597391 24° NE S-B29 (Dur_TG)</p>	
<b>GPS Location</b>	See photo above	<b>GPS Location</b>	See photo above	<b>Description</b>	View of contractor segregating streambed substrate into super sacks.
<b>Description</b>	View of contractor segregating streambed substrate into super sacks.	<b>Description</b>	View of flume pipe installed in S-B29 after removal of dam and pump.	<b>GPS Location</b>	See photo above

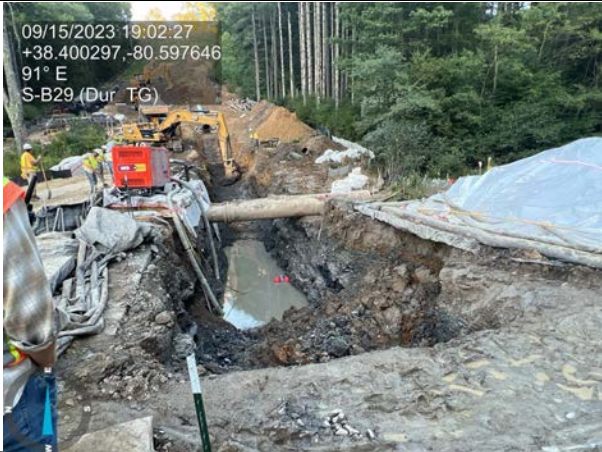
<p>09/15/2023 19:02:27 +38.400297,-80.597646 91° E S-B29 (Dur TG)</p>

<p>09/16/2023 14:08:36 +38.399467,-80.597667 71° E S-B29 (Dur TG)</p>	
<b>GPS Location</b>	See photo above	<b>GPS Location</b>	See photo above
<b>Description</b>	View of the ditch under the stream S-B29 flume pipe.	<b>Description</b>	View of the pipe extending under the flume pipe for stream S-B29.

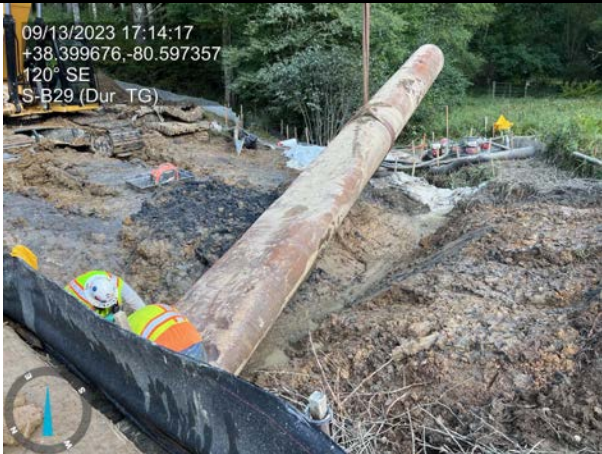
<p>09/13/2023 17:14:17 +38.399676,-80.597357 120° SE S-B29 (Dur TG)</p>

<p>09/14/2023 17:17:07 +38.400324,-80.597654 283° W S-B29 (Dur TG)</p>	
<b>GPS Location</b>	See photo above	<b>GPS Location</b>	See photo above
<b>Description</b>	View of dam and pump equipment and flume pipe being re-installed following blasting activities through stream S-B29.	<b>Description</b>	View of the pump around discharge at downstream LOD.

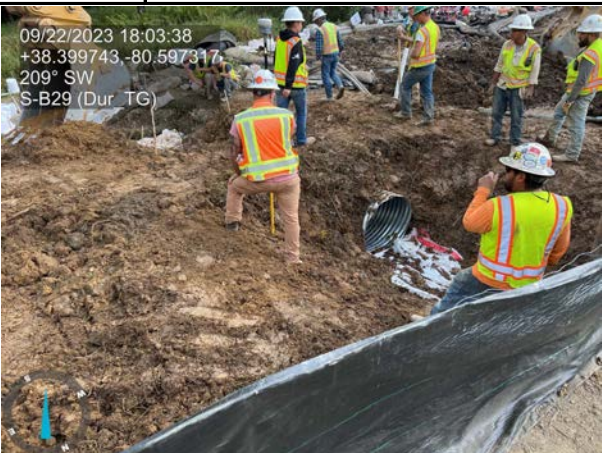
<p>09/22/2023 18:03:38 +38.399743,-80.597317 209° SW S-B29 (Dur TG)</p>

<b>GPS Location</b>	See photo above	<b>GPS Location</b>	See photo above
<b>Description</b>	View of survey activities during stream bank restoration.	<b>Description</b>	View of contractor environmental crew stabilizing stream banks and culvert.
