Stream Biological Conditions EA Report

Project Name	H-600 Pipeline Spread A	AFE	124300129	Spread	H-600 Pipeline Spread A
Contractor	Precision	Report #	254		
Environmental Auditor	Rachel Ellis	Date/Time	9/7/2023 11:23 AM		
Stream ID	S-B3a	Crossing Start Date	9/19/2023	Crossing Completion Date	9/23/2023
Milepost	18.92	Pre-Con Assessment Date	9/7/2023	Post-Con Assessment Date	10/3/2023
Station	998+83	Bankfull Width (ft.)	18.0	Riffle:Pool Complexes Present?	No
State	WV	Stream Classification	Perennial		
County	Harrison	303(d) Impairment Listing	Biological, Fecal, Iron

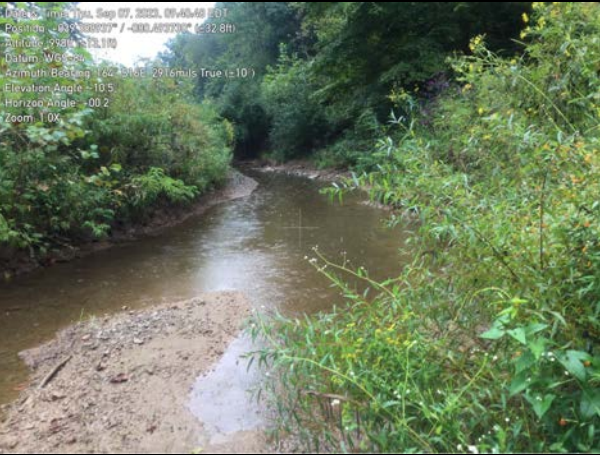
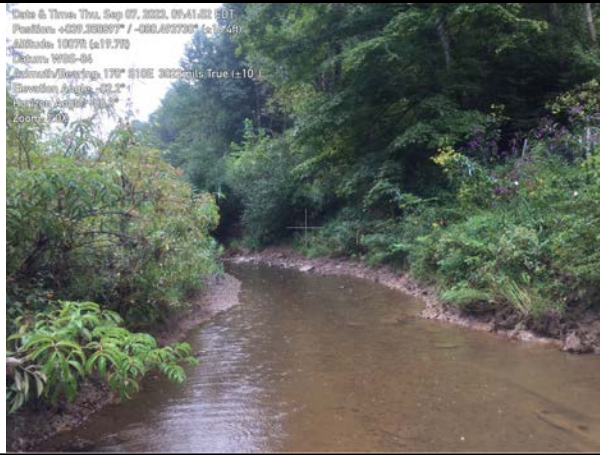
<p><small>Date & Time: Thu, Sep 07, 2023, 09:41:02 EDT Position: +039.358897° / -080.492707° (±16.8 ft) Altitude: 1077 ft (±19.7 ft) Datum: WGS-84 Azimuth Bearing: 177° 41'00" (±10°) Elevation Angle: -02.2° Horizon Angle: +00.2° Zoom: 1.0X</small></p>		GPS Location	Refer to Photograph.	GPS Location	Refer to Photograph.				
Description	Downstream view of permitted impact area during pre-construction assessment.	Description	Downstream view of unimpacted area during pre-construction assessment.

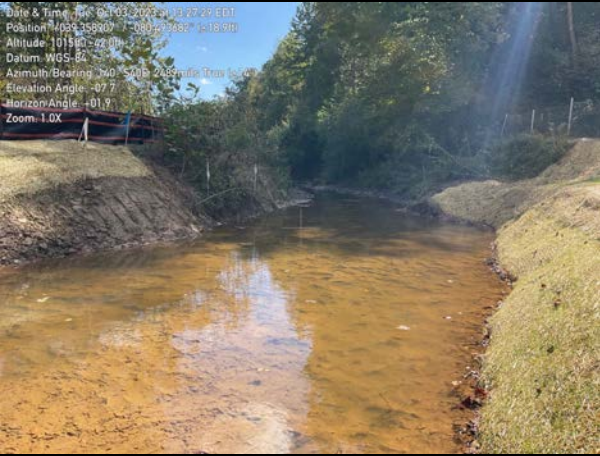
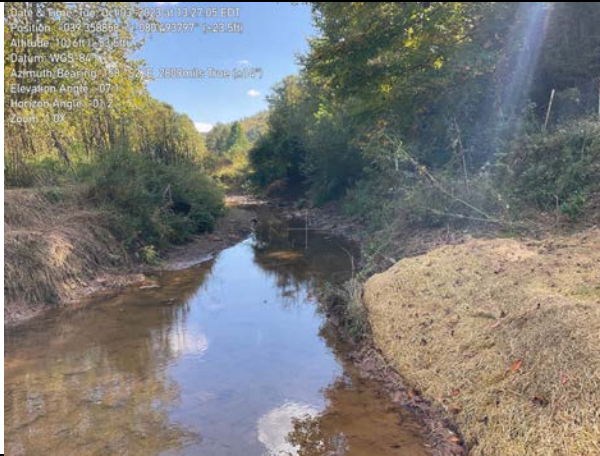
Description	Downstream view of permitted impact area during post-construction assessment.	Description	Downstream view of unimpacted area during post-construction assessment.

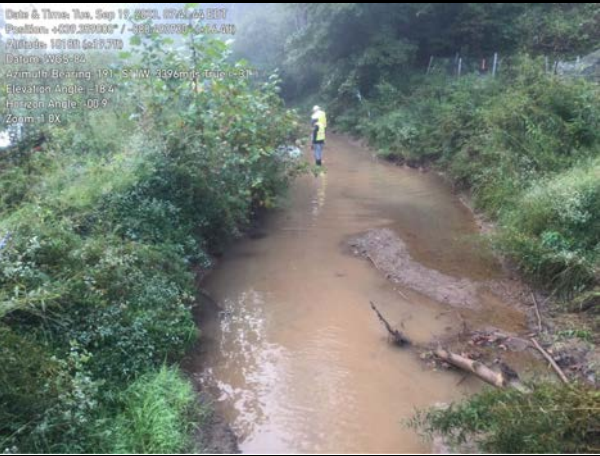
<p><small>Date & Time: Thu, Sep 07, 2023, 09:46:46 EDT Position: +039.359007° / -080.492707° (±16.8 ft) Altitude: 1077 ft (±19.7 ft) Datum: WGS-84 Azimuth Bearing: 177° 41'00" (±10°) Elevation Angle: -02.2° Horizon Angle: +00.2° Zoom: 1.0X</small></p>		  <p><small>Date & Time: Wed, Sep 20, 2023, 14:00:58 EDT Position: +039.359130° / -080.494070° (±16.421 ft) Altitude: 982 ft (±207.1 ft) Datum: WGS-84 Azimuth Bearing: 314° N44W 5618mils True (±25°) Elevation Angle: +26.3° Horizon Angle: +00.0° Zoom: 1.0X</small></p>		GPS Location	Refer to Photograph.	GPS Location	Refer to Photograph.
Description	The dams and pumps were placed into the permitted area.	Description	The excavation of the crossing continued.

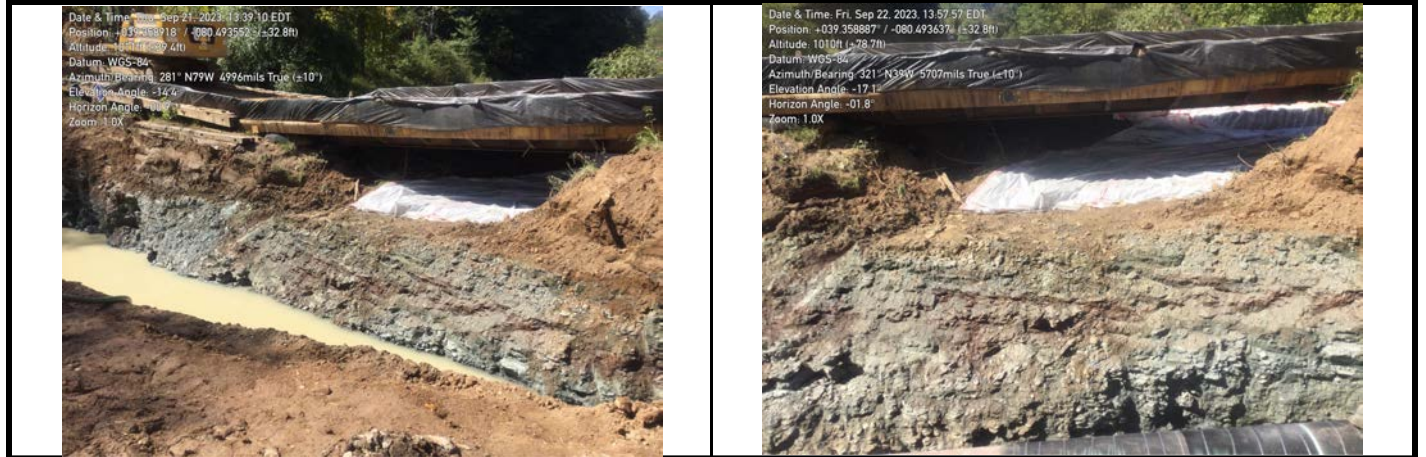
GPS Location	Refer to Photograph.	GPS Location	Refer to Photograph.
Description	The excavation continued until pipe could be placed into crossing.	Description	The construction continued as the area was prepared for backfilling.

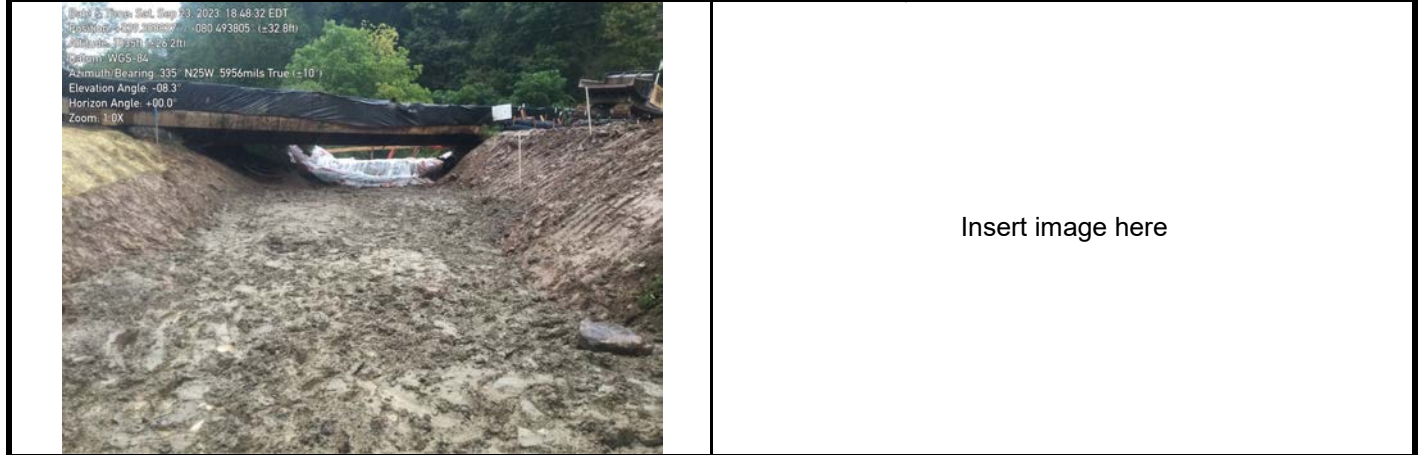
GPS Location	Refer to Photograph.	GPS Location	
Description	The stream crossing was backfilled and stabilized.	Description
