## Stream Biological Conditions EA Report

<b>Project Name</b>	H-600 Pipeline Spread C	<b>AFE</b>	124300131	<b>Spread</b>	H-600 Pipeline Spread C
<b>Contractor</b>	Precision	<b>Report #</b>	249		
<b>Environmental Auditor</b>	Jeffrey Arbogast	<b>Date/Time</b>	9/22/2023 3:19 PM		
<b>Stream ID</b>	S-H104	<b>Crossing Start Date</b>	9/22/2023	<b>Crossing Completion Date</b>	9/27/2023
<b>Milepost</b>	93.29	<b>Pre-Con Assessment Date</b>	9/11/2023	<b>Post-Con Assessment Date</b>	9/27/2023
<b>Station</b>	4925+68	<b>Bankfull Width (ft.)</b>	14.8	<b>Riffle:Pool Complexes Present?</b>	Yes
<b>State</b>	WV	<b>Stream Classification</b>	Perennial		
<b>County</b>	Webster	<b>303(d) Impairment Listing</b>	No

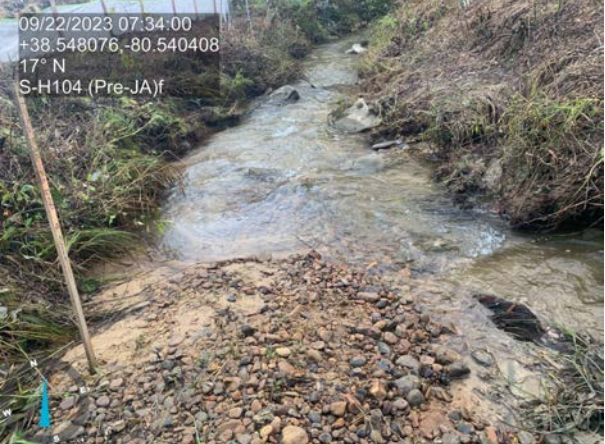
<p>09/22/2023 07:34:00 +38.548076,-80.540408 17° N S-H104 (Pre-JA)f</p>		  <p>09/22/2023 07:31:52 +38.548195,-80.540463 32° NE S-H104 (Pre-JA)f</p>	
<b>GPS Location</b>	See caption in photo	<b>GPS Location</b>	See caption in photo
<b>Description</b>	Downstream view of permitted impact area during pre-construction assessment. Standing with back against the timber mat bridge.	<b>Description</b>	Downstream view of unimpacted area during pre-construction assessment. Taken from edge of the LOD.
  <p>09/27/2023 18:09:07 +38.548061,-80.540484 29° NE S-H104 (Post-JA)f</p>		  <p>09/27/2023 18:06:19 +38.548191,-80.540468 66° NE S-H104 (Post-JA)f</p>	
<b>GPS Location</b>	See caption in photo	<b>GPS Location</b>	See caption in photo
<b>Description</b>	Downstream view of permitted impact area during post-construction assessment. Standing with back against the timber mat bridge.	<b>Description</b>	Downstream view of unimpacted area during post-construction assessment. Taken from edge of LOD

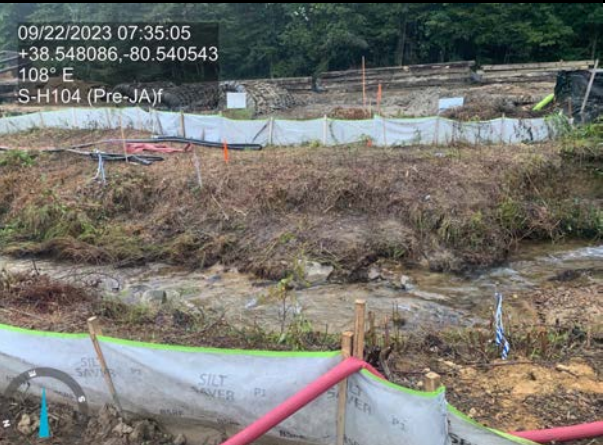
<p>09/22/2023 07:35:05 +38.548086,-80.540543 108° E S-H104 (Pre-JA)f</p>	
<b>GPS Location</b>	See caption in photo	<b>GPS Location</b>	See caption in photo
<b>Description</b>	Pre-construction cross stream view from the coming in side.	<b>Description</b>	Pre-construction cross stream view from the going away side.
