Stream Biological Conditions EA Report

Project Name	H-600 Pipeline Spread E	AFE	124300134	Spread	H-600 Pipeline Spread E
Contractor	Price Gregory	Report #	214		
Environmental Auditor	Allyson Kincaid	Date/Time	9/5/2023 1:27 PM		
Stream ID	S-I21 (2)	Crossing Start Date	9/6/2023	Crossing Completion Date	9/23/2023
Milepost	149.92	Pre-Con Assessment Date	9/5/2023	Post-Con Assessment Date	9/23/2023
Station	7915+78	Bankfull Width (ft.)	9.3	Riffle:Pool Complexes Present?	No
State	WV	Stream Classification	Perennial		
County	Greenbrier	303(d) Impairment Listing	None

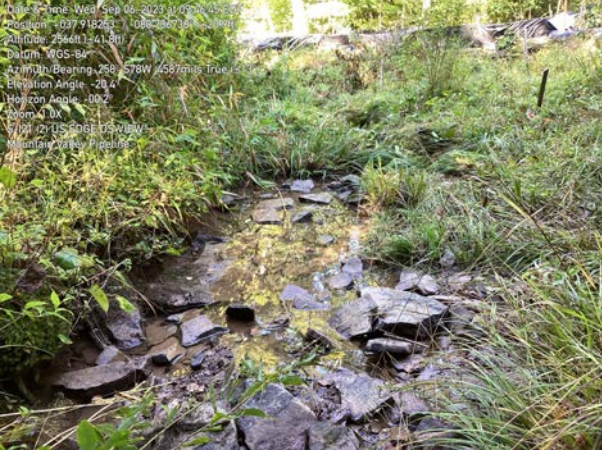
<p><small>Date & Time: Wed, Sep 06, 2023 at 09:44:57 EDT Position: +037.918263 / -080.736736 (E=18.7ft) Altitude: 2560ft (E=36.1ft) Datum: WGS-84 Azimuth/Bearing: 258.578W 4587mils True (E=12) Elevation Angle: -20.4 Zoom: 1.0X S-12112-DS-EDGE-DS VIEW Mountain Valley Pipeline</small></p>

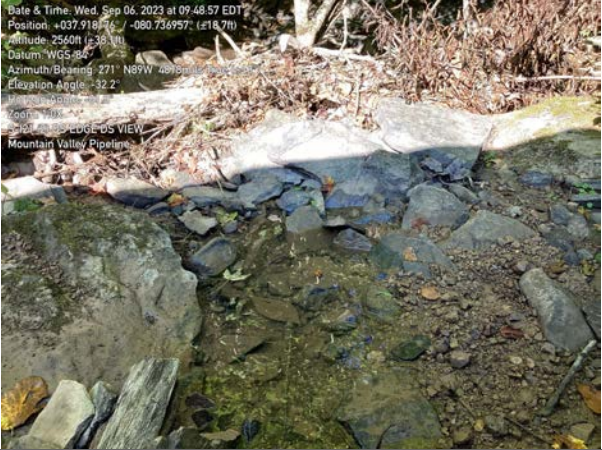
<p><small>Date & Time: Wed, Sep 06, 2023 at 09:48:57 EDT Position: +037.918176 / -080.736957 (E=18.7ft) Altitude: 2560ft (E=36.1ft) Datum: WGS-84 Azimuth/Bearing: 271.189W 4616mils True (E=12) Elevation Angle: -32.2 Zoom: 1.0X S-12112-DS-EDGE-DS VIEW Mountain Valley Pipeline</small></p>	
GPS Location	See photo	GPS Location	See photo
Description	Downstream view of permitted impact area during pre-construction assessment.	Description	Downstream view of unimpacted area during pre-construction assessment.

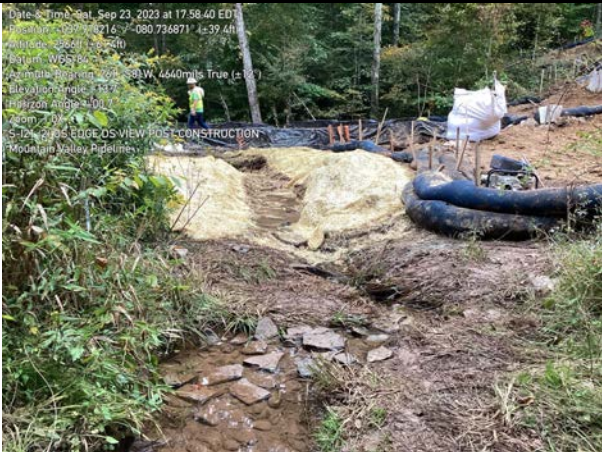
<p><small>Date & Time: Sat, Sep 23, 2023 at 17:58:40 EDT Position: +037.917216 / -080.736871 (E=39.4ft) Altitude: 2560ft (E=36.1ft) Datum: WGS-84 Azimuth/Bearing: 270.581W 4640mils True (E=12) Elevation Angle: -11.6 Zoom: 1.0X S-12112-DS-EDGE-DS VIEW POST-CONSTRUCTION Mountain Valley Pipeline</small></p>

GPS Location	See photo	GPS Location	See photo
Description	Downstream view of permitted impact area during post-construction assessment.	Description	Downstream view of unimpacted area during post-construction assessment.

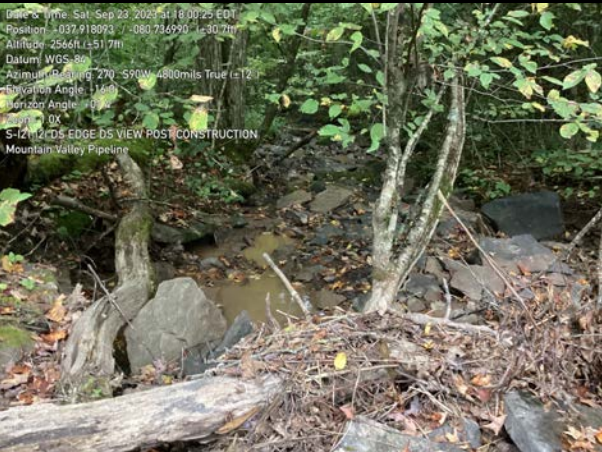
<p><small>Date & Time: Sat, Sep 23, 2023 at 18:00:25 EDT Position: +037.918093 / -080.736950 (E=39.7ft) Altitude: 2566ft (E=36.7ft) Datum: WGS-84 Azimuth/Bearing: 270.590W 4680mils True (E=12) Elevation Angle: -11.6 Zoom: 1.0X S-12112-DS-EDGE-DS VIEW POST-CONSTRUCTION Mountain Valley Pipeline</small></p>

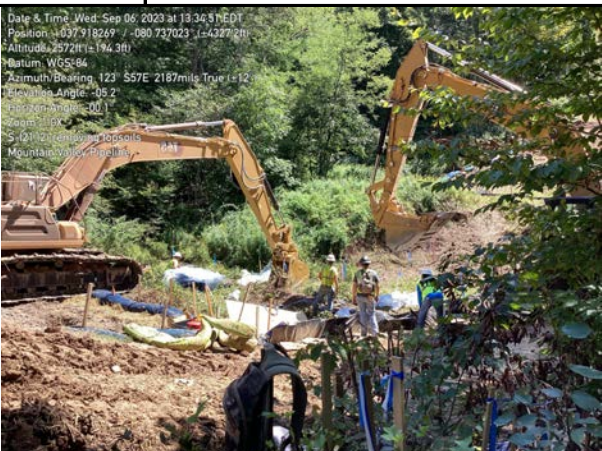
<p><small>Date & Time: Wed, Sep 06, 2023 at 13:36:33 EDT Position: +037.918269 / -080.737023 (E=43.77ft) Altitude: 2672ft (E=194.3ft) Datum: WGS-84 Azimuth/Bearing: 123.557E 2187mils True (E=12) Elevation Angle: -05.2 Zoom: 1.0X S-12112-DS-EDGE-DS VIEW Mountain Valley Pipeline</small></p>

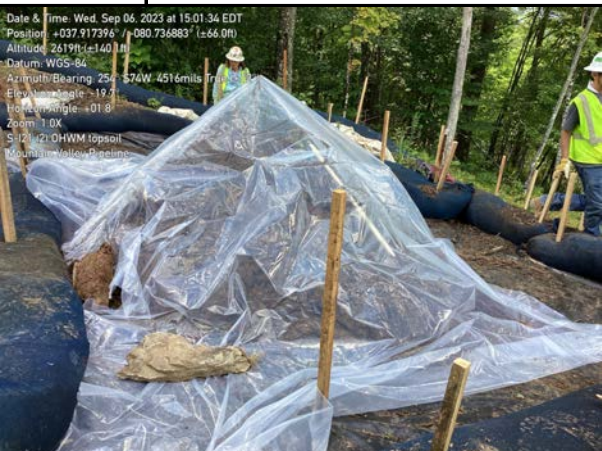
<p><small>Date & Time: Wed, Sep 06, 2023 at 15:01:34 EDT Position: +037.917396 / -080.736883 (E=66.0ft) Altitude: 2619ft (E=140.1ft) Datum: WGS-84 Azimuth/Bearing: 254.574W 4516mils True (E=12) Elevation Angle: -19.2 Zoom: 1.0X S-12112-DS-EDGE-DS VIEW Mountain Valley Pipeline</small></p>	
GPS Location	See photo	GPS Location	See photo
Description	Photo 1: Stream substrate being removed from aquatic resource.	Description	Photo 2: Stream substrate segregated in an upland area.

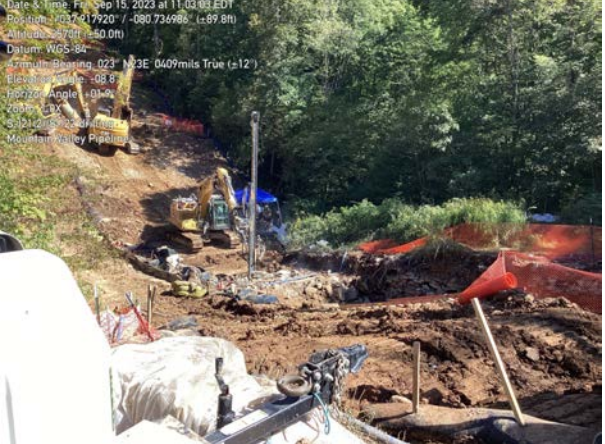
<p><small>Date & Time: Fri, Sep 15, 2023 at 11:03:03 EDT Position: +037.917920 / -080.734986 (-89.8ft) Altitude: 2570ft (+80.0ft) Datum: WGS-84 Azimuth/Bearing: 023 N33E 0409mils True (+12°) Elevation Angle: -48.8 Horizon Angle: 00.0 Zoom: 1.0X S-121 115-122 Mountain Valley Pipeline</small></p>
GPS Location See photo	GPS Location See photo
Description Photo 3: Pipe being brought down slope to aquatic resource area to verify proper alignment.	Description Photo 4: Drilling in aquatic resource area.

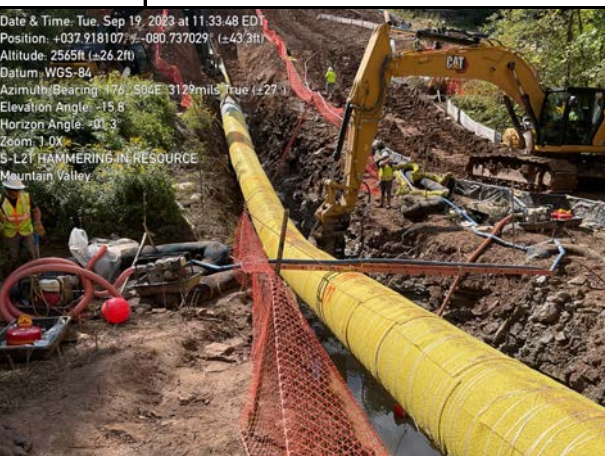
<p><small>Date & Time: Tue, Sep 19, 2023 at 11:33:48 EDT Position: +037.918107 / -080.737029 (-43.3ft) Altitude: 2565ft (+826.2ft) Datum: WGS-84 Azimuth/Bearing: 176 S04E 3129mils True (+27°) Elevation Angle: -15.8 Horizon Angle: -01.3 Zoom: 1.0X S-121 HAMMERING IN RESOURCE Mountain Valley Pipeline</small></p>

GPS Location See photo	GPS Location See photo
Description Photo 5: Pipe lowered into trench and making adjustment.	Description Photo 6: Trench breakers placed around aquatic resources.
  <p><small>Date & Time: Sat, Sep 23, 2023 at 16:19:35 EDT Position: +037.917547 / -080.737428 (-89.0ft) Altitude: 2639ft (+811.0ft) Datum: WGS-84 Azimuth/Bearing: 350 N08W 8728mils True (+43°) Elevation Angle: 1.8 Horizon Angle: -02.3 Zoom: 1.0X S-121 211 pulling in pipe from topsoil / survey Mountain Valley Pipeline</small></p>

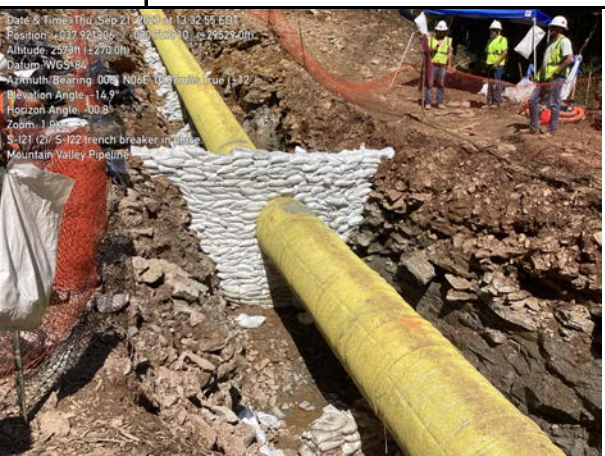
<p><small>Date & Time: Thu, Sep 21, 2023 at 13:32:55 EDT Position: +037.921366 / -080.735010 (-28529.4ft) Altitude: 2593ft (+1270.0ft) Datum: WGS-84 Azimuth/Bearing: 003 N08E 087mils True (+32°) Elevation Angle: -16.9 Horizon Angle: -10.8 Zoom: 1.0X S-121 121 5-122 trench breaker in place Mountain Valley Pipeline</small></p>

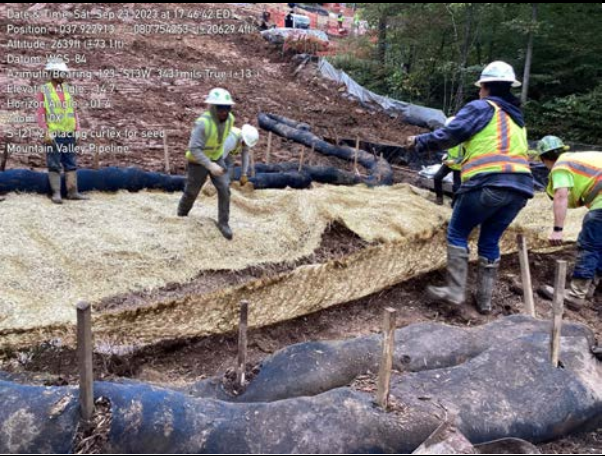
<p><small>Date & Time: Sat, Sep 23, 2023 at 17:42:42 EDT Position: +037.922719 / -080.734893 (-20629.4ft) Altitude: 2639ft (+811.0ft) Datum: WGS-84 Azimuth/Bearing: 493 S12W 463mils True (+13°) Elevation Angle: -14.3 Horizon Angle: 01.4 Zoom: 1.0X S-121 212 placing curlex for access Mountain Valley Pipeline</small></p>
GPS Location See photo	GPS Location See photo
Description Photo 7: Survey crew verifying contours.	Description Photo 8: Placement of curlex.
