Stream Biological Conditions EA Report

Project Name	H-600 Pipeline Spread E	AFE	124300134	Spread	H-600 Pipeline Spread E
Contractor	Price Gregory	Report #	243		
Environmental Auditor	Tim Ferguson	Date/Time	9/20/2023 9:17 AM		
Stream ID	S-L10	Crossing Start Date	9/20/2023	Crossing Completion Date	9/28/2023
Milepost	148.46	Pre-Con Assessment Date	9/20/2023	Post-Con Assessment Date	9/28/2023
Station	7838+73	Bankfull Width (ft.)	5.8	Riffle:Pool Complexes Present?	No
State	WV	Stream Classification	Perennial		
County	Greenbrier	303(d) Impairment Listing	No

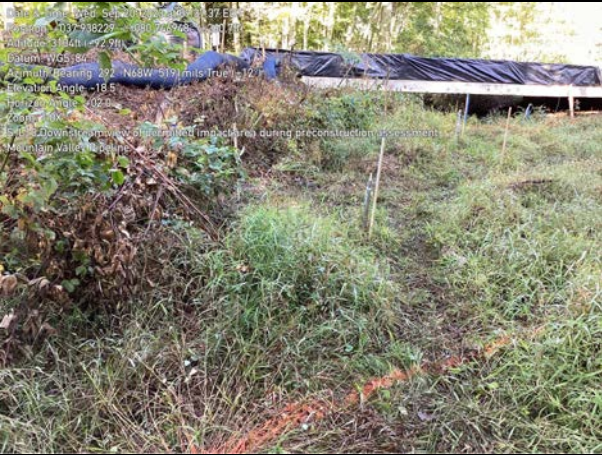
<p><small>Date & Time: Wed, Sep 20, 2023 at 9:17:00 EDT Position: +037.938221 / -080.747029 (±137.4ft) Altitude: 310.4ft (±68.1ft) Datum: WGS84 Azimuth Bearing: 292.186W 519mils True (±12°) Pitch Angle: -18.5° Zoom: 10X S-19 Downstream view of permitted impact area during pre-construction assessment. Mountain Valley Pipeline</small></p>

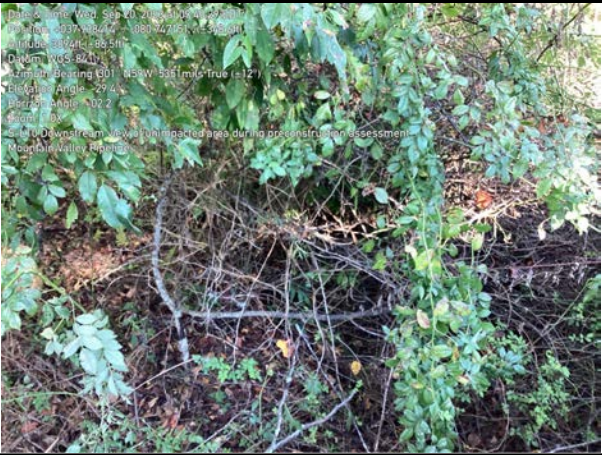
<p><small>Date & Time: Wed, Sep 20, 2023 at 9:17:00 EDT Position: +037.938221 / -080.747029 (±137.4ft) Altitude: 310.4ft (±68.1ft) Datum: WGS84 Azimuth Bearing: 001.858W 501mils True (±12°) Pitch Angle: -29.4° Zoom: 10X S-19 Downstream view of unimpacted area during pre-construction assessment. Mountain Valley Pipeline</small></p>			
GPS Location	See Photo	GPS Location	See Photo		
Description	Downstream view of permitted impact area during pre-construction assessment.	Description	Downstream view of unimpacted area during pre-construction assessment.

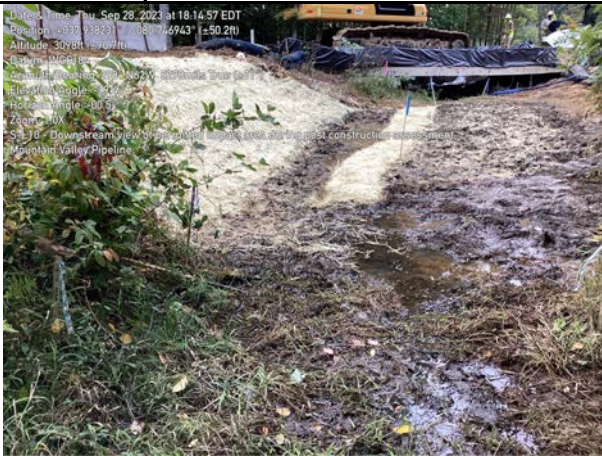
<p><small>Date & Time: Thu, Sep 28, 2023 at 18:14:57 EDT Position: +037.938221 / -080.747029 (±137.4ft) Altitude: 309.8ft (±67.7ft) Datum: WGS84 Azimuth Bearing: 292.186W 519mils True (±12°) Pitch Angle: -18.5° Zoom: 10X S-19 Downstream view of permitted impact area during post-construction assessment. Mountain Valley Pipeline</small></p>

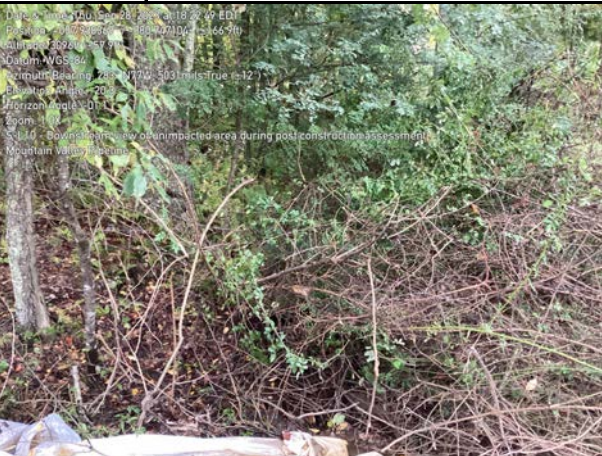
<p><small>Date & Time: Thu, Sep 28, 2023 at 18:28:49 EDT Position: +037.938221 / -080.747029 (±137.4ft) Altitude: 309.8ft (±67.7ft) Datum: WGS84 Azimuth Bearing: 292.186W 519mils True (±12°) Pitch Angle: -18.5° Zoom: 10X S-19 Downstream view of unimpacted area during post-construction assessment. Mountain Valley Pipeline</small></p>			
GPS Location	See Photo	GPS Location	See Photo		
Description	Downstream view of permitted impact area during post-construction assessment.	Description	Downstream view of unimpacted area during post-construction assessment.

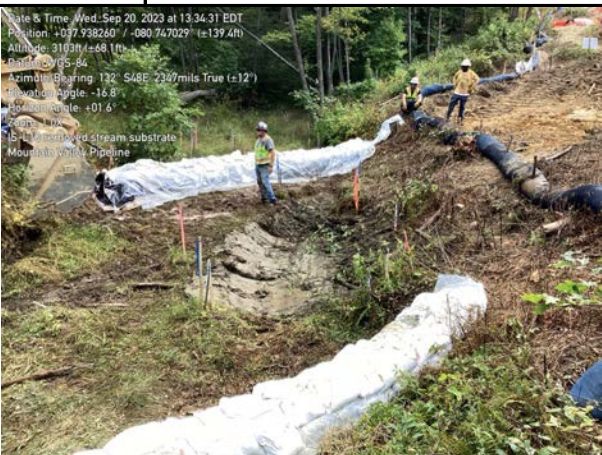
<p><small>Date & Time: Wed, Sep 20, 2023 at 13:34:31 EDT Position: +037.938260 / -080.747029 (±137.4ft) Altitude: 310.3ft (±68.1ft) Datum: WGS84 Azimuth Bearing: 132.548E 239mils True (±12°) Pitch Angle: -15.8° Zoom: 10X S-19 Segregated stream substrate. Mountain Valley Pipeline</small></p>

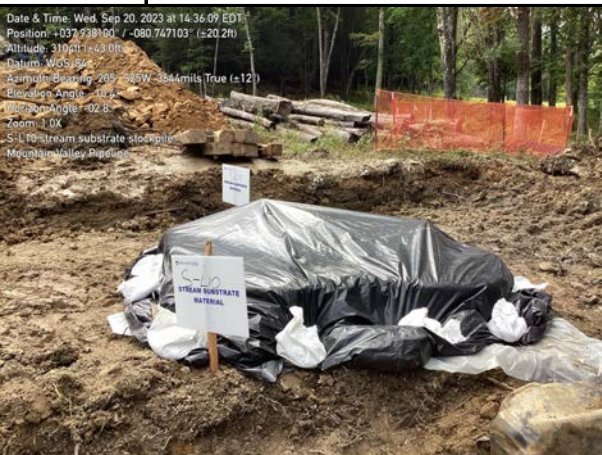
<p><small>Date & Time: Wed, Sep 20, 2023 at 14:36:09 EDT Position: +037.938160 / -080.747103 (±20.2ft) Altitude: 310.6ft (±68.0ft) Datum: WGS84 Azimuth Bearing: 289.286W 384mils True (±12°) Pitch Angle: -19.7° Zoom: 10X S-19 Stream substrate slopepile. Mountain Valley Pipeline</small></p>			
GPS Location	See Photo	GPS Location	See Photo		
Description	Photo 1: Removal of stream substrate.	Description	Photo 2: Segregated stream substrate.

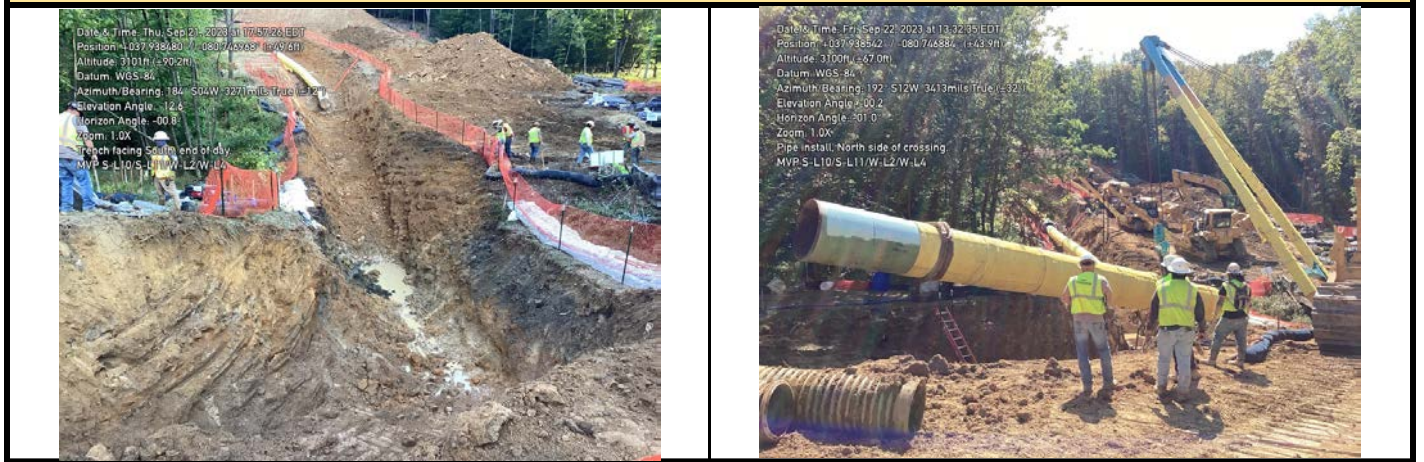
GPS Location See Photo	GPS Location See Photo
Description Photo 3: Trenching through aquatic resources.	Description Photo 4: Pipe being placed in trench.

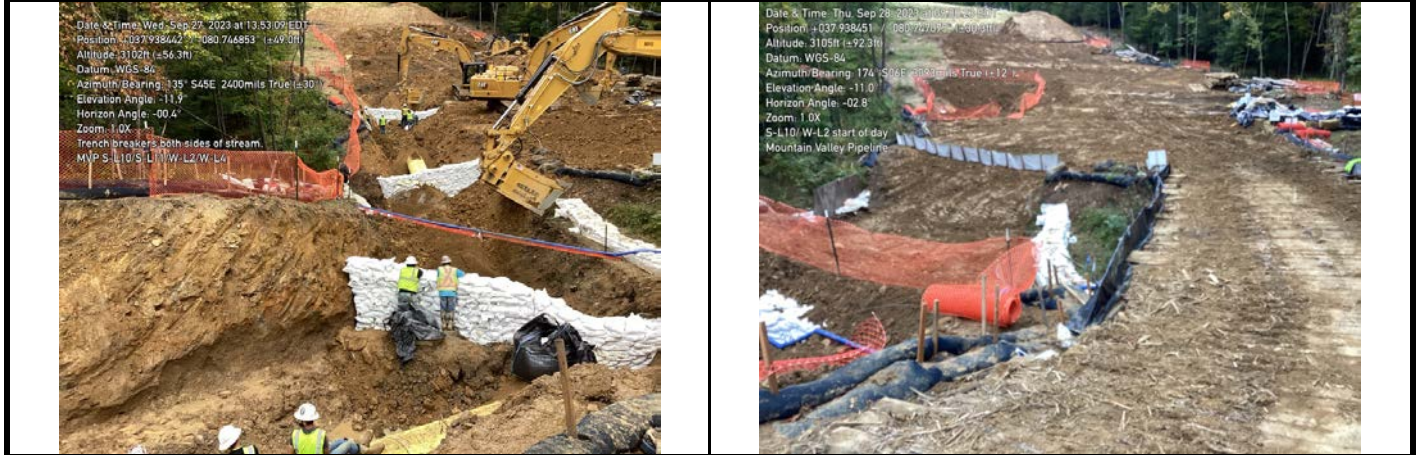
GPS Location See Photo	GPS Location See Photo
Description Photo 5: Filling of trench and construction of trench breakers.	Description Photo 6: Filling of trench in aquatic resource area complete.

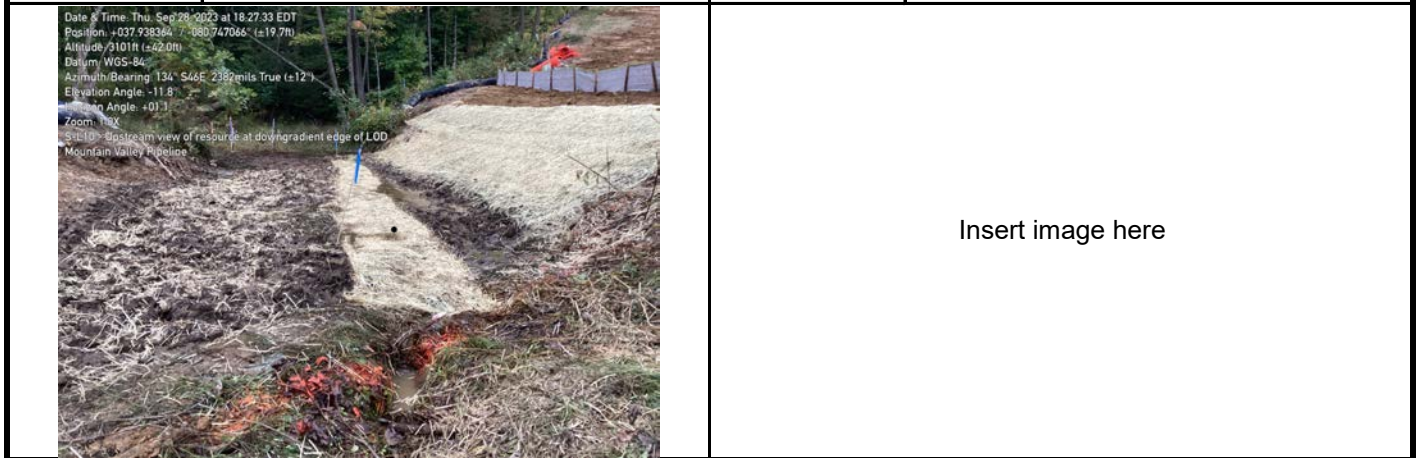
GPS Location See Photo	GPS Location
Description Photo 7: Curlex installed on bank.	Description
