## Stream Biological Conditions EA Report

<b>Project Name</b>	H-600 Pipeline Spread C	<b>AFE</b>	124300131	<b>Spread</b>	H-600 Pipeline Spread C
<b>Contractor</b>	Precision	<b>Report #</b>	250		
<b>Environmental Auditor</b>	Brian Montgomery	<b>Date/Time</b>	9/19/2023 11:03 AM		
<b>Stream ID</b>	S-L46	<b>Crossing Start Date</b>	9/19/2023	<b>Crossing Completion Date</b>	9/22/2023
<b>Milepost</b>	77.81	<b>Pre-Con Assessment Date</b>	9/16/2023	<b>Post-Con Assessment Date</b>	9/25/2023
<b>Station</b>	4108+56	<b>Bankfull Width (ft.)</b>	21.0	<b>Riffle:Pool Complexes Present?</b>	No
<b>State</b>	WV	<b>Stream Classification</b>	Perennial		
<b>County</b>	Braxton	<b>303(d) Impairment Listing</b>	No

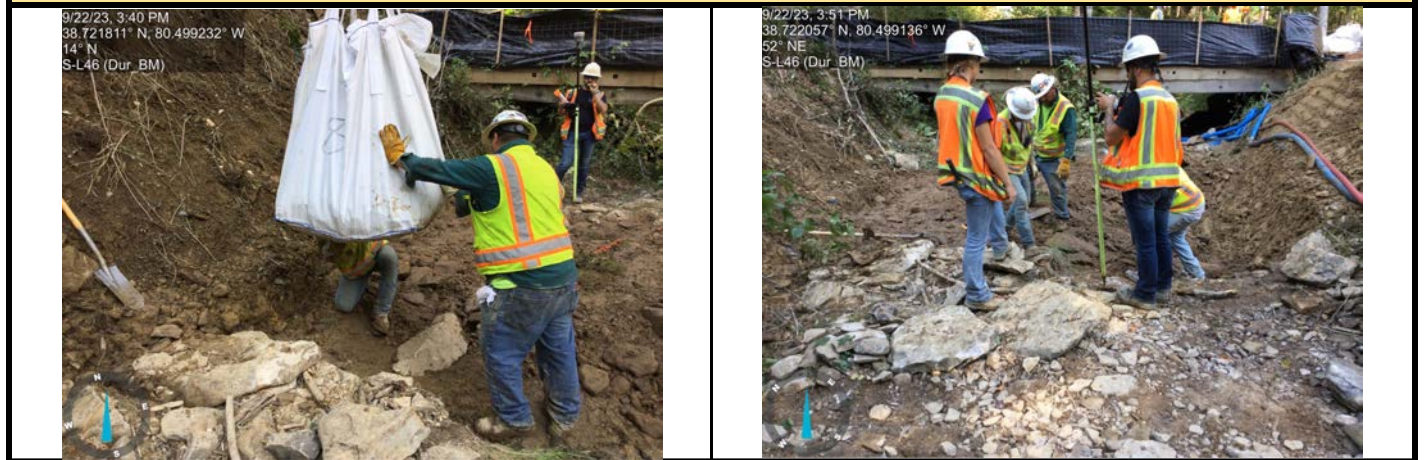
<b>GPS Location</b> See photo	<b>GPS Location</b> See photo
<b>Description</b> Replacing stream bed substrate, in the reverse order they were removed.	<b>Description</b> Replacing stream bed substrate, and GPS located prominent boulders.

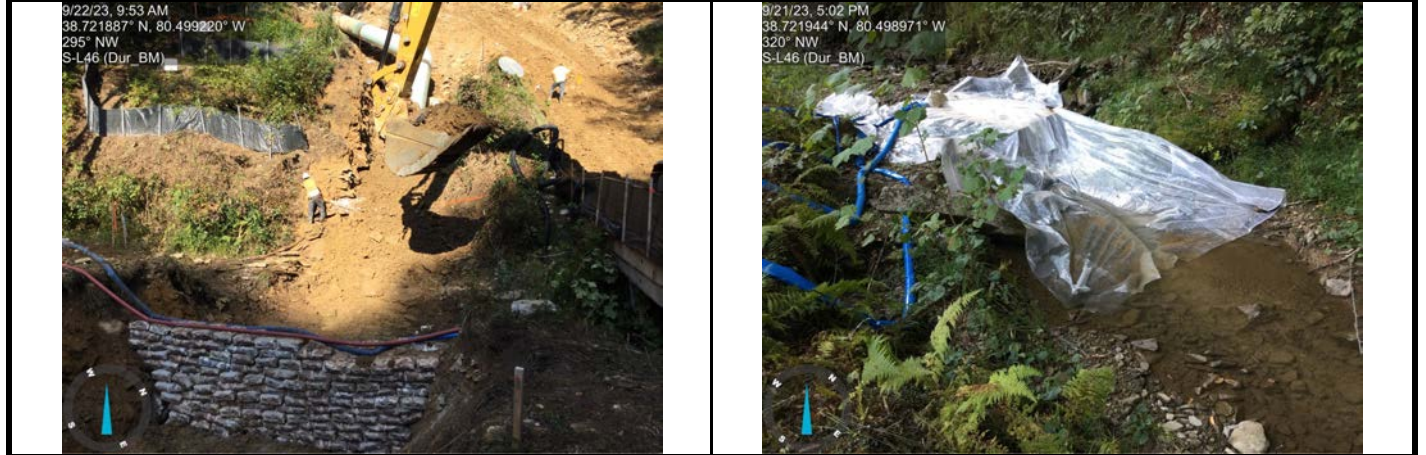
<b>GPS Location</b> See photo	<b>GPS Location</b> See photo
<b>Description</b> Padding the pipe after trench breaker installation.	<b>Description</b> Dam and pump outflow downstream off ROW. Clear water, no scouring or erosion.

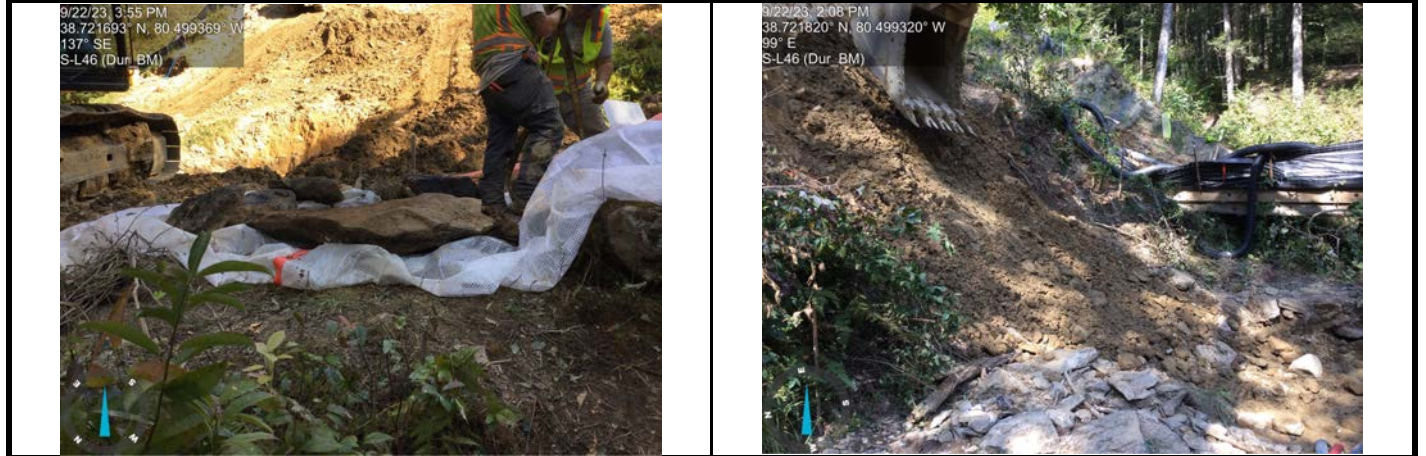
<b>GPS Location</b> See photo	<b>GPS Location</b> See photo
<b>Description</b> GPS boulders stored in plastic are now being placed back in the stream.	<b>Description</b> Rebuilding the stream banks.
