Wetland Biological Conditions EA Report

Project Name	H-600 Pipeline Spread D	AFE	124300131	Spread	H-600 Pipeline Spread D
Contractor	Precision	Report #	52		
Environmental Auditor	Todd Grant			Date/Time	9/11/2023 2:08 PM
Wetland ID	W-B28	Crossing Start Date	9/11/2023	Crossing Completion Date	9/22/2023
Milepost	107.20	Pre-Con Assessment Date	9/8/2023	Post-Con Assessment Date	9/23/2023
Station	5660+25	Cowardin Classification	PEM	Wetland Impact Area(acres)	0.0992
State	WV				
County	Webster

Resource Post-Crossing Conditions

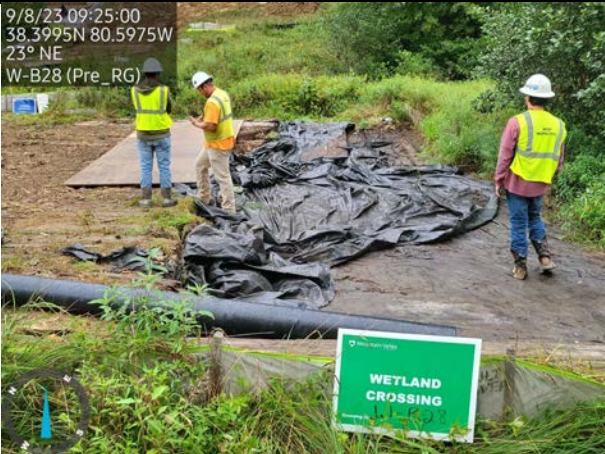
<p>9/8/23 09:25:00 38.3995N 80.5975W 23° NE W-B28 (Pre_RG)</p>

<p>9/8/23 09:25:16 38.3996N 80.5976W 38° NE W-B28 (Pre_RG)</p>  
<p>GPS Location See photo above</p>	<p>GPS Location See photo above</p>
<p>Description View of permitted resource impact area during pre-construction assessment. Timber mats and geotextile fabric that has been covering wetland for a long time.</p>	<p>Description At edge of LOD, view of unimpacted resource area conditions during pre-construction assessment. View of undisturbed wetland outside of the LOD pre-construction.</p>
<p>09/23/2023 14:26:02 +38.399573,-80.597518 82° E W-B28 (Pos_TG)</p>

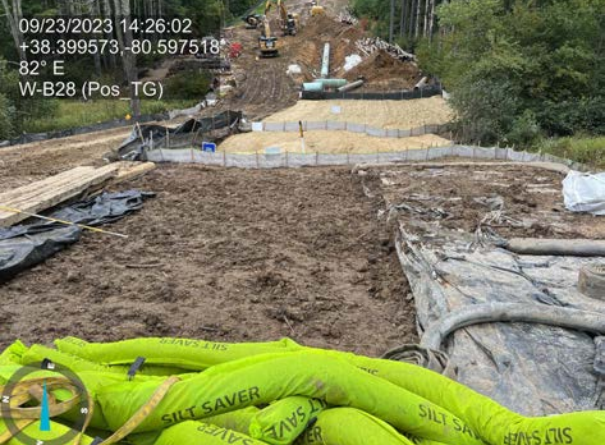
<p>09/23/2023 13:56:44 +38.399646,-80.597599 62° NE W-B28 (Pos_TG)</p>  
<p>GPS Location See photo above</p>	<p>GPS Location See photo above</p>
<p>Description View of permitted resource impact area during post-construction assessment. View of restored disturbed wetland topsoil at approximately centerline from the edge of the road.</p>	<p>Description At edge of LOD, view of unimpacted resource area conditions during post-construction assessment. View of undisturbed wetland outside of the LOD post-construction.</p>

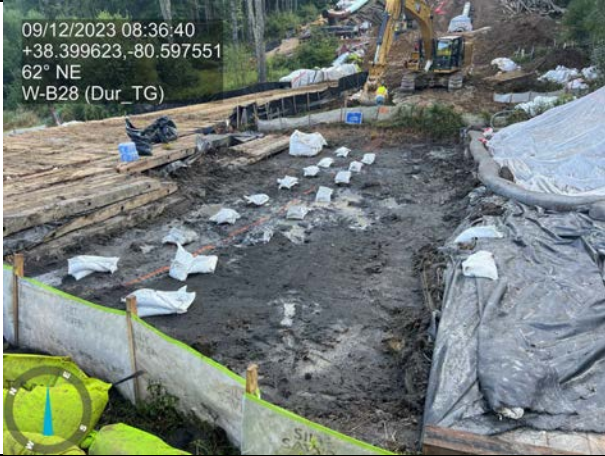
<p>09/12/2023 08:36:40 +38.399623,-80.597551 62° NE W-B28 (Dur_TG)</p>

<p>09/13/2023 10:12:40 +38.399789,-80.597117 229° SW W-B28 (Dur_TG)</p>  
<p>GPS Location See photo above</p>	<p>GPS Location See photo above</p>
<p>Description View of wetland ditch line drilled and prepared for blasting.</p>	<p>Description View of blasting crew preparing explosives for blasting.</p>
