Wetland Biological Conditions EA Report

Project Name	H-600 Pipeline Spread D	AFE	124300132	Spread	H-600 Pipeline Spread D
Contractor	Precision	Report #	83		
Environmental Auditor	Gary Cruz			Date/Time	10/2/2023 8:14 PM
Wetland ID	W-J8	Crossing Start Date	10/2/2023	Crossing Completion Date	10/11/2023
Milepost	119.93	Pre-Con Assessment Date	10/2/2023	Post-Con Assessment Date	10/11/2023
Station	6332+05	Cowardin Classification	PFO	Wetland Impact Area(acres)	0.0533
State	WV				
County	Nicholas

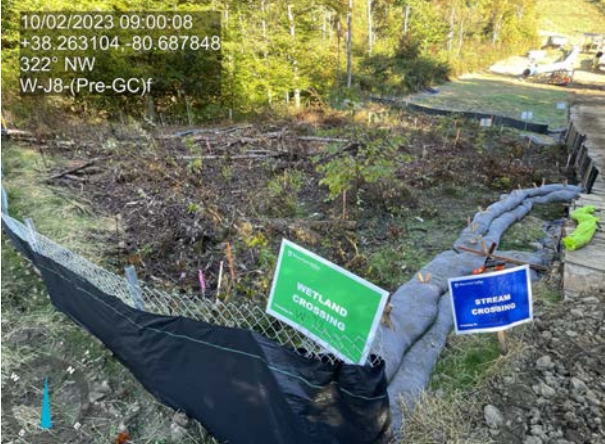
<p>10/02/2023 09:00:08 +38.263104,-80.687848 322° NW W-J8-(Pre-GC)f</p>

<p>10/02/2023 09:01:56 +38.263059,-80.687969 259° W W-J8-(Pre-GC)f</p>	
GPS Location	See photo above	GPS Location	See photo above
Description	View of permitted resource impact area during pre-construction assessment. Photo taken from the left side of ROW from the GAS of the wetland.	Description	At edge of LOD, view of unimpacted resource area conditions during pre-construction assessment. Photo taken from right edge of LOD looking off LOD.

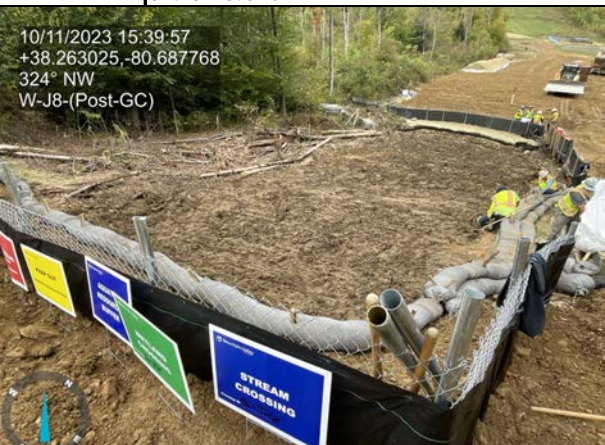
<p>10/11/2023 15:39:57 +38.263025,-80.687768 324° NW W-J8-(Post-GC)</p>

Conditions 18 & 19 were given a rating of 4 due to the lack of vegetation in the disturbed permitted impact area following completion of the crossing and restoration efforts. The W-J8 PFO topsoil has been properly stabilized and the disturbed area has been seeded with the appropriate permanent seed mix in accordance with Appendix B: Restoration Work Plan of the Mountain Valley Pipeline Comprehensive Stream and Wetland Monitoring, Restoration and Mitigation Framework.

<p>10/11/2023 15:40:42 +38.263141,-80.687948 265° W W-J8-(Post-GC)</p>	
GPS Location	See photo above	GPS Location	See photo above
Description	View of permitted resource impact area during post-construction assessment. Photo taken from the left side of ROW from the GAS of the wetland.	Description	At edge of LOD, view of unimpacted resource area conditions during post-construction assessment. Photo taken from right edge of LOD looking off LOD.

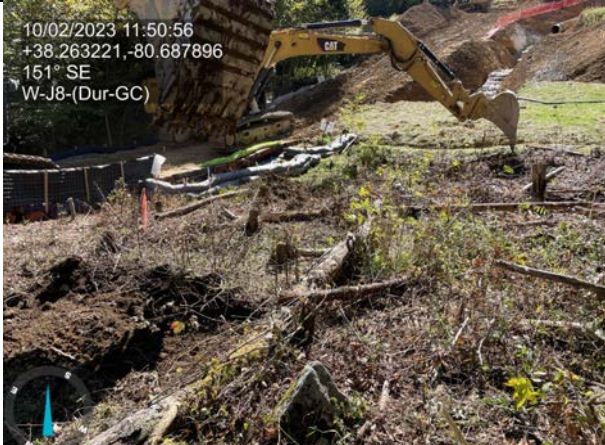
<p>10/02/2023 11:50:56 +38.263221,-80.687896 151° SE W-J8-(Dur-GC)</p>

<p>10/03/2023 16:22:50 +38.263233,-80.687985 154° SE W-J8-(Dur-GC)</p>	
GPS Location	See photo above	GPS Location	See photo above
Description	Contractor removing topsoil of wetland.	Description	Timber mats were installed within the wetland to minimize soil compaction.

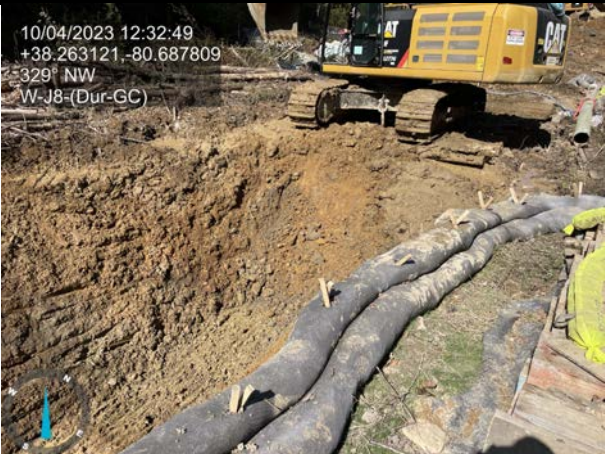
<p>10/04/2023 12:32:49 +38.263121,-80.687809 329° NW W-J8-(Dur-GC)</p>

<p>10/04/2023 16:46:01 +38.263304,-80.687958 164° S W-J8-(Dur-GC)</p>
<p>GPS Location See photo above</p>	<p>GPS Location See photo above</p>
<p>Description Contractor excavating ditch line within the wetland.</p>	<p>Description Section of pipe has been laid within the wetlands ditch.</p>

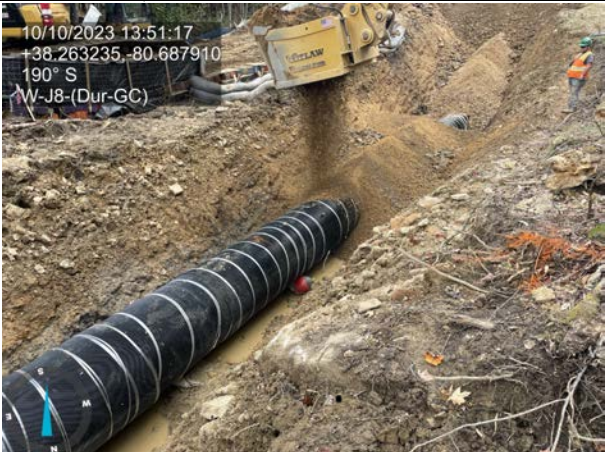
<p>10/10/2023 13:51:17 +38.263235,-80.687910 190° S W-J8-(Dur-GC)</p>

<p>10/10/2023 15:28:14 +38.263143,-80.687955 135° SE W-J8-(Dur-GC)</p>
<p>GPS Location See photo above</p>	<p>GPS Location See photo above</p>
<p>Description Operator padding the ditch line within the feature.</p>	<p>Description Impervious trench breaker has been installed at 6332+90.</p>

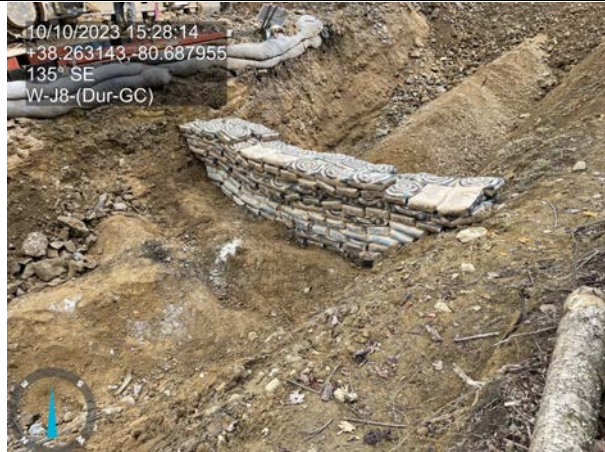
10/10/2023 – Trench breakers were installed on the CIS and GAS of the wetland at station number 6332+90 & 6331+95 respectively. Using the wetland subsoil, the contractor padded the pipe and started backfilled the trench.

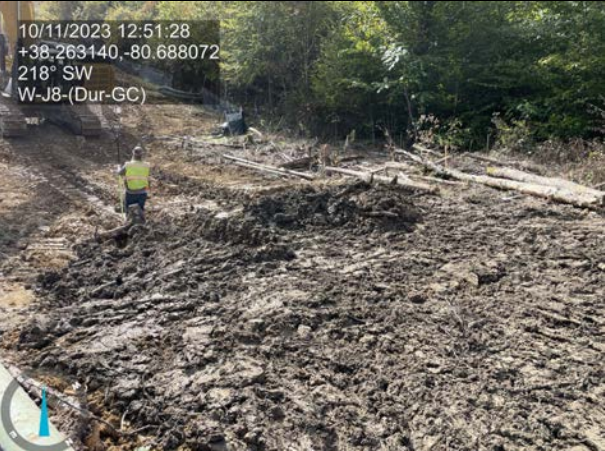
<p>10/11/2023 12:51:28 +38.263140,-80.688072 218° SW W-J8-(Dur-GC)</p>	  <p>10/11/2023 14:45:37 +38.263279,-80.687879 193° S W-J8-(Dur-GC)</p>
<p>GPS Location See photo above</p>	<p>GPS Location See photo above</p>

<p>Description Survey shooting the grade of the wetland to original grade.</p>	<p>Description Wetland has been restored to its pre-construction grade according to survey.</p>
