Wetland Biological Conditions EA Report

Project Name	H-600 Pipeline Spread E	AFE	124300134	Spread	H-600 Pipeline Spread E
Contractor	Price Gregory	Report #	78		
Environmental Auditor	Dan Miller			Date/Time	10/6/2023 9:11 AM
Wetland ID	W-L11	Crossing Start Date	10/6/2023	Crossing Completion Date	10/14/2023
Milepost	147.53	Pre-Con Assessment Date	10/6/2023	Post-Con Assessment Date	10/14/2023
Station	7789+40	Cowardin Classification	PEM	Wetland Impact Area(acres)	0.0194
State	WV				
County	Greenbrier

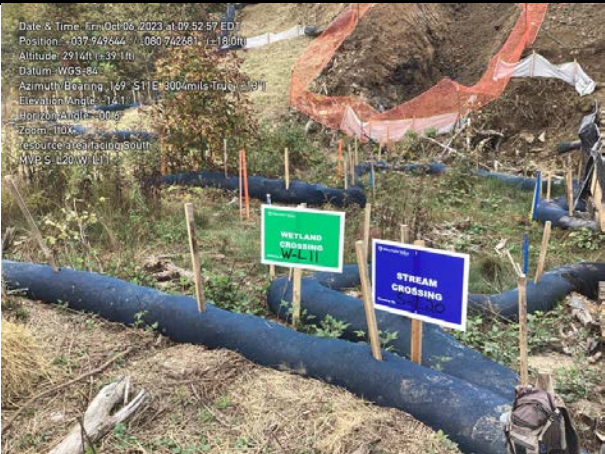
<p><small>Date & Time: Fri, Oct 06, 2023 at 07:52:57 EDT Position: 4037.514244, -860.742361, 111.13011 Altitude: 291.61 m (957.1ft) Datum: WGS 84 Azimuth Bearing: 147.51 E 3004mils True (±15°) Elevation Angle: -04.1 Horizon Angle: -00.6 Zoom: 1.0X Resource: Wetland South MVP S-L20/W-L11</small></p>

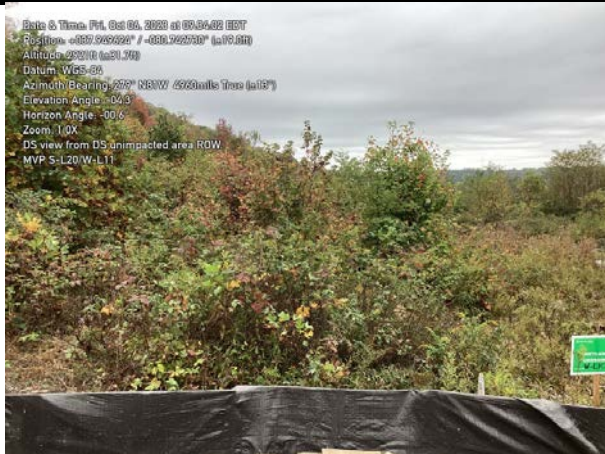
<p><small>Date & Time: Fri, Oct 06, 2023 at 08:04:02 EDT Position: 4037.514244, -860.742361, 111.13011 Altitude: 291.61 m (957.1ft) Datum: WGS 84 Azimuth Bearing: 229.56 NW 4526mils True (±15°) Elevation Angle: -04.3 Horizon Angle: -00.6 Zoom: 1.0X DS view from DS unimpacted area ROW MVP S-L20/W-L11</small></p>	
GPS Location	See Photo	GPS Location	See Photo
Description	View of permitted resource impact area during pre-construction assessment.	Description	At edge of LOD, view of unimpacted resource area conditions during pre-construction assessment.

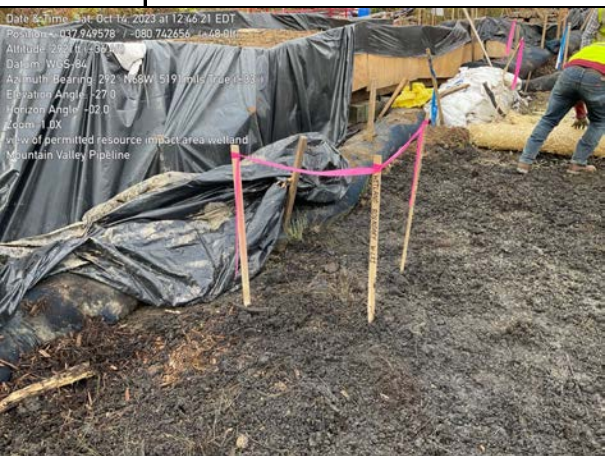
<p><small>Date & Time: Sat, Oct 14, 2023 at 12:46:21 EDT Position: 4047.747578, -860.742656, 111.13011 Altitude: 291.61 m (957.1ft) Datum: WGS 84 Azimuth Bearing: 232.16 SW 519 mils True (±15°) Elevation Angle: -02.0 Horizon Angle: -02.0 Zoom: 1.0X View of permitted resource impact area wetland Mountain Valley Pipeline</small></p>

GPS Location	See Photo	GPS Location	See Photo
Description	View of permitted resource impact area during post-construction assessment.	Description	At edge of LOD, view of unimpacted resource area conditions during post-construction assessment.

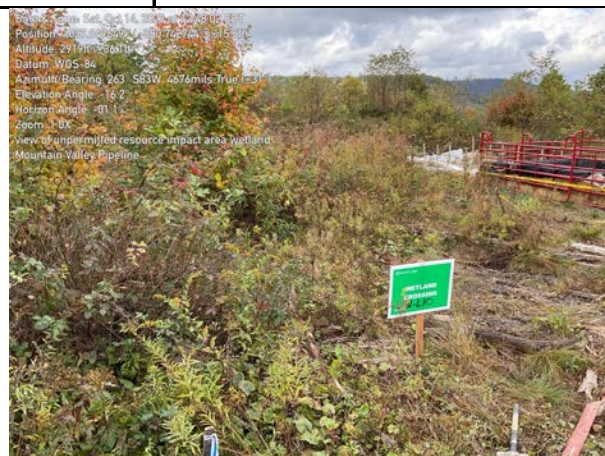
<p><small>Date & Time: Sat, Oct 14, 2023 at 02:28:10 EDT Position: 4047.747578, -860.742656, 111.13011 Altitude: 291.61 m (957.1ft) Datum: WGS 84 Azimuth Bearing: 263.58 SW 4876mils True (±15°) Elevation Angle: -14.2 Horizon Angle: -01.1 Zoom: 1.0X View of unimpacted resource impact area wetland Mountain Valley Pipeline</small></p>

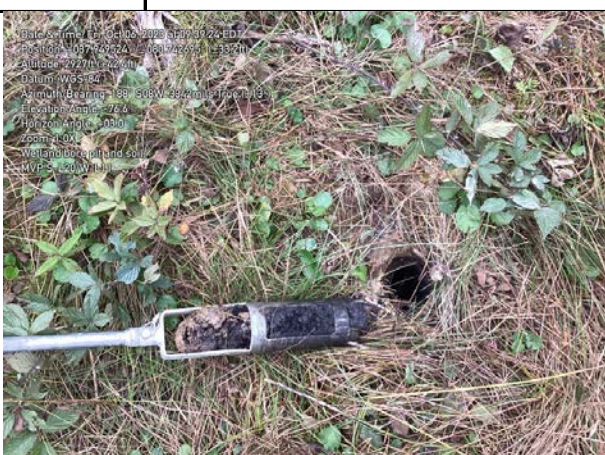
<p><small>Date & Time: Fri, Oct 06, 2023 at 08:03:26 EDT Position: 4037.514244, -860.742361, 111.13011 Altitude: 291.61 m (957.1ft) Datum: WGS 84 Azimuth Bearing: 188.50 SW 4927mils True (±15°) Elevation Angle: -03.6 Horizon Angle: -03.0 Zoom: 1.0X Wetland Soil Impact South MVP S-L20/W-L11</small></p>

Description	Photo 1: Soil test pit. No recharge. Soils are not saturated.	Description	Photo 2: Wetland soil separation from stream soil.

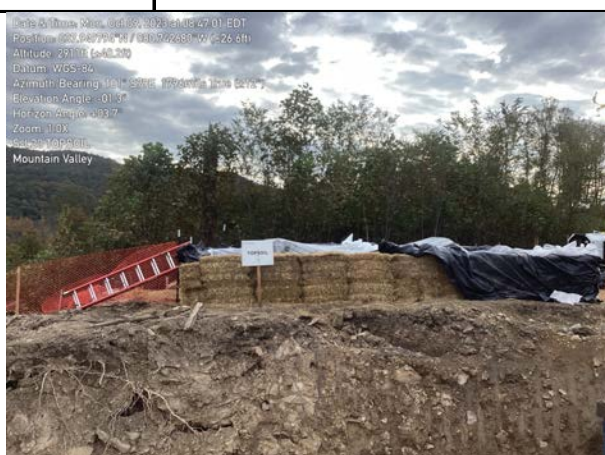
<p><small>Date & Time: Fri, Oct 06, 2023 at 08:47:01 EDT Position: 4037.514244, -860.742361, 111.13011 Altitude: 291.61 m (957.1ft) Datum: WGS 84 Azimuth Bearing: 194.51 SW 4880mils True (±15°) Elevation Angle: -01.7 Horizon Angle: -03.7 Zoom: 1.0X Wetland Soil Impact South Mountain Valley</small></p>	
GPS Location	See Photo	GPS Location	See Photo
