Wetland Biological Conditions EA Report

Project Name	H-600 Pipeline Spread E	A/E	124300134	Spread	H-600 Pipeline Spread E
Contractor	Price Gregory	Report #	42		
Environmental Auditor	Kristin Duty	Date/Time	9/6/2023 8:17 AM		
Wetland ID	W-L13	Crossing Start Date	10/2/2023	Crossing Completion Date	10/13/2023
Milepost	147.00	Pre-Con Assessment Date	9/6/2023	Post-Con Assessment Date	10/13/2023
Station	7761+60	Cowardin Classification	PEM	Wetland Impact Area(acres)	0.0316
State	WV				
County	Greenbrier

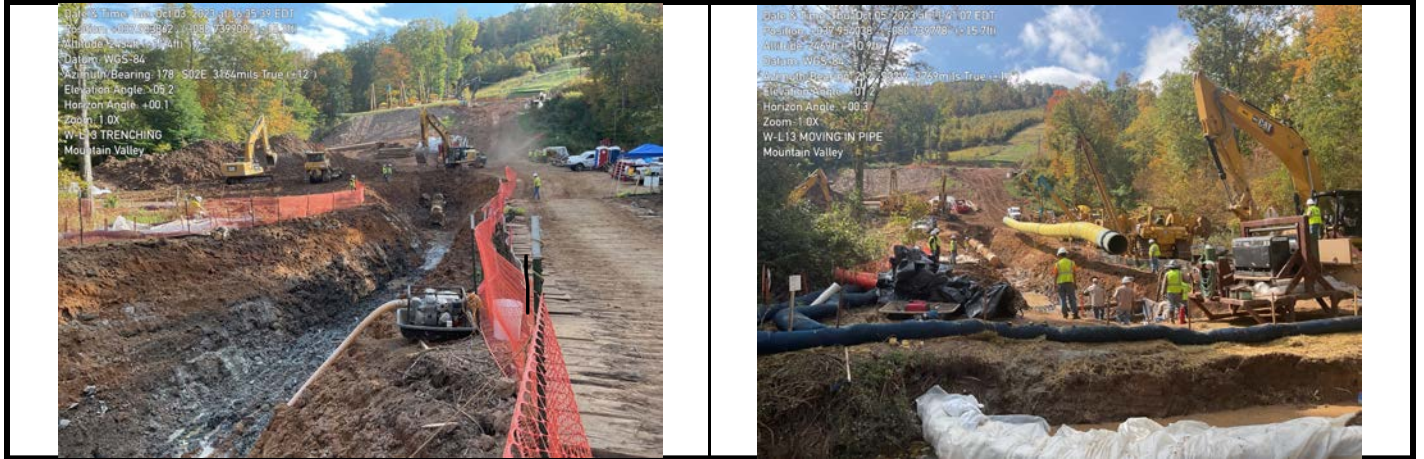
10/3/2023 - 10/4/2023 - Excavation of trench continued (Photo 3). Pipe in upland area exposed.

10/5/2023 - Section of pipe lowered into trench through aquatic resource (Photo 4).

GPS Location	See Photo	GPS Location	See Photo
Description	Photo 3: Trench completed through aquatic resource and upland pipe exposed.	Description	Photo 4: Lowering pipe into trench in aquatic resource area.

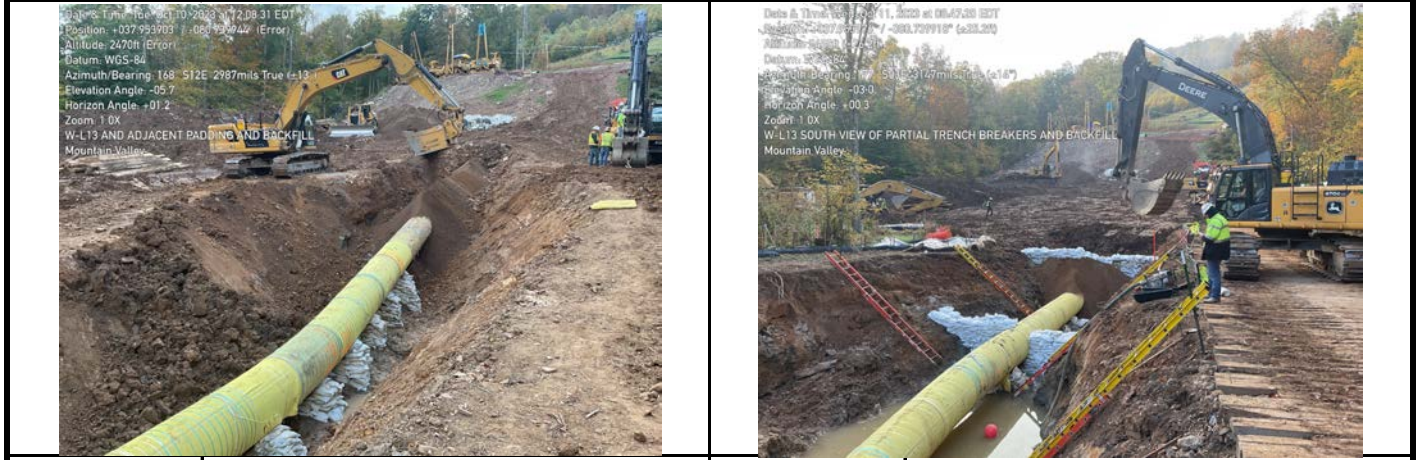
10/10/2023 - Placement of additional padding in trench. Began backfilling of aquatic resource area (Photo 5) and construction of trench breakers.

10/11/2023 - 10/12/2023 - Completed construction of trench breakers (Photo 6). Wetland topsoil restored in area identified by survey (Photo 7). P1 fence installed to protect resource from additional work being completed in the vicinity of resource.

GPS Location	See Photo	GPS Location	See Photo
Description	Photo 5: Sifting and backfilling of trench in aquatic resource area.	Description	Photo 6: Construction of trench breakers adjacent to aquatic resource area.

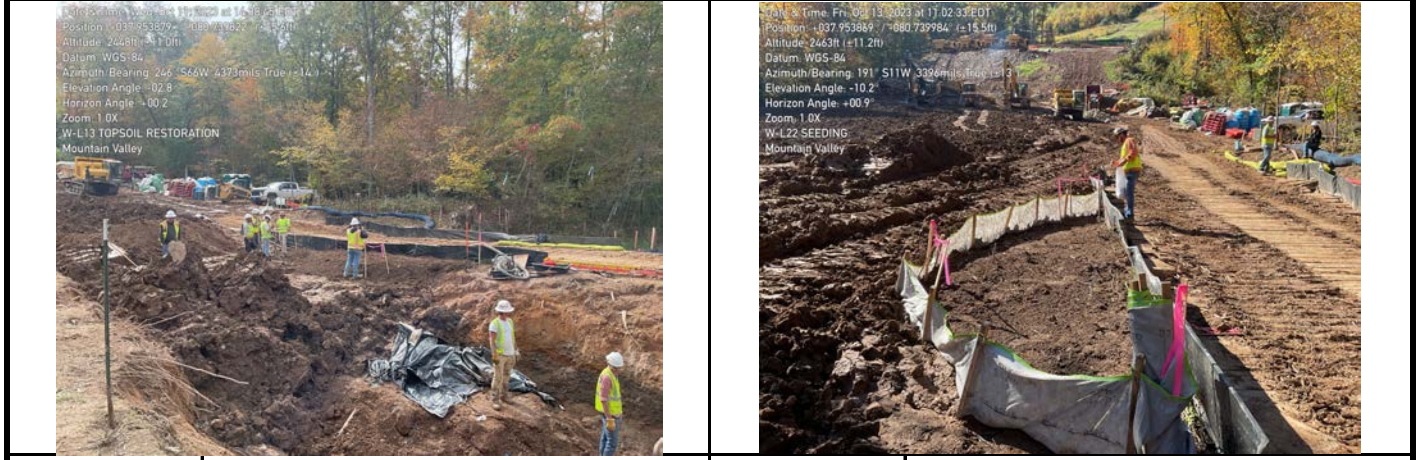
10/13/2023 - Topsoil seeded in restored wetland resource (Photo 8).

GPS Location	See Photo	GPS Location	See Photo
Description	Photo 7: Survey verifying final grade and location of restored (topsoiled) wetland resource.	Description	Photo 8: Seeding of wetland resource.
