Wetland Biological Conditions EA Report

Project Name	H-600 Pipeline Spread E	AFE	124300134	Spread	H-600 Pipeline Spread E
Contractor	Price Gregory	Report #	41		
Environmental Auditor	Kristin Duty			Date/Time	9/6/2023 8:10 AM
Wetland ID	W-L19	Crossing Start Date	9/8/2023	Crossing Completion Date	10/11/2023
Milepost	147.00	Pre-Con Assessment Date	9/6/2023	Post-Con Assessment Date	10/11/2023
Station	7761+60	Cowardin Classification	PEM	Wetland Impact Area(acres)	0.1060
State	WV				
County	Greenbrier

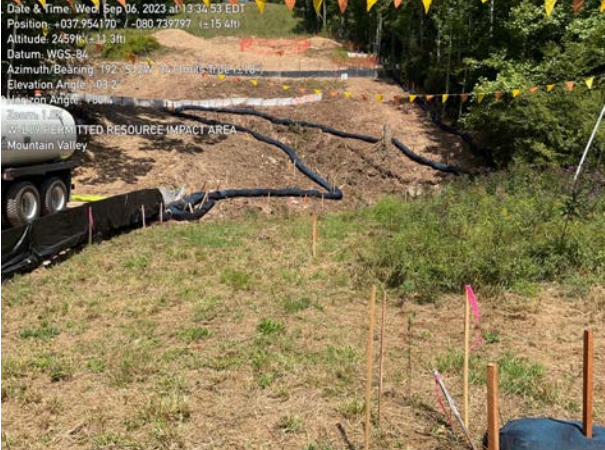
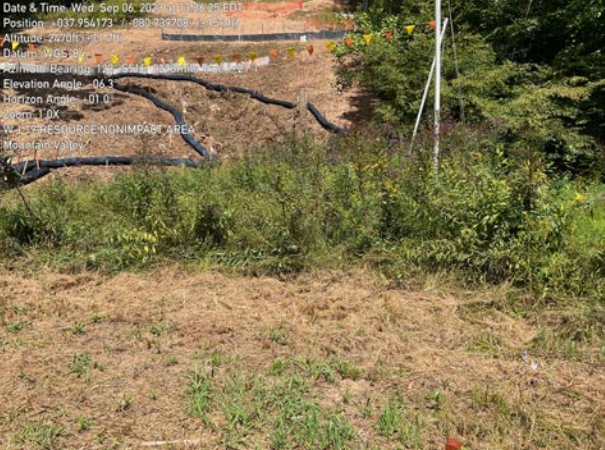
<p><small>Date & Time: Wed, Sep 06, 2023 at 13:36:05 EDT Position: +037.954173° / -080.739768° (+15.41) Altitude: 2270ft (+11.3ft) Datum: WGS-84 Azimuth/Bearing: 188.951E (10.000mils True (+189)) Elevation Angle: +04.1° Horizon Angle: +01.0° Zoom: 1.0X W-L19 RESOURCE NONIMPACT AREA Mountain Valley</small></p>
GPS Location See Photo	GPS Location See Photo
Description View of permitted resource impact area during pre-construction assessment. Overview of W-L19 proposed trench location facing North.	Description At edge of LOD, view of unimpacted resource area conditions during pre-construction assessment. Overview of W-L19 nonimpact facing North.

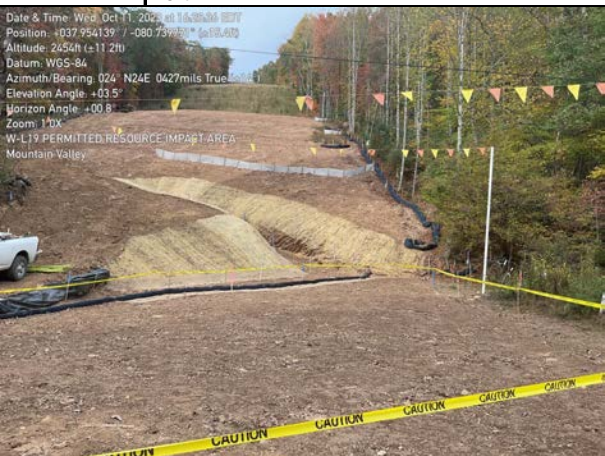
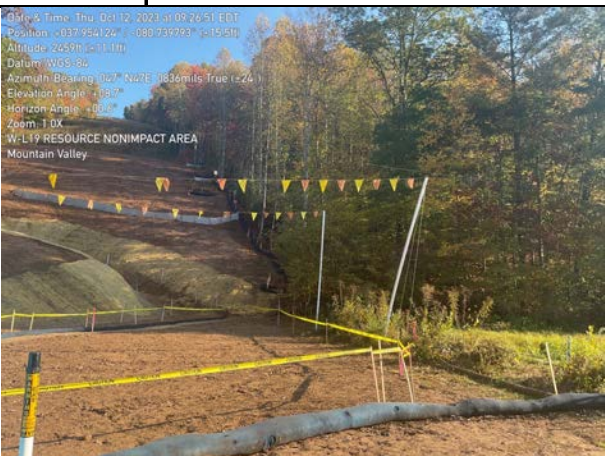
Post Construction Notes
 17. Water did not recharge in post construction test pit.
 18. Crossing and riparian areas have been recently restored. These areas will be monitored until 80% vegetative coverage has been achieved and areas that do not have 80% vegetative cover within 30 days will be reseeded.
 Timber mat remains in place for travel lane.

<p><small>Date & Time: Thu, Oct 12, 2023 at 09:28:31 EDT Position: +037.954126° / -080.739793° (+15.41) Altitude: 2459ft (+11.1ft) Datum: WGS-84 Azimuth/Bearing: 107. N107E (1080mils True (+107)) Elevation Angle: +03.9° Horizon Angle: +00.2° Zoom: 1.0X W-L19 RESOURCE NONIMPACT AREA Mountain Valley</small></p>
GPS Location See Photo	GPS Location See Photo
Description View of permitted resource impact area during post-construction assessment. Overview of W-L19 proposed trench location facing North.	Description At edge of LOD, view of unimpacted resource area conditions during post-construction assessment. Overview of W-L19 nonimpact facing North.

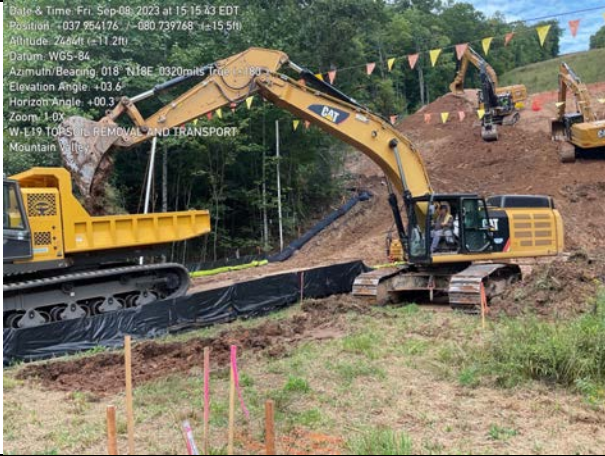
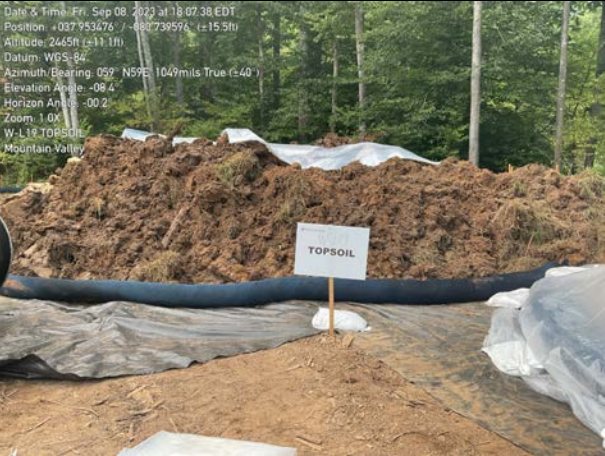
(9/8/2023) - First 12" of wetland topsoil removed (Photo 1) and segregated in upland area (Photo 2). Trenching began in upland area. Approximately 0.1" of rain occurred.
 (9/9/2023) - Timber mats placed in wetland area to allow for additional topsoil removal.
 (9/11/2023) - Approximately 0.8 inches of rain occurred. Began trenching in aquatic resource. Welding on-going outside resource.
 (9/12/2023) - Welding outside of aquatic resource. Pumping of water out of trench in aquatic resource. Timber mats moved in aquatic resource.
 (9/13/2023 - 9/14/2023) - Continued pumping water from the resource area. Trenching ongoing (Photo 3 and Photo 4). Additional topsoil removed from wetland resource (9/14/2023). Rain event of approximately 0.1 inches of rain on 9/13/2023.
 (9/15/2023) - Bedding placed in trench in aquatic resource area. A portion of pipe lowered into trench running through aquatic resource area (Photo 5).

<p><small>Date & Time: Fri, Sep 08, 2023 at 18:07:38 EDT Position: +037.933676° / -080.739596° (+15.5ft) Altitude: 2458ft (+11.1ft) Datum: WGS-84 Azimuth/Bearing: 057. N57E (1049mils True (+57)) Elevation Angle: +08.4° Horizon Angle: +00.2° Zoom: 1.0X W-L19 TOPSOIL Mountain Valley</small></p>
GPS Location See Photo	GPS Location See Photo
Description Photo 1. Wetland 12" of topsoil excavation and segregation onto morooka.	Description Photo 2. Wetland 12" topsoil segregated and stockpiled in upland area.

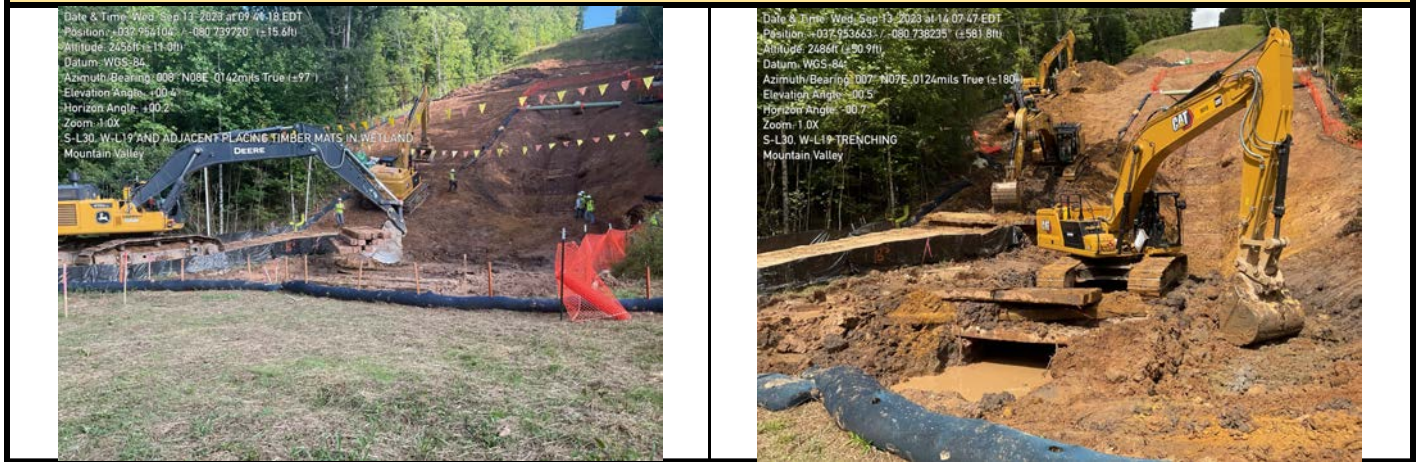
GPS Location	See Photo	GPS Location	See Photo
Description	Photo 3: Adjusting timber mats for work in wetland.	Description	Photo 4: Trenching in aquatic resource from timber mats.

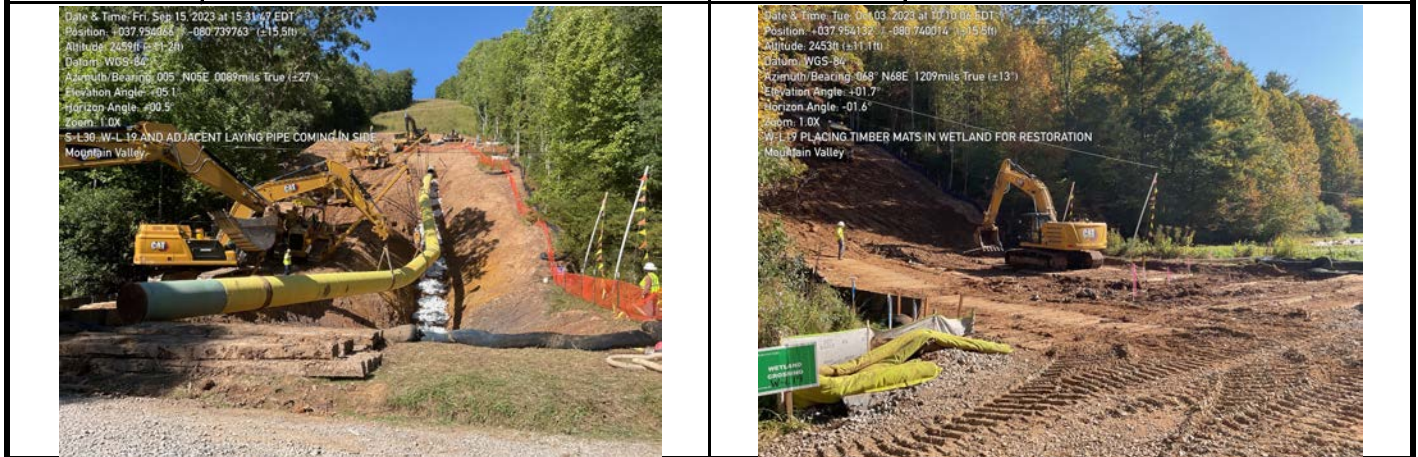
(10/3/2023) - Backfilling ongoing around aquatic resource and survey established elevations. Prepping site for restoration activities in aquatic resource (Photo 6)
 (10/4/2023) - Subsoils restored in aquatic resource. Survey was present to work on elevations.
 (10/5/2023 - 10/6/2023) - Ongoing adjustments to elevation of aquatic resource. Substantial rain event late in the day on 10/6/2023.
 (10/7/2023) - Seeding occurred in aquatic resource (Photo 7).
 (10/09/2023) - Additional seeding and survey in wetland completed.
 (10/10/2023) - Test station in wetland must be removed, will require work in wetland boundaries.
 (10/11/2023) - Test station was removed from wetland boundary (Photo 8). Wetland topsoil and subsoil were properly excavated, segregated, and then wetland was restored.

GPS Location	See Photo	GPS Location	See Photo
Description	Photo 5: Installation of south trench breaker between S-L22 and W-L19.	Description	Photo 6: Restoration of wetland 12" topsoil to resource.

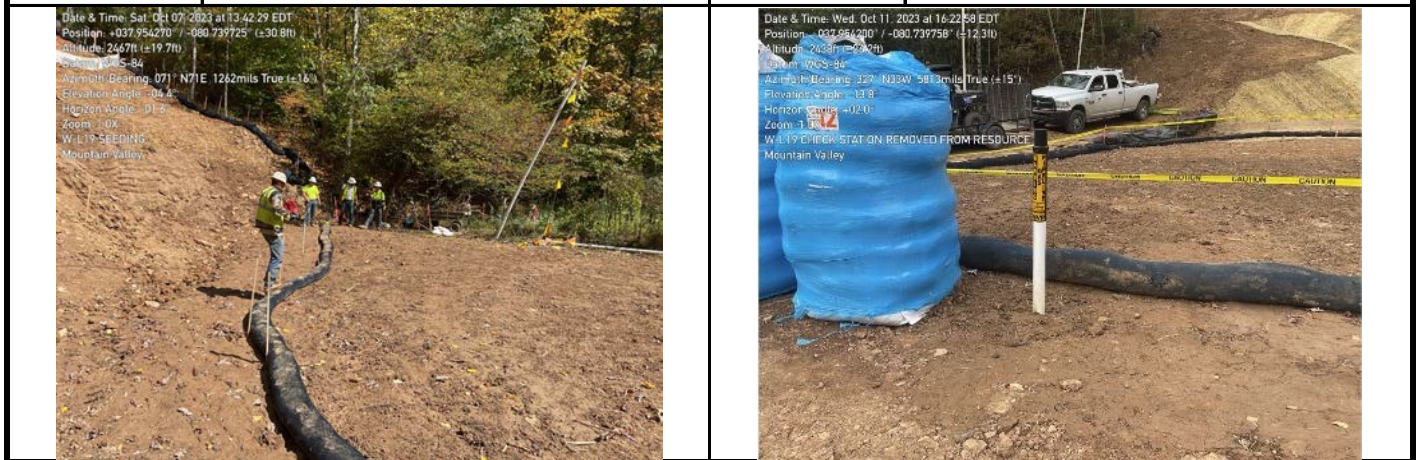
GPS Location	See Photo	GPS Location	See Photo
Description	Photo 7: Seeding aquatic resources.	Description	Photo 8: Test station after removal from wetland (now outside of resource).
