# Wetland Biological Conditions EA Report

<b>Project Name</b>	H-600 Pipeline Spread E	<b>AFE</b>	124300134	<b>Spread</b>	H-600 Pipeline Spread E
<b>Contractor</b>	Price Gregory	<b>Report #</b>	62		
<b>Environmental Auditor</b>	Tim Ferguson	<b>Date/Time</b>	9/20/2023 9:53 AM		
<b>Wetland ID</b>	W-L2	<b>Crossing Start Date</b>	9/20/2023	<b>Crossing Completion Date</b>	9/28/2023
<b>Milepost</b>	148.46	<b>Pre-Con Assessment Date</b>	9/20/2023	<b>Post-Con Assessment Date</b>	9/28/2023
<b>Station</b>	7838+69	<b>Cowardin Classification</b>	PEM	<b>Wetland Impact Area(acs)</b>	0.0393
<b>State</b>	WV				
<b>County</b>	Greenbrier

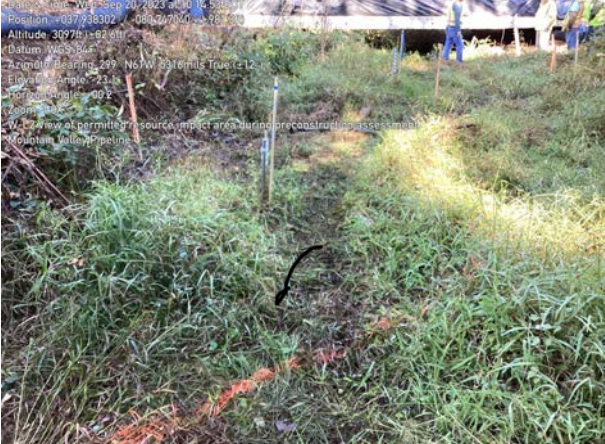
<b>GPS Location</b>	See Photo.	<b>GPS Location</b>	See Photo.
<b>Description</b>	View of permitted resource impact area during pre-construction assessment.	<b>Description</b>	At edge of LOD, view of unimpacted resource area conditions during pre-construction assessment.
