# Wetland Biological Conditions EA Report

<b>Project Name</b>	H-600 Pipeline Spread A	<b>AFE</b>	124300129	<b>Spread</b>	H-600 Pipeline Spread A
<b>Contractor</b>	Precision	<b>Report #</b>	46		
<b>Environmental Auditor</b>	Samantha Felix			<b>Date/Time</b>	9/7/2023 8:42 AM
<b>Wetland ID</b>	W-UU3	<b>Crossing Start Date</b>	9/11/2023	<b>Crossing Completion Date</b>	9/23/2023
<b>Milepost</b>	26.03	<b>Pre-Con Assessment Date</b>	9/7/2023	<b>Post-Con Assessment Date</b>	9/23/2023
<b>Station</b>	1374+54	<b>Cowardin Classification</b>	PFO	<b>Wetland Impact Area(acres)</b>	0.0065
<b>State</b>	WV				
<b>County</b>	Harrison

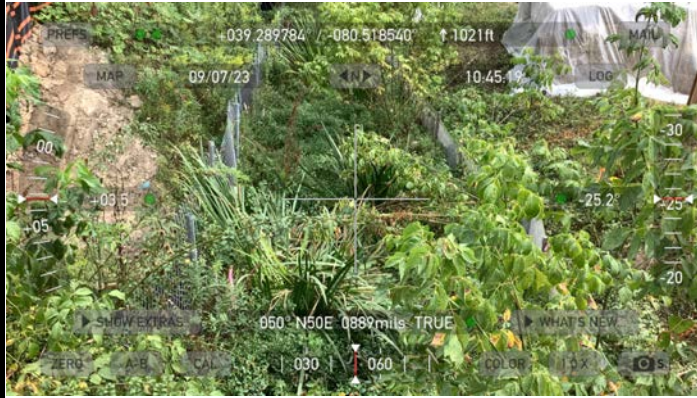
<b>GPS Location</b>	
<b>Description</b>	View of permitted resource impact area during pre-construction assessment.

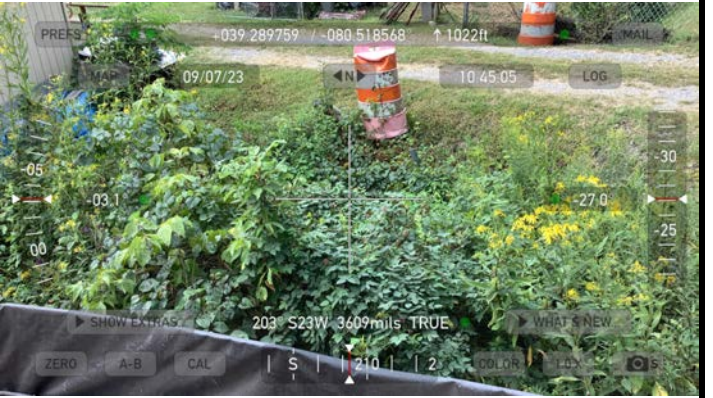
<b>GPS Location</b>	
<b>Description</b>	At edge of LOD, view of unimpacted resource area conditions during pre-construction assessment.

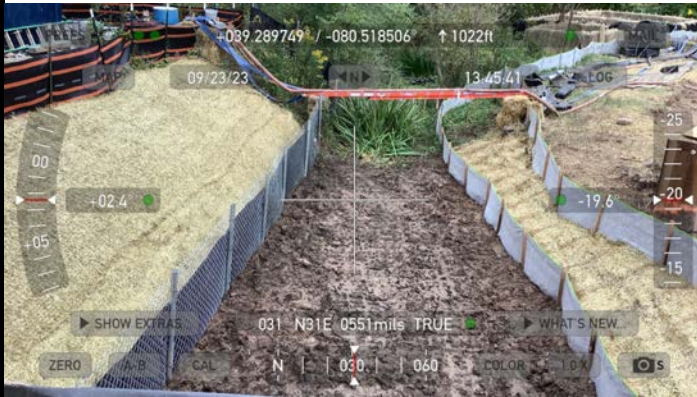
Conditions 18 and 19 were given a rating of 4 during post-construction assessment due to lack of vegetation in the disturbed permitted impact area following the completion of the crossing and restoration efforts. The W-UU3 substrate has been properly stabilized and the disturbed area has been seeded with the appropriate permanent seed mix in accordance with Appendix B: Restoration Work Plan of the Mountain Valley Pipeline Comprehensive Stream and Wetland Monitoring, Restoration and Mitigation Framework.

<b>GPS Location</b>	
<b>Description</b>	View of permitted resource impact area during post-construction assessment.

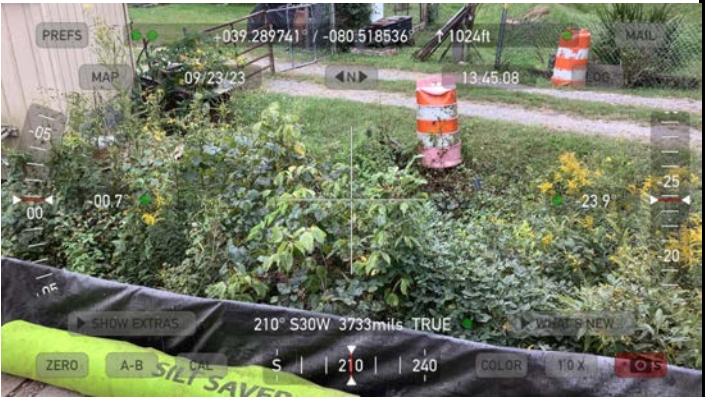
<b>GPS Location</b>	
<b>Description</b>	At edge of LOD, view of unimpacted resource area conditions during post-construction assessment.

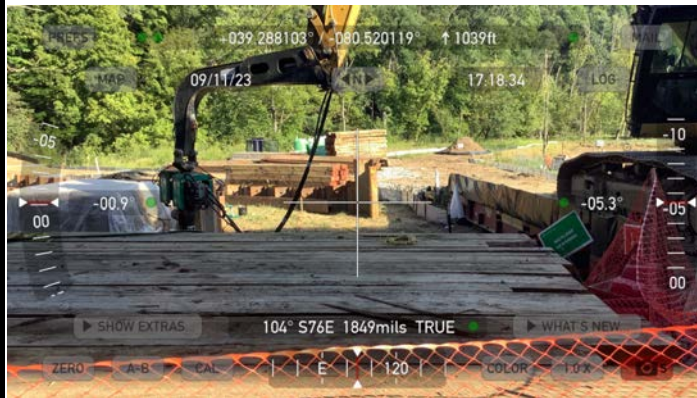
<b>GPS Location</b>	See above.
<b>Description</b>	Sheet piling in progress.

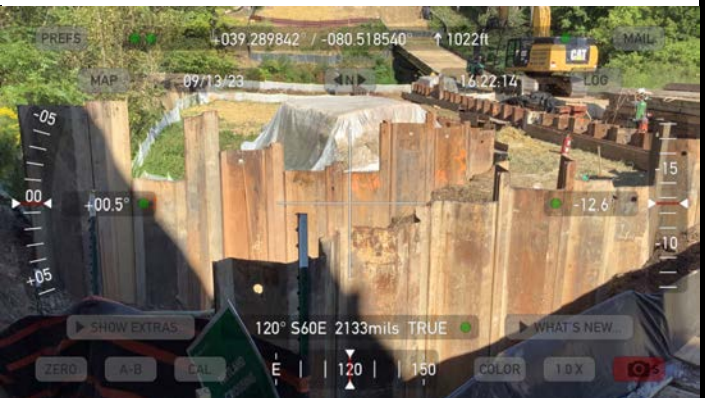
<b>GPS Location</b>	See above.
<b>Description</b>	Continuation of sheet piling.

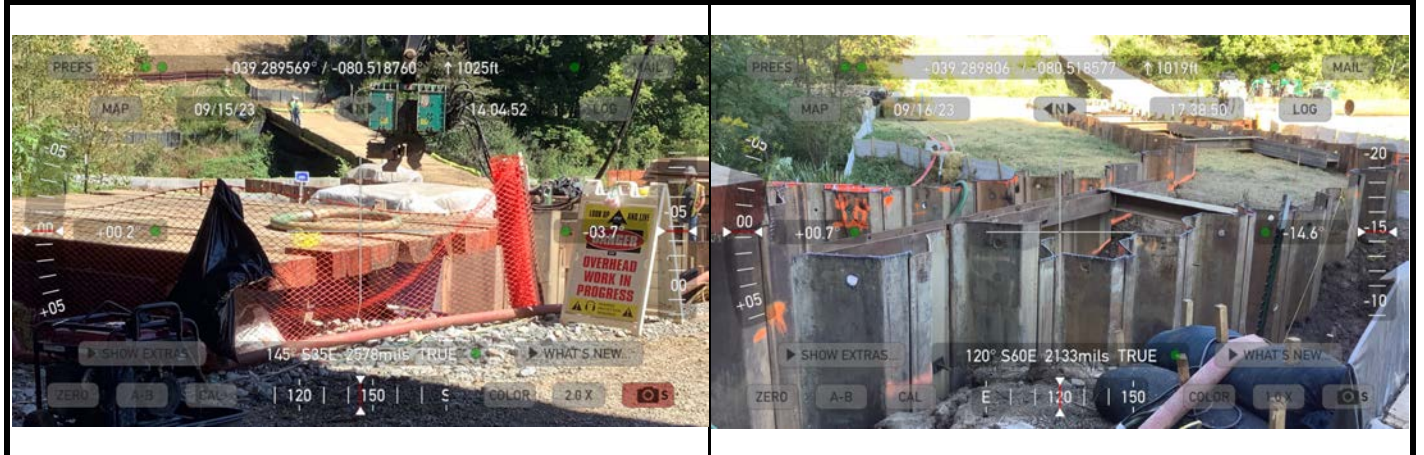
<b>GPS Location</b>	See above.	<b>GPS Location</b>	See above.
<b>Description</b>	Finishing sheet piling.	<b>Description</b>	I-beams installed.

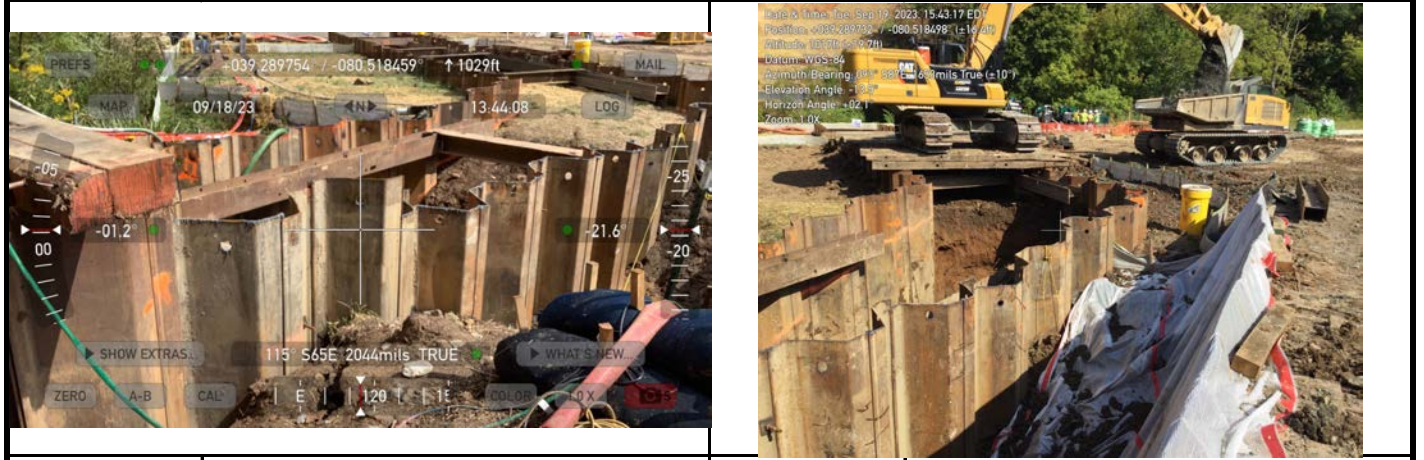
<b>GPS Location</b>	See above.	<b>GPS Location</b>	See above.
<b>Description</b>	Preparation for excavation.	<b>Description</b>	Excavation of trench.

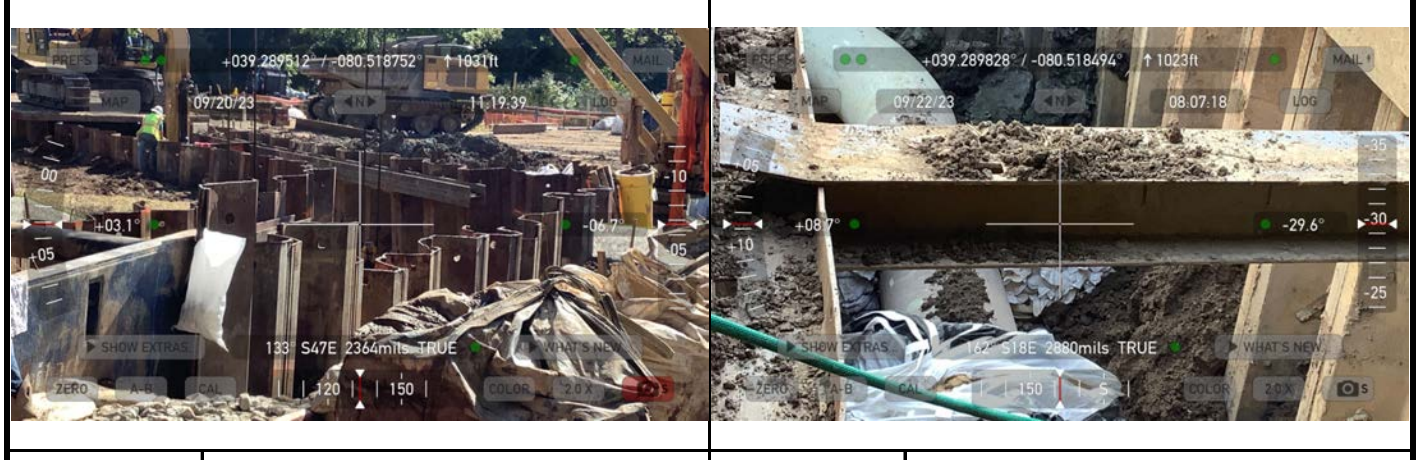
<b>GPS Location</b>	See above.	<b>GPS Location</b>	See above.
<b>Description</b>	Welding.	<b>Description</b>	Backfill with subsoil.
