# Wetland Biological Conditions EA Report

<b>Project Name</b>	H-600 Pipeline Spread B	<b>AFE</b>	124300130	<b>Spread</b>	H-600 Pipeline Spread B
<b>Contractor</b>	Precision	<b>Report #</b>	47		
<b>Environmental Auditor</b>	Elyse Johnston			<b>Date/Time</b>	9/5/2023 10:07 AM
<b>Wetland ID</b>	W-VV8	<b>Crossing Start Date</b>	9/5/2023	<b>Crossing Completion Date</b>	10/11/2023
<b>Milepost</b>	61.20	<b>Pre-Con Assessment Date</b>	9/5/2023	<b>Post-Con Assessment Date</b>	10/11/2023
<b>Station</b>	3231+36	<b>Cowardin Classification</b>	PEM	<b>Wetland Impact Area(acres)</b>	0.0708
<b>State</b>	WV				
<b>County</b>	Lewis

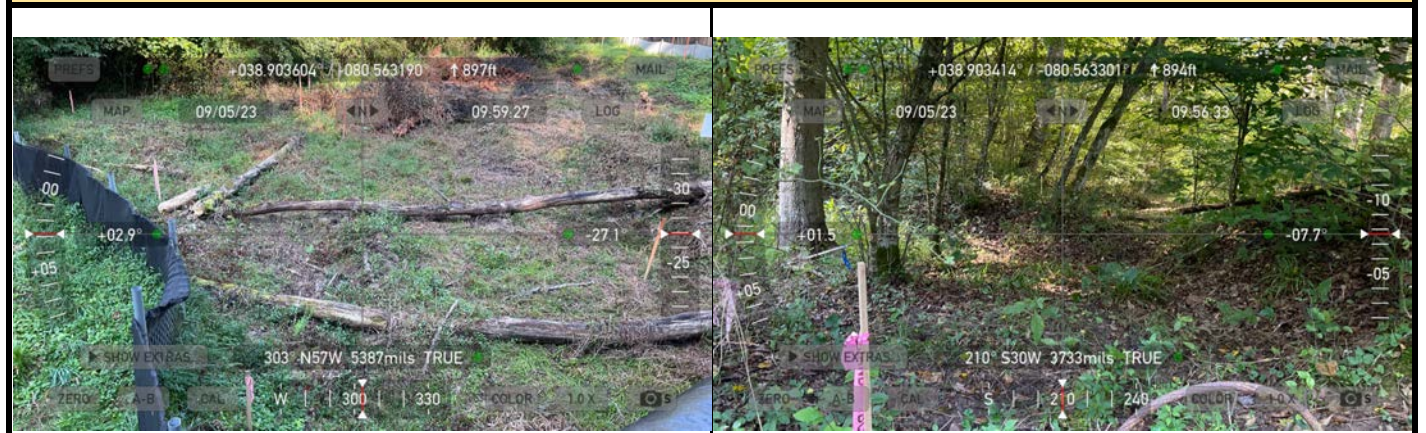
<b>GPS Location</b>	See Photo.	<b>GPS Location</b>	See Photo.
<b>Description</b>	View of permitted resource impact area during pre-construction assessment.	<b>Description</b>	At edge of LOD, view of unimpacted resource area conditions during pre-construction assessment.

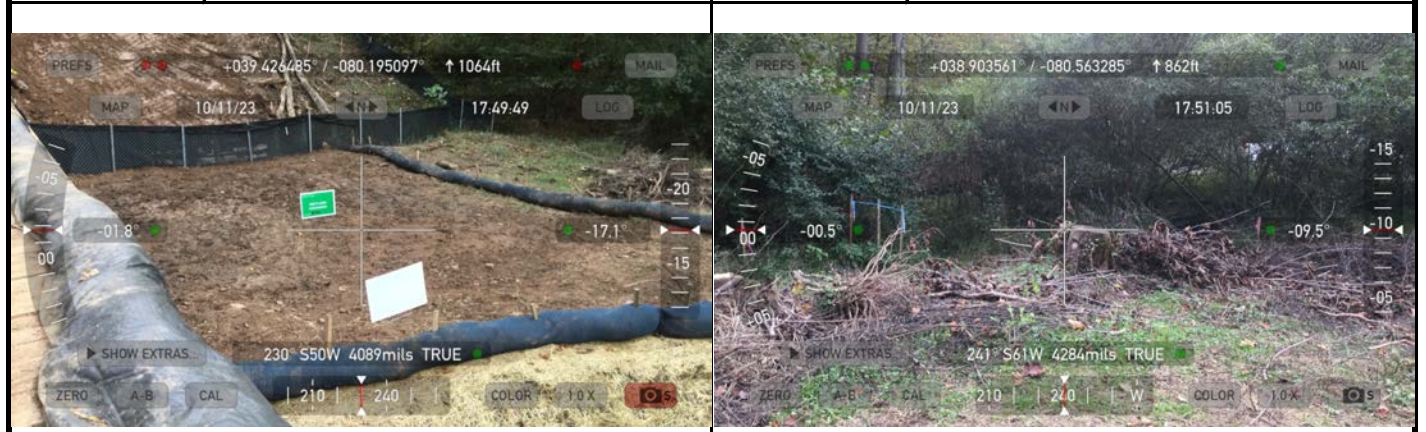
10/11 Conditions 18 and 19 were given a rating of 4 during post-construction assessment due to lack of vegetation in the disturbed permitted impact area following the completion of the crossing efforts. The W-VV8 wetland topsoils have been properly restored and the disturbed area has been seeded with the appropriate permanent seed mix in accordance with Appendix B: Restoration Work Plan of the Mountain Valley Pipeline Comprehensive Stream and Wetland Monitoring, Restoration and Mitigation Framework. -A. Dunn

<b>GPS Location</b>	See Photo.	<b>GPS Location</b>	See Photo
<b>Description</b>	View of permitted resource impact area during post-construction assessment.	<b>Description</b>	At edge of LOD, view of unimpacted resource area conditions during post-construction assessment.

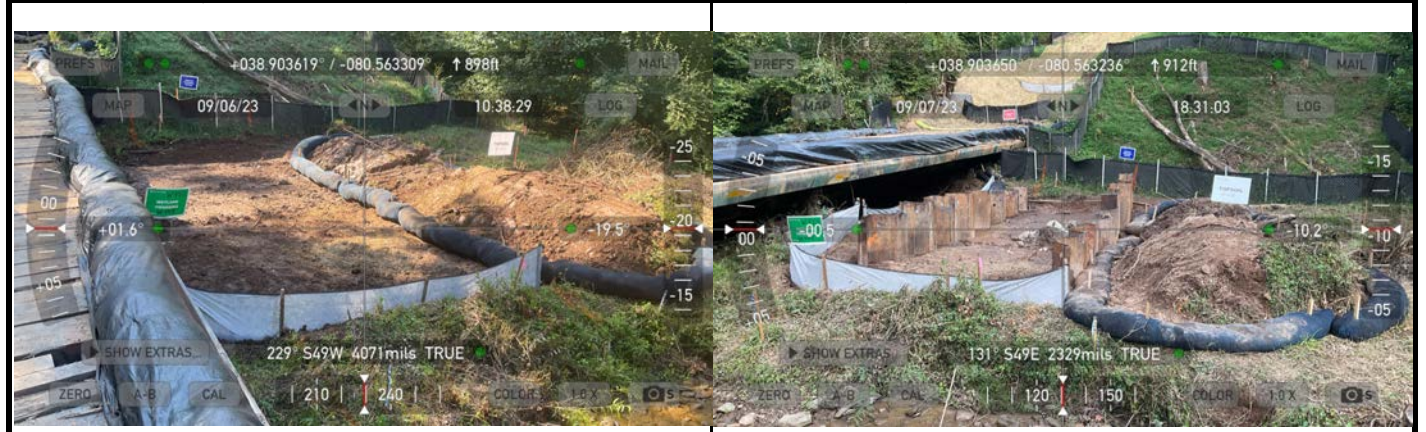
9/5 The contractor removed the topsoil from W-VV8, stockpiled the wetland topsoil within the wetland boundaries, and placed filter sock around the stockpile for stabilization. - E. Johnston

<b>GPS Location</b>	See Photo.	<b>GPS Location</b>	See Photo.
<b>Description</b>	View of wetland W-VV8 after topsoil removal and stabilization.	<b>Description</b>	View of sheet piling installed in W-VV8.

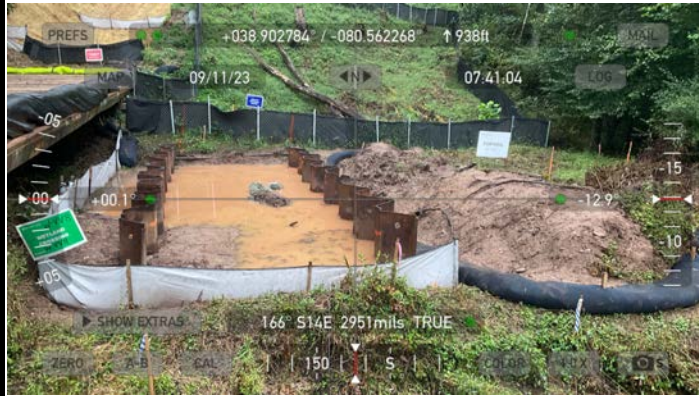
9/19 Contractor dewatered groundwater from W-VV8 and worked on nearby associated crossings. - C. Calmindon

<b>GPS Location</b>	See Photo.
<b>Description</b>	View of water pumped from W-VV8.

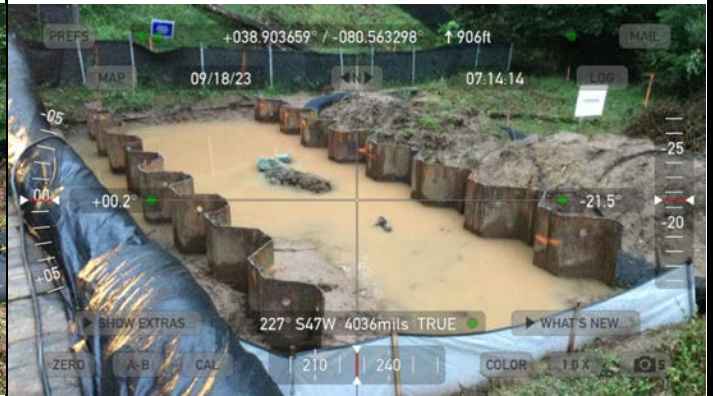
<b>GPS Location</b>	See Photo.
<b>Description</b>	View of W-VV8 on 9/18/2023.

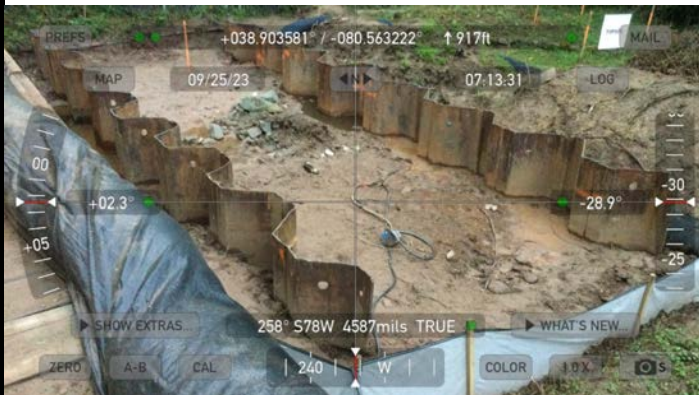
<b>GPS Location</b>	See Photo.
<b>Description</b>	View of W-VV8 on 9/25/2023.

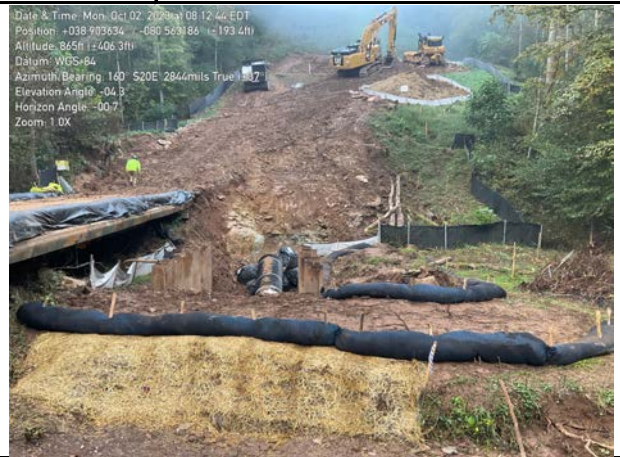
<b>GPS Location</b>	See Photo.
<b>Description</b>	View of W-VV8 on 10/2/2023.

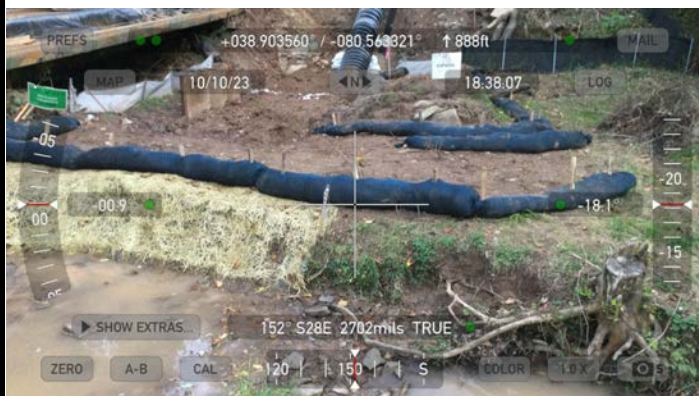
10/10 The crew removed the sheet piling, backfilled the trench, and replaced the original 12" of segregated wetland topsoil to the wetland area and graded it to the correct contour. Erosion and sediment controls were then installed around the wetland. - A. Dunn

<b>GPS Location</b>	See Photo.
<b>Description</b>	View of W-VV8 on 10/10/2023.
