Stream Biological Conditions EA Report

Project Name	H-600 Pipeline Spread D	AFE	124300132	Spread	H-600 Pipeline Spread D
Contractor	Precision	Report #	329		
Environmental Auditor	Scott Wessel	Date/Time	10/25/2023 9:08 PM		
Stream ID	S-139	Crossing Start Date	10/26/2023	Crossing Completion Date	10/29/2023
Milepost	125.70	Pre-Con Assessment Date	10/23/2023	Post-Con Assessment Date	10/29/2023
Station	6636+85	Bankfull Width (ft.)	7.0	Riffle:Pool Complexes Present?	No
State	WV	Stream Classification	Intermittent		
County	Nicholas	303(d) Impairment Listing	No

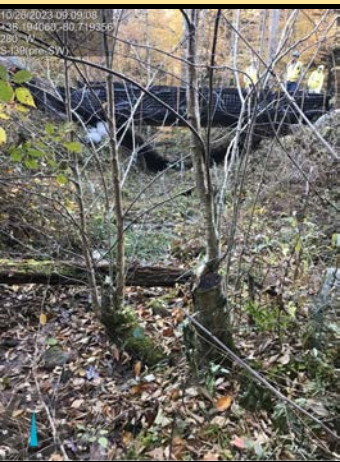
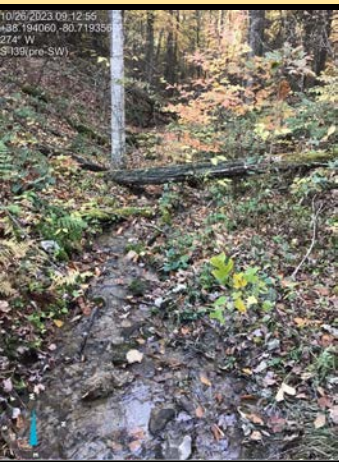
GPS Location	See GPS in above photo.
Description	Downstream view of permitted impact area during pre-construction assessment.	Description	Downstream view of unimpacted area during pre-construction assessment.	GPS Location	See GPS in above photo.
Description	Downstream view of permitted impact area during post-construction assessment.	Description	Downstream view of unimpacted area during post-construction assessment.	GPS Location	See GPS in above photo.
Description	Flume being installed at stream S-I39.	Description	Substrate material from resource S-I39 segregated in super sacks.	GPS Location	See GPS in above photo.
Description	Flume being installed at stream S-I39.	Description	Substrate material from resource S-I39 segregated in super sacks.

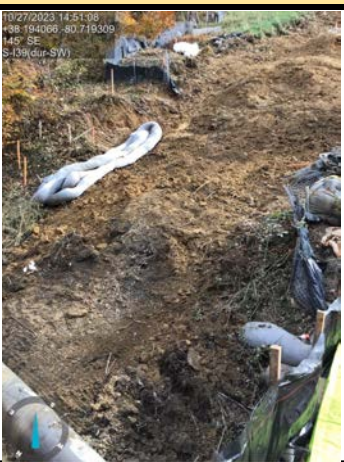
<p>10/27/2023 14:51:08 +38.194366,-80.719309 145° SE S-I39(dur-SW)</p>			  <p>10/28/2023 12:02:53 +38.194071,-80.719328 138° SE S-I39(dur-SW)</p>	
GPS Location	See GPS in above photo.		GPS Location	See GPS in above photo.	
Description	GAS of S-I39 after blasting.		Description	Trenching activities on the GAS of S-I39.	
	  <p>10/28/2023 15:42:30 +38.194994,-80.719356 154° SE S-I39(dur-SW)</p>			  <p>10/28/2023 12:32:35 +38.194071,-80.719397 154° SE S-I39(dur-SW)</p>	
GPS Location	See GPS in above photo.		GPS Location	See GPS in above photo.	
Description	Pipe section being lowered in ditch on top of sandbags.		Description	Buffer zone area being backfilled on the GAS of S-I39.	
	  <p>10/28/2023 16:11:12 +38.193964,-80.719322 73° E S-I39(dur-SW)</p>			  <p>10/28/2023 12:32:45 +38.194071,-80.719397 49° NE S-I39(dur-SW)</p>
