# Stream Biological Conditions EA Report

<b>Project Name</b>	H-600 Pipeline Spread A	<b>AFE</b>	124300129	<b>Spread</b>	H-600 Pipeline Spread A
<b>Contractor</b>	Precision	<b>Report #</b>	238		
<b>Environmental Auditor</b>	Devin Jen	<b>Date/Time</b>	9/18/2023 11:31 AM		
<b>Stream ID</b>	S-K74	<b>Crossing Start Date</b>	9/21/2023	<b>Crossing Completion Date</b>	10/26/2023
<b>Milepost</b>	31.42	<b>Pre-Con Assessment Date</b>	9/18/2023	<b>Post-Con Assessment Date</b>	10/26/2023
<b>Station</b>	1658+77	<b>Bankfull Width (ft.)</b>	2.5	<b>Riffle:Pool Complexes Present?</b>	No
<b>State</b>	WV	<b>Stream Classification</b>	Ephemeral		
<b>County</b>	Harrison	<b>303(d) Impairment Listing</b>	No/A

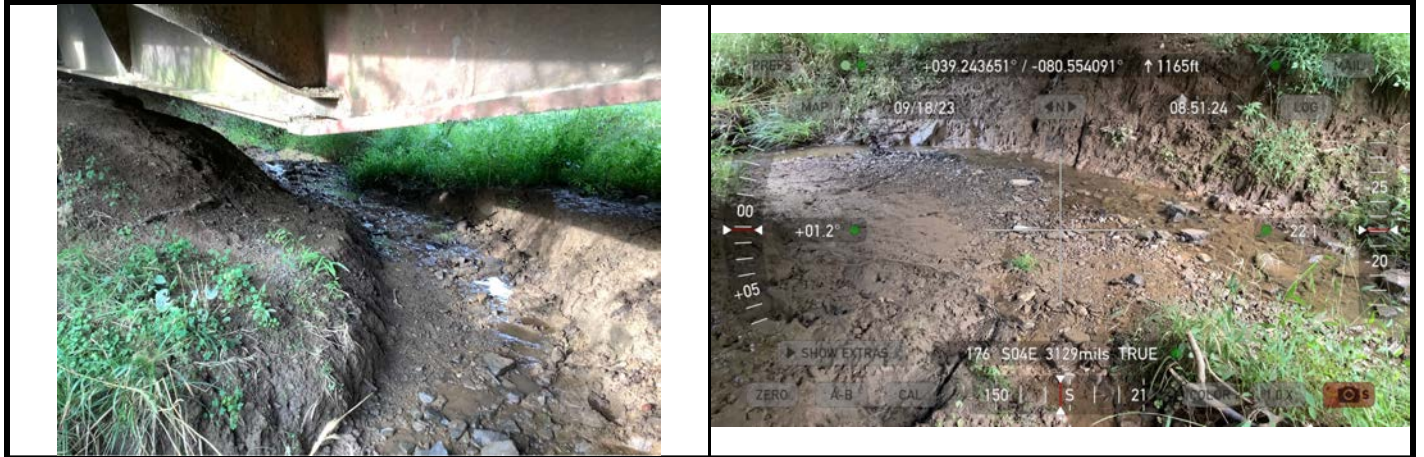
<b>GPS Location</b>	See photo.	<b>GPS Location</b>	See photo.
<b>Description</b>	Downstream view of permitted impact area during pre-construction assessment.	<b>Description</b>	Downstream view of unimpacted area during pre-construction assessment.

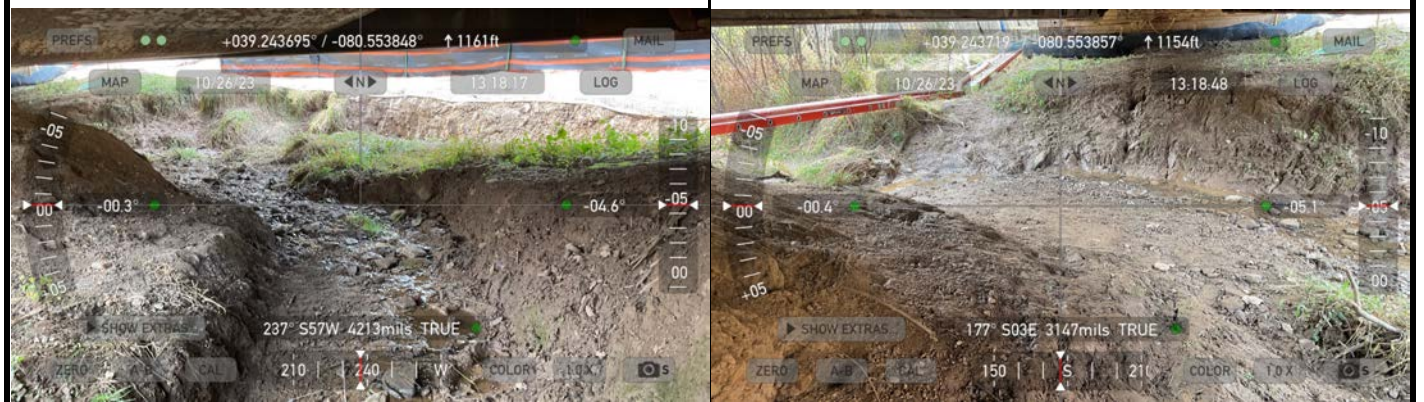
<b>GPS Location</b>	See photo	<b>GPS Location</b>	See photo
<b>Description</b>	Downstream view of permitted impact area during post-construction assessment.	<b>Description</b>	Downstream view of unimpacted area during post-construction assessment.

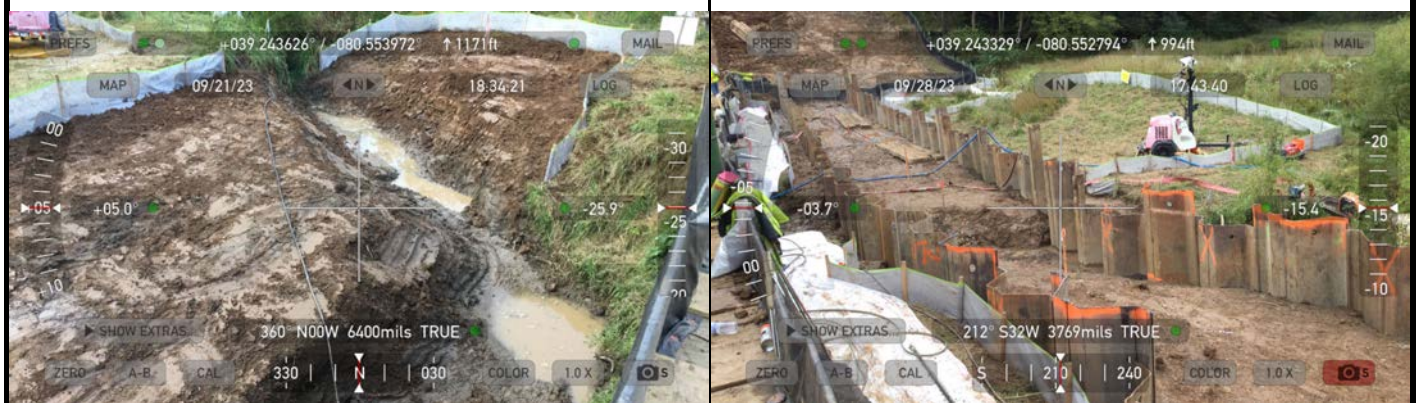
<b>GPS Location</b>	See photo	<b>GPS Location</b>	See photo
<b>Description</b>	This photo shows topsoil removed from the adjacent stream crossing	<b>Description</b>	This photo shows the sheetpiling installed in the stream/wetland complex
