Stream Biological Conditions EA Report

Project Name	H-600 Pipeline Spread D	AFE	124300132	Spread	H-600 Pipeline Spread D
Contractor	Precision	Report #	331		
Environmental Auditor	Scott Wessel	Date/Time	10/27/2023 8:14 AM		
Stream ID	S-L35-1	Crossing Start Date	10/27/2023	Crossing Completion Date	11/1/2023
Milepost	124.86	Pre-Con Assessment Date	10/27/2023	Post-Con Assessment Date	11/1/2023
Station	6592+76	Bankfull Width (ft.)	4.0	Riffle:Pool Complexes Present?	No
State	WV	Stream Classification	Perennial		
County	Nicholas	303(d) Impairment Listing	No

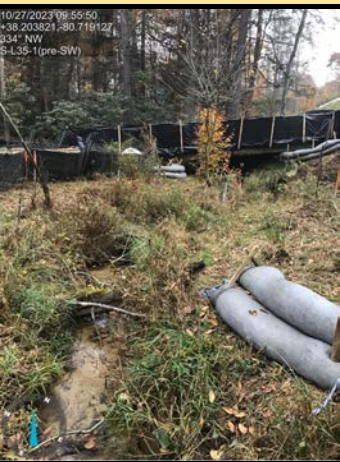
GPS Location	See coordinates in above photo.	GPS Location	See coordinates in above photo.				
Description	Downstream view of permitted impact area during pre-construction assessment.	Description	Downstream view of unimpacted area during pre-construction assessment.

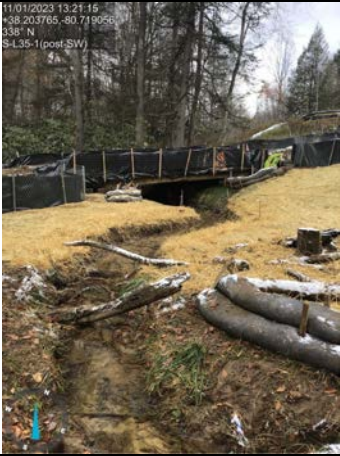
GPS Location	See coordinates in above photo.	GPS Location	See coordinates in above photo.
Description	Downstream view of permitted impact area during post-construction assessment.	Description	Downstream view of unimpacted area during post-construction assessment.

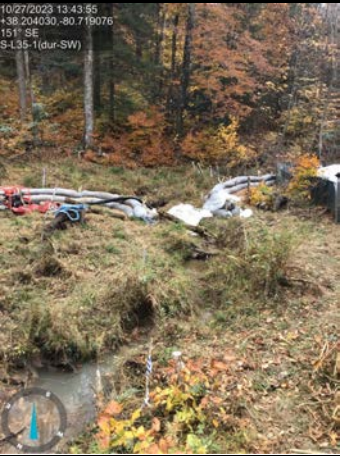
GPS Location	See coordinates in above photo.	GPS Location	See coordinates in above photo.
Description	Dam and pump around materials being set up.	Description	Stream substrate material segregated into super sacks and staged on the CIS of resource in an upland area.
