Stream Biological Conditions EA Report

Resource Post-Crossing Conditions

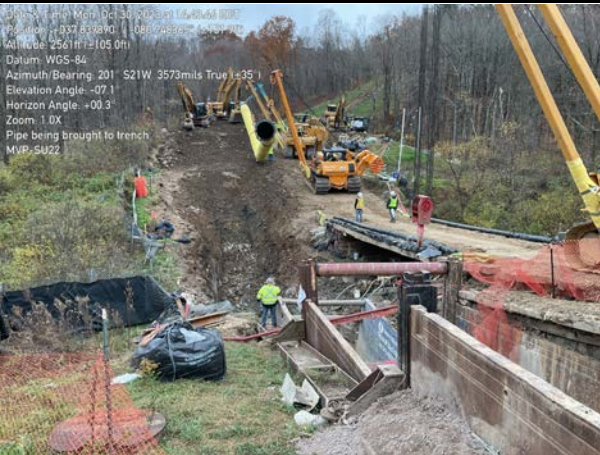
<p>Date & Time: Mon, Oct 30, 2023 at 14:04:00 EDT Position: +037.837890 / -080.748461 (+11.6ft) Altitude: 2561ft (+105.0ft) Datum: WGS-84 Azimuth Bearing: 201 S21W 3573mils True (+35.1) Elevation Angle: -07.1 Horizon Angle: +00.3 Zoom: 1.0X Pipe being brought to trench MVP-SU22</p>

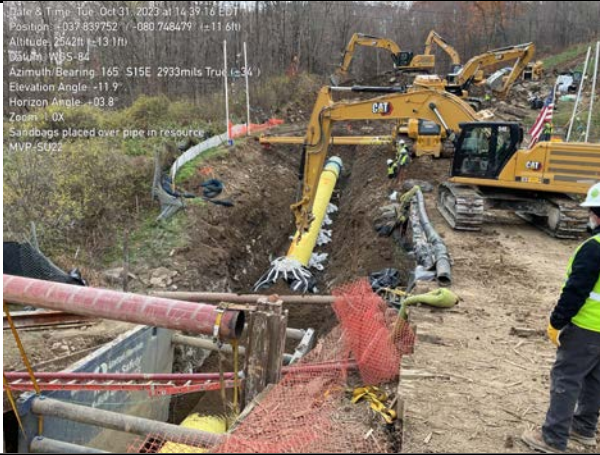
<p>Date & Time: Tue, Oct 31, 2023 at 14:39:18 EDT Position: +037.837872 / -080.748479 (+11.6ft) Altitude: 2542ft (+103.1ft) Datum: WGS-84 Azimuth Bearing: 165 S15E 2933mils True (+34.1) Elevation Angle: +11.9 Horizon Angle: +03.8 Zoom: 1.0X Sandbags placed over pipe in resource MVP-SU22</p>		GPS Location See Photo	GPS Location See Photo				
Description	Photo 3: Transporting pipe to be placed in aquatic resource.	Description	Photo 4: Sandbag padding in trench and river weights placed in aquatic resource area.

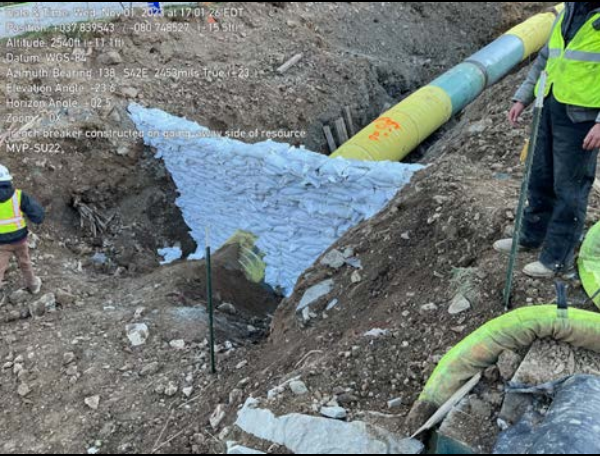
<p>Date & Time: Wed, Nov 01, 2023 at 17:01:26 EDT Position: +037.837843 / -080.748522 (+15.5ft) Altitude: 2540ft (+11.1ft) Datum: WGS-84 Azimuth Bearing: 138 S42E 2653mils True (+23.1) Elevation Angle: +23.3 Horizon Angle: +02.3 Zoom: 1.0X Trench breaker constructed on east side of resource MVP-SU22</p>

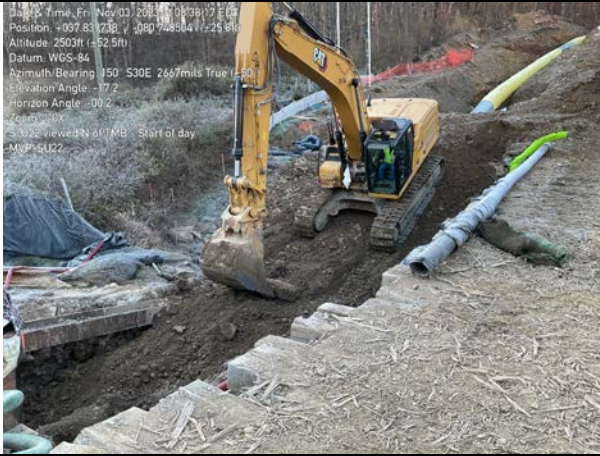
<p>Date & Time: Fri, Nov 03, 2023 at 08:39:17 EDT Position: +037.837732 / -080.748444 (+25.6ft) Altitude: 2503ft (+92.5ft) Datum: WGS-84 Azimuth Bearing: 150 S30E 2667mils True (+23.1) Elevation Angle: +17.2 Horizon Angle: +00.2 Zoom: 1.0X Large rock returned to resource MVP-SU22</p>		GPS Location See Photo	GPS Location See Photo

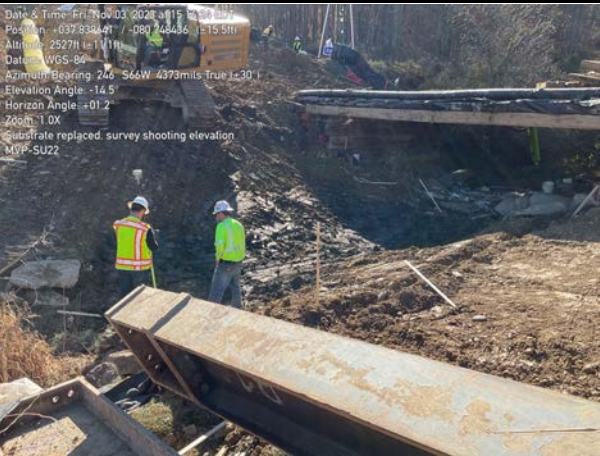
<p>Date & Time: Fri, Nov 03, 2023 at 15:12:58 EDT Position: +037.838481 / -080.748436 (+15.5ft) Altitude: 2527ft (+11.1ft) Datum: WGS-84 Azimuth Bearing: 266 S66W 4373mils True (+30.1) Elevation Angle: +14.9 Horizon Angle: +01.2 Zoom: 1.0X Substrate replaced, survey shooting elevation MVP-SU22</p>

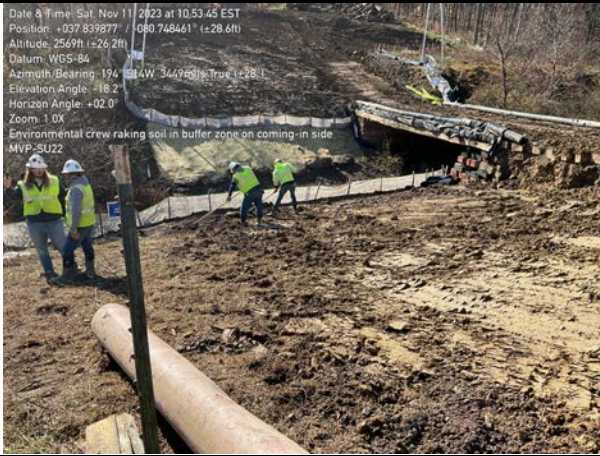
<p>Date & Time: Sat, Nov 11, 2023 at 10:53:45 EST Position: +037.837877 / -080.748461 (+28.6ft) Altitude: 2569ft (+92.6ft) Datum: WGS-84 Azimuth Bearing: 194 S14W 3449mils True (+28.1) Elevation Angle: +18.2 Horizon Angle: +02.0 Zoom: 1.0X Environmental crew raking soil in buffer zone on coming-in side MVP-SU22</p>		GPS Location See Photo	GPS Location See Photo
Description	Photo 7: Substrate replaced and elevation verified by survey.	Description	Photo 8: Environmental crew raking the buffer in preparation for seeding.
