# Wetland Biological Conditions EA Report

<b>Project Name</b>	H-600 Pipeline Spread B	<b>AFE</b>	124300130	<b>Spread</b>	H-600 Pipeline Spread B
<b>Contractor</b>	Precision	<b>Report #</b>	72		
<b>Environmental Auditor</b>	Elyse Johnston			<b>Date/Time</b>	9/27/2023 6:42 AM
<b>Wetland ID</b>	W-A23	<b>Crossing Start Date</b>	9/27/2023	<b>Crossing Completion Date</b>	10/25/2023
<b>Milepost</b>	34.96	<b>Pre-Con Assessment Date</b>	9/27/2023	<b>Post-Con Assessment Date</b>	10/26/2023
<b>Station</b>	1845+83	<b>Cowardin Classification</b>	PEM	<b>Wetland Impact Area(acres)</b>	.2701
<b>State</b>	WV				
<b>County</b>	Doddridge

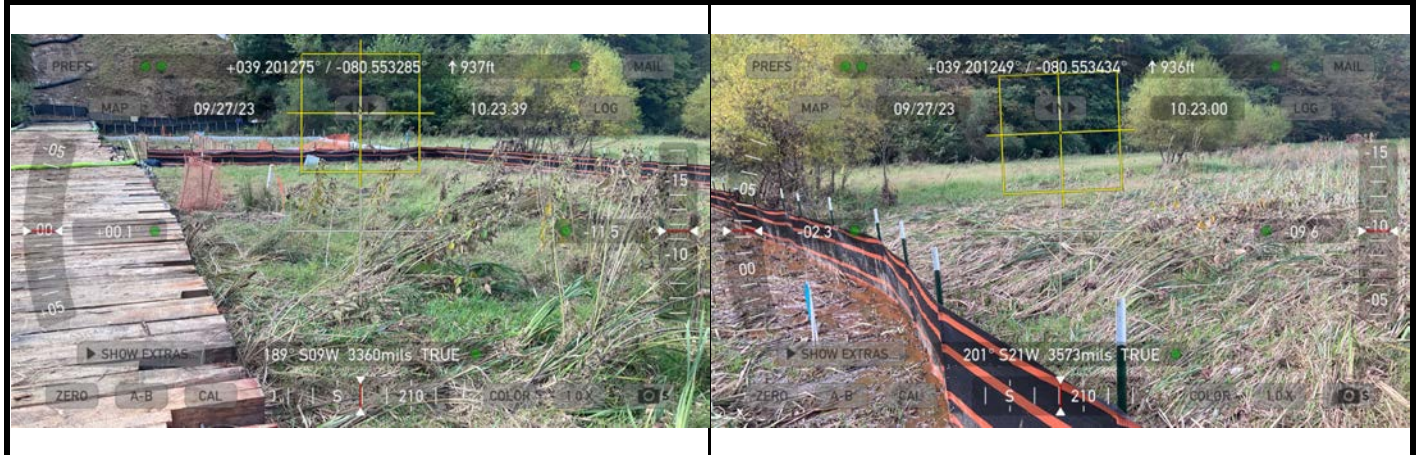
<b>GPS Location</b>	See photo	<b>GPS Location</b>	See photo
<b>Description</b>	View of permitted resource impact area during pre-construction assessment.	<b>Description</b>	At edge of LOD, view of unimpacted resource area conditions during pre-construction assessment.

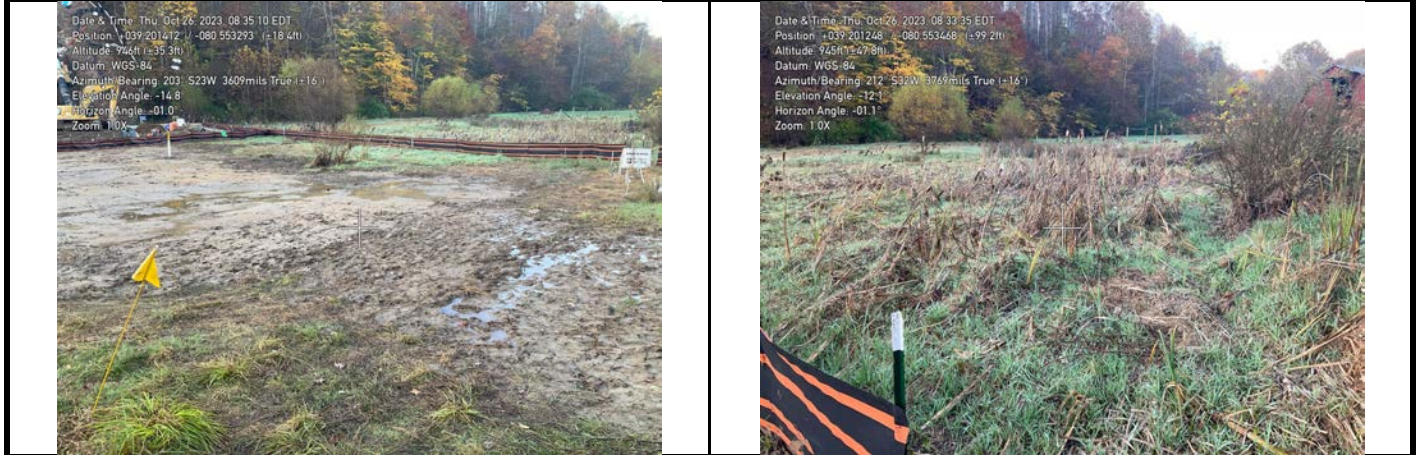
#18 and #19 were rated as "poor" due to the lack of vegetation in the disturbed permitted impact area following the completion of the crossing and restoration efforts. The W-A23 PEM wetland topsoil has been properly stabilized and the disturbed area has been seeded with the appropriate permanent seed mix in accordance with Appendix B: Restoration Work Plan of the Mountain Valley Pipeline Comprehensive Stream and Wetland Monitoring, Restoration, and Mitigation Framework.

<b>GPS Location</b>	See photo	<b>GPS Location</b>	See photo
<b>Description</b>	View of permitted resource impact area during post-construction assessment.	<b>Description</b>	At edge of LOD, view of unimpacted resource area conditions during post-construction assessment.

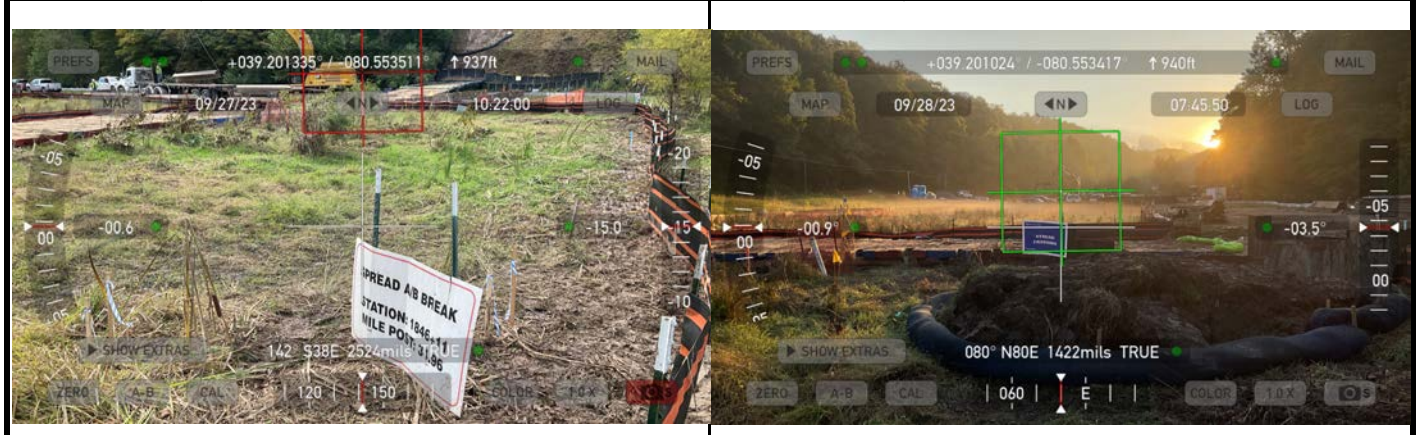
<b>GPS Location</b>	See photo	<b>GPS Location</b>	See photo
<b>Description</b>	Alternate view of wetland W-A23.	<b>Description</b>	View of wetland topsoil segregated, stockpiled, stabilized, and labeled.

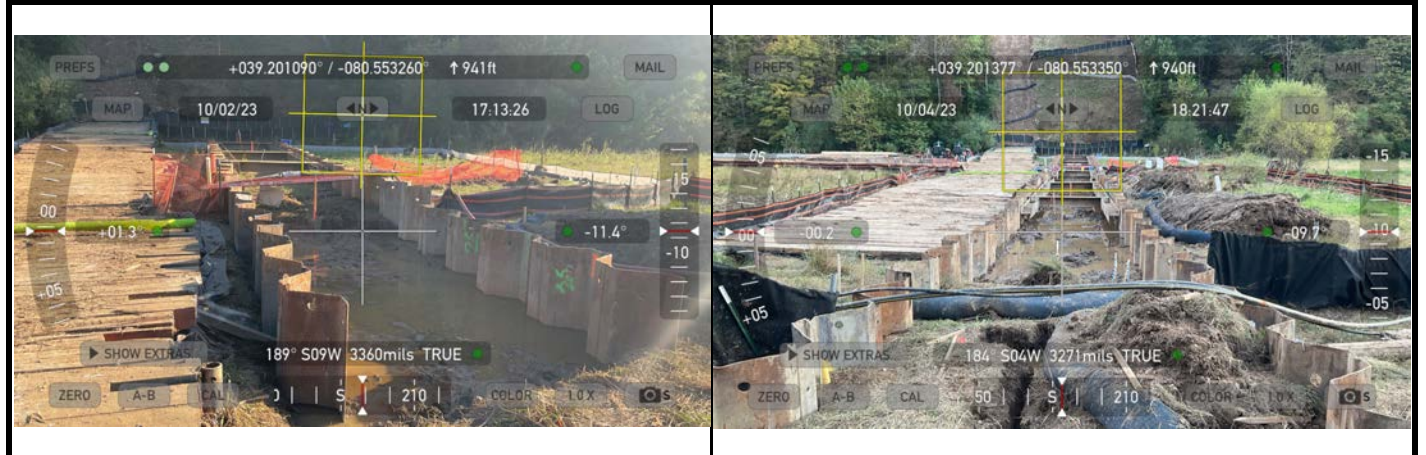
<b>GPS Location</b>	See photo	<b>GPS Location</b>	See photo
<b>Description</b>	View of sheet piling prior to removing S-A110/K62 topsoil and subsequent sheet piling.	<b>Description</b>	View of sheet piling through wetland W-A23 & S-A110/K62.

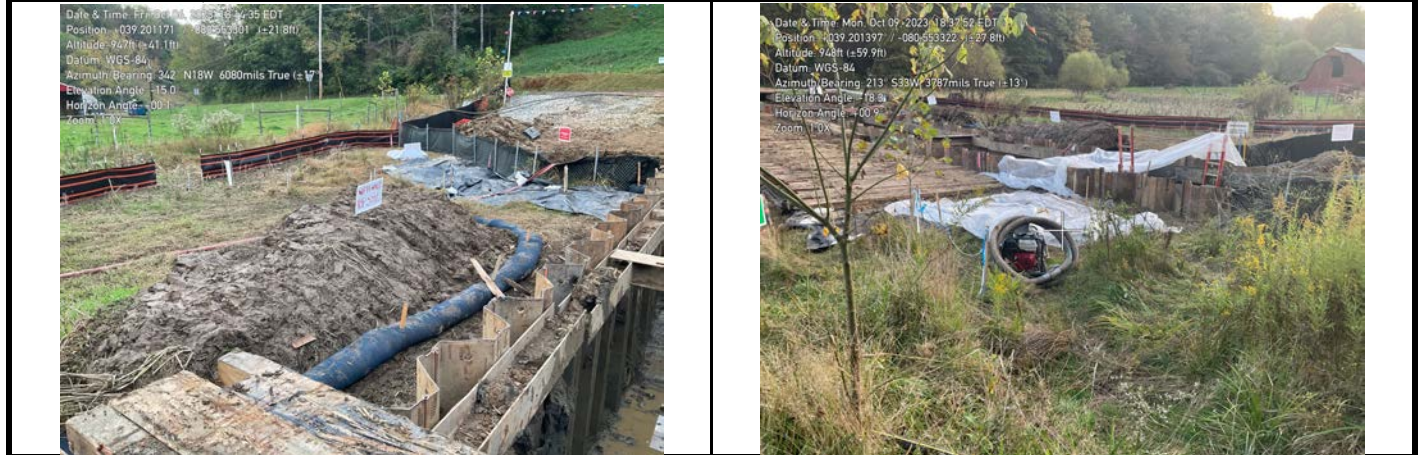
<b>GPS Location</b>	See photo	<b>GPS Location</b>	See photo
<b>Description</b>	View of segregated, stabilized, and labeled topsoil.	<b>Description</b>	View of resource post-sheet piling.

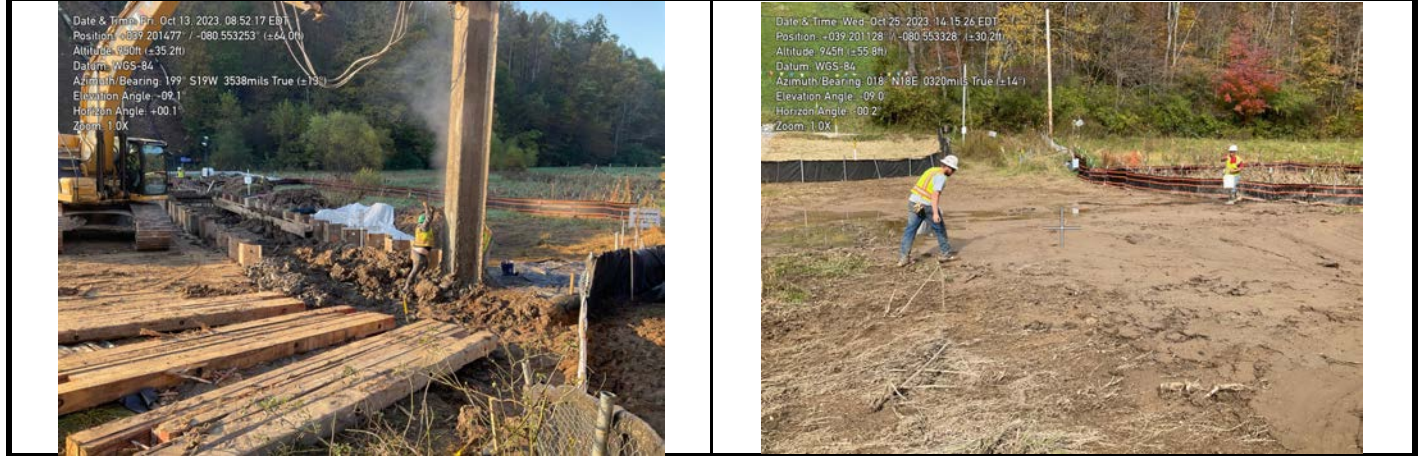
<b>GPS Location</b>	See photo	<b>GPS Location</b>	See photo
<b>Description</b>	View of sheet piling removal effort.	<b>Description</b>	View of crew stabilizing wetland with native seed mix.
