# Wetland Biological Conditions EA Report

<b>Project Name</b>	H-600 Pipeline Spread B	<b>AFE</b>	124300130	<b>Spread</b>	H-600 Pipeline Spread B
<b>Contractor</b>	Precision	<b>Report #</b>	108		
<b>Environmental Auditor</b>	Samantha Felix			<b>Date/Time</b>	10/12/2023 4:13 PM
<b>Wetland ID</b>	W-J23	<b>Crossing Start Date</b>	10/13/2023	<b>Crossing Completion Date</b>	10/25/2023
<b>Milepost</b>	43.29	<b>Pre-Con Assessment Date</b>	10/11/2023	<b>Post-Con Assessment Date</b>	10/25/2023
<b>Station</b>	2285+79	<b>Cowardin Classification</b>	PEM	<b>Wetland Impact Area(acres)</b>	0.0130
<b>State</b>	WV				
<b>County</b>	Lewis

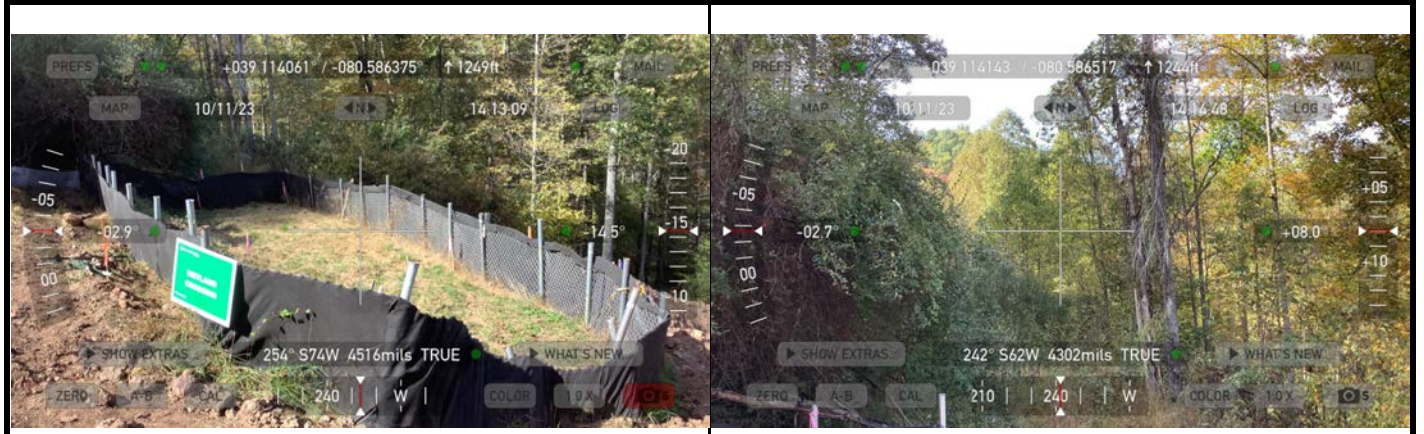
<b>GPS Location</b>	See above.	<b>GPS Location</b>	See above.
<b>Description</b>	View of permitted resource impact area during pre-construction assessment.	<b>Description</b>	At edge of LOD, view of unimpacted resource area conditions during pre-construction assessment.

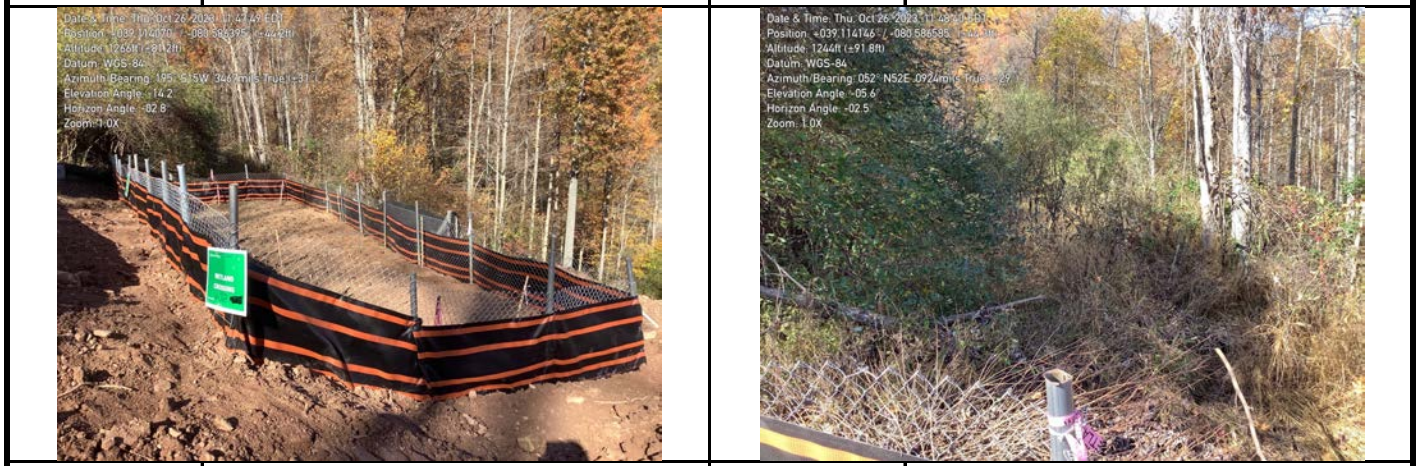
Conditions 18 and 19 were given a rating of 4 during post-construction assessment due to lack of vegetation in the disturbed permitted impact area following the completion of the crossing and restoration efforts. The W-J23 substrate has been properly stabilized and the disturbed area has been seeded with the appropriate permanent seed mix in accordance with Appendix B: Restoration Work Plan of the Mountain Valley Pipeline Comprehensive Stream and Wetland Monitoring, Restoration and Mitigation Framework.

<b>GPS Location</b>	See above.	<b>GPS Location</b>	See above.
<b>Description</b>	View of permitted resource impact area during post-construction assessment.	<b>Description</b>	At edge of LOD, view of unimpacted resource area conditions during post-construction assessment.

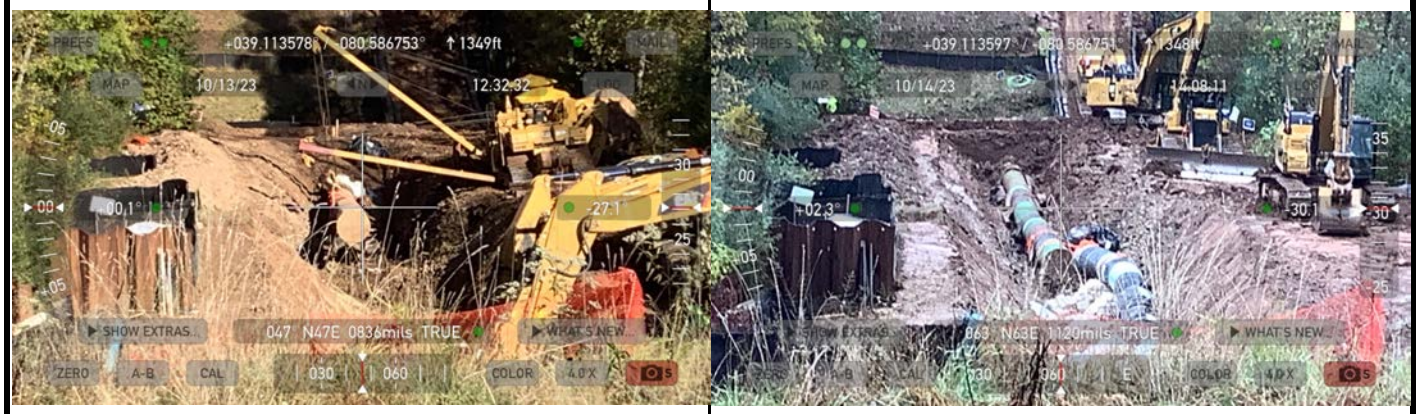
<b>GPS Location</b>	See above.	<b>GPS Location</b>	See above.
<b>Description</b>	Crew inserted pipe into trench after excavation.	<b>Description</b>	Pipe in ground.

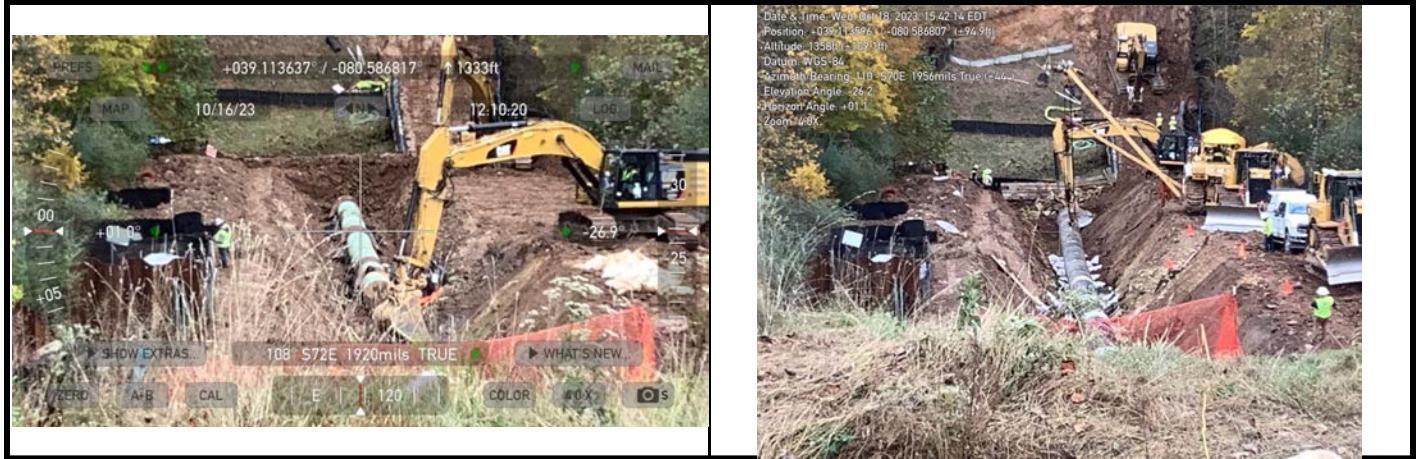
<b>GPS Location</b>	See above.	<b>GPS Location</b>	See above.
<b>Description</b>	Crew repositioned pipe and excavated more trench.	<b>Description</b>	The pipe section inside of the wetland was being welded.

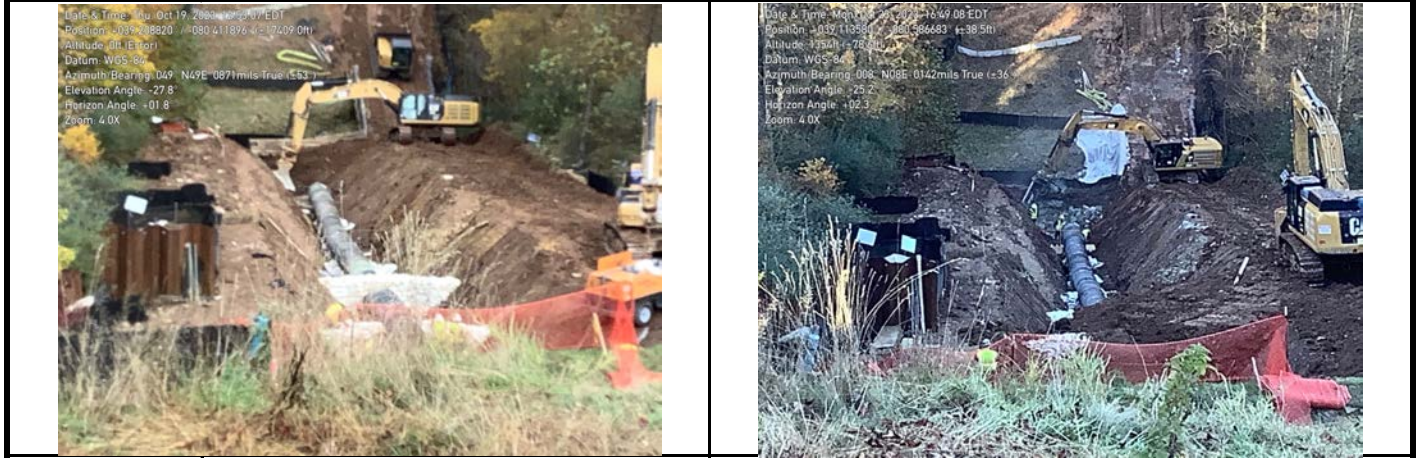
<b>GPS Location</b>	See above.	<b>GPS Location</b>	See above.
<b>Description</b>	Trench breakers installed and pipe being coated.	<b>Description</b>	Crew filling trench with soil.

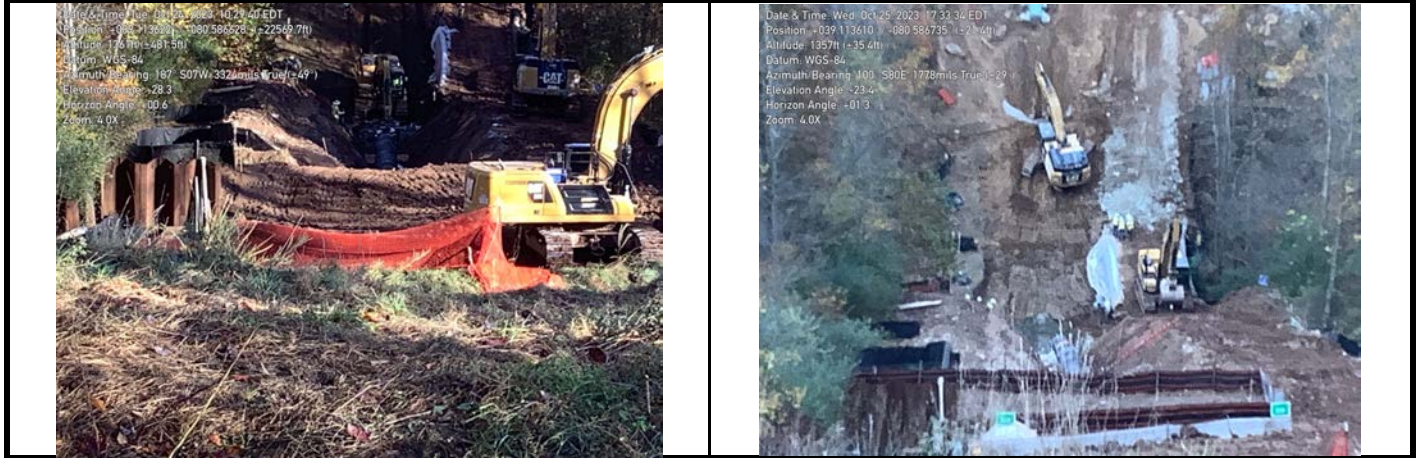
<b>GPS Location</b>	See above.	<b>GPS Location</b>	See above.
<b>Description</b>	Continuation of soil filling.	<b>Description</b>	Installing erosion controls.
