Wetland Biological Conditions EA Report

Project Name	H-600 Pipeline Spread A	A/E	124300129	Spread	H-600 Pipeline Spread A
Contractor	Precision	Report #	94		
Environmental Auditor	Danielle Payne			Date/Time	10/19/2023 11:53 AM
Wetland ID	W-J40	Crossing Start Date	10/23/2023	Crossing Completion Date	10/27/2023
Milepost	38.20	Pre-Con Assessment Date	10/17/2023	Post-Con Assessment Date	10/27/2023
Station	2016+93	Cowardin Classification	PEM	Wetland Impact Area(acres)	1.812
State	WV				
County	Lewis

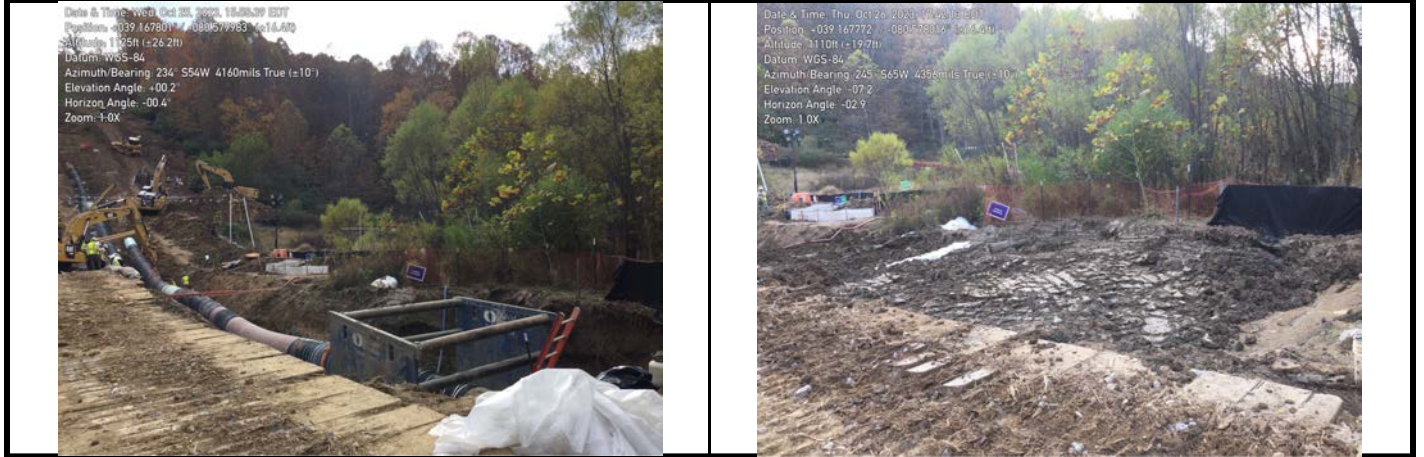
Description	View of pipe as construction continued.	Description	View of area while backfilling progressed.
--------------------	---	--------------------	--
