Wetland Biological Conditions EA Report

Project Name	H-600 Pipeline Spread D	AFE	124300132	Spread	H-600 Pipeline Spread D
Contractor	Precision	Report #	110		
Environmental Auditor	Gary Cruz			Date/Time	10/27/2023 10:37 AM
Wetland ID	W-J7	Crossing Start Date	10/23/2023	Crossing Completion Date	11/1/2023
Milepost	122.47	Pre-Con Assessment Date	10/23/2023	Post-Con Assessment Date	11/1/2023
Station	6466+43	Cowardin Classification	PFO	Wetland Impact Area(acres)	0.0693
State	WV				
County	Nicholas

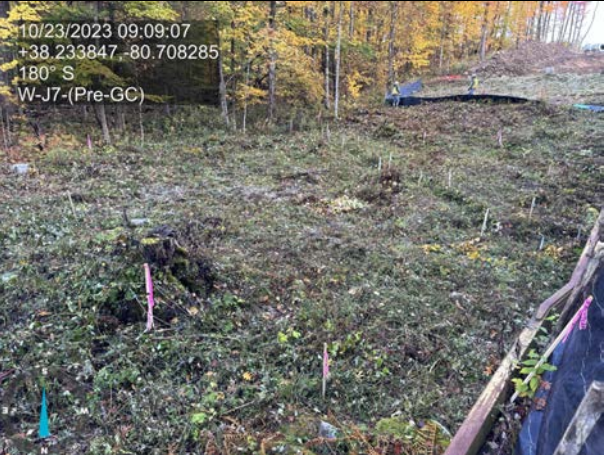
<p>10/23/2023 09:09:07 +38.233847,-80.708285 180° S W-J7-(Pre-GC)</p>

<p>10/23/2023 09:12:31 +38.233645,-80.708213 141° SE W-J7-(Pre-GC)</p>		GPS Location	See photo above	GPS Location	See photo above
Description	View of permitted resource impact area during pre-construction assessment.	Description	At edge of LOD, view of unimpacted resource area conditions during pre-construction assessment.

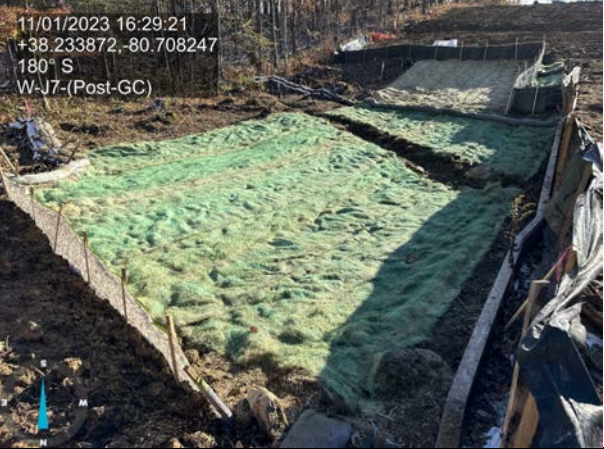
<p>11/01/2023 16:29:21 +38.233872,-80.708247 180° S W-J7-(Post-GC)</p>

Conditions 18 & 19 were given a rating of 4 due to the lack of vegetation in the disturbed permitted impact area following completion of the crossing and restoration efforts. The W-J7 PFO topsoil has been properly stabilized and the disturbed area has been seeded with the appropriate permanent seed mix in accordance with Appendix B: Restoration Work Plan of the Mountain Valley Pipeline Comprehensive Stream and Wetland Monitoring, Restoration and Mitigation Framework.

<p>11/01/2023 16:30:52 +38.233628,-80.708318 162° S W-J7-(Post-GC)</p>		GPS Location	See photo above	GPS Location	See photo above
Description	View of permitted resource impact area during post-construction assessment.	Description	At edge of LOD, view of unimpacted resource area conditions during post-construction assessment.

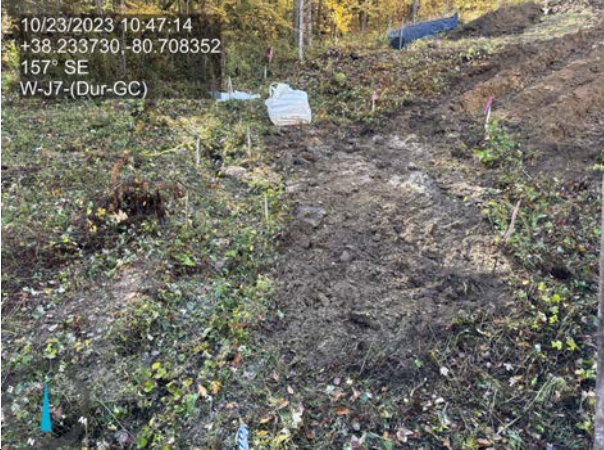
<p>10/23/2023 10:47:14 +38.233730,-80.708352 157° SE W-J7-(Dur-GC)</p>

Description	Contractor began removing top 12" of topsoil.	Description	Blasting crew setting up markers for drill holes.
