Wetland Biological Conditions EA Report

| Project Name | H-600 Pipeline Spread B | AFE | 124300130 | Spread | H-600 Pipeline Spread B |
| Wetland ID | W-K31 | Crossing Start Date | 10/16/2023 | Crossing Completion Date | 11/7/2023 |

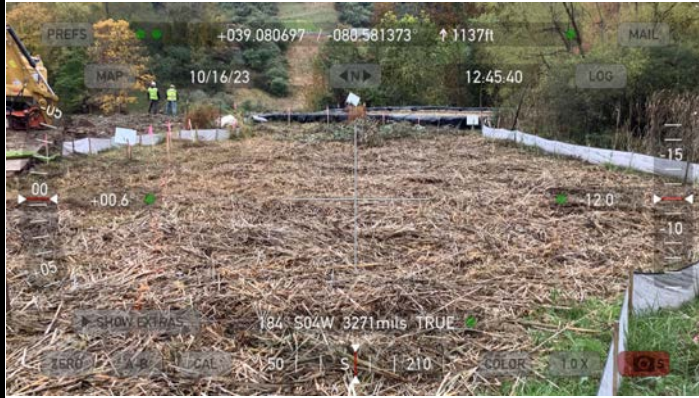
| Description | View of permitted resource impact area during pre-construction assessment. |

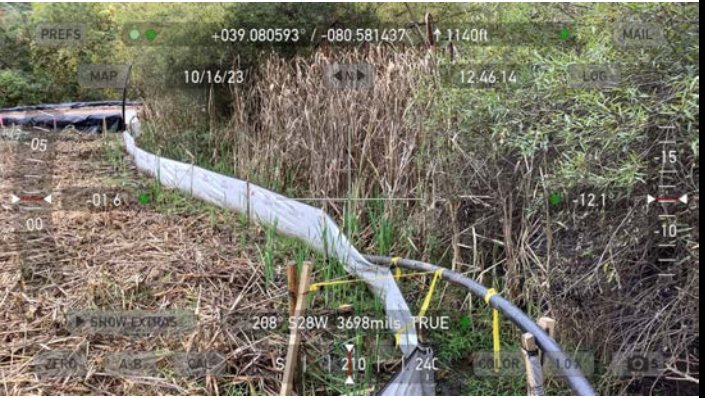
| Description | At edge of LOD, view of unimpacted resource area conditions during pre-construction assessment. |

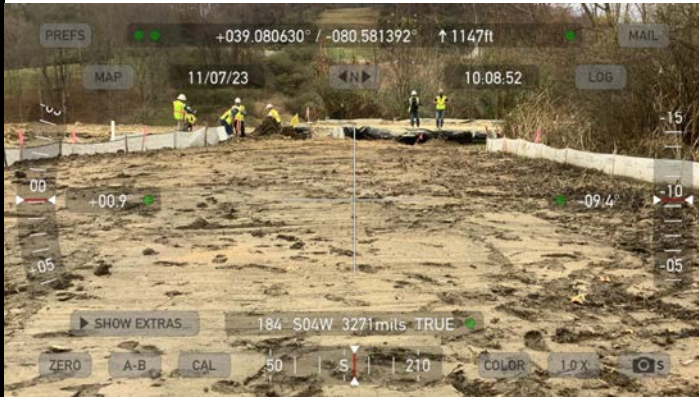
Post Construction Assessment
 Conditions 18 and 19 were given a rating of 4 during the post-construction assessment due to the lack of vegetation in the disturbed permitted impact area following the completion of the crossing. The W-K31 topsoil was seeded with the appropriate permanent seed mix in accordance with Appendix B: Restoration Work Plan of the Mountain Valley Pipeline Comprehensive Stream and Wetland Monitoring, Restoration and Mitigation Framework.

| Description | View of permitted resource impact area during post-construction assessment. |

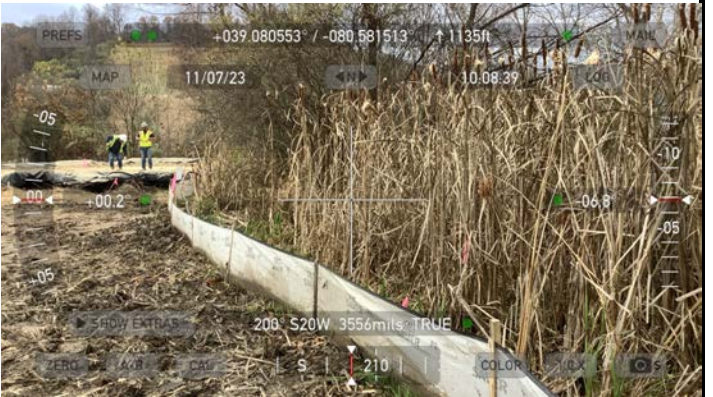
| Description | At edge of LOD, view of unimpacted resource area conditions during post-construction assessment. |

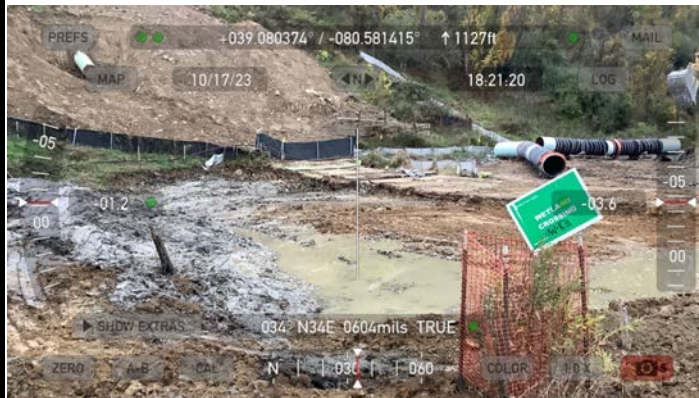
| Description | Soil segregation continued and groundwater was pumped out as needed. |

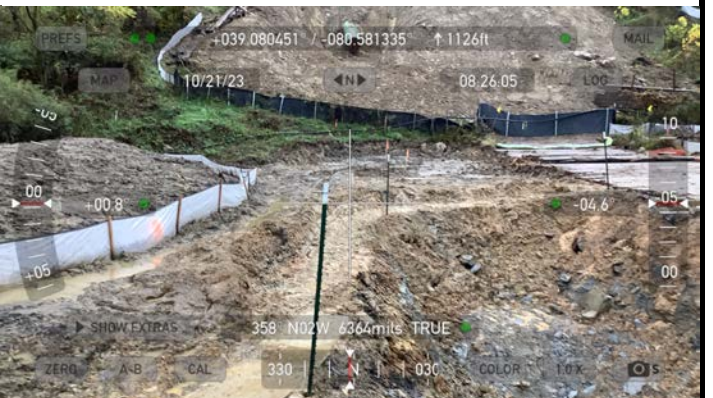
| Description | The digging of the trench continued. |

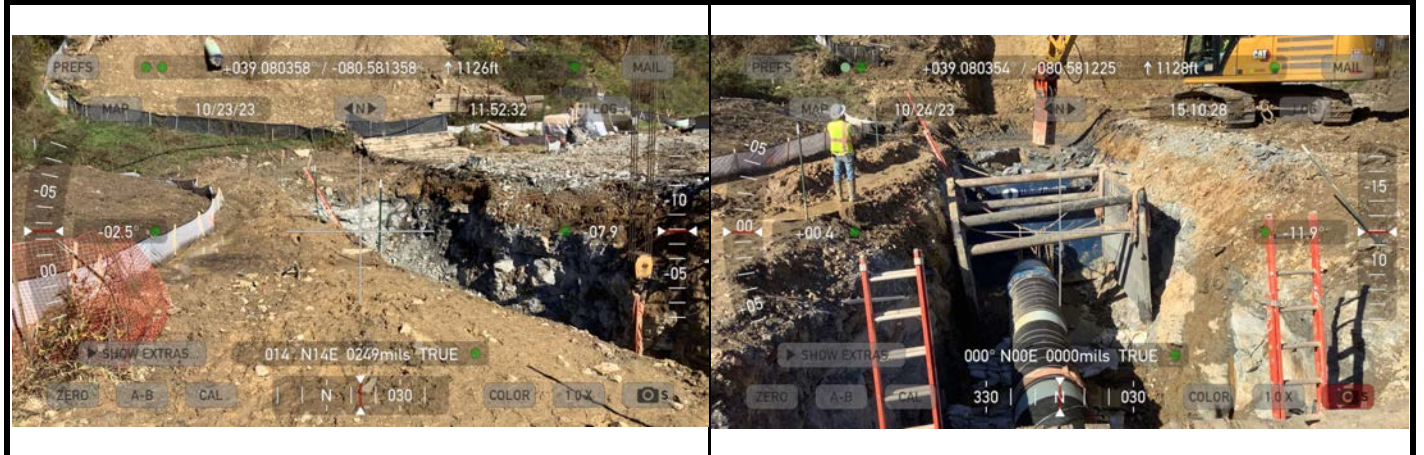
| Description | The welding on the first pipe section began. | Description | The bedrock removal continued. |

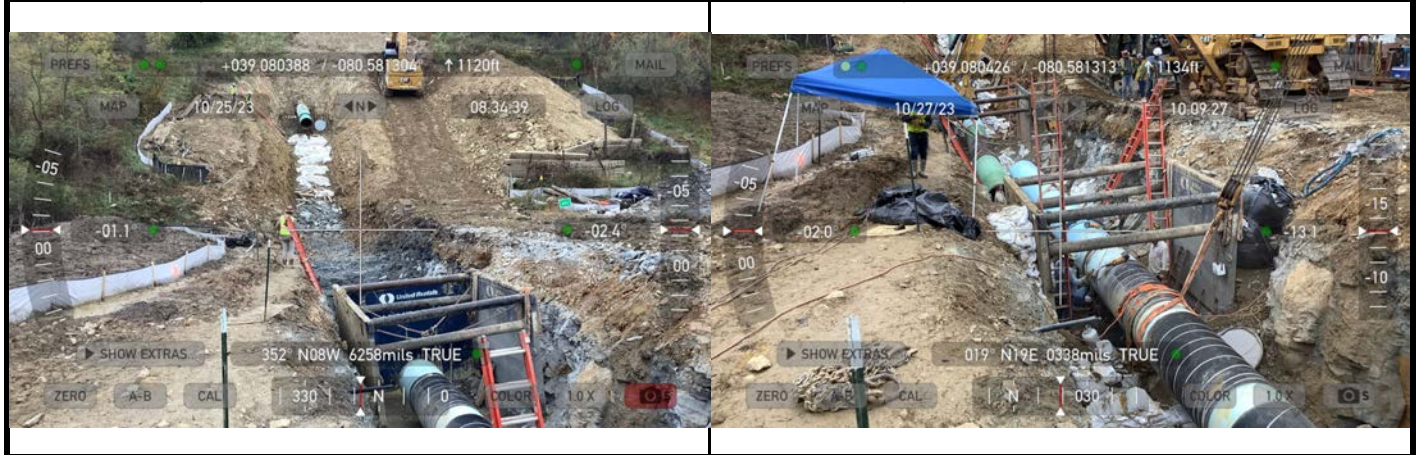
| Description | The bedrock removal continued. | Description | The welding on the pipe continued. |

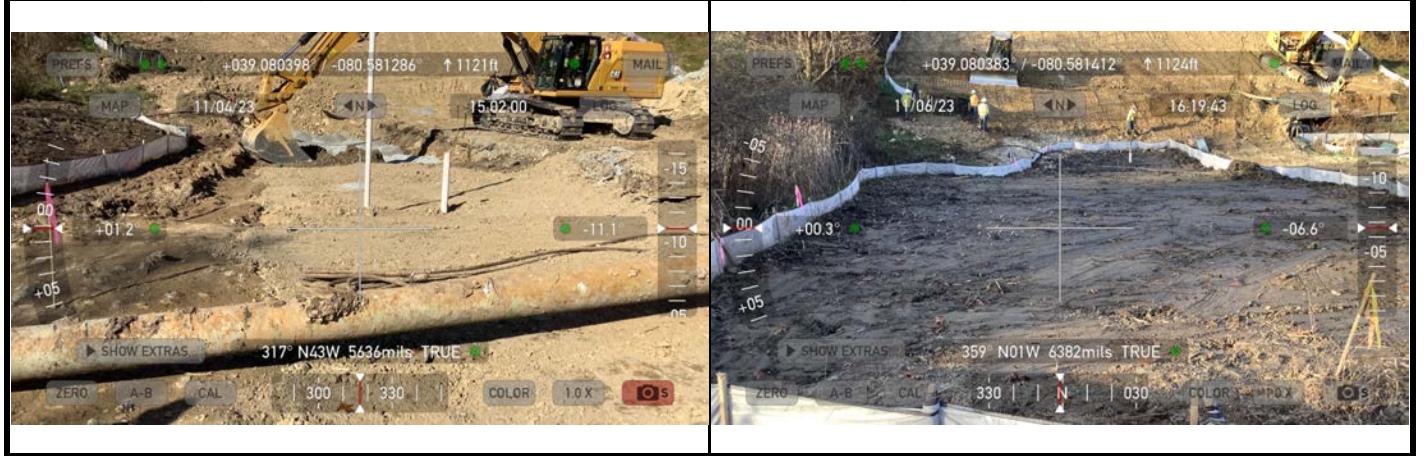
| Description | The backfilling continued. | Description | The topsoil was returned. |
