Wetland Biological Conditions EA Report

Project Name	H-600 Pipeline Spread F	A/E	124300135	Spread	H-600 Pipeline Spread F
Contractor	Price Gregory	Report #	93		
Environmental Auditor	Alyssa Jones			Date/Time	10/20/2023 11:12 AM
Wetland ID	W-OP1-PEM	Crossing Start Date	10/23/2023	Crossing Completion Date	11/13/2023
Milepost	179.10	Pre-Con Assessment Date	10/20/2023	Post-Con Assessment Date	11/13/2023
Station	9456+48	Cowardin Classification	PEM	Wetland Impact Area(acres)	0.1359
State	WV				
County	Monroe

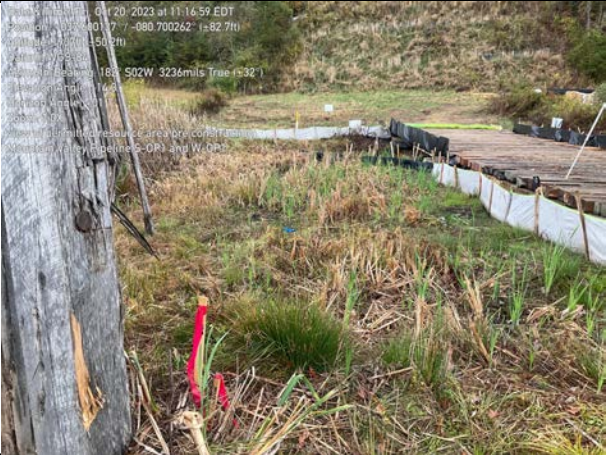
<p>View of permitted resource impact area during pre-construction assessment.</p>

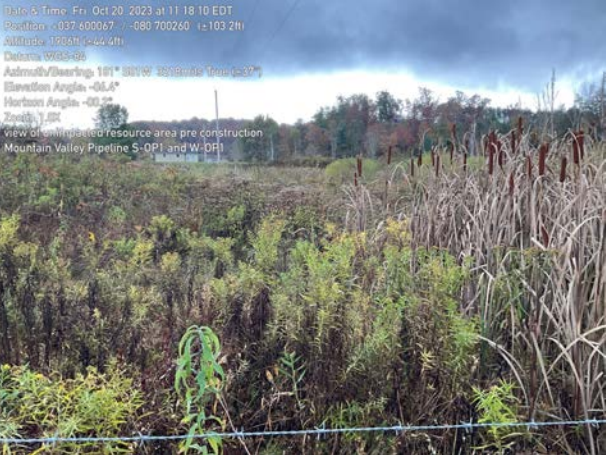
<p>At edge of LOD, view of unimpacted resource area conditions during pre-construction assessment.</p>

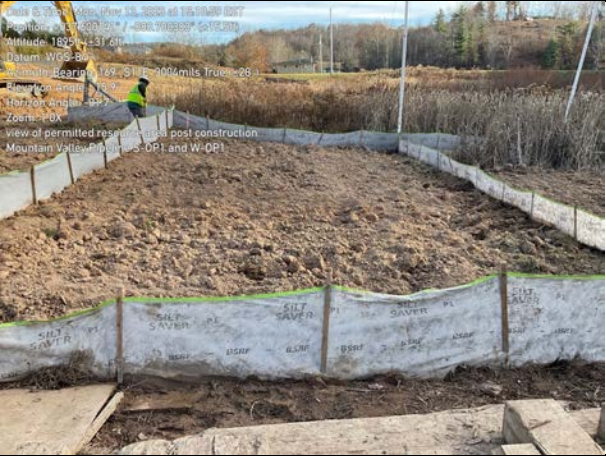
<p>View of permitted resource impact area during post-construction assessment.</p>

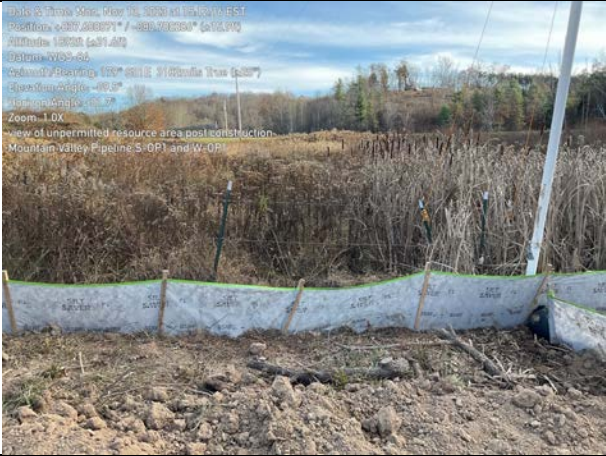
<p>At edge of LOD, view of unimpacted resource area conditions during post-construction assessment.</p>

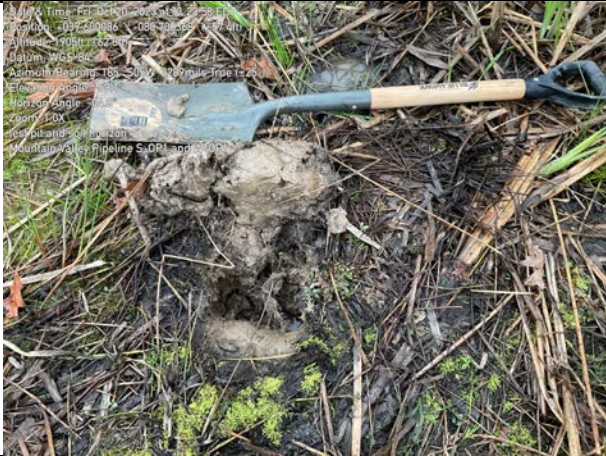
- 17. Wetland test pit recharged. Saturated soils present (Photo1).
- 18. Timber mats in place prior to assessment. Wetland topsoil removed and excavation occurred at this site in 2018.
- 19. Wetland topsoil was not restored during 2018 construction; however, vegetative growth has occurred.

<p>Photo 1: Test pit and soil horizon</p>

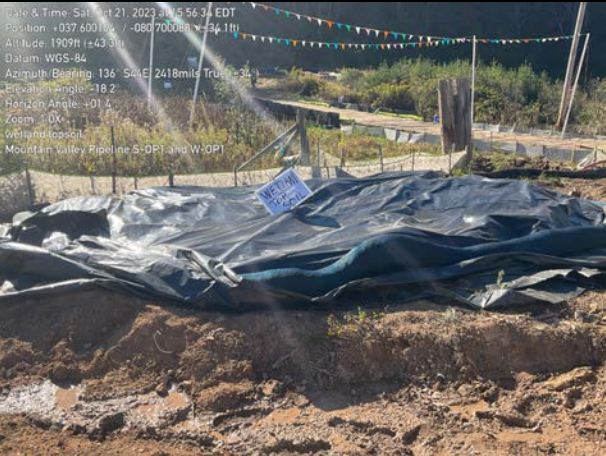
10/21/2023 - Initiated wetland topsoil removal. Excavated topsoil segregated and stored in work area (Photo 2). Began to excavate trench late in day; however, backfilled due to safety concerns.

<p>Photo 2: Segregated wetland topsoil in work area.</p>

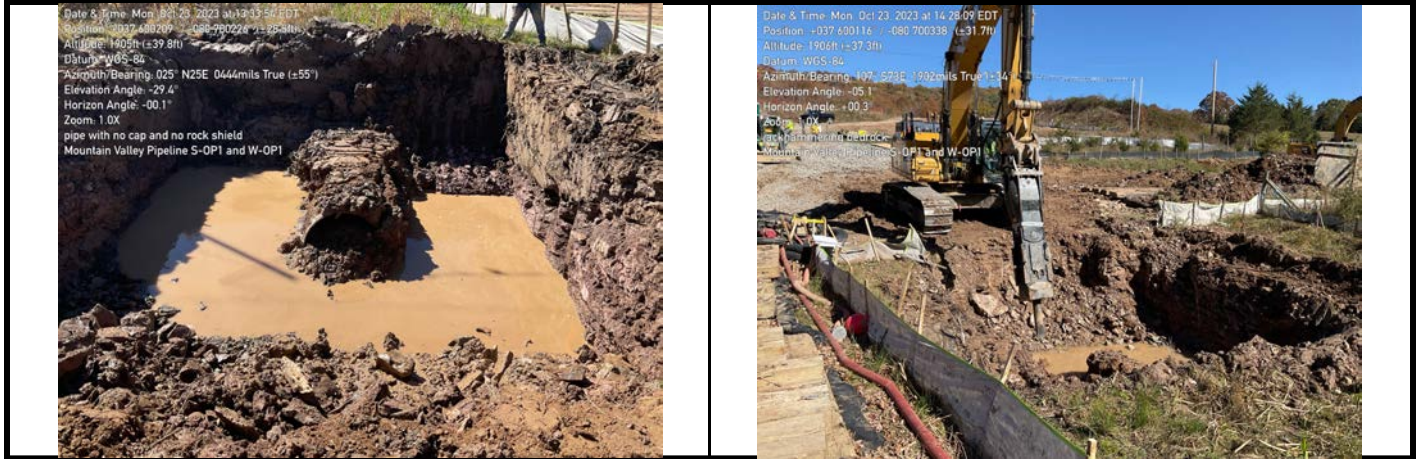
10/23/2023 - Began excavating to expose pipe. Began pumping water from trench in aquatic resource. Additional wetland topsoil excavated, segregated and stored in work area. Once pipe exposed excavating continued around pipe including hammering (Photo 3 and 4).

GPS Location See Photo	GPS Location See Photo
Description Photo 3: Exposed pipe in aquatic resource.	Description Photo 4: Hammering in aquatic resource.

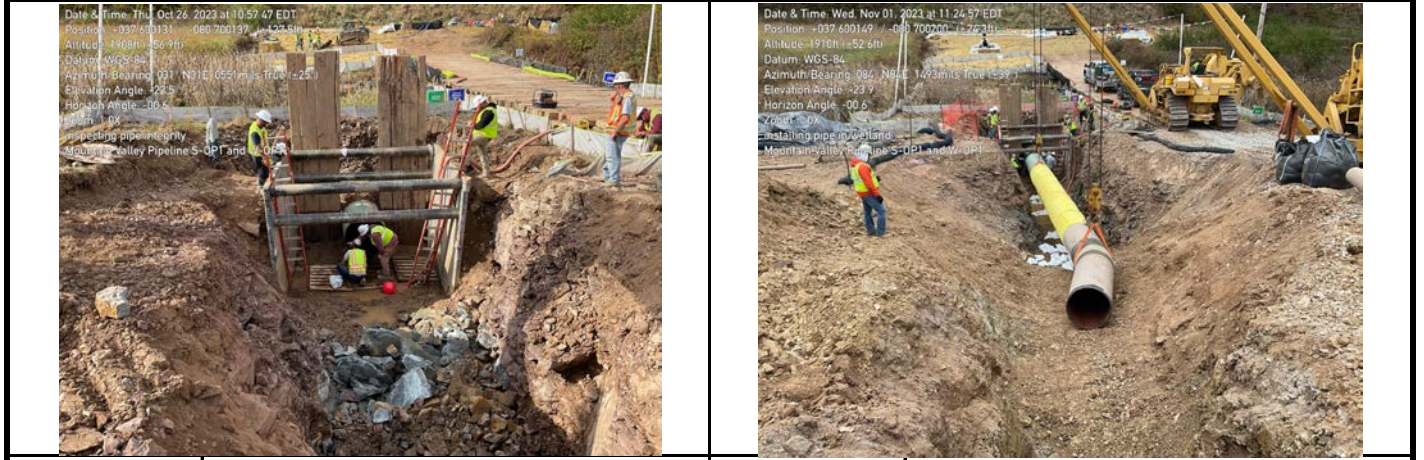
10/26/2023 - Pumping water from trench in aquatic resource. Survey marked pipe trajectory. Final pipe inspection (Photo 5), five inches to cut from end of pipe. 811 paperwork obtained. Began to excavate trench out of aquatic resource on opposite side of road.

11/1/2023 - Pumping water from trench in aquatic resource. Installing rock shield. Sandbags for padding added to trench. Pipe placed in trench (Photo 6) and welding began.

GPS Location See Photo	GPS Location See Photo
Description Photo 5: Pipe inspection.	Description Photo 6: Installing pipe in trench in aquatic resource area.

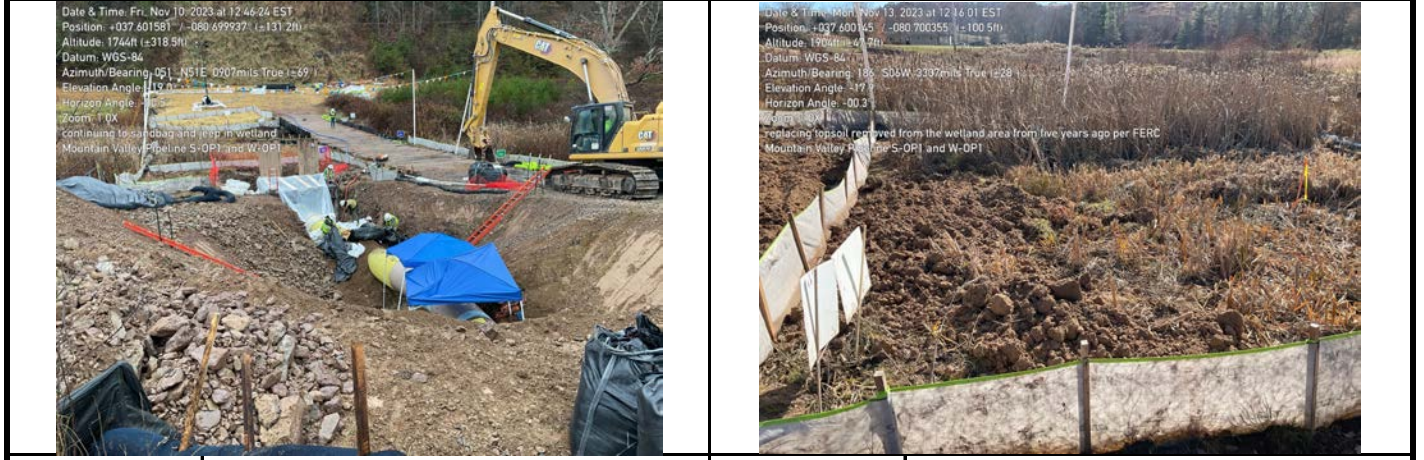
11/10/2023 - Sandblasting, coating, and coating of pipe and adding padding and backfill to trench ongoing. Constructing trench breaker adjacent to aquatic resource (Photo 7). Concrete poured into trench between two quikcrete trench breakers.

11/13/2023 - Survey onsite. Topsoil restored. Topsoil from 2018 construction also restored as per FERC (Photo 8). Aquatic resource seeded. Survey signed off on boundaries. Restoration complete.

GPS Location See Photo	GPS Location See Photo
Description Photo 7: Backfilling and constructing trench breaker outside of aquatic resource.	Description Photo 8: Restoring wetland topsoil removed during 2018 construction as per FERC instruction.
