# STREAM BIOLOGICAL CONDITIONS ENVIRONMENTAL AUDITOR REPORT

<b>Stream ID:</b> S-CC1	<b>Crossing Start Date:</b> 11/16/2023	<b>Crossing Completion Date:</b> 11/20/2023
<b>Milepost:</b> 295.2	<b>Pre-Con Assessment Date:</b> 11/11/2023	<b>Post-Con Assessment Date:</b> 11/22/2023
<b>Station:</b> 15596+32	<b>Stream Classification:</b> Perennial (Perennial, Intermittent, Ephemeral)	<b>Bankfull Width (ft.):</b> 15
<b>County:</b> Pittsylvania	<b>303(d) Impairment Listing:</b> Impaired	<b>Riffle:Pool Complexes Present?</b> Yes

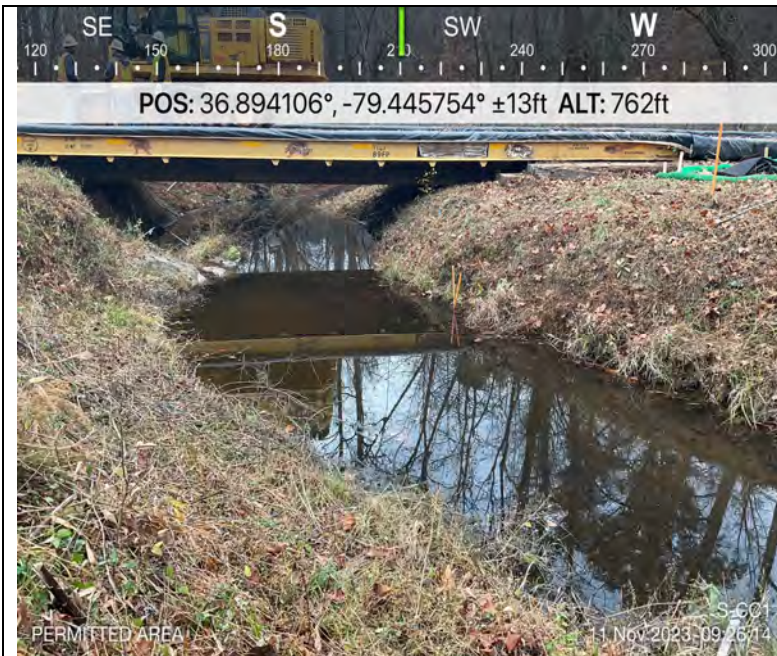
**Photo Description:** Downstream view of permitted impact area during pre-construction assessment.

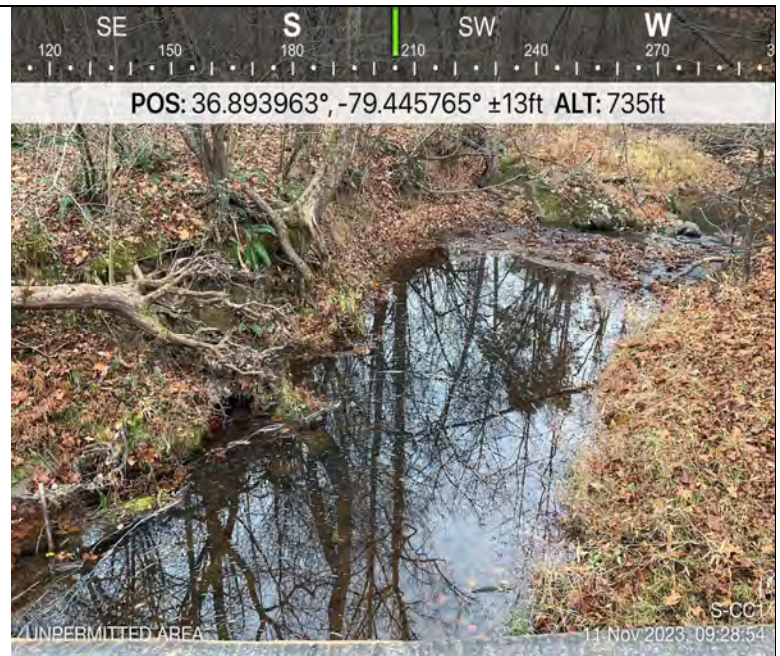
**Photo Description:** Conditions of the downstream area outside the ROW during pre-construction assessment.

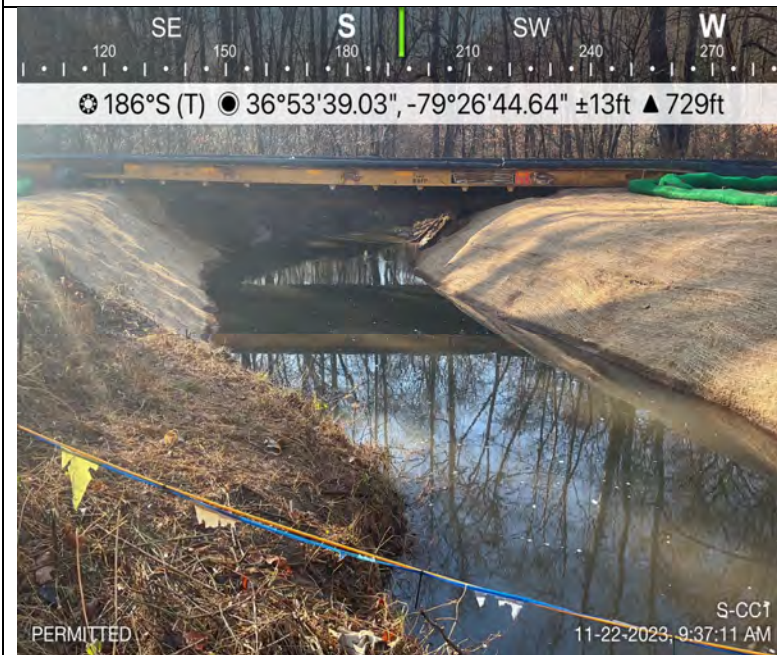
**Photo Description:** Downstream view of permitted impact area during post-construction assessment.

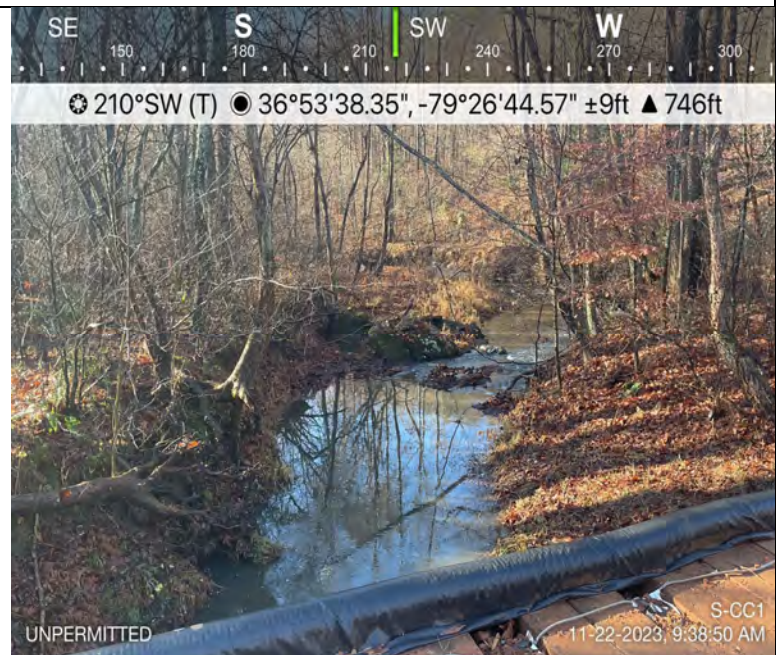
**Photo Description:** Conditions of the downstream area outside the ROW during post-construction assessment.

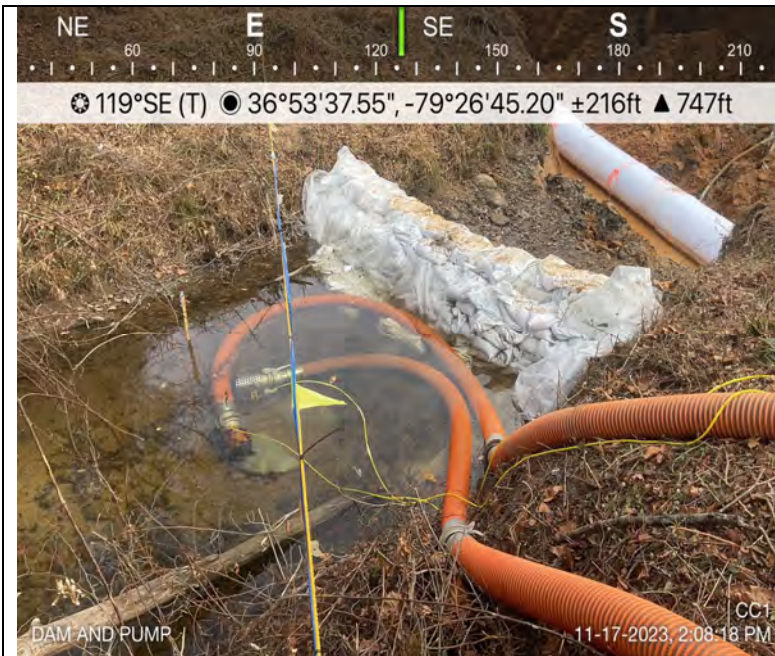
**Photo Description:** The dam and pump installed and functioning.

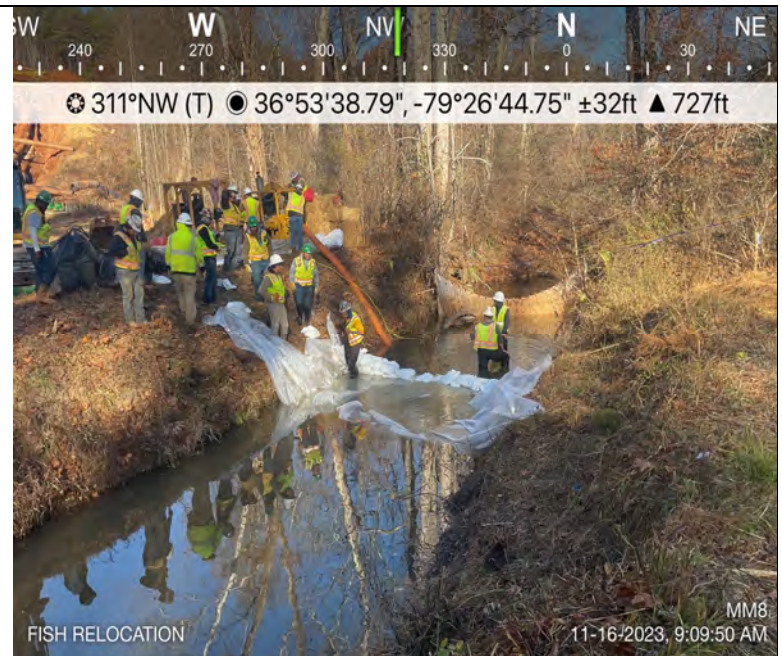
**Photo Description:** Fish relocation.

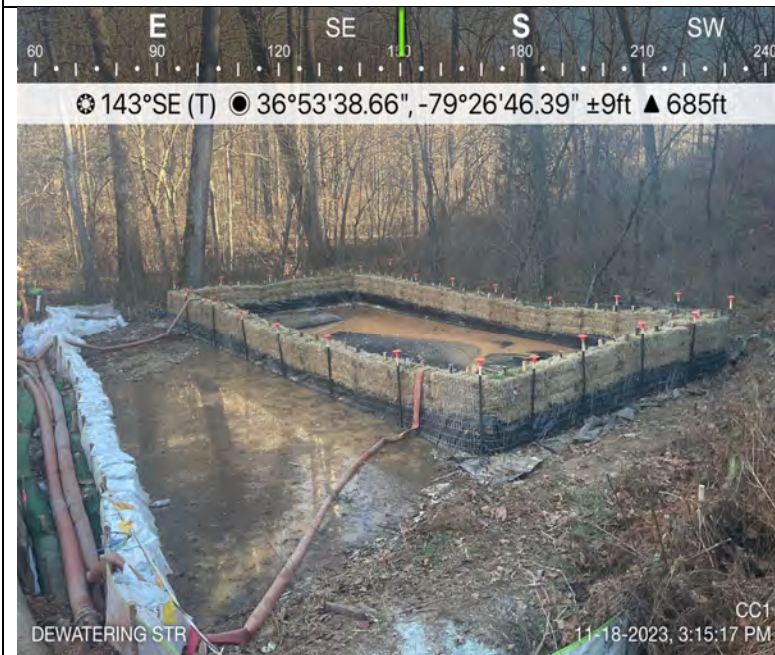
**Photo Description:** An overview of the dewatering structure.

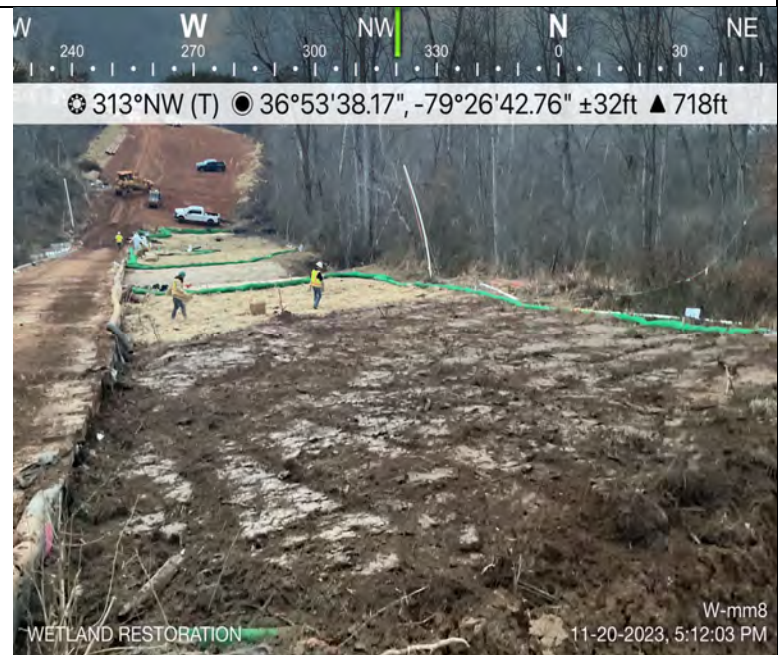
**Photo Description:** Seed and straw mulch applied during site restoration.
