Stream Biological Conditions EA Report

Project Name	H-600 Pipeline Spread F	AFE	124300135	Spread	H-600 Pipeline Spread F
Contractor	Price Gregory	Report #	361		
Environmental Auditor	Elyse Johnston	Date/Time	11/16/2023 8:59 AM		
Stream ID	S-E45	Crossing Start Date	11/17/2023	Crossing Completion Date	12/14/2023
Milepost	191.60	Pre-Con Assessment Date	11/15/2023	Post-Con Assessment Date	12/15/2023
Station	10116+48	Bankfull Width (ft.)	3.0	Riffle:Pool Complexes Present?	No
State	WV	Stream Classification	Ephemeral		
County	Monroe	303(d) Impairment Listing	No

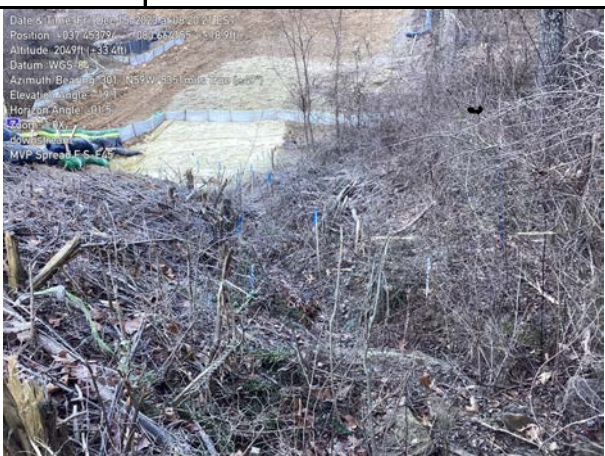
<p><small>Date & Time: Wed Nov 15, 2023 10:35:45 EST Position: -037.453788, -080.664533, 117.65m Altitude: 2037ft (-39.1ft) Datum: WGS-84 Azimuth Bearing: 197.517W-3502mils True (-12) Elevation Angle: -08.6 Horizon Angle: -03.0 Zoom: 1.0X -0.443.45 of LOD MVP ERM</small></p>	  <p><small>Date & Time: Wed Nov 15, 2023 10:37:54 EST Position: -037.453788, -080.664533, 117.65m Altitude: 2037ft (-39.1ft) Datum: WGS-84 Azimuth Bearing: 197.517W-3502mils True (-12) Elevation Angle: -08.6 Horizon Angle: -03.0 Zoom: 1.0X -0.443.45 of LOD MVP ERM</small></p>
GPS Location See Photo	GPS Location See Photo
Description Downstream view of permitted impact area during pre-construction assessment.	Description Downstream view of unimpacted area during pre-construction assessment.

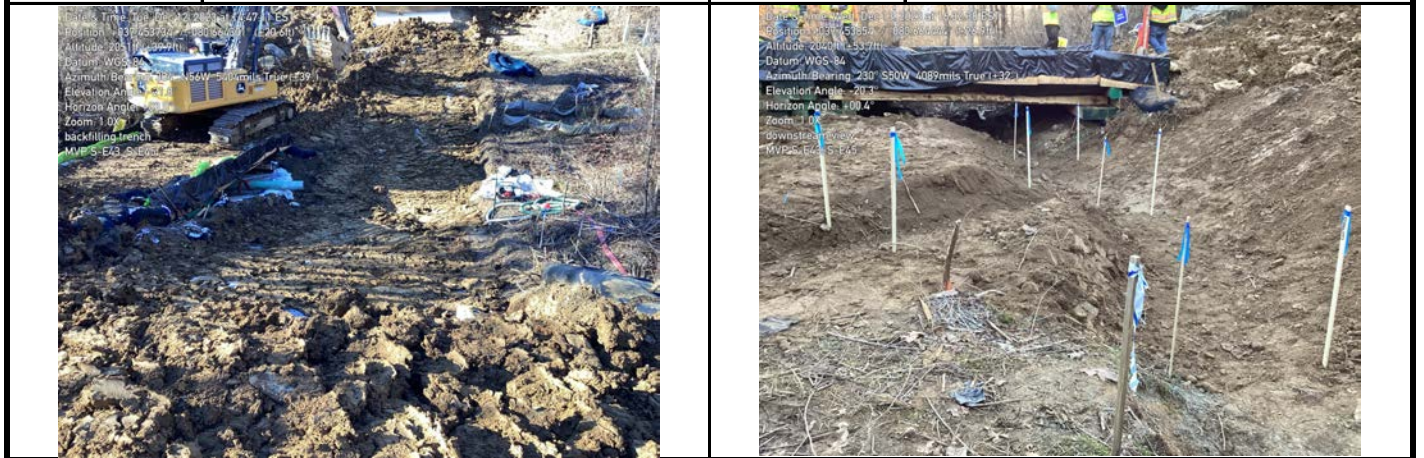
GPS Location	See Photo	GPS Location	See Photo
Description	Photo 5: Pipe lowered into trench and flume pipe restored.	Description	Photo 6: Padding and backfilling of trench. Completed trench breaker.
